**1a Ladywell Road
Corstorphine
Edinburgh**

Archaeological Watching Brief

Report No. 3523

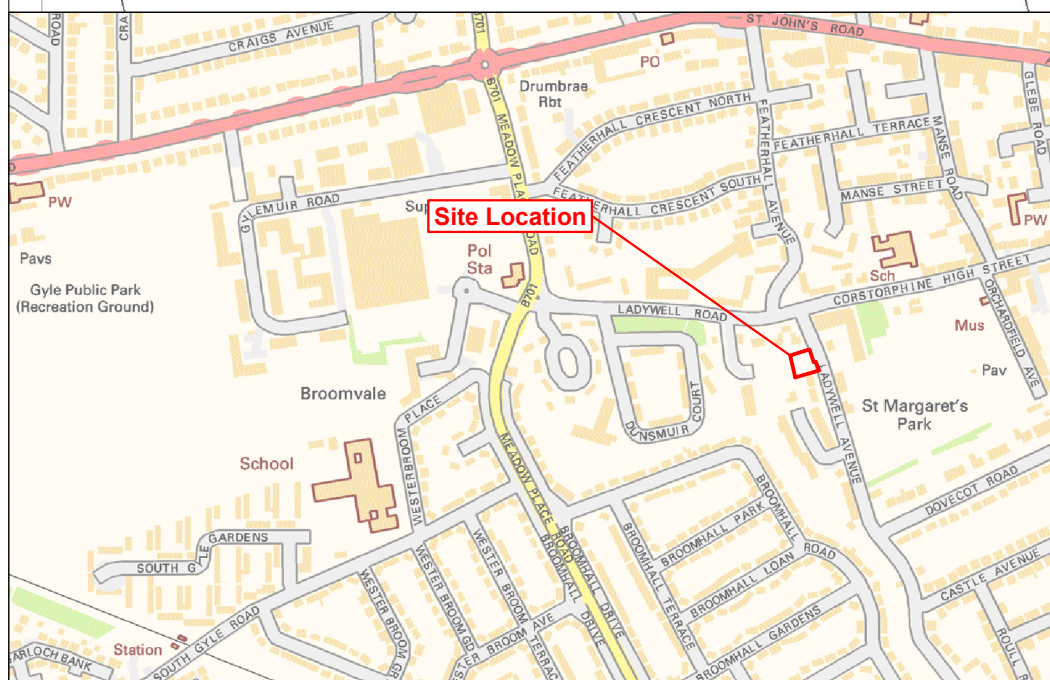
| Report No: 3523 | Fig. No: 1 |

- Site Boundary
- Foundation Trench

Title:
**Site location plan showing
foundation trenches**

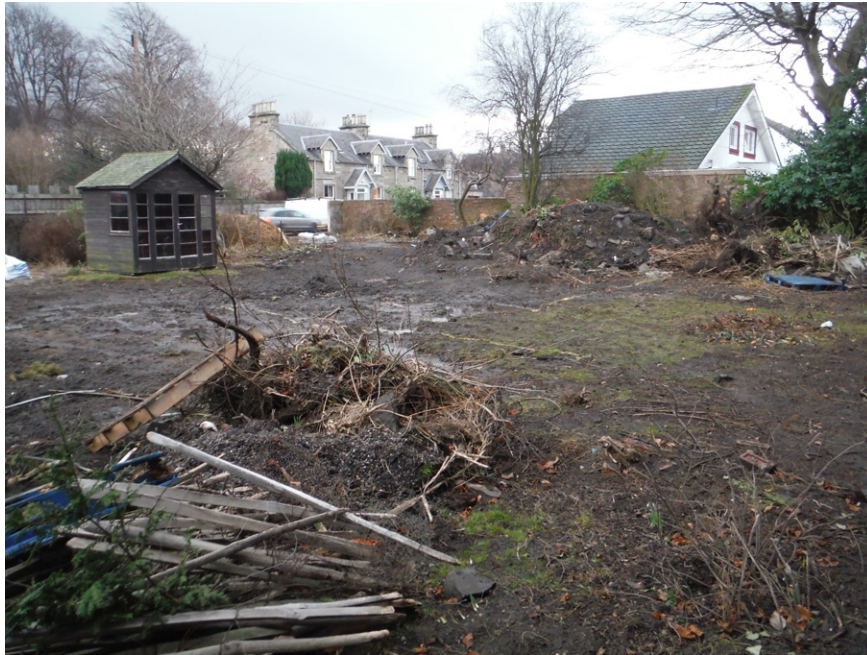
When this watching brief was undertaken in January/February 2017, the area consisted of the former garden of the c.1930s house situated immediately to the north. A recently built wall divided this plot from the aforementioned property and a degree of vegetation/tree removal had been undertaken (Fig. 2).

Fig. 2 - Pre-excitation shot of area from north-west

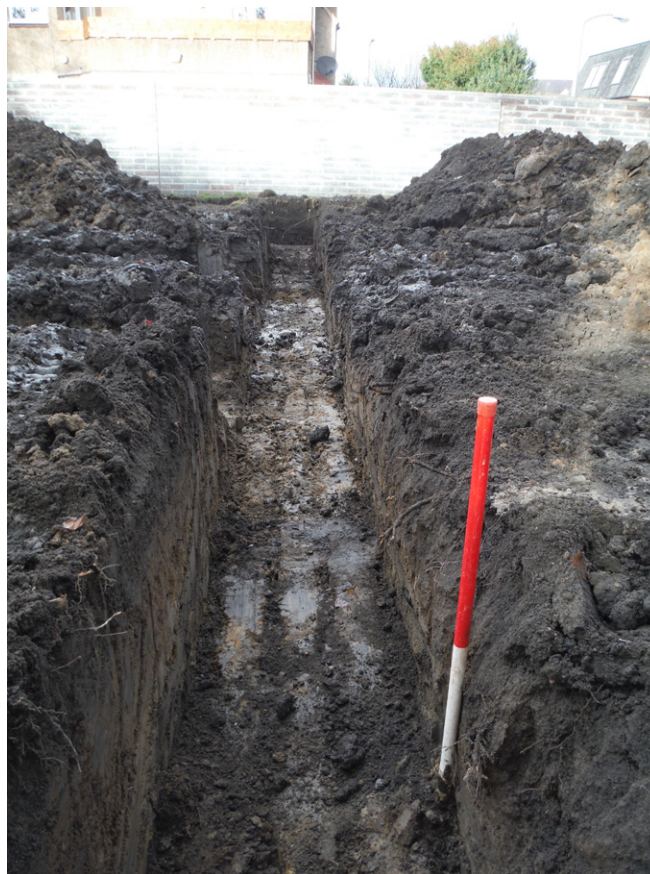
The foundation trenches typically had a width of 0.65m (Fig. 3-4), but were widened out to c.1.6m (Fig. 6) within the area of the two bay-windows along the eastern edge of the proposed house. They were excavated to a depth of up to 0.8m. Natural deposits were encountered at a depth of c.0.4m-0.6m below the current ground surface.

Fig. 3 - Example of foundation trench from south

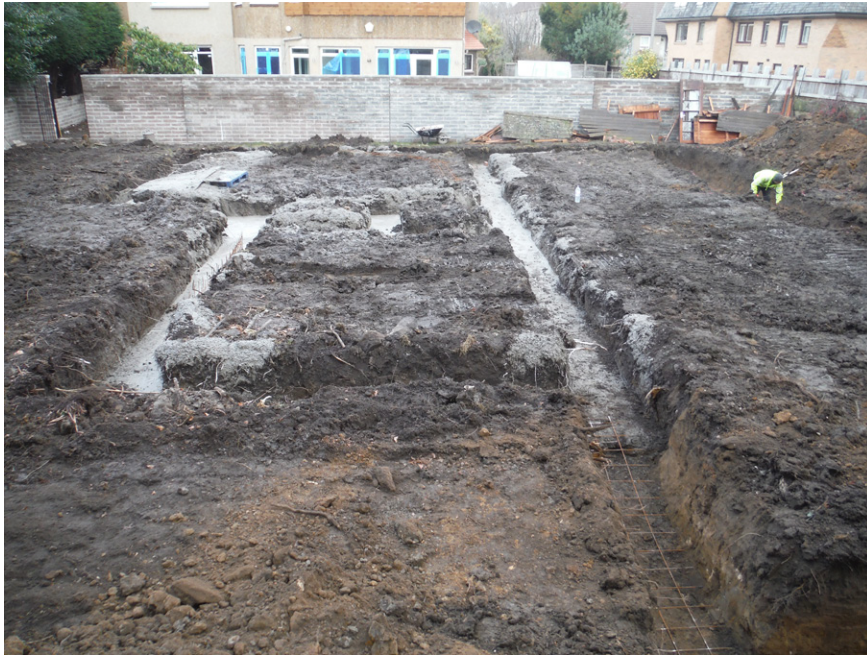
Fig. 4 - General site shot from south

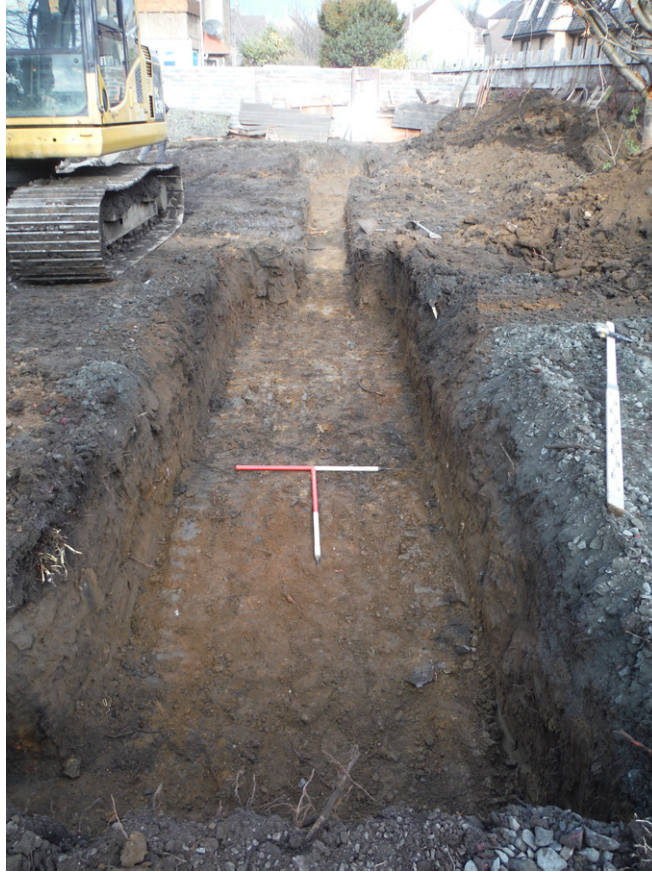
Fig. 6 - Wider foundation trench for bay window from south
