Drumduff Wind Farm, West Lothian

Archaeological Mitigation Works

Report No. 3543

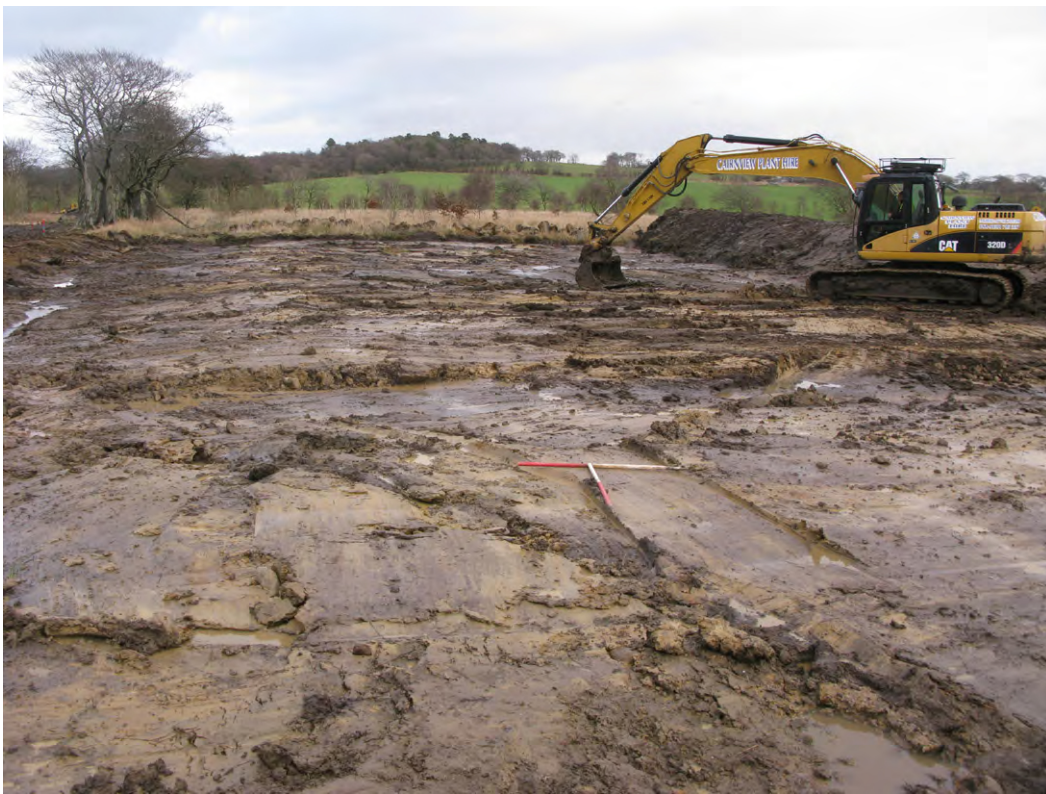
One field bank was recorded during topsoil stripping at the Turbine 2 crane pad (Fig. 2-3). The ground here was waterlogged. The field bank (**004**) ran to the east of the crane pad, orientated NW-SE, measuring at least 10m long by 4m wide (at base) by 0.5m high and comprised mixed loose stony clayey silt. Trees were growing along the top of the field banks around this location. The field bank is likely to relate to Site 2, forming part of an enclosed field system. This may also align to the field boundary depicted within Drum Park Plantation to the north, now masked by afforestation. A section of field bank running along the edge of the haul road was preserved in situ.

Fig. 2 General Post ex of Turbine 2 crane pad looking NE

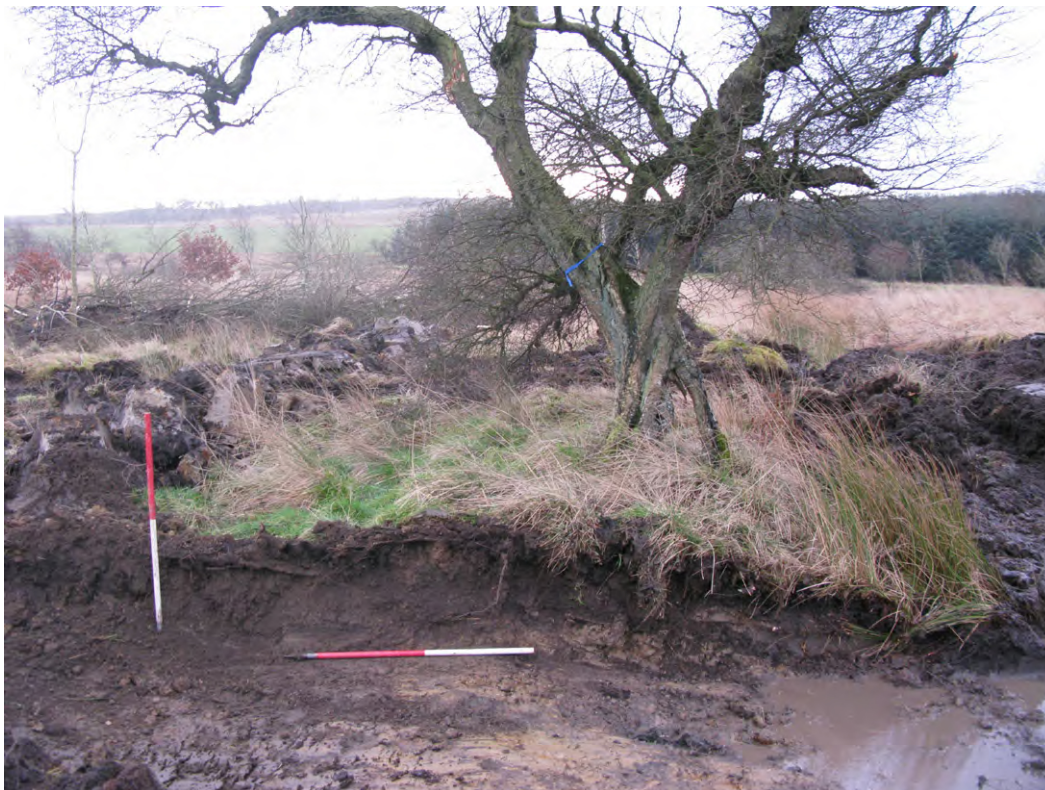
Fig. 3 NW facing section of Field bank 004

Context	Fill of	Description
001		Topsoil. Dark brown clayey silt 0.10m to 0.80m in depth.
002		Natural subsoil consisting of mottled light brown and orange grey clay. Encountered at 0.20-0.40m in depth.
003		Boulder clay. Encountered at 0.20-0.40m in depth.
004		NW-SE aligned mixed loose stony clayey silt. Field bank material with occasional roots. 10m section removed. 4m wide by 0.50m deep.

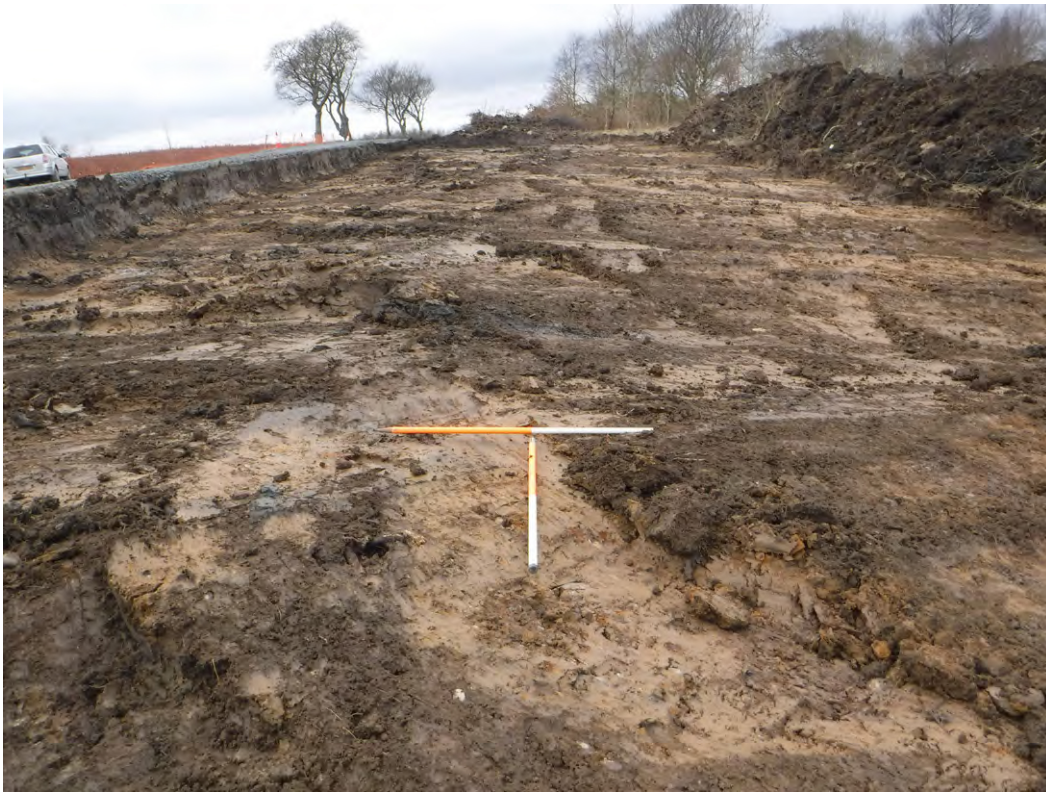
The lay-down area for Turbine 2 was excavated within dispersed woodland to the north of the haul road at Turbine 2 (Fig. 4). The ground here was heavily disturbed by at least six tree boles measuring up to 2m in diameter by 0.50m in depth. These contained upturned tree-stumps, likely felled and redeposited in the 20th century, relating to the open-cast mine nearby. Natural subsoil consisted of mottled light brown and orange/grey clay below 0.1-0.4m of peaty topsoil.

Fig. 4 General Post ex of Turbine 2 lay-down area looking SW

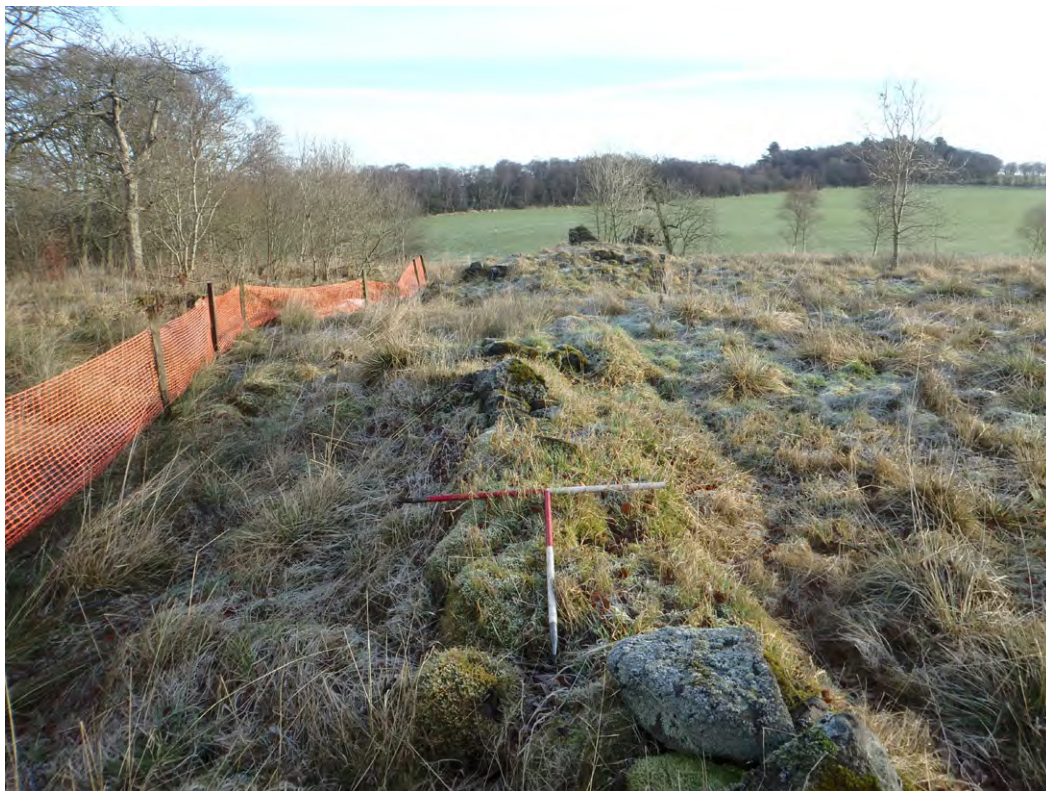
The remains of Sites 1a and 1b were demarcated with orange netlon fencing on wooden posts, and the features remained undamaged by construction activities (Fig. 5).

Fig. 5 Demarcation - Site 1b, looking towards Site 1a

Sites 1a and 1b (Drumduff Farmstead, see Fig. 1 and 5) were demarcated with visible barrier fencing for the duration of groundbreaking works.
