Skipness Castle, Kintyre, Argyll and Bute **PIC101**

Archaeological Watching Brief on Installation of New Boundary Fence, August 2017

Report No. HES-PIC101-2017-01

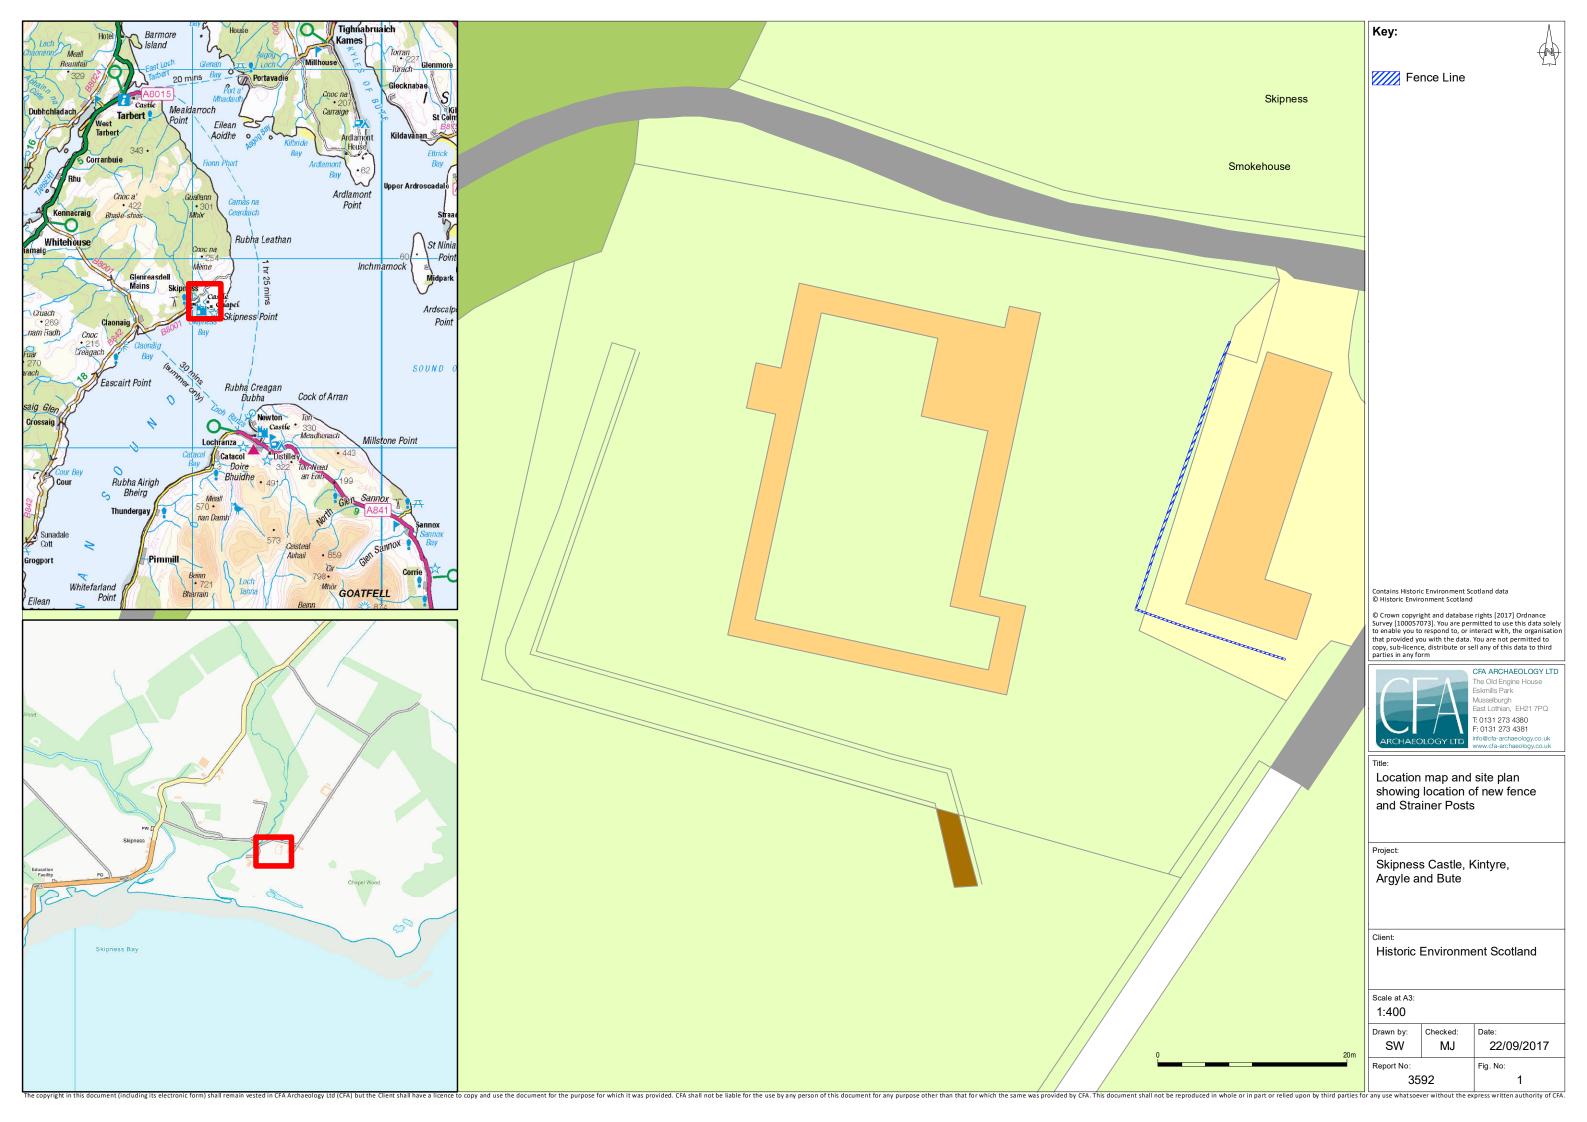
will sit within the guardianship area and its corner will sit within the Scheduled Area. (Fig. 1) In total, 3 Strainer Posts will form both ends and corner of the new fence line.

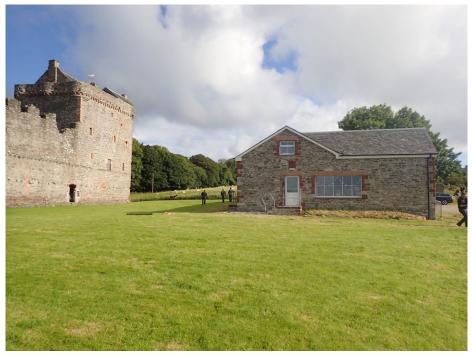
Fig. 2 - New smokehouse building showing location of new fence and strainer posts

To the east of the castle, a group of estate buildings formed an MCU workshop used during the consolidation of the castle. In the early 2000s the buildings were in a dangerous and ruinous state but have recently been renovated and re-roofed for use as a smokehouse (Fig. 2). It is this building that the estate fence is to be installed around. The smokehouse is out with the guardianship area however the new surrounding fence

Prior to excavation, the area was covered with lawn (Fig. 2, Fig. 6), adjacent to the smokehouse building.

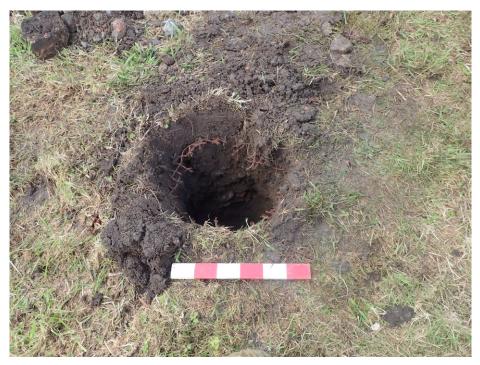
Fig. 3 - Post 1, post excavation

Post 1: The excavation for Post 1 was 350mm wide and 900mm deep and disturbed a single context **(001)** (Fig. 3). This was a layer of turf and mid-brown sandy silt topsoil which contained numerous small, rounded pebbles. Directly under the turf at 200mm the hole cut through a section of orange, modern nylon fishing net. Two fragments of modern brick were also found within **001** but not retained.

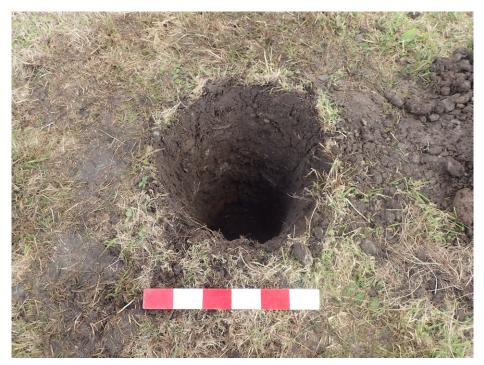
Fig. 4 - Post 2, post excavation

Post 2: The excavation for Post 2 was 400mm wide and 970mm deep and disturbed a single context **(001)**. (Fig. 4)

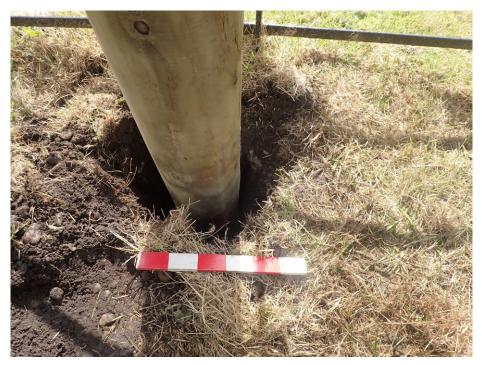
Fig. 5 - Post 3, post excavation

Post 3: The excavation for Post 3 was 400mm wide and 870mm deep and disturbed a single context **(001)**. (Fig. 5)
