**Cowane's Hospital
49 St John Street
Stirling**

Archaeological Test-Pitting

Report No. 3532

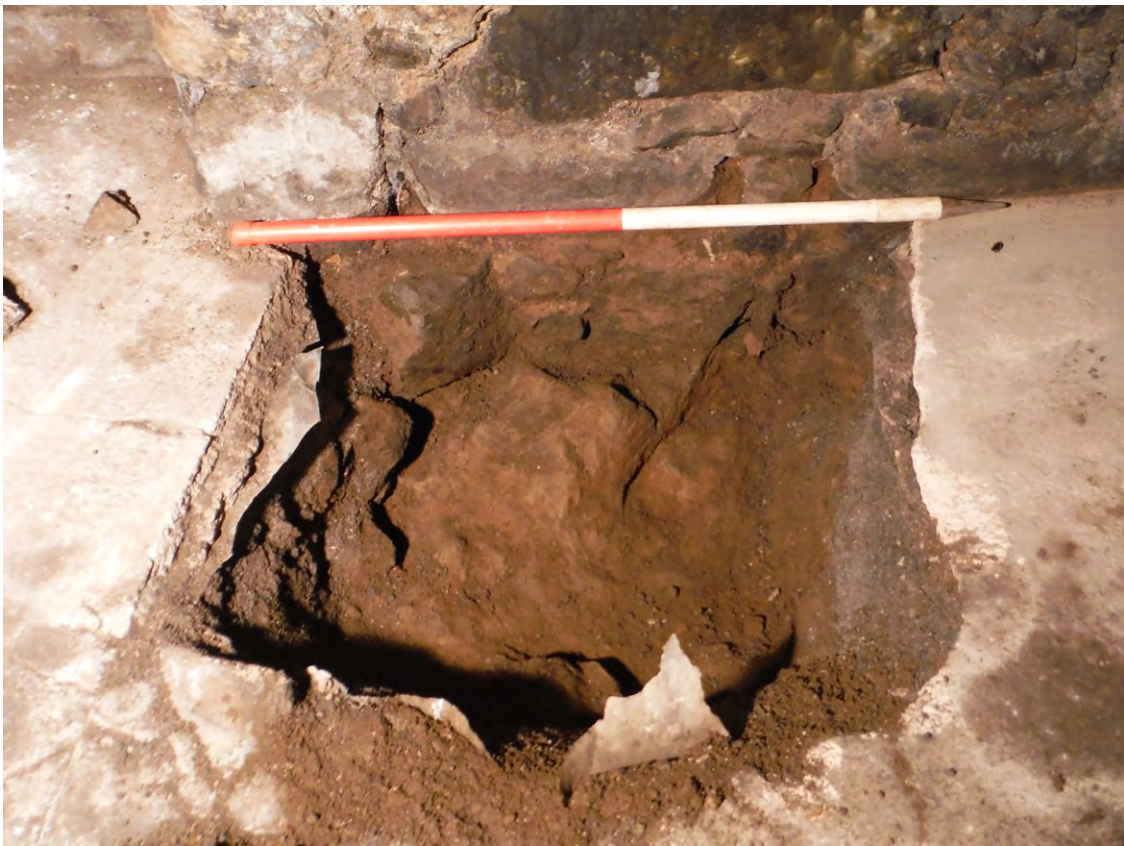
Fig. 3 - TP1, post-excavation

Test Pit 1 (Fig.3) measured 0.8m ENE to WSW by 0.7m NNW to SSE. The layers (Fig.4) from the top downwards consisted of 0.07m of modern concrete (**1/001**); a thin sheet of damp-proofing material (**1/002**); a 0.1m thick leveling deposit of modern hardcore (**1/003**); and a 0.23m thick earlier leveling deposit of mixed orangey-brown sand and mortar (**1/004**). This last layer directly overlay bedrock (**1/005**), which was situated 0.4m below the current floor surface. The hospital walls (**1/006**) sat directly on top of the bedrock, and there was no evidence of any earlier floor surfaces.

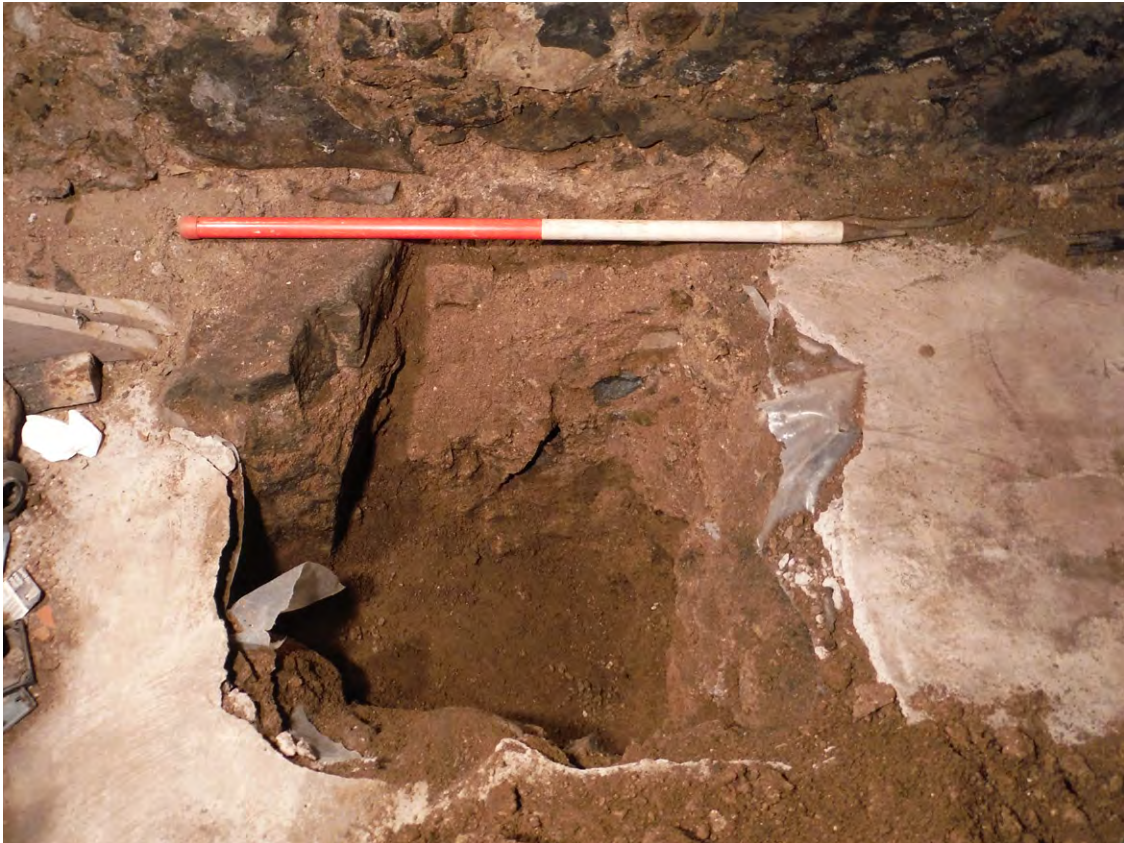
Fig. 5 - TP2, post-excitation

test Pit 2 (Fig.5) measured 0.7m by 0.7m. The layers (Fig.6) from the top downwards consisted of 0.05m of modern concrete (**2/001**); a thin sheet of damp-proofing material (**2/002**); a thin (<0.05m) leveling deposit of modern hardcore (**2/003**); and a c.0.57m thick earlier leveling deposit of orangey-brown sand, rubble and mortar (**2/004**). This last layer directly overlay bedrock (**2/005**), which was situated 0.65m below the current floor surface.

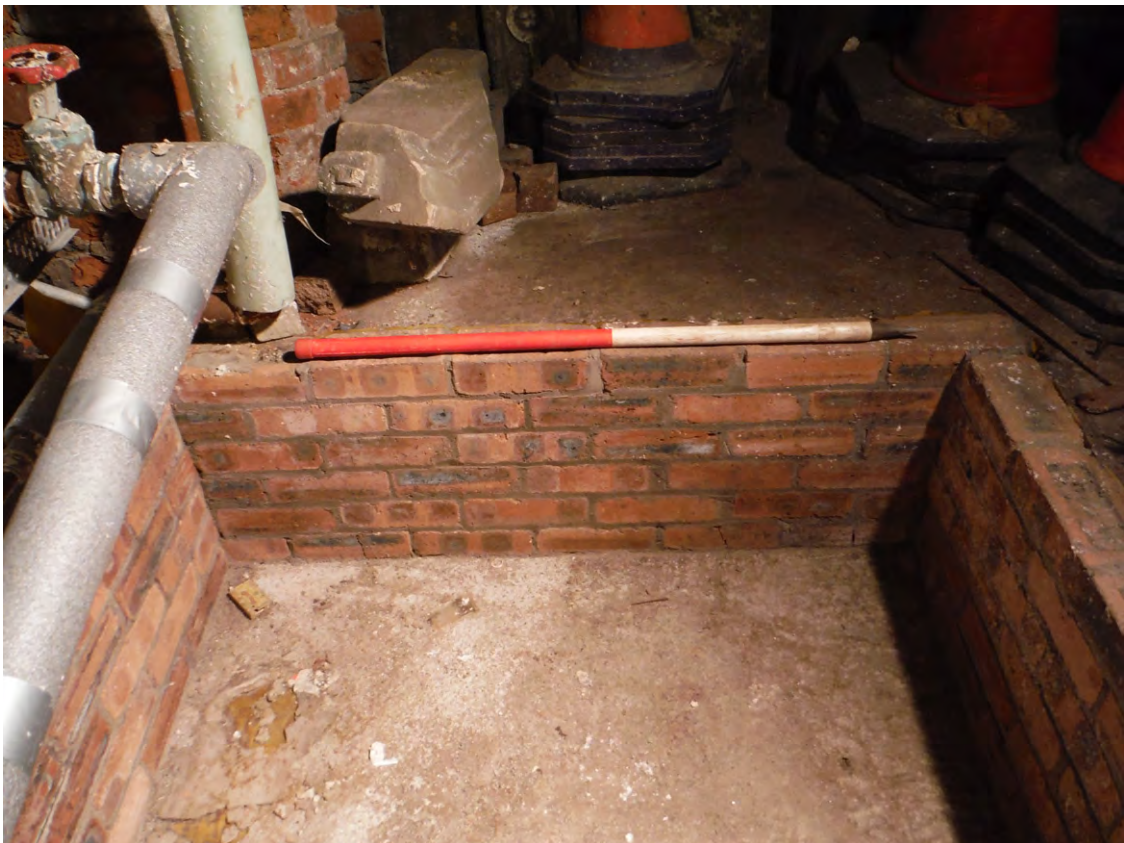
Fig. 8 - Existing brick-lined pit (pre-excavation)

A 1.3m wide section was exposed behind the bricks lining the western end of a rectangular pit (Figs. 8 and 9). The layers behind the brick lining from the top downwards (Fig.9) consisted of 0.05m of concrete (**3/001**); a thin (<0.05m) leveling deposit of modern hardcore (**3/002**); and a >0.35m thick (measured to concrete floor of pit at a depth of 0.4m) earlier leveling deposit of mixed orangey-brown sand and mortar (**3/003**). The concrete floor (**3/004**) of the pit was not lifted and bedrock was not exposed.
