Site Investigation Works New Brunstane Masterplan Edinburgh

Archaeological Watching Brief
Report No. 3605

**Site Investigation Works,
New Brunstane Masterplan,
Edinburgh**

Archaeological Watching Brief

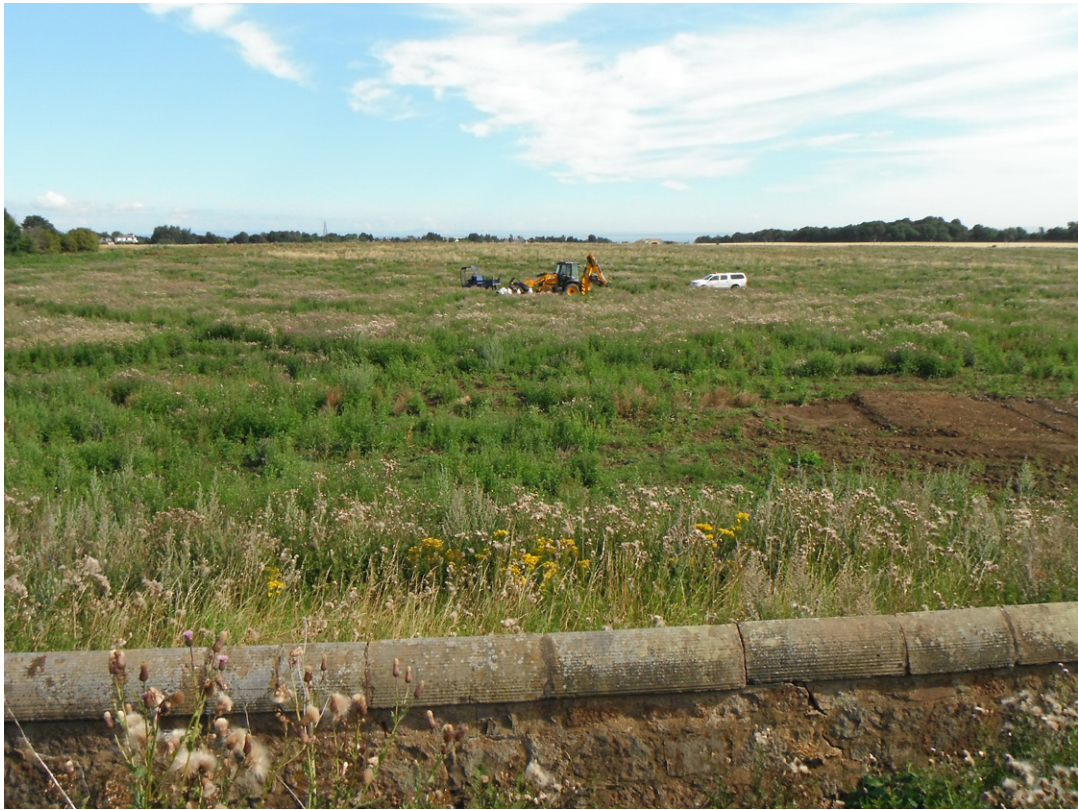
The site (Fig. 2) has been ploughed and then left unsown. It is covered with thistles, and a variety of self-seeded weeds. In general, 0.3m of topsoil (**001**) overlay a sandy subsoil in some test-pits (**002**) and natural in others. The natural (**003**) was in general an orange-brown, fairly soft, gravelly sand with occasional small stones. The exception to this was along the slope in the north of the site where a stiff orange-brown clay-silt with cobbles was present.

Fig. 2 View NNE over the site from Newcraighall. The Niddrie Burn and Joppa are at the trees in the distance

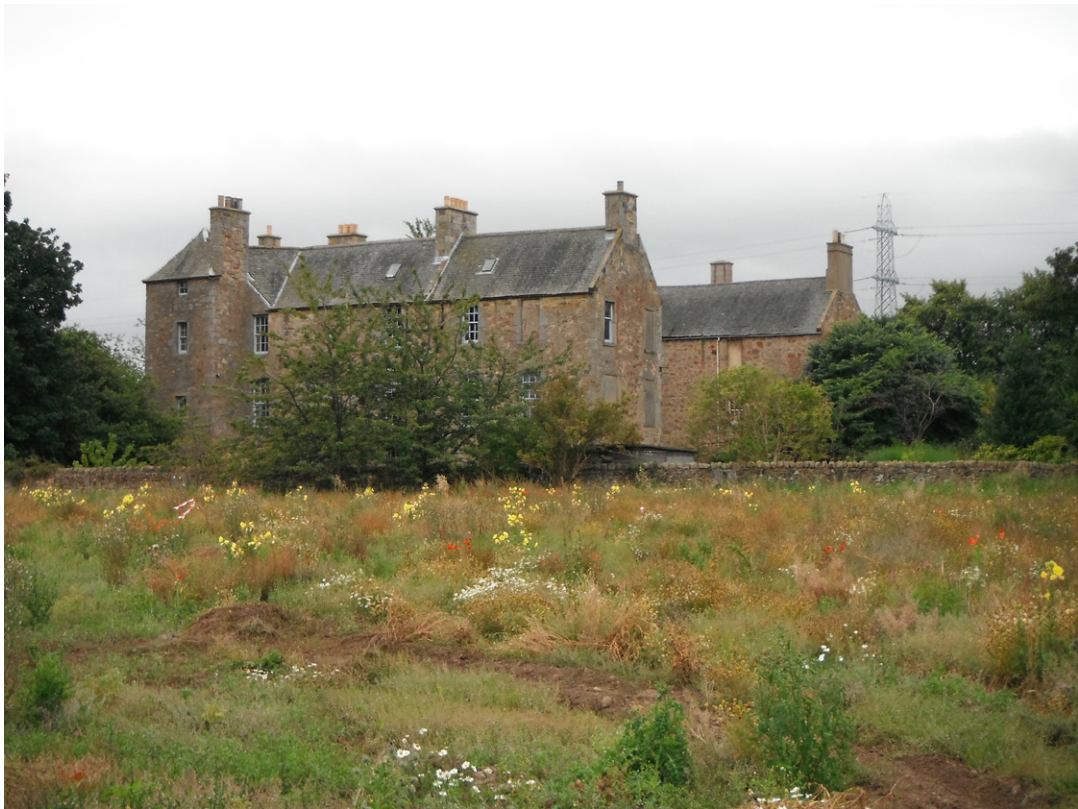
Fig. 3 Test-pit 333 in the foreground with Brunstane House beyond

The site is large and contains varied terrain. It is bisected north to south by the main Edinburgh to London railway line. To the east of Brunstane House (Fig. 3), the ground is fairly level. No the north of this, the site slopes increasingly steeply towards the Brunstane Burn. To the south, the ground slopes gently towards the abandoned Wanton Walls Farm and Newcraighall.

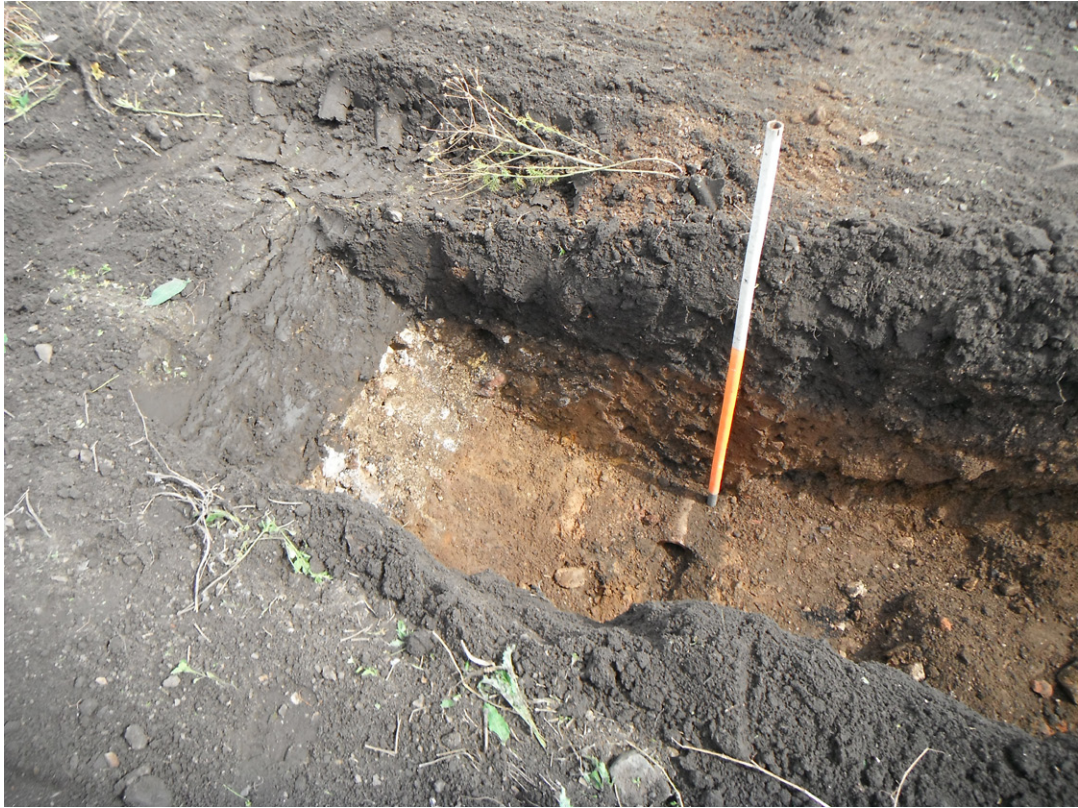
Apart from cultivation furrows and field drains, only one feature was recorded in the thirty-seven test-pits excavated. Test-Pit 324 (Figs. 1, 4) was located on the perimeter of the Walled Garden (Site 20) and a linear ditch feature (**005**) was recorded at the NE end of the trench. This was over 0.5m in width and was filled (**006**) with chunks of lime mortar, stone chips and fragments of fire clay. This is interpreted as a robbed wall foundation trench. No finds were recovered.

Fig. 4 Test-pit 324 with possible wall foundation trench

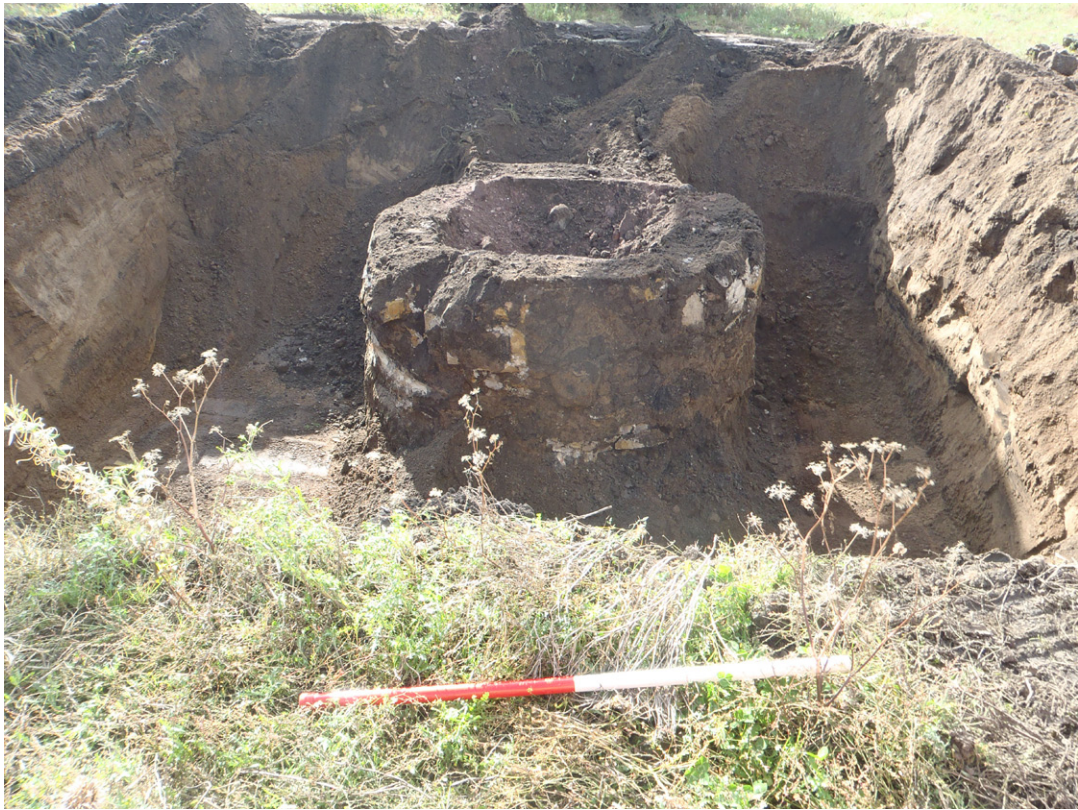
Two of these features had a brick capping (SH504 **017**, SH505 **018**, Figs. 1, 5) and one had a stone capping (SH515 **021**, Figs. 1, 6). These features were all in the north of the area to the west of the railway line. To the south of them and to the east of Brunstane House, a second group of mining features were recorded. One of these (SH507 **024**, Figs. 1, 7) was cut by a furrow (**026**) from which a glass bottle was recovered. Trench SH509, comprising feature **032** (Figs. 1, 8), was particularly clear.

Fig. 6 Shaft Investigation Trench SH515 showing stone capping 021

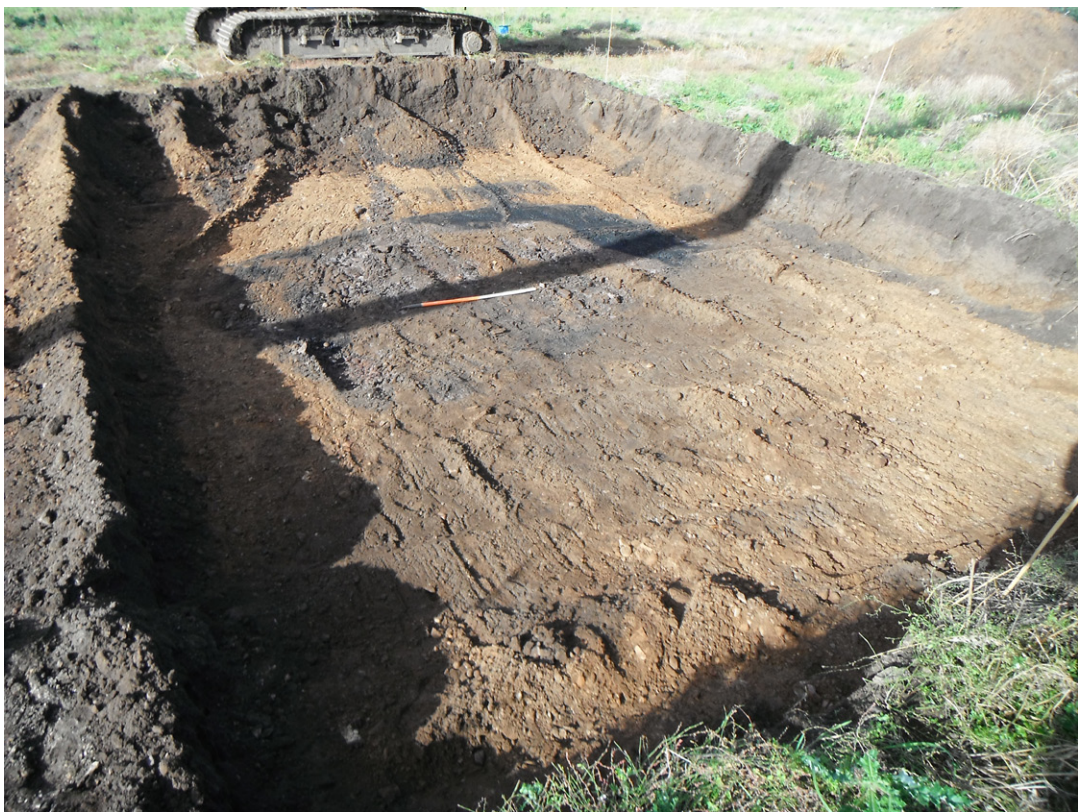
A multi-period suite of mining features was recorded. Some of these may well be either mineshafts or air vents and were lined with either brick or stone whereas some appeared to be conical test-pits to assess the nature of the solid geology. One feature was cut by a cultivation furrow, but the wavelength, and hence potential dating, of the furrows at Brunstane has not so far been established.

Fig. 7 Shaft Investigation Trench SH507 showing the circular feature 024 cut by furrow 026

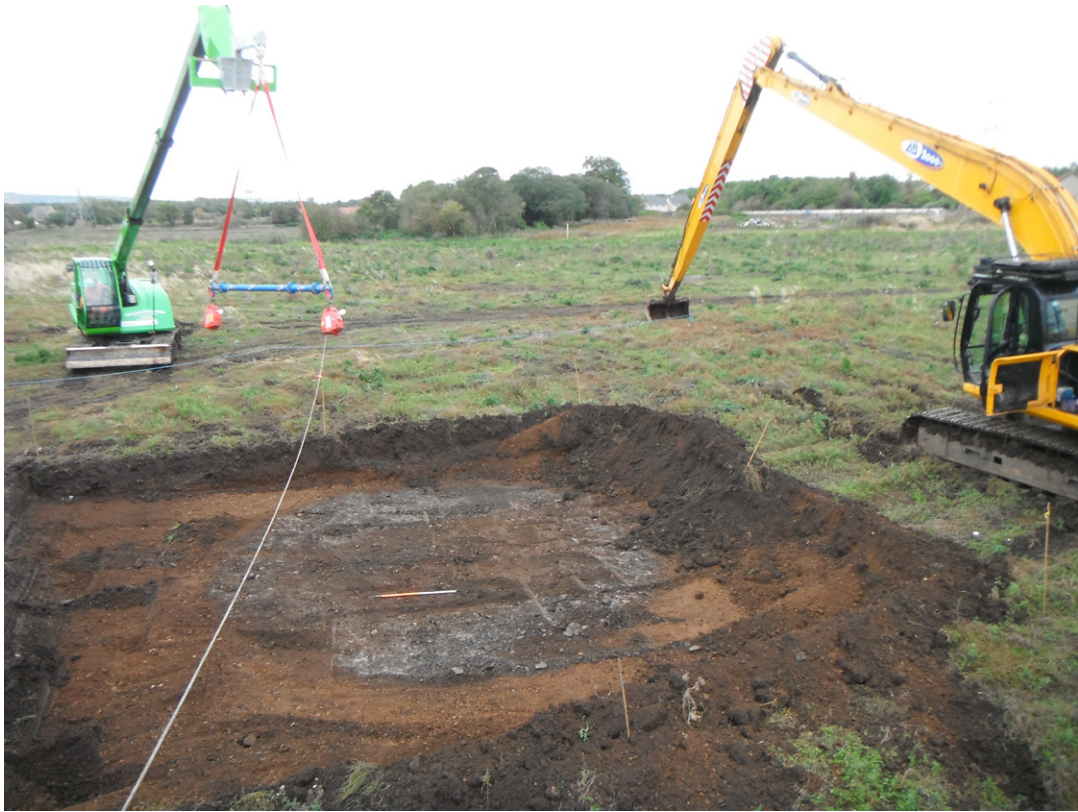
Fig. 8 Shaft Investigation Trench SH509 showing circular feature 032
