Minor Archaeological Services Call-  
Off Contract  
Mavisbank Policies (PIC156)  
Drainage Repair Works  
Evaluation - October 2017

Report No. HES-PIC156-2017-01

**Drainage Repair Works  
Evaluation  
October 2017**

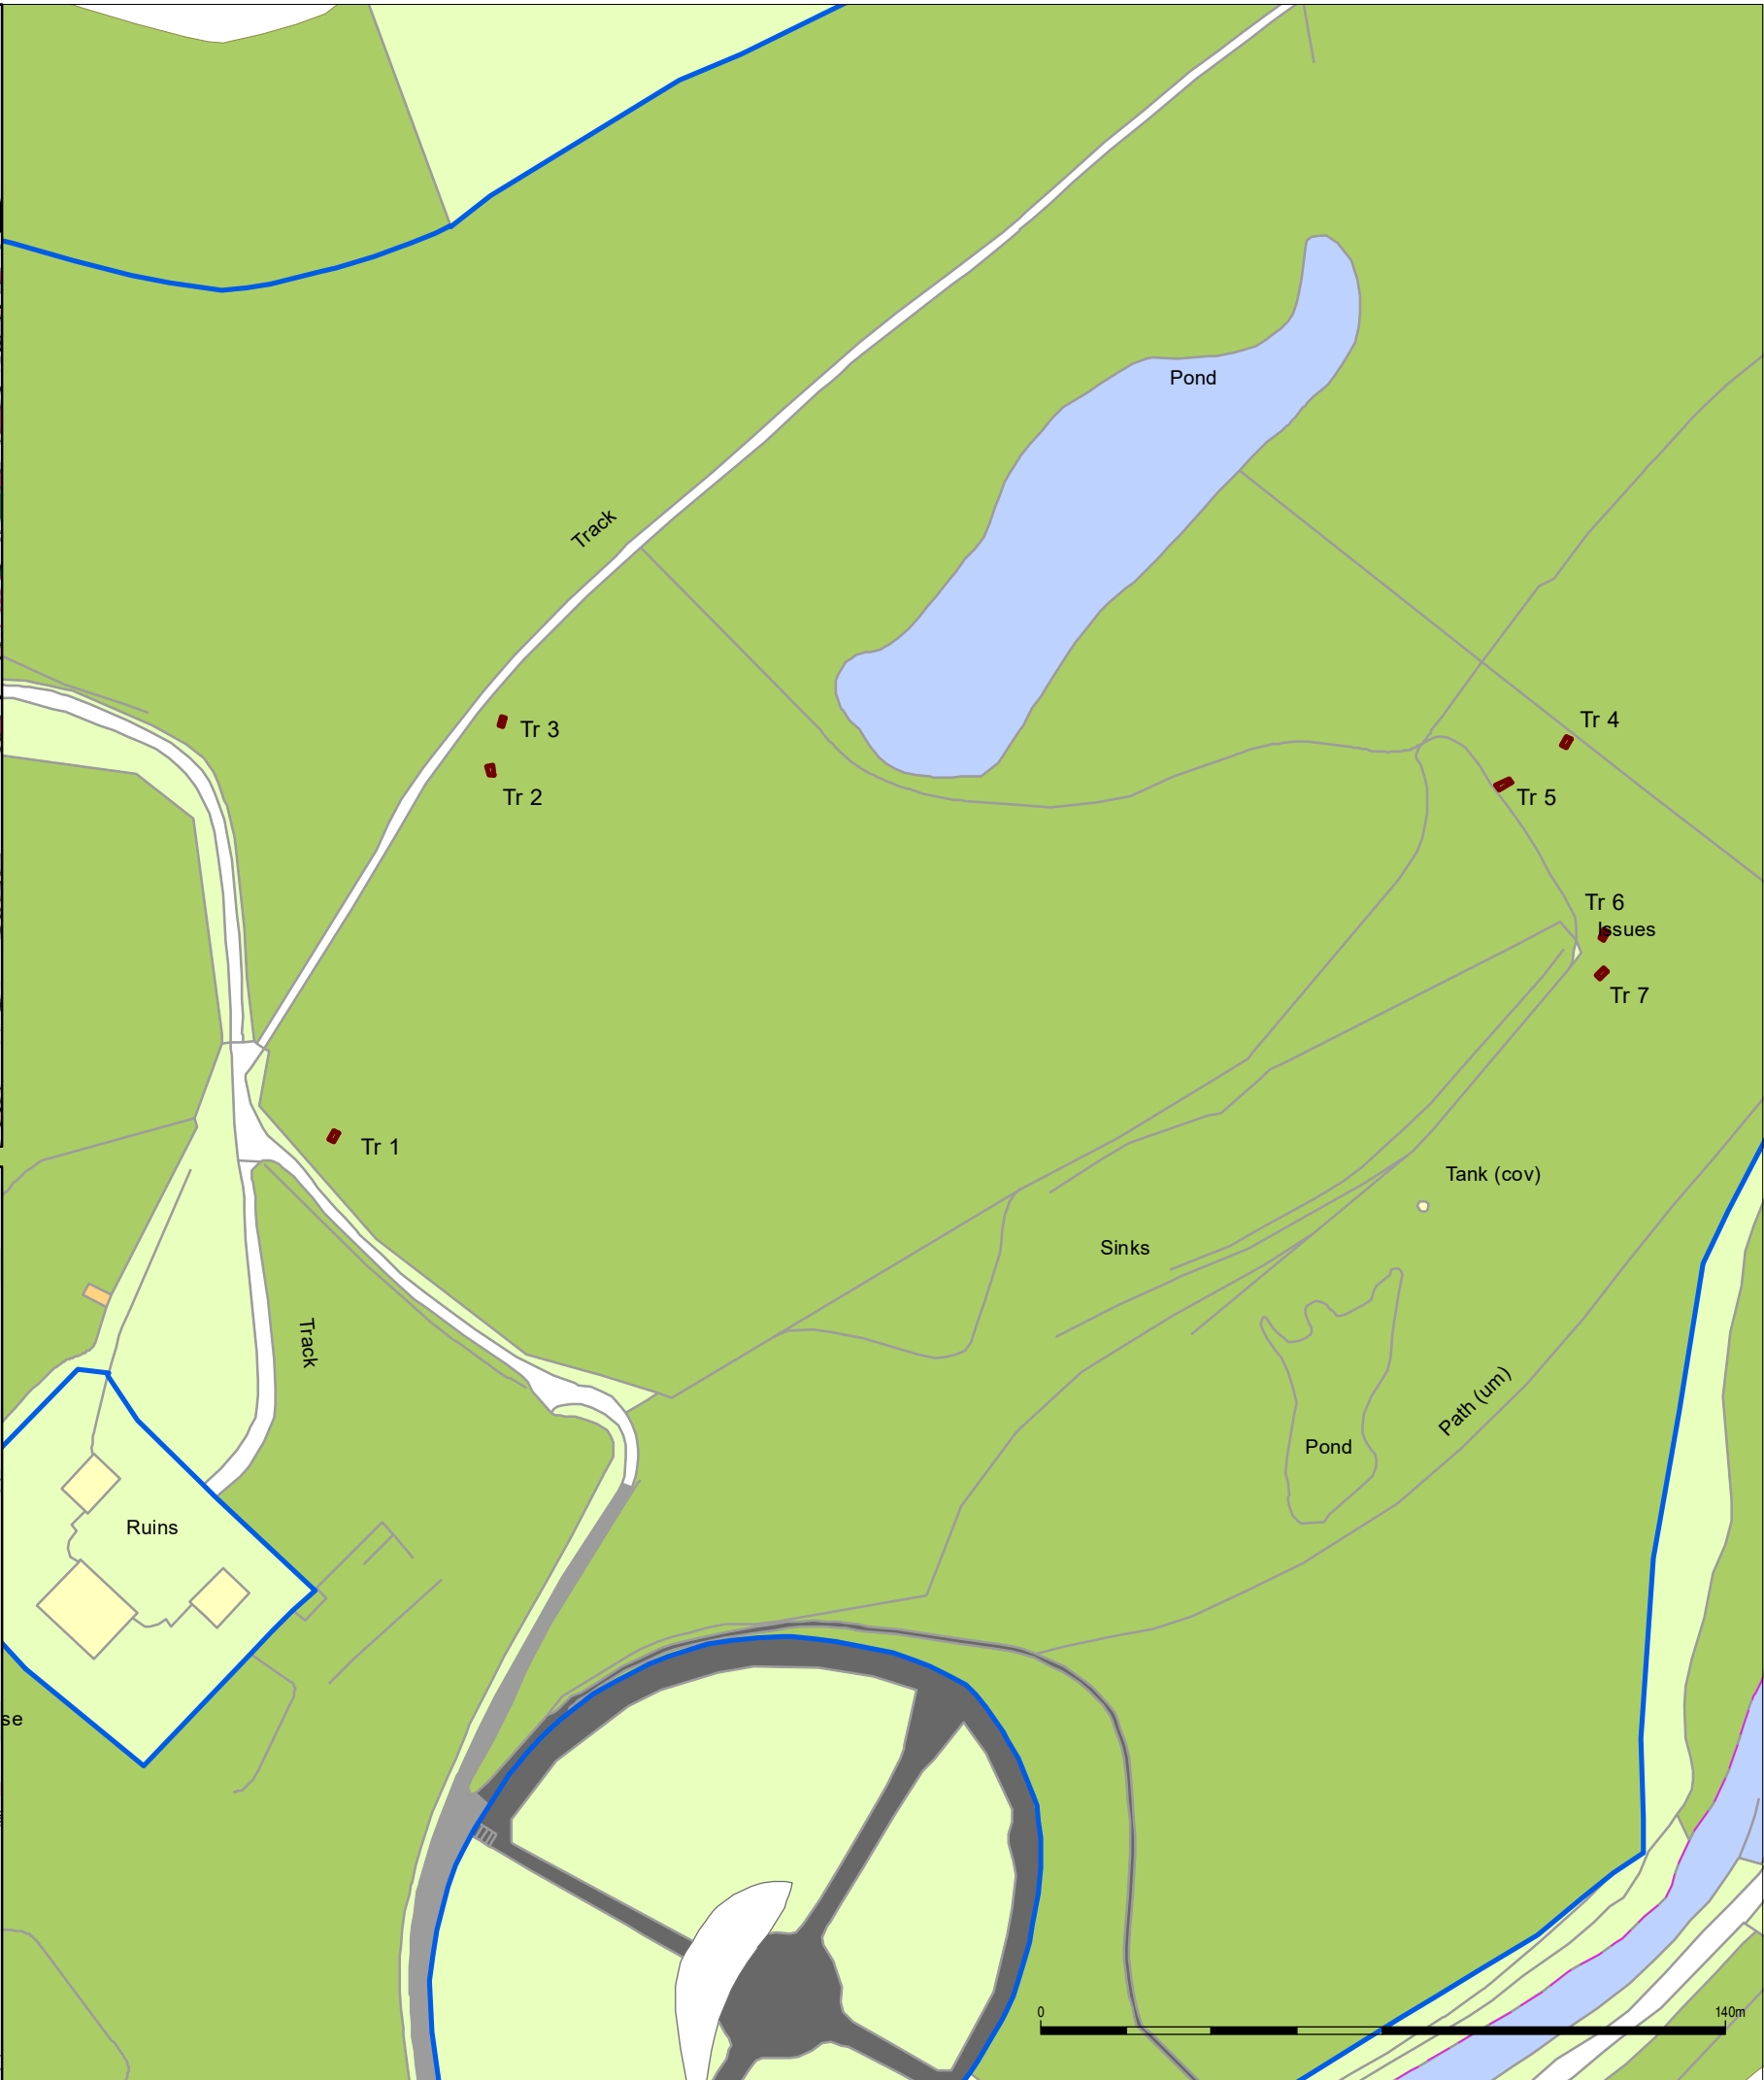
<b>Report No:</b> 3603	<b>Fig. No:</b> 1
---------------------------	----------------------

**Title:**  
Site location and plan of trenches

Seven evaluation trenches were placed across the linear geophysical anomalies. The trenches were hand dug and recorded down to the appropriate archaeological level or a safe working depth of 1.2m.

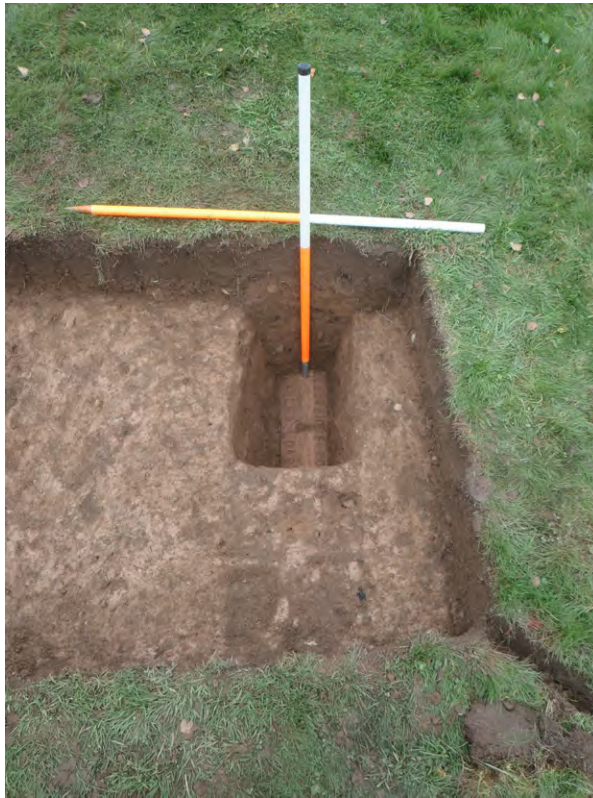
Fig. 2 Tr.1, post-excavation showing electric cable tiles within cut **004**

Trench 1 was 2m x 1m. The topsoil (**001**) was 0.18m deep and lay over subsoil (**002**). Cut into (**002**), and the underlying natural clay substrate (**003**), was a 0.34m wide linear feature (**004**) that ran north-west to south-east out of the trench; this was filled by a 0.45m deep mix of clay and topsoil (**005**) at the base of which a line of ridged ceramic tiles stamped 'Electric Cable' were found (Fig. 2). These were not removed or the cable underneath examined as it was not certain whether the cable was live or not. It is assumed that this cable trench was generating the geophysical anomaly.

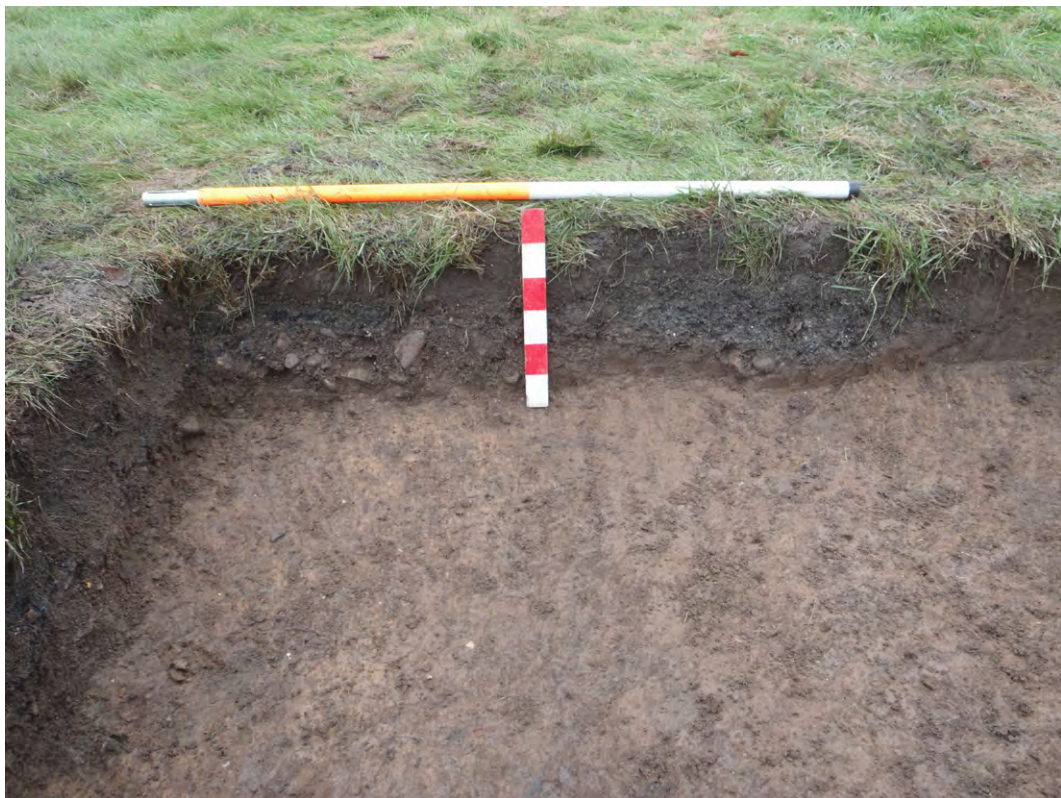
Fig. 3 Tr.2, post-excavation showing cinder pathway **006** sitting above clay and cobble layer **007**

Trench 2 was 2m x 1m. The topsoil (**001**) was 0.16m deep and lay over subsoil (**002**). Cut into and sitting slightly above **002** was a 0.13m deep cinder and ash pathway (**006**). This sat upon a gravel and stone levelling layer (**007**) (Fig. 3). The path continued into the eastern end of Trench 2 and probing with a spade revealed that the path extended to an approximate width of 2.8m. It is assumed that the path was generating the geophysical anomaly.

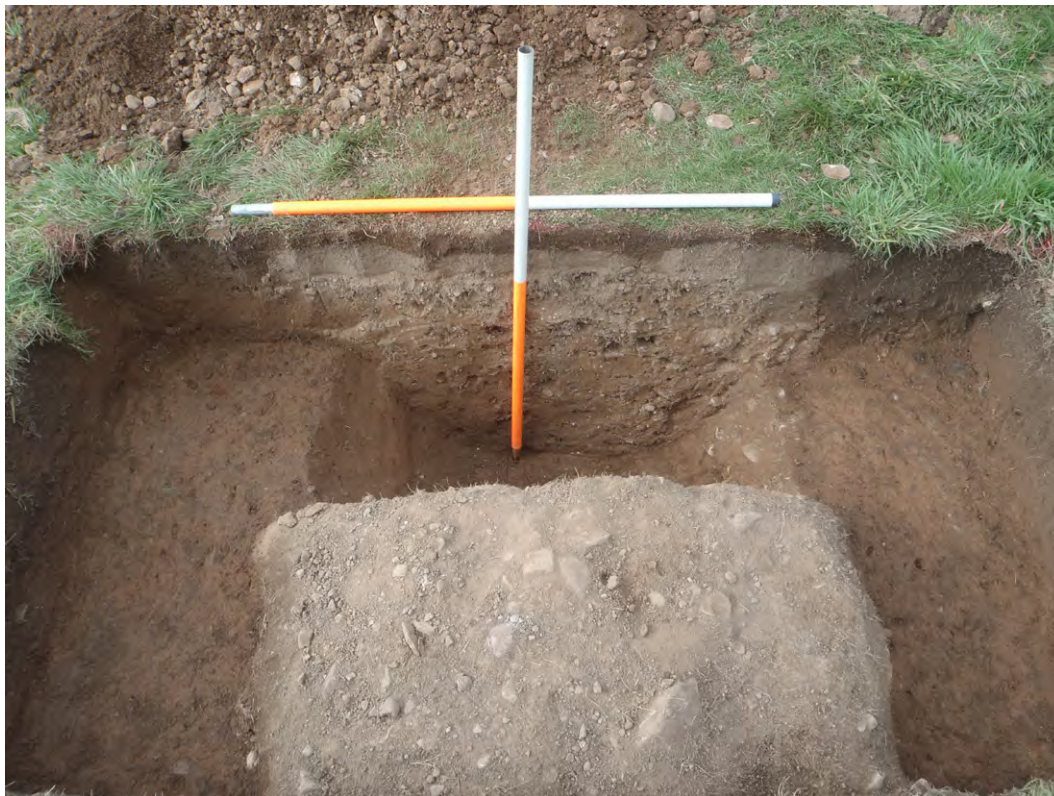
Fig. 4 Tr.3, post-excitation showing domed layer **011** over cut **008**

Trench 3 was 2m x 1m. The topsoil (**001**) was 0.24m deep over a 0.12m deep subsoil layer (**002**), below which was natural substrate (**003**). Cut into **003** was a U-profile linear ditch (**008**) that ran east to west out of the trench. This was filled with compact clay layers (**009**, **010**) and capped with a 0.25m deep sand and gravel layer (**011**) which extended over the edges of **008** by 0.15m on either side, creating a shallow linear hump at ground level, which has been adopted as a desire line (Fig. 4). It is assumed that this feature was generating the geophysical anomaly.

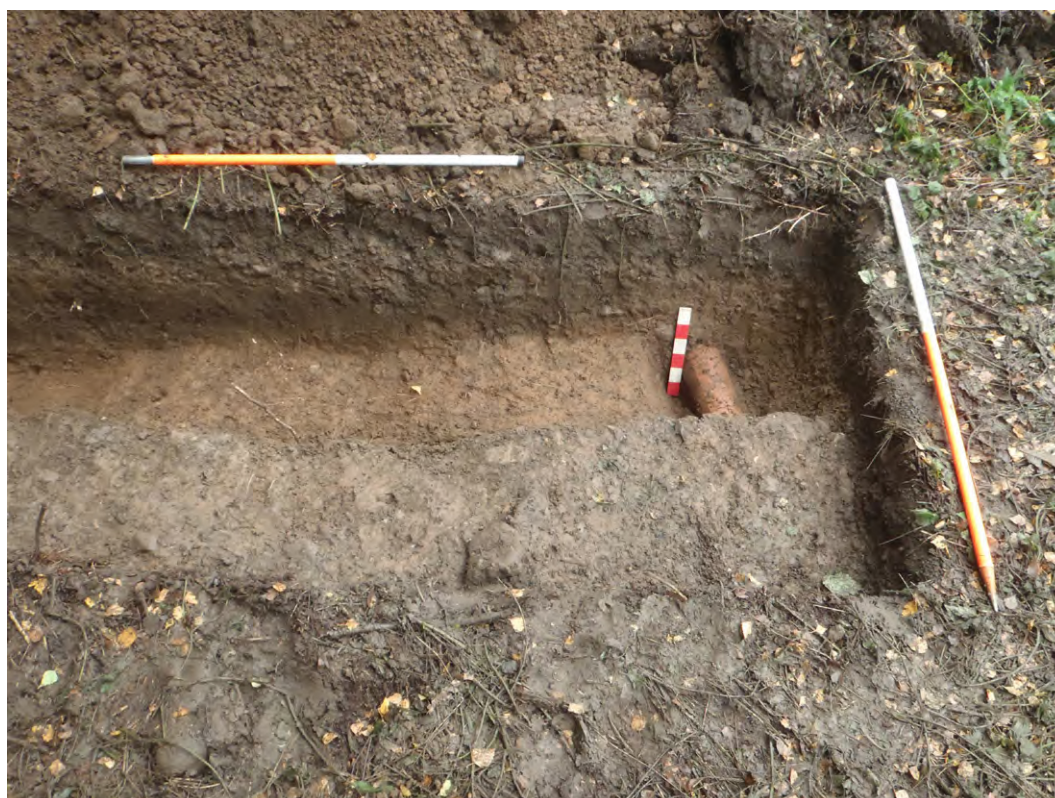
Fig. 5 Tr.5, post-excitation showing ceramic drain within cut **015** and covered by clay and cobble layer **012**

Trench 5 was 3m x 1m. The topsoil (**001**) was 0.25m in depth and lay over a layer of clay with a cobble upper surface (**012**). Below this was subsoil (**002**) and cut into this and the underlying natural (**003**) was a cut containing at its base a ceramic field drain (**013**) (Fig. 5). Only the western side of the field drain cut was exposed; the drain was unbroken and appeared in good condition. It is assumed that this feature was generating the geophysical anomaly.

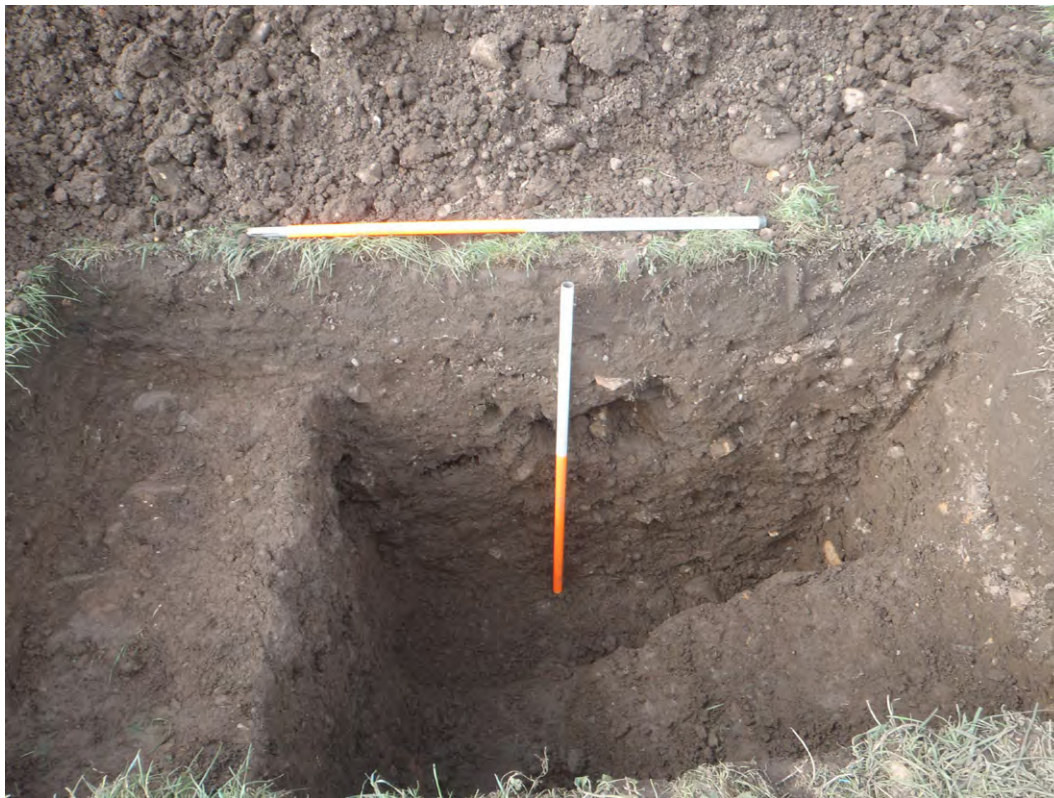
Fig. 6 Tr.6, post-excavation showing one side of cut **015** and fill **016**

Trench 6 was 2m x 1m. Topsoil (**001**) was 0.3m in depth, this lay over the natural substrate (**003**). Cut into the natural was an almost vertical sided cut (**015**) that continued below the trench's safe working depth of 1.2m. Only the western side of **015** was seen in the trench, with the other side of the cut presumably outwith Trench 6. The cut (**015**) was filled by a sandy silt with numerous small to medium sized rounded and flat stones throughout (**016**), (Fig. 6). A small lead figurine of a griffin was recovered from the top 0.2m of this ditch and there were white ceramic fragments throughout. It is assumed that this feature was generating the geophysical anomaly.
