## Land south of Ivy House, Lodge Road, Cranfield, Bedford

Archaeological Evaluation  
Report No. MK109/18

### **Land south of Ivy House, Lodge Road, Cranfield, Bedford: Archaeological Evaluation Report No. MK109/18**

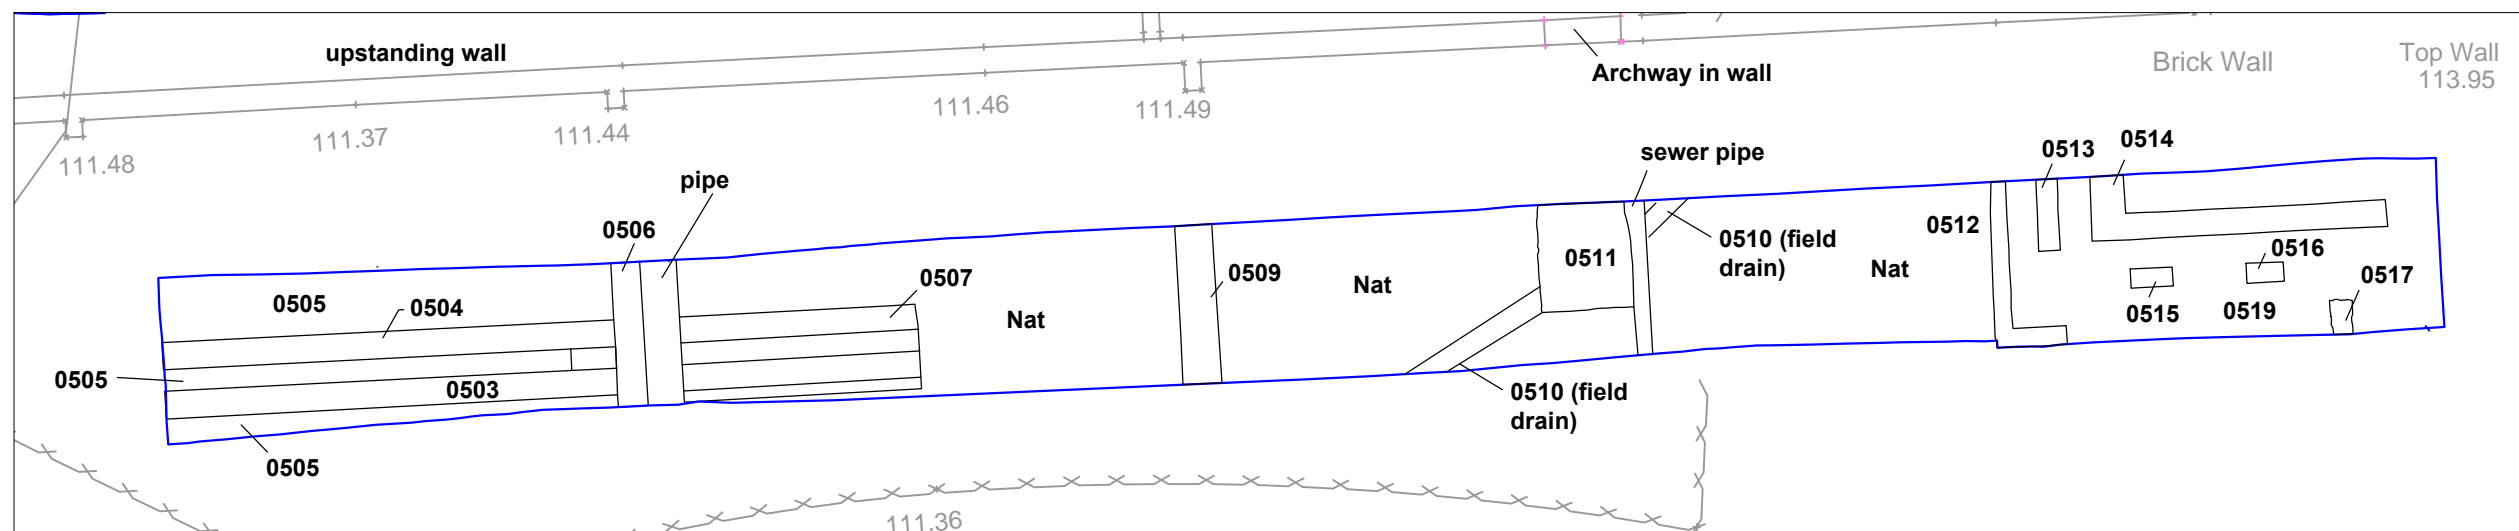
Fig. 2 - Plan of Trench 5

This exposed a series of foundations for former glasshouses which were built against the upstanding northern wall. At the west end below the topsoil was a layer of loose brick rubble (**0502**) 0.14m thick, a well-draining floor deposit for the base of a glasshouse. Two brick walls (**0503** and **0504**) parallel to the upstanding wall lay below this, foundations for the southern wall of the glasshouse. The walls and Layer **0502** were constructed above mortar and gravel (**0505**), levelling for the building. To the east was a brick wall and a water pipe running north-south, the former connecting to a wall stub on the upstanding wall (**0506**). This was clearly an internal division in the glasshouse. To the east was a continuation of Walls **0504** and **0503** (**0507**). A sondage was excavated east of this revealing natural clay and chalk 0.1m below Levelling **0505**. Further east was another north-south brick wall, the east wall the glass house, joining to another wall stub on the upstanding wall (**0509**).

East of this there were no glasshouse foundations. Below the topsoil was a layer similar to the subsoil / cultivation layer found in Trenches 1-4 - clay containing coal and CBM fragments (**0518**). A field drain (**0510**), a modern square feature filled with brick rubble (**0511**) and a sewer pipe running north-south were located opposite the archway in the upstanding wall.

At the east end of the trench were more glasshouse foundations. Brick wall **0512** marked the western wall of this building, with brick walls **0513**, **0514**, **0515**, **0516** and **0517** acting as foundations to stabilise the floor of the structure which was filled with crushed brick rubble (**0519**).

The foundations of the glasshouses found in Trench 5 bear some correspondence to the Washbourne Greenwood survey plan of the buildings made in 2006 (Fig. 15). The foundations at either end of the trench clearly align with two 'Principal Greenhouses' shown on the plan. The centre of the trench opposite the archway where no glasshouse foundations were found is marked as 'Vinery' on the Washbourne Greenwood survey. This structure

was wider than the two greenhouses on either side which may explain why no foundations were exposed. The floor of this structure appears to have been redeposited natural clay rather than the well-draining crushed brick found in the greenhouses. It is likely that the sewer pipe under this building provided drainage from south side of this structure through to the main sewer beside the cess pit to the north.

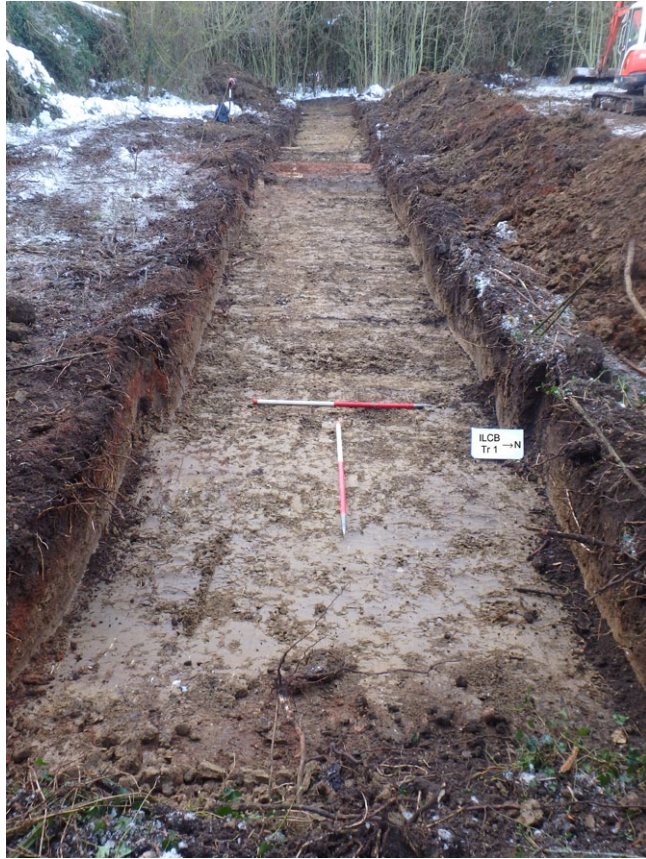
Fig. 4 - General shot of Trench 1, facing W

A path made of crushed brick-dust and gravel (**0104**) was found just below the topsoil opposite an existing gateway in the southern wall of the garden. This was identified in the other trenches and was clearly the central path through the garden marked on 19th century OS mapping. This joined the archway in the northern wall. Two brick features were identified in the trench. To the west of the path were two parallel brick walls constructed on the natural clay (Fig. 5) just over a meter long and 0.5m apart (**0105 / 0106**) with a metal water pipe running parallel to the east. Four square pillar foundations in brick (**0107**) were found on either side of path connected by cream coloured ceramic pipe (Fig. 6).

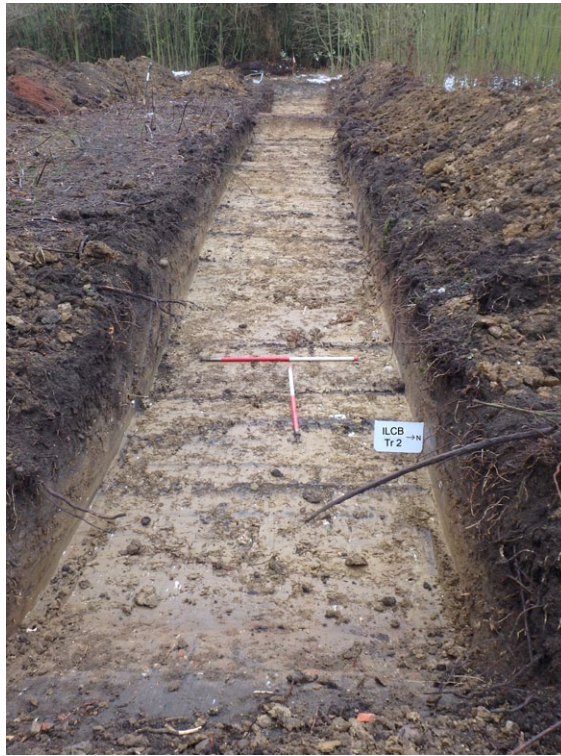
Fig. 8 - General shot of Trench 2, facing W

No archaeology was found in this trench apart from the central garden path (**0204**).

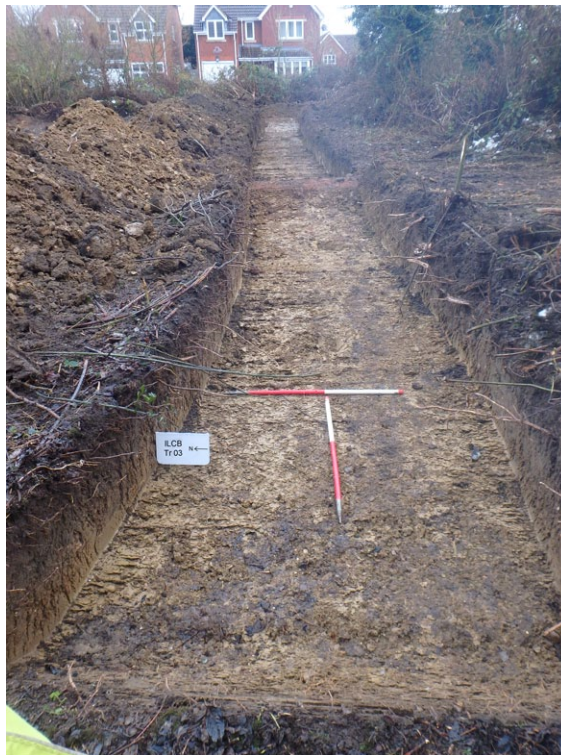
Fig. 9 - General shot of Trench 3, facing E

No archaeology was found in this trench apart from the central garden path (**0304**).

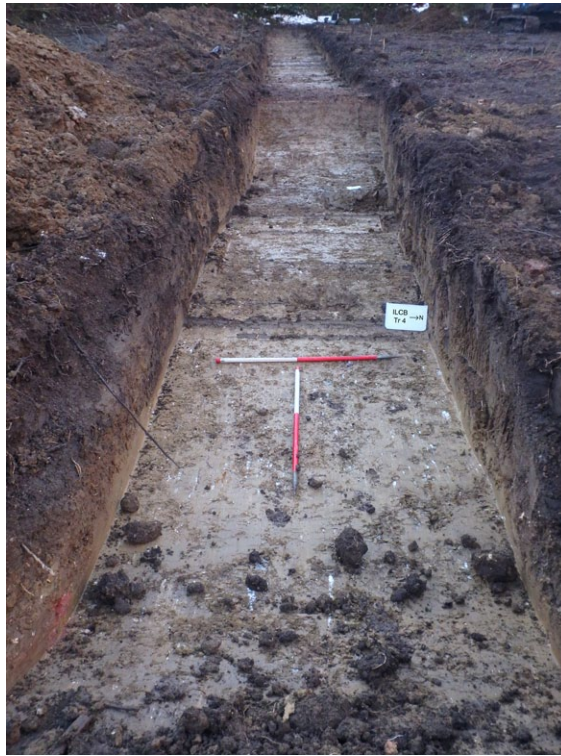
Fig. 10 - General shot of Trench 4, facing W

Trench 4 was heavily bioturbated but a post-hole or small pit was revealed at the east end of the trench (**0406**). This was oval measuring 0.4m x 0.5m x

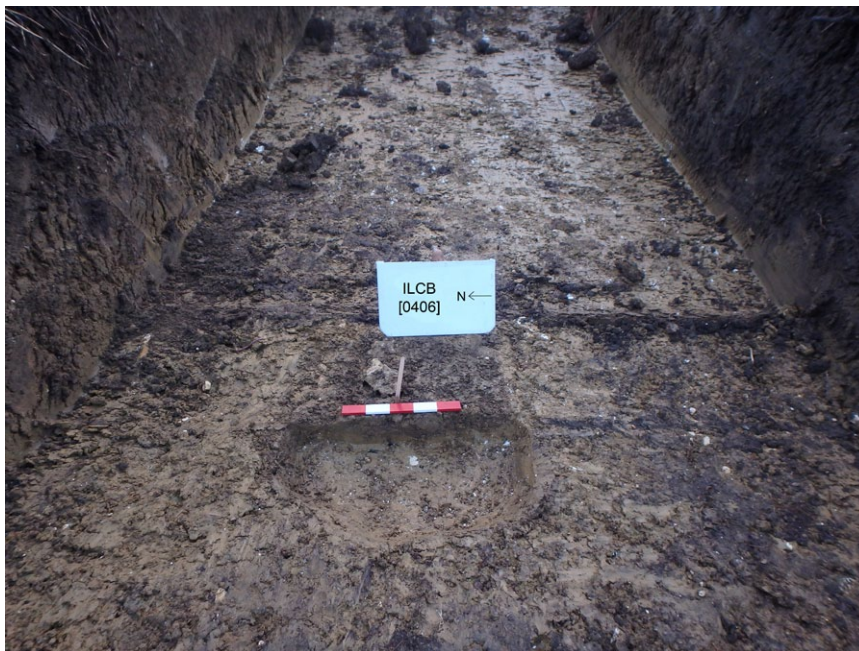
Fig. 11 - Shot of post-hole 0406 in Trench 4, facing E

0.12m and had a flat base. It was filled with a medium brown silty-clay containing no finds (Fig. 11).

The function of the single undated post-hole in Trench 4 is unclear, but it is likely to relate to the 19th century garden rather than any other activity.

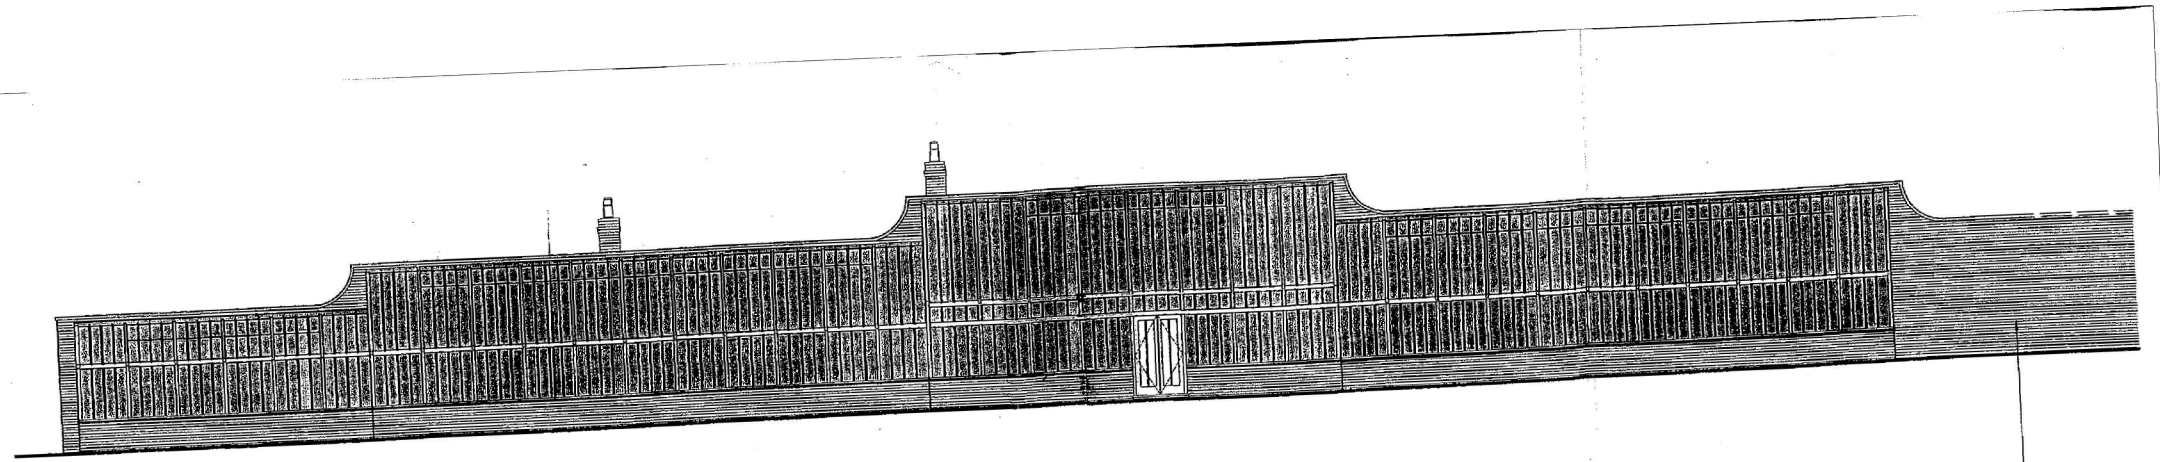
client: WASHBOURNE GREENWOOD DEVELOPMENT PLANNING  
 project: LODGE ROAD/AILWYNS ACRE WOOD END CRANFIELD BEDFORD  
 date: 30/11/04  
 scale: 1:100  
 drg. no: 5205/01  
 rev: C

SOUTH ELEVATION

this section of the original green house has been demolished

PLAN

The buildings identified in Trench 6 align well with the buildings on the Washbourne and Greenwood survey plan. The long three-roomed structure is clearly the remains of the '*Bothy with Bed Room, Living Room and Pantry*' mentioned in the sales catalogue from 1885, through matching these rooms to the excavated evidence is difficult. The room at the west end of the building with the black and red chequered floor tiles had clearly been built with care, so was possibly the living room. Wall **0609** contained a fireplace suggesting that it separated the living room and the bedroom. This suggests that the eastern room was the pantry. The area with the cess-pit at the east end of the range was clearly the 'water closet' for the Bothy. The sales catalogue also mentions a 'large tool shed' and a 'small tool house', though the difference between the two is unclear. One of them is clearly represented by the small building at the east end of the Bothy (**0607/0617**).
