### St Andrews Cathedral and Priory

Boundary Wall Buttressing and Consolidation  
Archaeological Evaluation and Watching Brief

Report No. HES-PIC035-2017-01

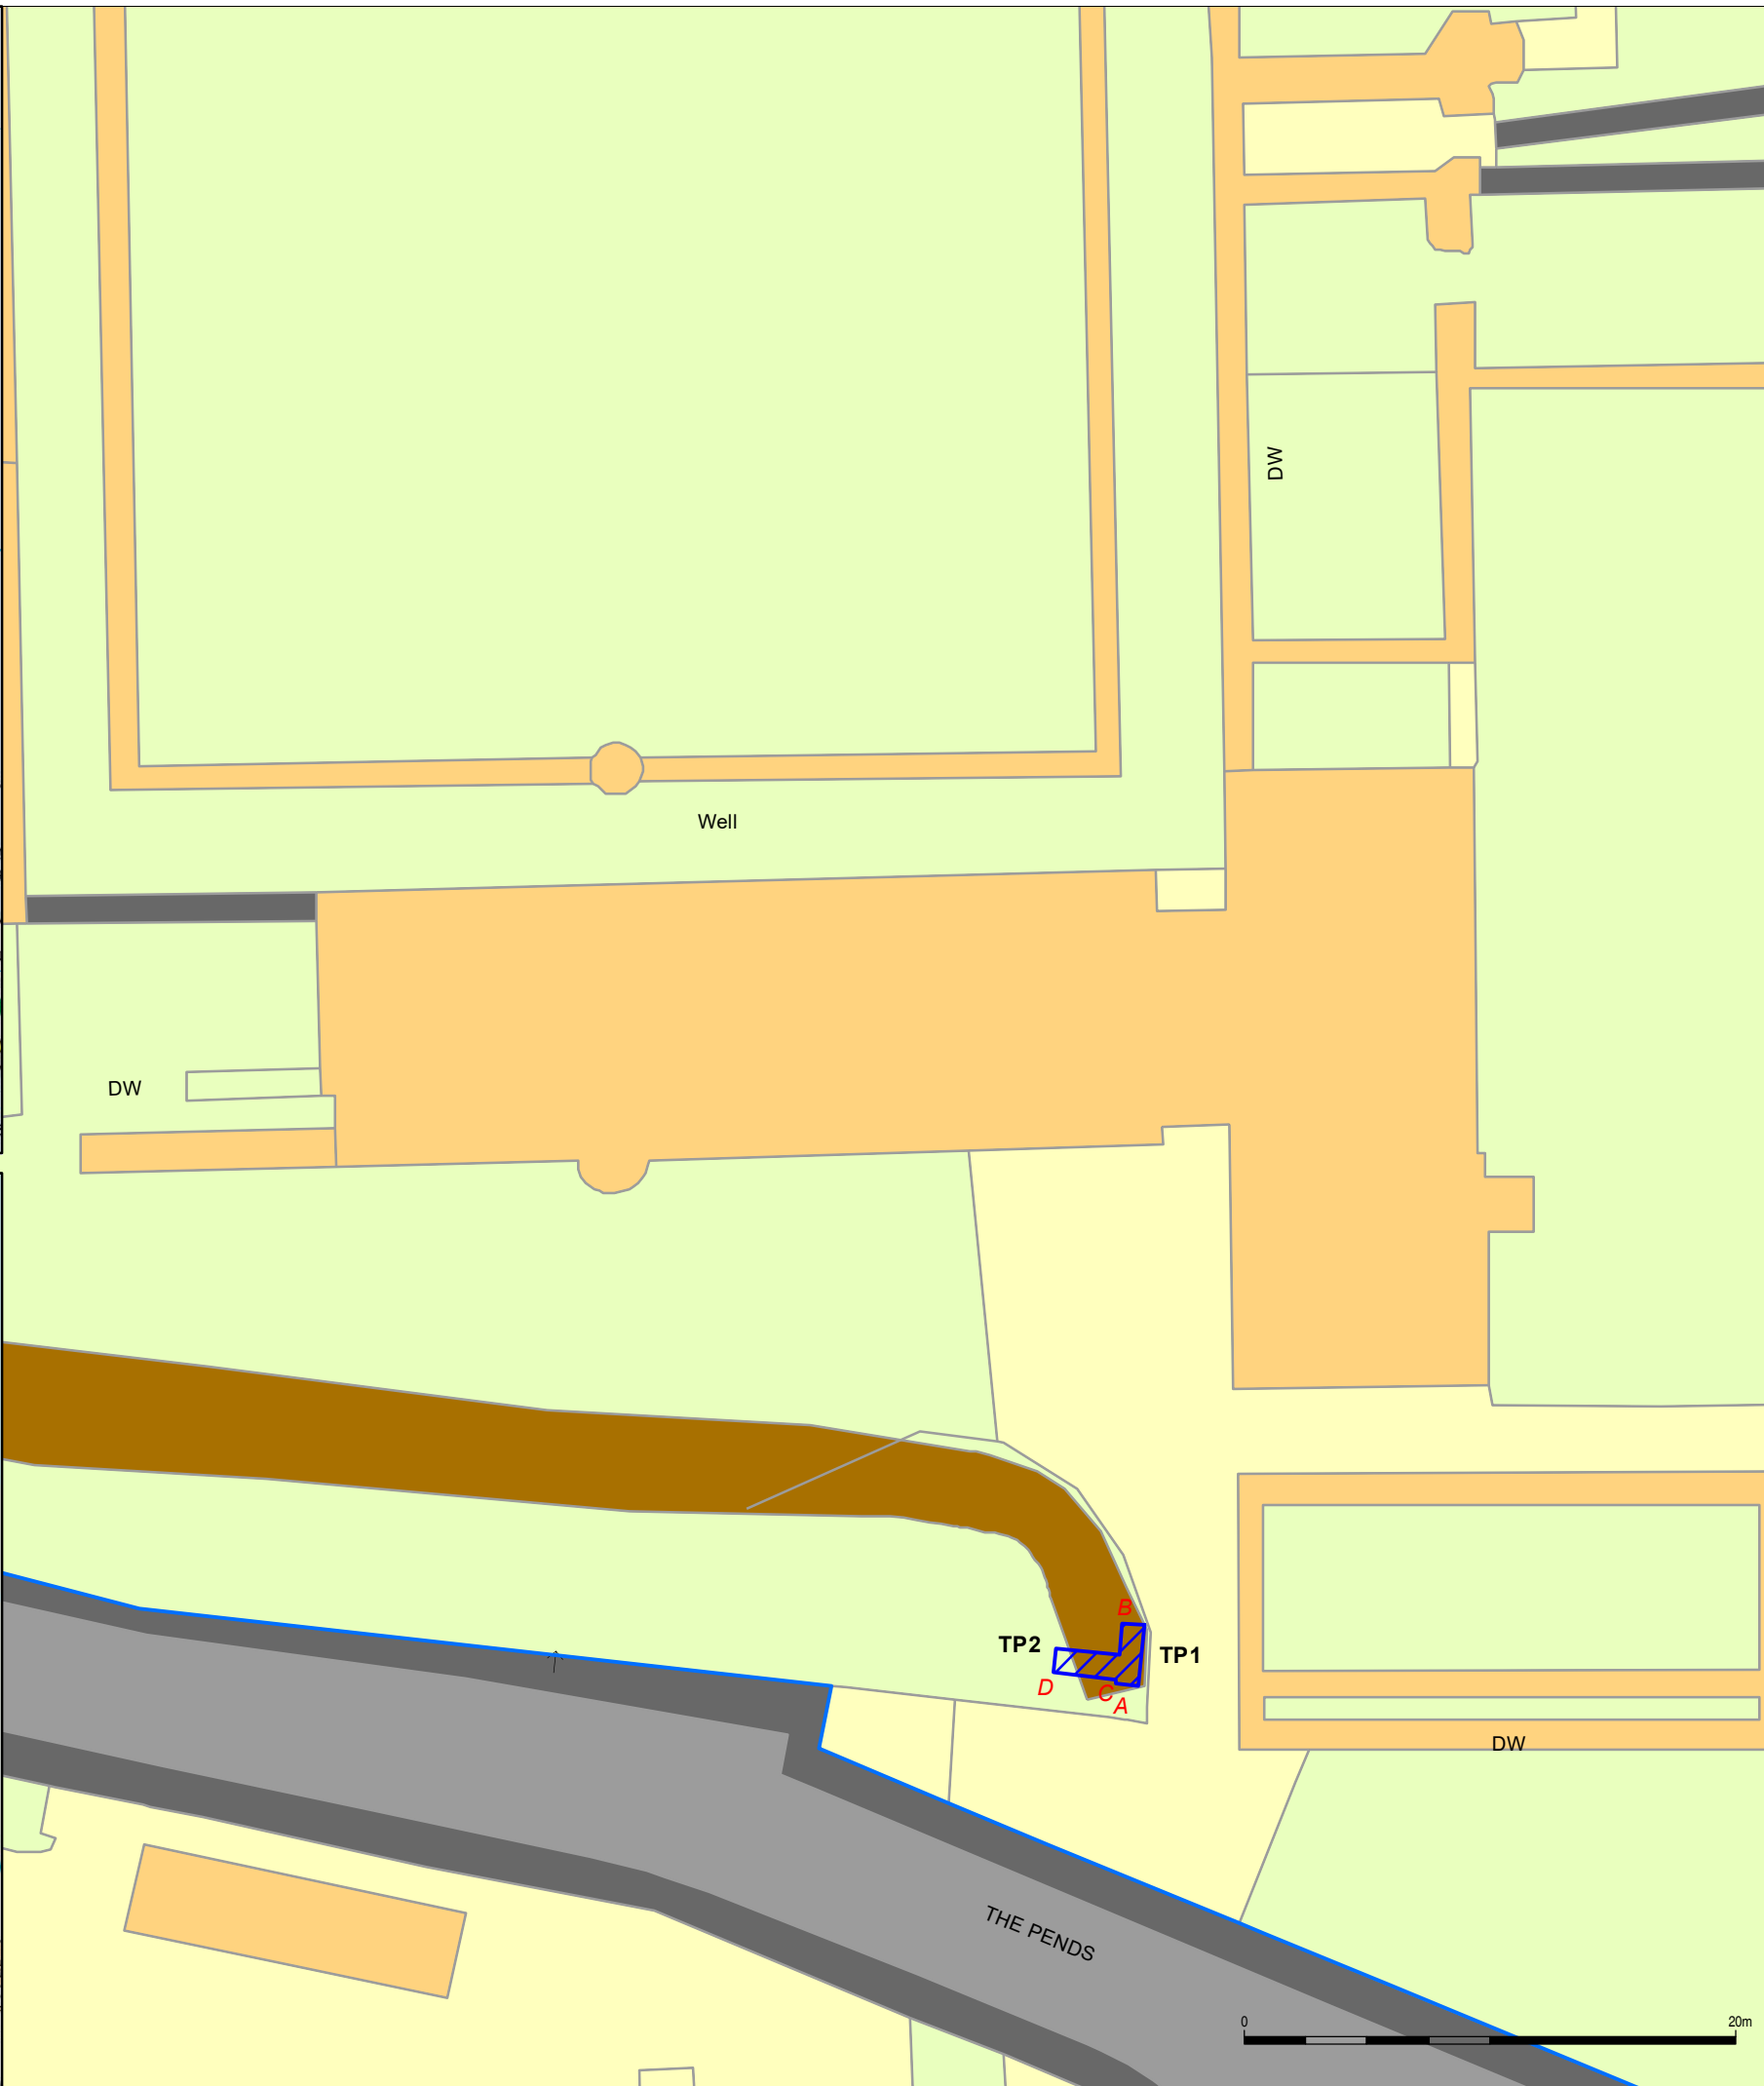
Report No: 3601	Fig. No: 1
--------------------	---------------

Title:  
 Location map and site plan

A programme of site investigation was required at St Andrew's Cathedral, Fife (NGR: approx NO 51400 16593; Fig. 1), consisting of ground investigation works in order to inform the proposed depth and location of stabilisation buttresses for a section of wall within the cathedral precinct. The wall is unstable and is currently supported by temporary timber props; in order to avoid the dismantling and rebuilding of the wall, buttressing is required. The wall runs alongside the Pends Road from the Pends Yett to the Mill Port and harbour. It is not part of the precinct walls, but may nevertheless be a significant component of the monument, although its dating is ambiguous.

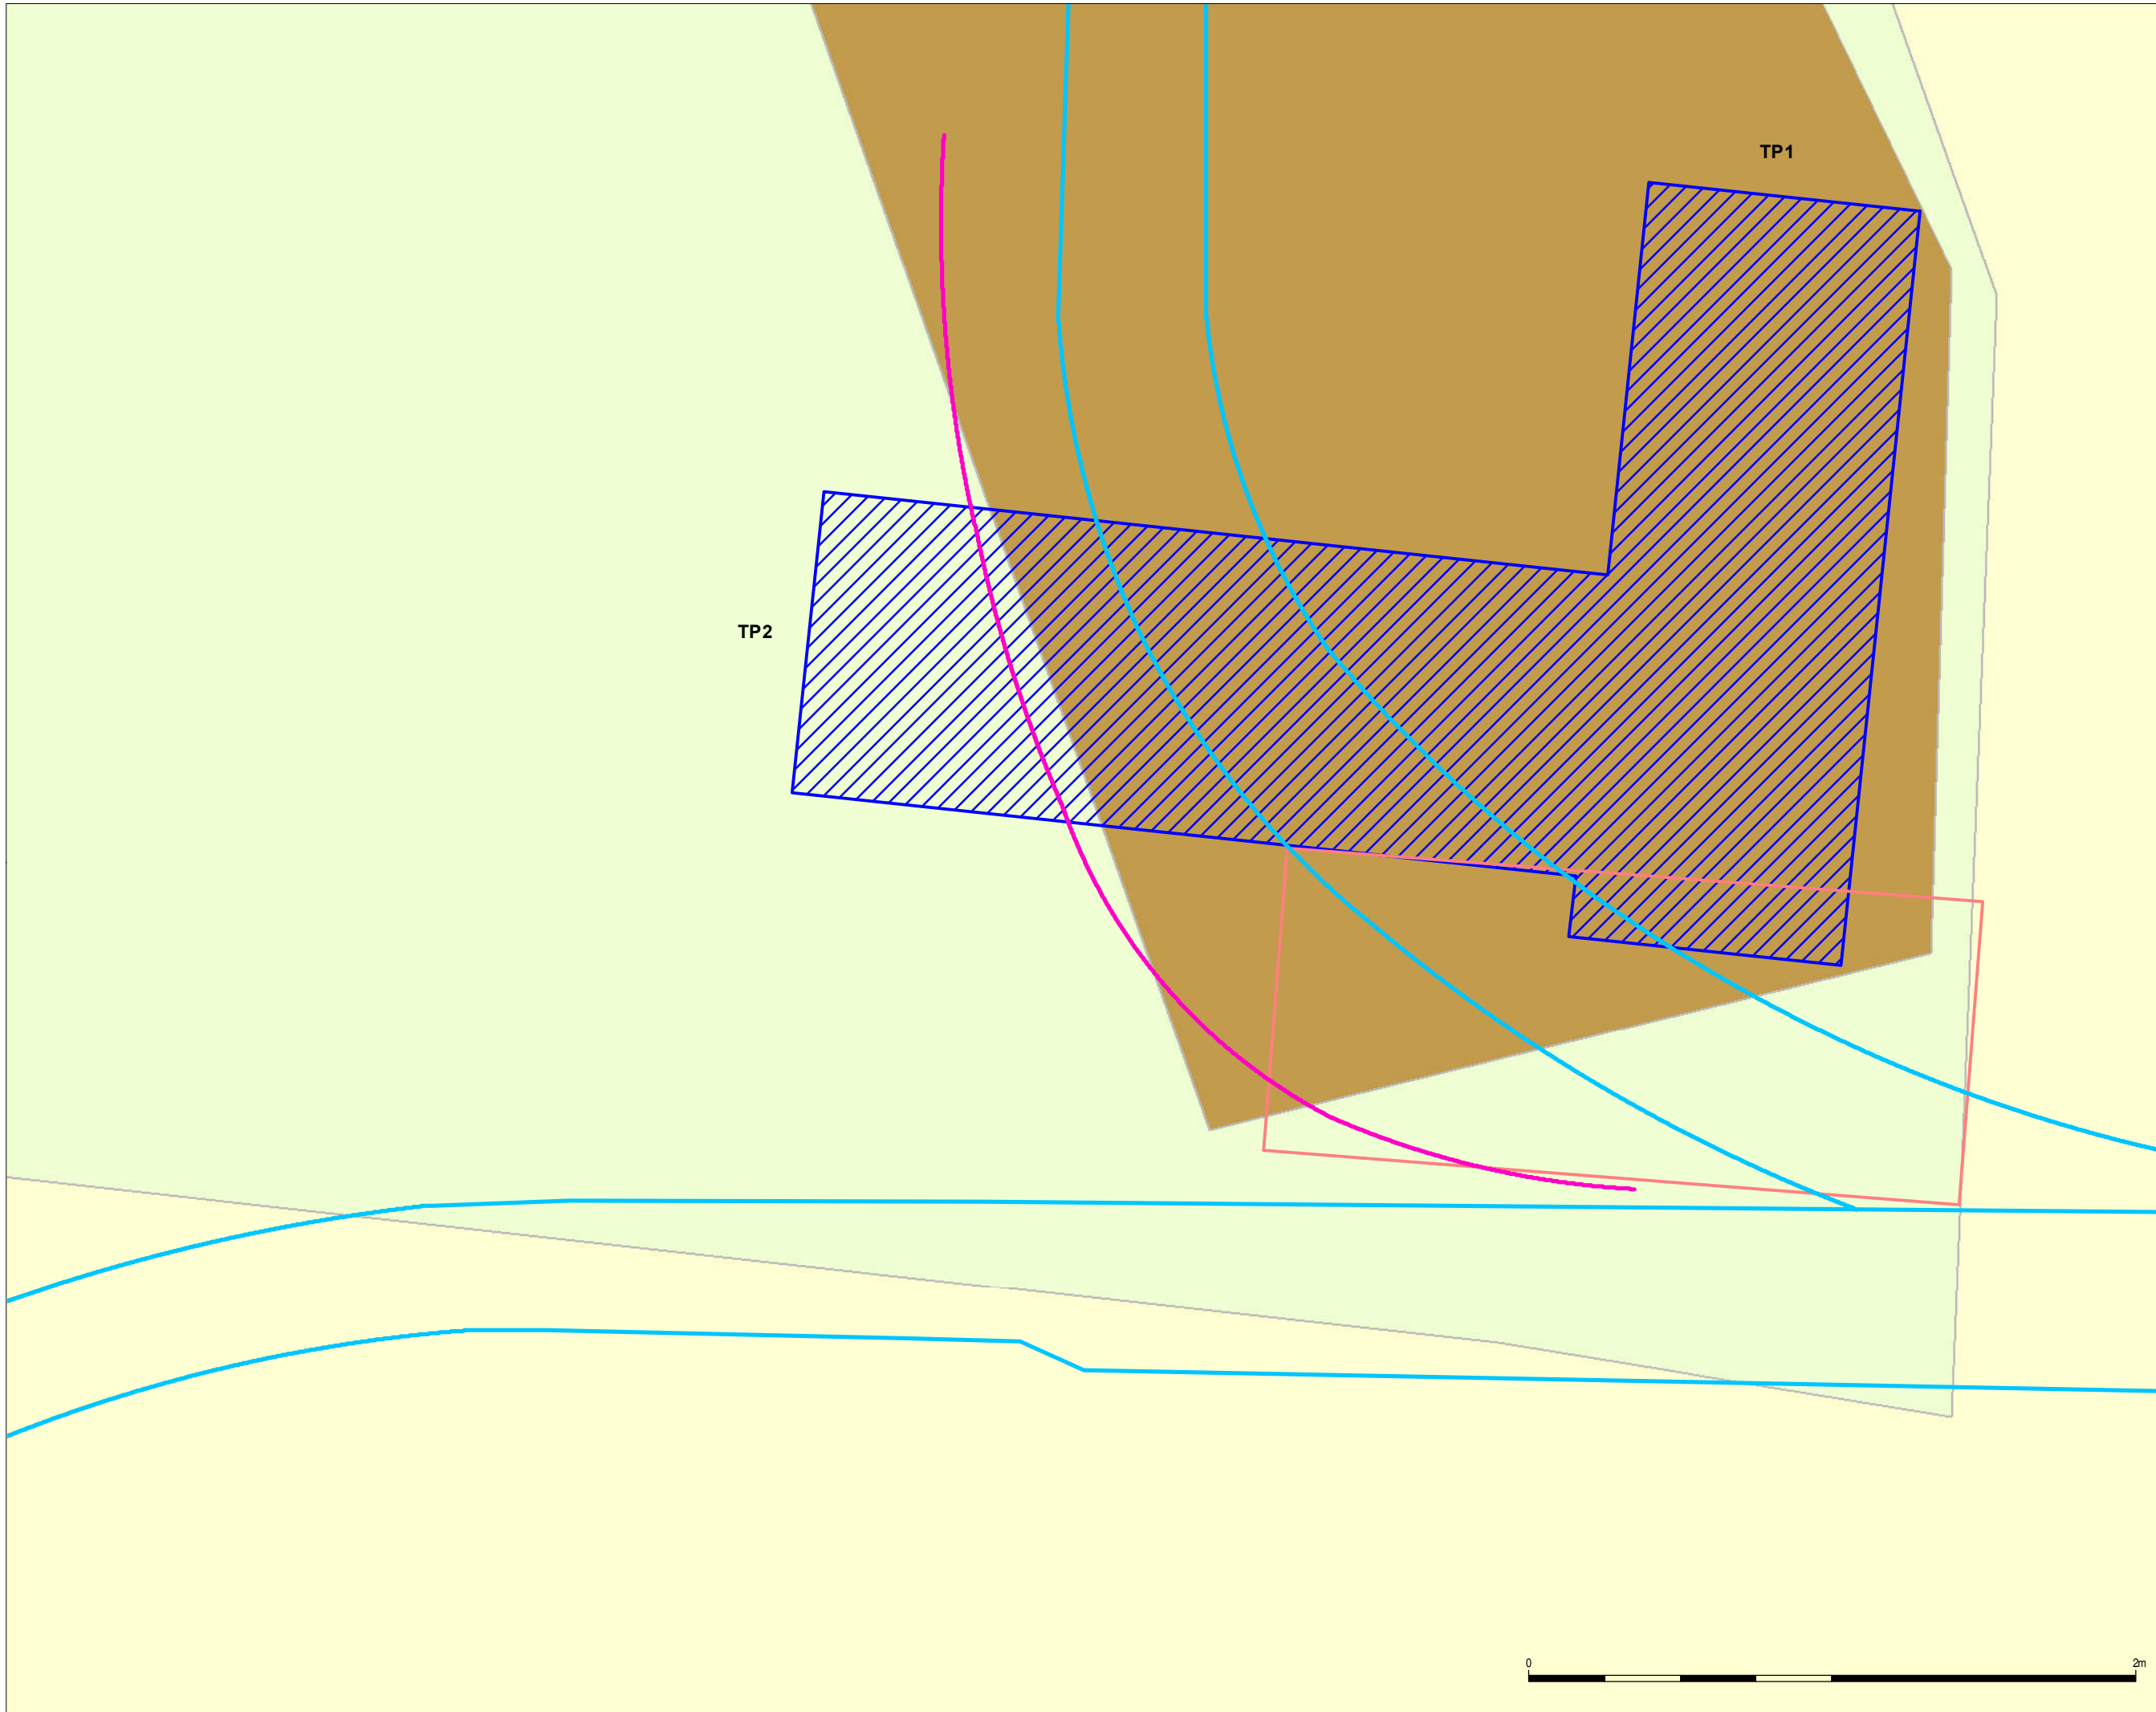
Report No: <b>3601</b>	Fig. No: <b>2</b>
---------------------------	----------------------

**Title:**  
 Projected route of reredorter drain from Kirkdale's 2001 work

Excavations in 2001 by Kirkdale Archaeology at the east end of the upstanding wall (Trench 2) uncovered evidence for a reredorter/town drain/culvert apparently running below the wall. The projected alignment of this stone drain was provided by HES on the basis of the excavation results from 2001, and test pits were placed to intersect with this alignment on the east side (TP1) and north side (TP2) of the wall, both within the grassy bank area (Fig. 2).

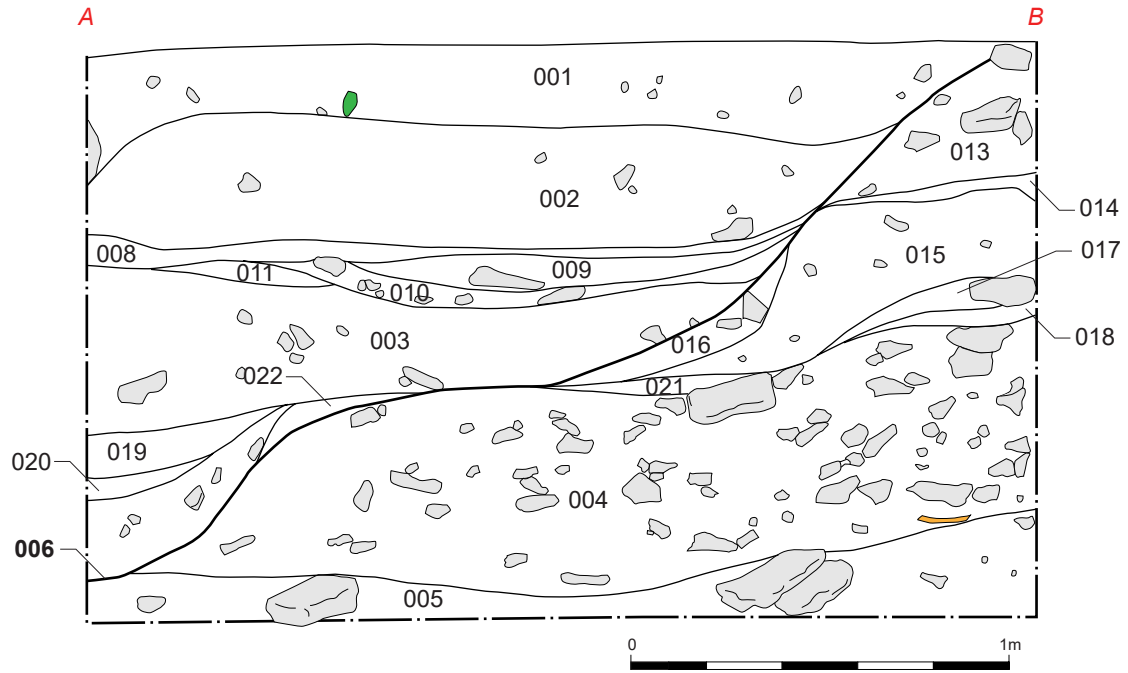
Fig. No:  
4

Title:  
East-facing section of TP1

#### 3.1 Test Pit 1 (Figs. 3 & 4)

At the base of the test pit was a dark grey organic layer (**005**) of possibly in situ medieval garden soil, containing a large amount of animal bone as well as some medieval pottery. Full exploration of this layer was not possible, and thus its depth remained unknown. Natural was not reached.

Overlying **005** was an orange-brown sandy layer (**004**), c.0.5m thick, containing numerous small stones, and interpreted as the same bank material as was recorded in the 2001 excavation. Visible in both the east- and west-facing sections of TP1, it sloped down towards the east. Animal bones and some medieval pottery were recovered.

Overlying **004** were a sequence of deposits (**013-018, 021**), comprising mixed silty deposits, all of which were cut by an irregular-profiled cut (**006**), probably relating to the construction of a breezeblock shoring structure (**007**) located at the southern end of the trench or other earlier activities.

Cut **006** was filled by a thick layer of mid grey silty sand (**003**), c.0.35m thick, containing numerous individual lenses (**008-012, 019, 020, 023, 024**) of mixed mortar-rich and charcoal-rich, ashy and silty deposits, all likely tip events relating to the backfilling of the cut (**006**).

Above this was a 0.2m thick layer (**002**) which consisted of mixed mid-grey silty sand with inclusions of coal and mortar, intermixed with modern ceramic, animal bone and shell. This layer was also interpreted as backfilled material intended to level up the cut **006**.

Dark brown silty sand topsoil (**001**) formed the uppermost deposit.

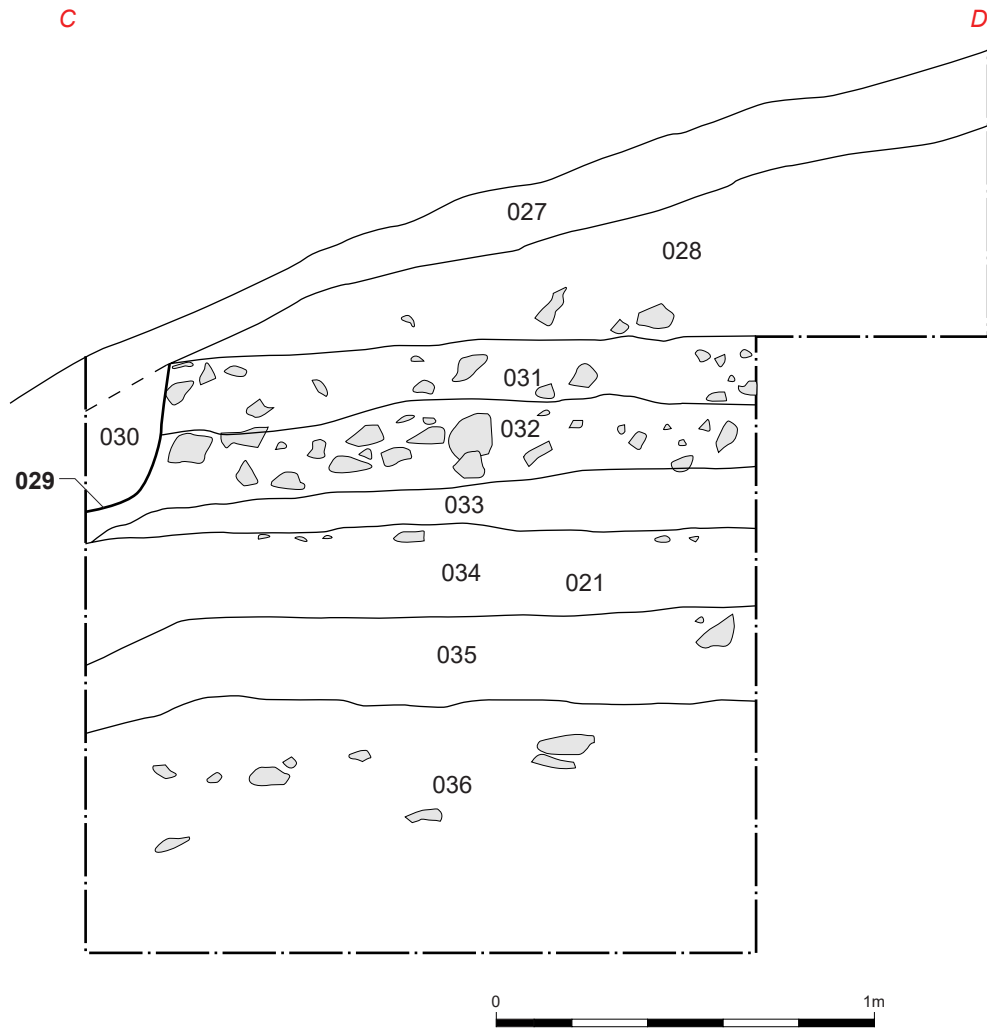
Fig. No:  
 8

Title:  
 North-facing section of TP2

There were seven distinct horizons in Test Pit 2 (see Fig. 8). However, they differed slightly from TP1.

The lowest deposit (**036**) consisted of dark greyish-brown sandy silt and was interpreted as garden soils which the drain, identified in the previous excavation, had been cut through, and likely the same as **005** in TP1. Full exploration of this layer was not possible, and thus its depth remained unknown. Natural was not reached.

A compacted light-mid brown silty sand (**035**) was overlying **036**. This was interpreted as the bank material and was also observed in the previous excavations. Above this was a thick layer of dark greyish-brown sandy silt with numerous flecks of charcoal (**034**). A similar level had been observed during the earlier excavations and was interpreted as a deposit which predated the construction of the wall. Overlying these two compacted layers was a thin charcoal-rich layer (**033**) which had been interpreted as construction debris in the previous Kirkdale excavation.

Above this were two horizons of light brown sand and grit (**032**) followed by sandstone rubble within a matrix of light brownish-grey silty sand (**031**) and which was interpreted as re-deposited demolition material. This had been severely truncated

in TP1 and only a small trace was left (**013**). The less compacted of the two (**031**) contained pottery, shells and bone.

Above this was a re-deposited brownish mid-grey sandy silt (**028**). Both pottery and bone was recovered from **028**. The pottery was a mix of modern and late medieval sherds, which indicated the deposit represented possible upcast material from previous excavations. This was overlain by the same (0.2m deep) dark brown silty sand topsoil (**027**) which was observed in TP1.
