Minor Archaeological Services Call-Off Contract St Andrews Cathedral and Priory (PIC035)

Boundary Wall Buttressing and Consolidation
Archaeological Excavation, January 2018
Report No. HES-PIC035-2018-01

St Andrews Cathedral and Priory, Fife (PIC035)

Boundary Wall Buttressing and Consolidation Archaeological Excavation, January 2018

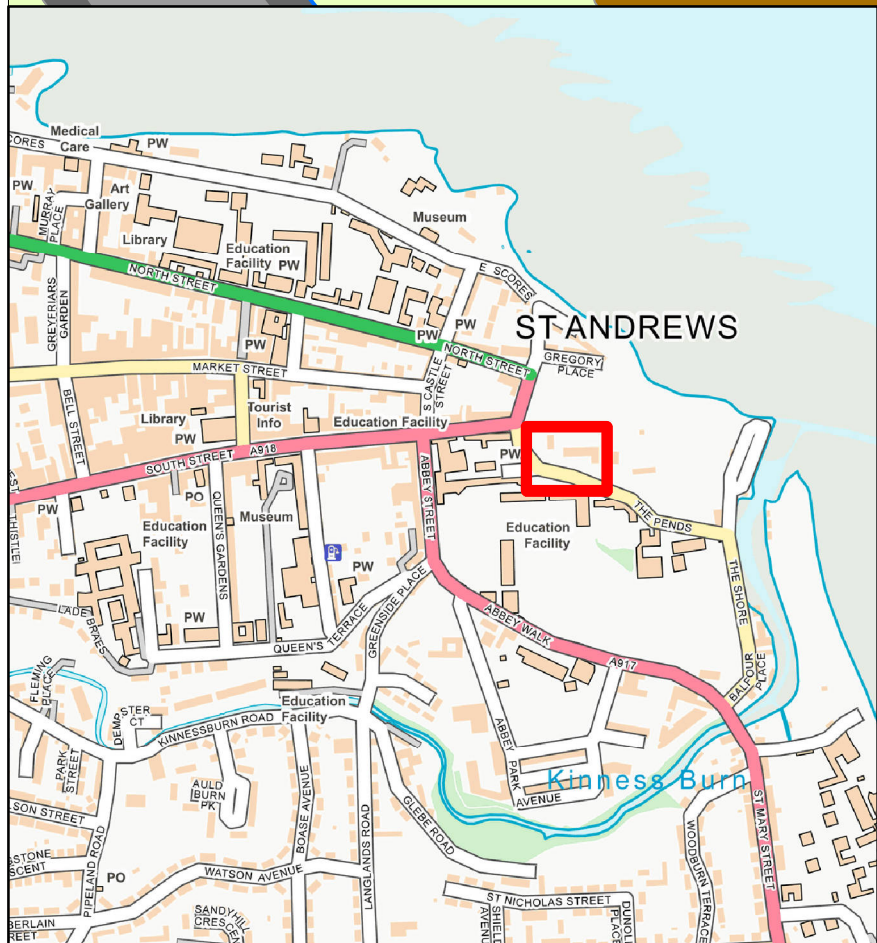
Fig. No:
1

Title:
Location map and site plan

Excavation by hand of six trenches was undertaken at the locations where pile caps will be inserted to form the stabilisation buttressing for the wall. Each trench measured c.1.7m x 0.8m x 0.6m deep. The trench locations were laid out on the ground in advance by HES staff (Fig. 1).

The trench locations are shown on Fig. 1. Tree roots from two extant trees in the vicinity of the works were encountered in the trenches. Small roots were removed during the excavation but larger roots were left intact.

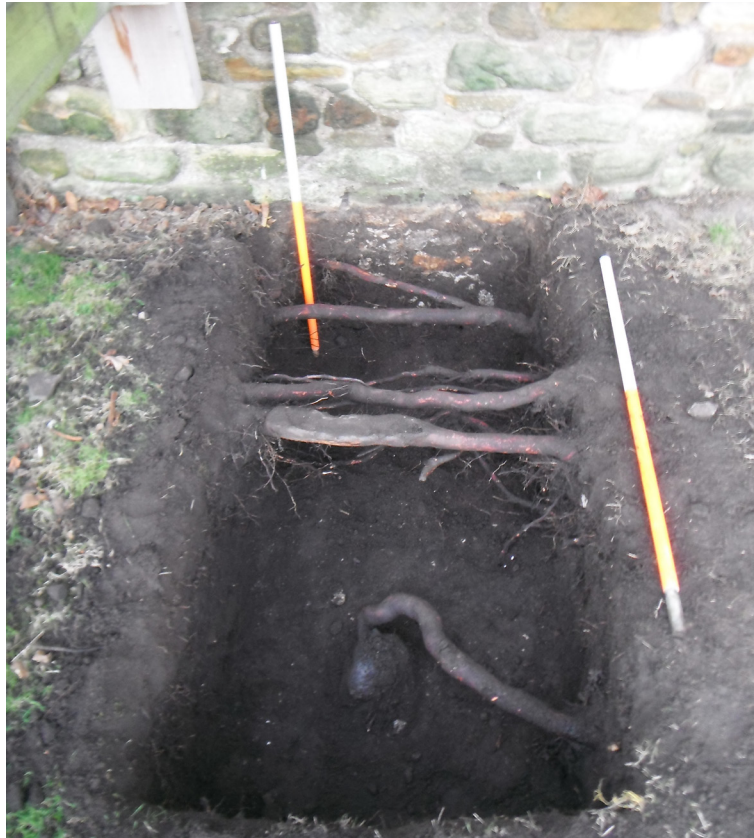
Fig. 2 - Pile Cap Trench 1

Pile Cap 1 measured 1.7m x 0.83m x 0.6m, running N-S. The Pile Cap trench had three contexts: uppermost was 0.2m of topsoil of a mid grey-brown sandy silt (**041**), followed by 0.2m of a mid to light greyish-brown sandy silt (**042**), and below that was light brownish-grey sandy silt (**043**) which continued beyond the formation depth. The root disturbance was extensive.

Pile Cap Trench 1 (Fig. 2)

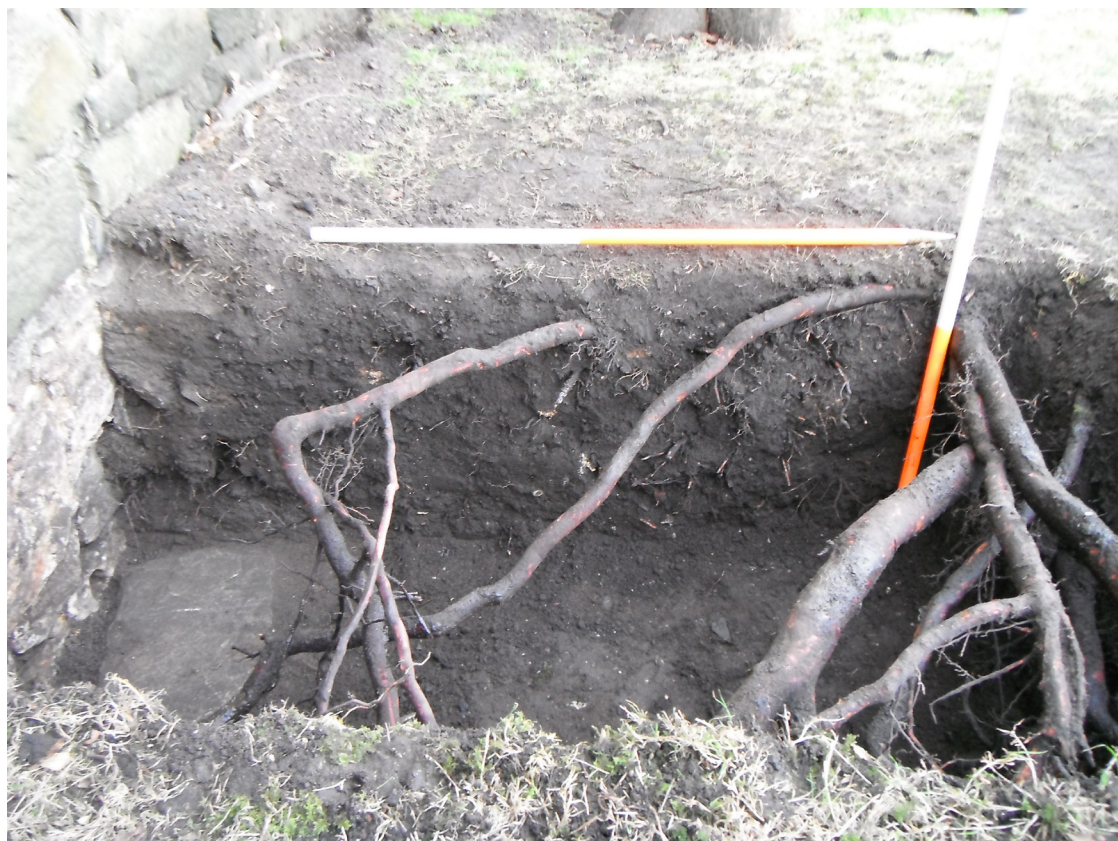
Fig. 3 - Pile Cap Trench 2

Pile Cap 2 measured 1.7m x 0.8m x 0.6m, running N-S. The Pile Cap trench had two contexts: topsoil (**037**) was 0.1m of mid greyish-brown sandy silt, below which was 0.1m of light grey-brown silt (**038**), while the lowest deposit, which appears to be bank

material, was 0.6m of mid grey-brown sandy silt (**039/040**) which continued beyond the formation depth. A large stone roof tile was found in **039**.

Pile Cap Trench 2 (Fig. 3)

One large stone slab was found in deposit **039**, it had a large perforation at one end and was 34x59cm in size, and had likely formerly been used as a roof tile.

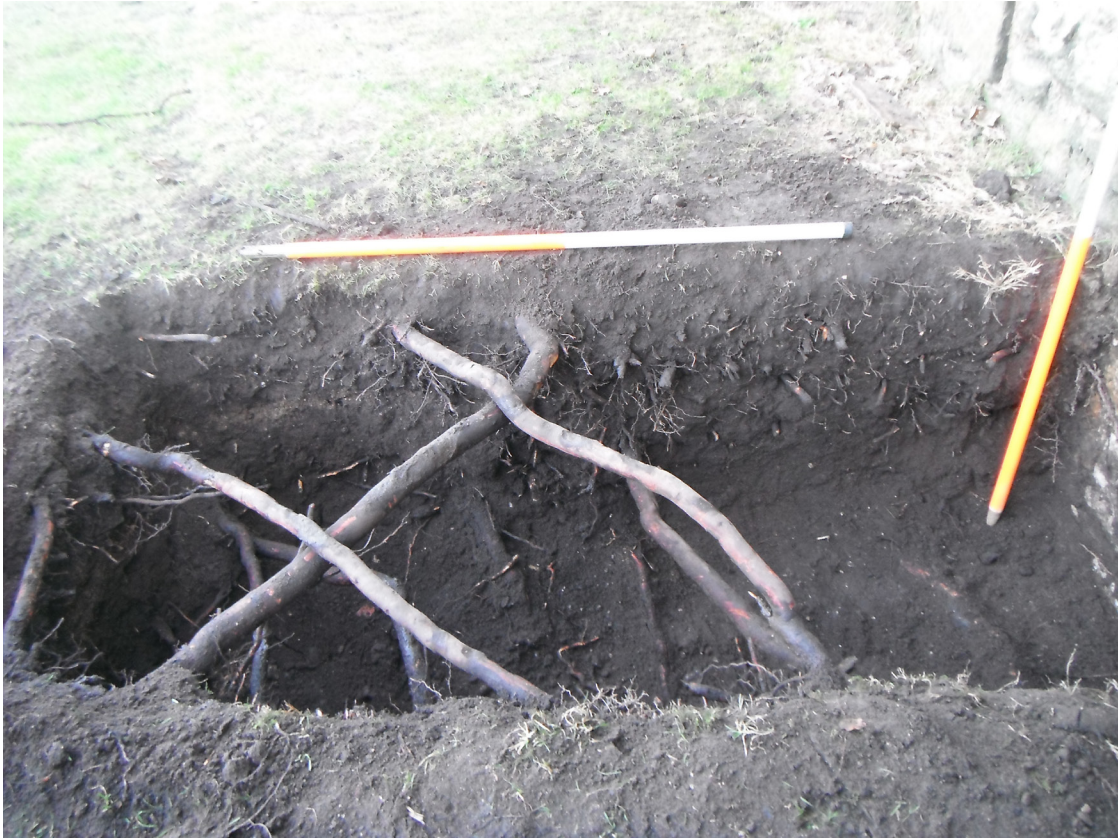
Fig. 4 - Pile Cap Trench 3

Pile Cap 3 measured 1.7m x 0.8m x 0.6m, running N-S . The trench contained two deposits: the topsoil (**048**) was 0.1m of mid greyish-brown sandy silt below which was 0.5m of light greyish-brown sandy silt (**050**) which continued beyond the formation depth. Within this lower deposit was a lens of light yellowish-grey gravel (**049**).

Pile Cap Trench 3 (Fig. 4)

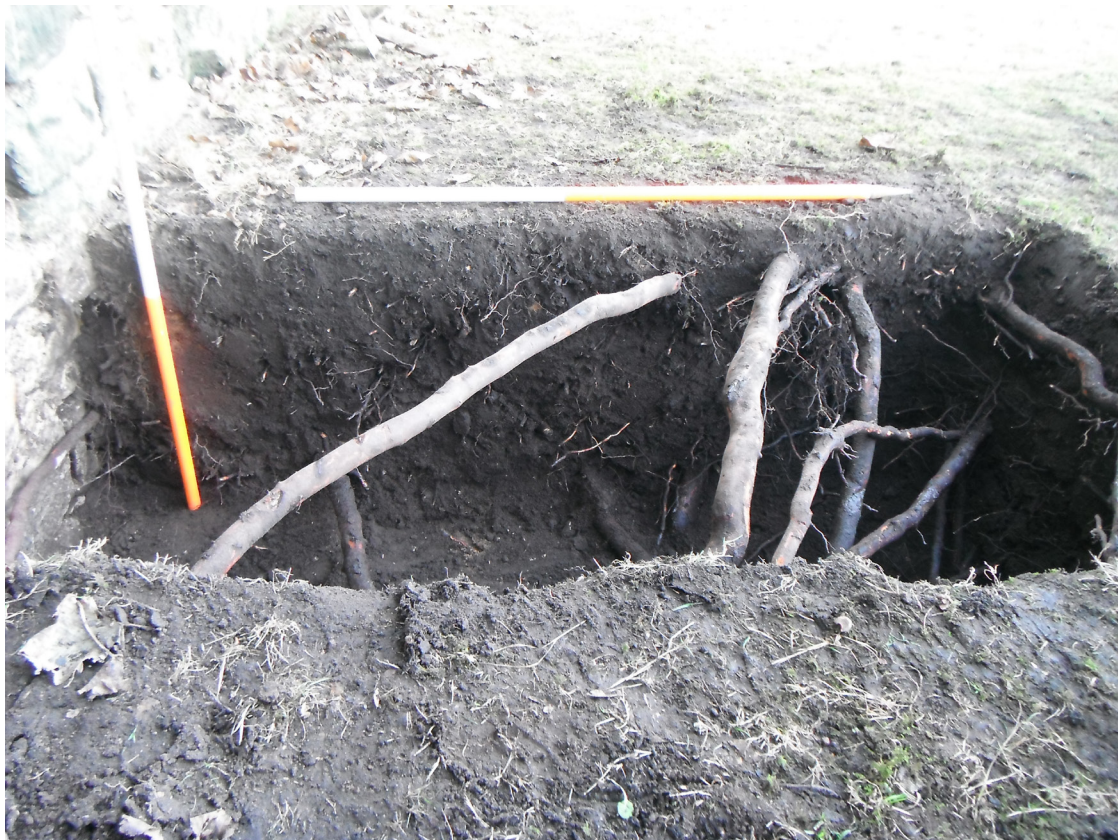
Fig. 5 - Pile Cap Trench 4

Pile Cap 4 measured 1.7m x 0.8m x 0.6m, running N-S. The trench revealed two indistinct deposits of heavily rooted soil: 0.35m of topsoil (**045**) and 0.45m of mid greyish-brown sandy silt (**047**) which continued beyond the formation depth. A 0.1m thick deposit of brownish-yellow sand was present against the base of the wall. The heavy rooting had caused a large amount of disruption to the deposits.

Pile Cap Trench 4 (Fig. 5)

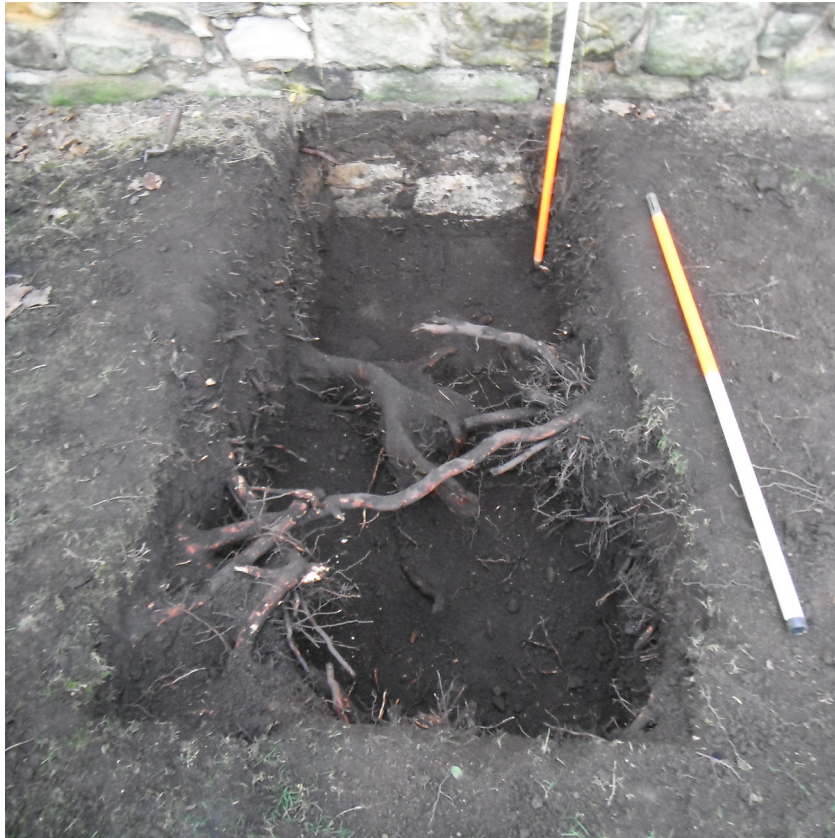
Fig. 6 - Pile Cap Trench 5

Pile Cap 5 measured 1.7m x 0.9m x 0.6m, running N-S. The trench had one context, 0.5m of mid brown sandy silt (**052**) underlying topsoil (**051**). A spindle whorl came from (**052**).

Pile Cap Trench 5 (Fig. 6)

A spindle whorl was found in deposit **052** it is circular (34mm diam.) with a central hole (8mm diam.). The spindle whorl is stone, domed on one side and broken on the other.

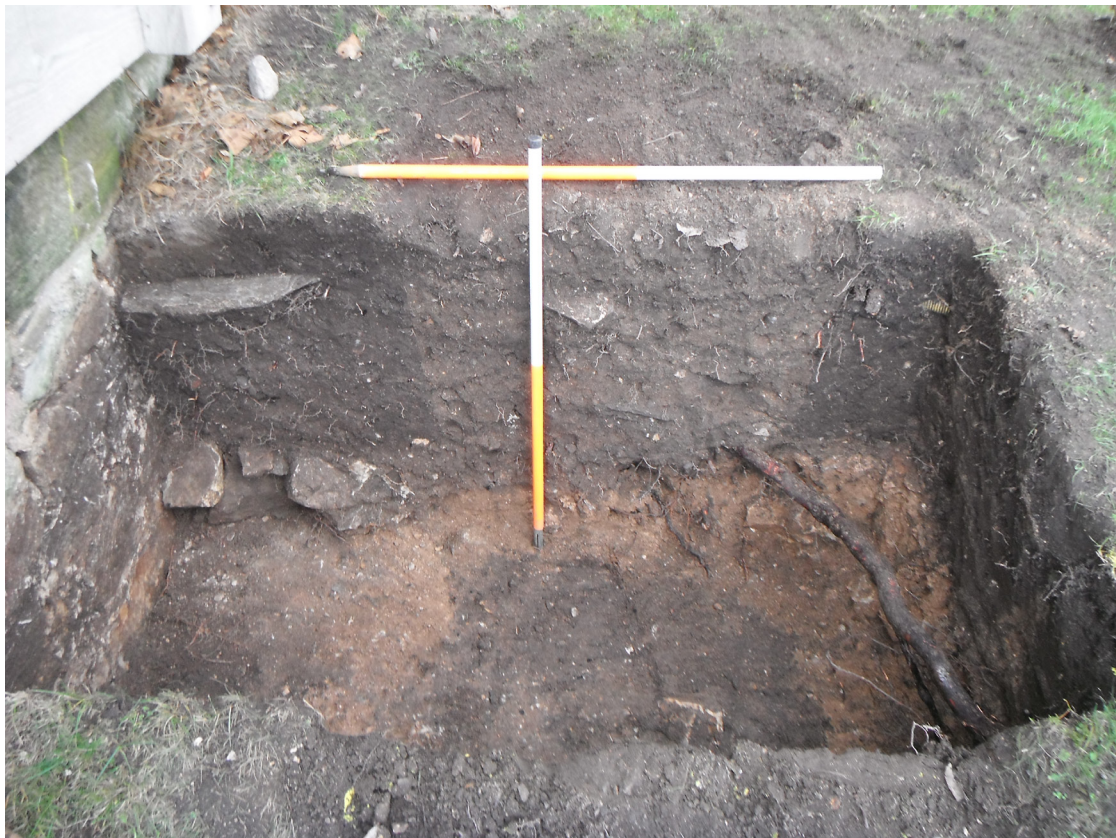
Fig. 7 - Pile Cap Trench 6

Pile Cap Trench 6 measured 1.7m x 0.9m x 0.8m, running N-S. Heavily rooted topsoil (**053**) overlay **057/058**, 0.35-0.5m of mid grey-brown silty sand. Beneath **058** was a stony, light grey-brown silty sand deposit (**061**) up to 0.25m thick and a deposit of angular stones with yellowish-grey mortar (**062**) up to 0.2m thick.

A modern plastic pipe within a cut was present (**055/056**). The trench also contained the cut of CFA Trench TP2 (**059**) (Rayner & Savory 2017).

Pile Cap Trench 6 (Fig. 7)
