The Boiler House, High School Wynd, Edinburgh

Level 2 Historic Building Survey Report No. 3610

The Boiler House High School Wynd, Edinburgh Level 2 Historic Building Survey

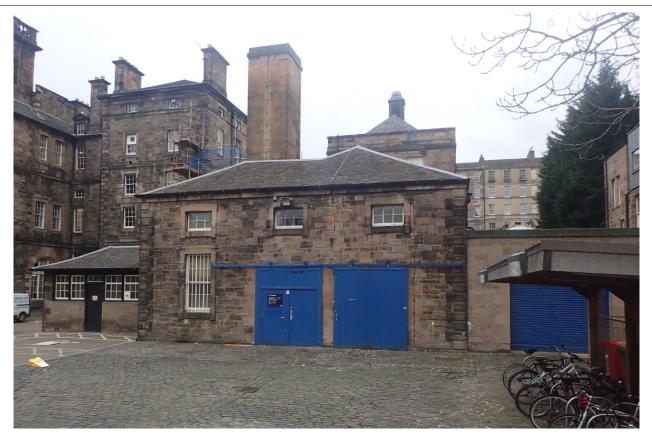
Fig. 5 - North-facing elevation

The north-facing elevation included an Edinburgh University electrical switch room building that did not form part of the survey. This was a single storey addition dating to the 1930s attached to the east side of the boiler house. The building was constructed of snecked sandstone with an off-centre panelled door. The door was flanked by a pair of windows on its east side and three more on its west side. All were nine-paned casement windows. The hipped roof was slated.

The main boiler house block measured 12.5m long and 5.5m to the cornice at eaves level. The building had been constructed of snecked and stugged ashlar sandstone and framed by raised quoins and the ashlar margins around the windows were polished and raised. The ground floor contained a tall barred window at its east end and two large blue painted plank-built sliding doors on rails. The pier between the two doors comprised polished ashlar and is a recent addition.

The first floor had three identical windows which comprised rectangular openings with raised ashlar margins each containing six paned windows. Above the windows at eaves level was a plain ashlar cornice.

Adjoining the west side of the boiler house was a modern garage (1980s) used as a workshop and storage area with a large bay entrance with roller shutter door. The garage was built of snecked sandstone that was heavily stugged. The doorway was framed by polished ashlar. The roof was flat and felted.

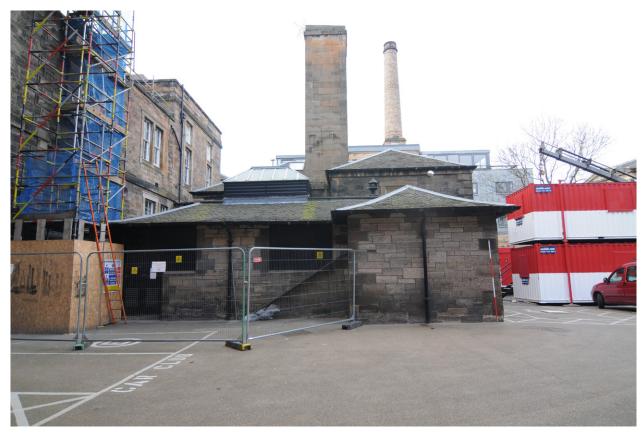
Fig. 6 - East-facing elevation

The east-facing elevation (Fig 6) comprised the aforementioned electrical switch gear room behind which was a Scottish Power sub-station. Two large boarded windows occupied the centre of the wall. The window reveals were surrounded by ashlar. The roof was slate and contained a louver vented pagoda.

The only notable feature in this elevation was an earlier roof raggle on the main boiler house block which marked the position of an earlier roofline. This earlier roofline possibly relates to an earlier

building shown on the 1908 OS map (Fig 2b). The east-facing wall of the boiler house also contained a single central window at first floor level. This window was the same as those described on the North-facing elevation.

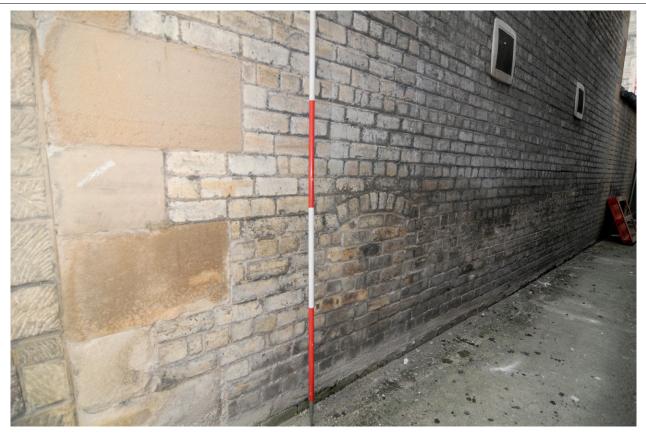
Fig. 7 - South-facing elevation

The south-facing elevation comprised the back wall of the boiler house workshop/stores building that was brick-built. The rear of the plant room was snecked ashlar. A central window contained a galvanised zinc louver vent. The elevation of the boiler house workshop/stores abutted the main elevation of the back wall of the boiler house which was brick-built (EGB 3:1) and framed by dressed ashlar sandstone quoins. The only notable feature was a small blocked brick arch (Fig 7) about 1m high and 1m wide, its function other than a flue is not exactly clear. The rest of the wall was uniform brick for its full length. At the east end of the elevation access was restricted but the back wall of the aforementioned switch-gear room was visible and it contained four nine-paned windows below very wide eaves.

The rear wall of the Boiler House incorporated 19th century shale brick that was framed by ashlar dressings. A small blocked arched-opening (Fig 7) close to ground level may be the remains of a flue that was made redundant in the mid-20th century when the boilers became oil fired.

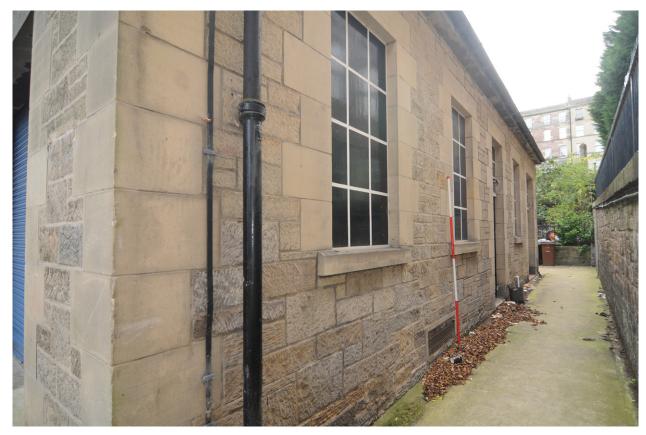
Fig. 8 - West-facing elevation

The west-facing elevation formed the side wall of the workshop/storage building and comprised the same fabric as that on the north-facing elevation (Fig 8). Three blocked windows were present on this elevation and were painted to resemble actual windows. The south end of the building previously contained a boiler. Two black-painted plank-built doors with louver vents above provided access to this part of the building.

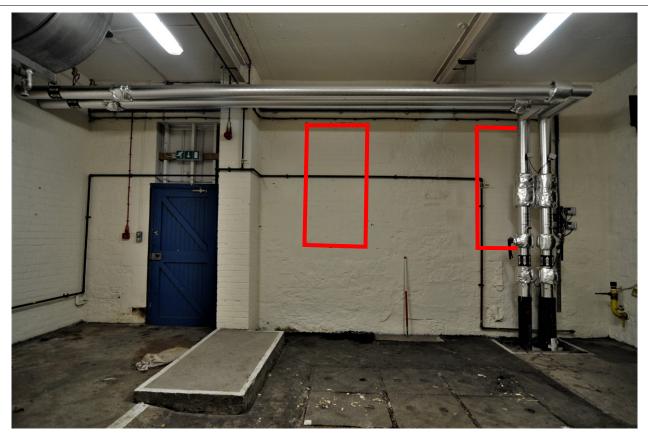
Fig. 9 - Ground floor Unit 1 workshop/storage showing two brick-blocked windows

The west-facing elevation of Unit 1 was stone-built and was the original outside wall of the main block prior to the construction of Unit 1. A series of quoins were still visible at the north end of the wall. The north-facing elevation wall was a brick-built partition between Unit 1 and Unit 2. The east-facing elevation comprised snecked sandstone with brick-built buttresses to support the slab concrete roof. Two brick blocked windows were present on the right hand side of the buttress (Fig

9). The south-facing elevation contained a steel roller door. The floor was a mixture of concrete and flagstones.

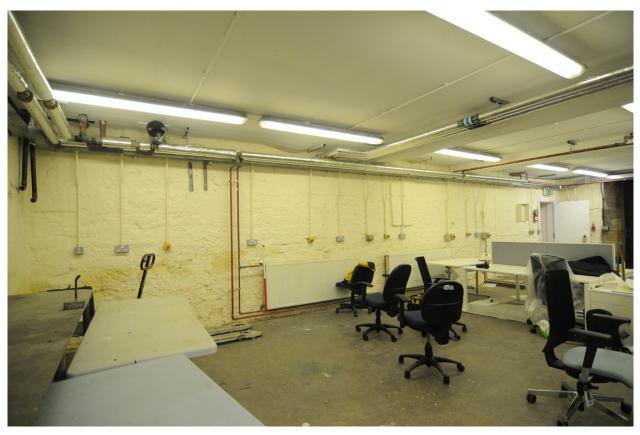
Fig. 10 - Ground floor Unit 3 workshop/storage general view

This large open plan room was accessed on the north wall by a large sliding plank-built door that was flanked on its east side by a staircase. The east and west-facing long walls comprised creampainted walls with an array of electrical sockets for benches that had since been removed (Fig 10). The rear wall (south end of the unit) was clad with plaster board and was featureless.

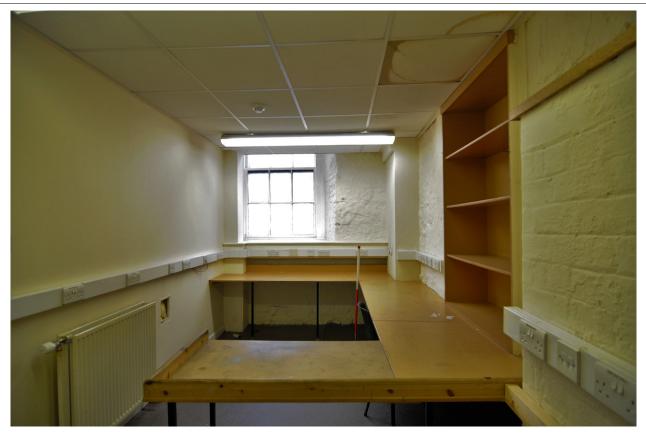
Fig. 11 - Unit 6 Ground floor office

Unit 6 was a small office lit on its north wall by a six-paned window (Fig 11). The wall on the east side (west-facing elevation) was stone-built and the one opposite was lined with plaster board. A desk with built-in bookcase dominated the room. At the south end was the other side of the blocked-up doorway that once accessed Unit 5. The interior walls were 0.5m thick showing that this was a substantial spine or load-bearing wall.

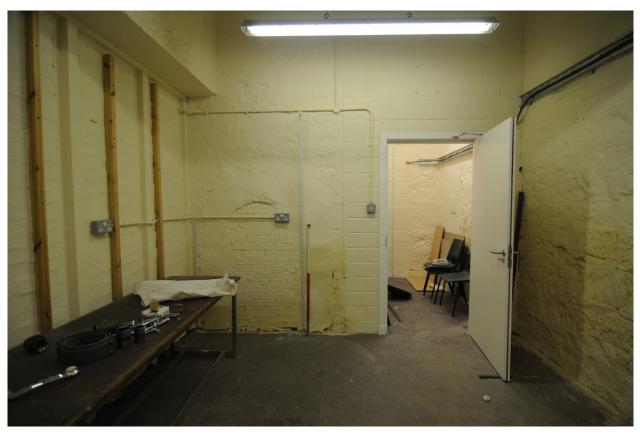
Fig. 12 - Unit 4 Ground floor plant room

Unit 4 was a former plant room with brick and stone walls on its east and west sides. A stone and brick partition wall contained a bricked-up arch (Fig 12) which was flanked by a doorway leading into Unit 5; a storeroom. It is surmised that the bricked-up opening was a flue leading to the chimney stack.

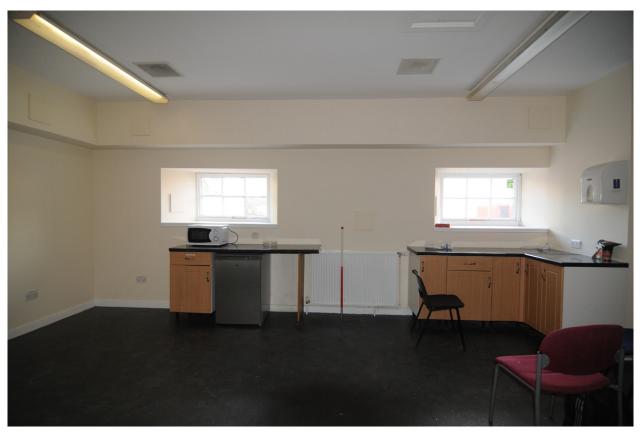
Fig. 14 - Unit 10 First floor mess room

This was the former mess room (Fig 14) of the maintenance personnel and it contained featureless plaster-boarded walls and modern kitchen units and worktops. Two rectangular six-paned windows were present on the south-facing wall.

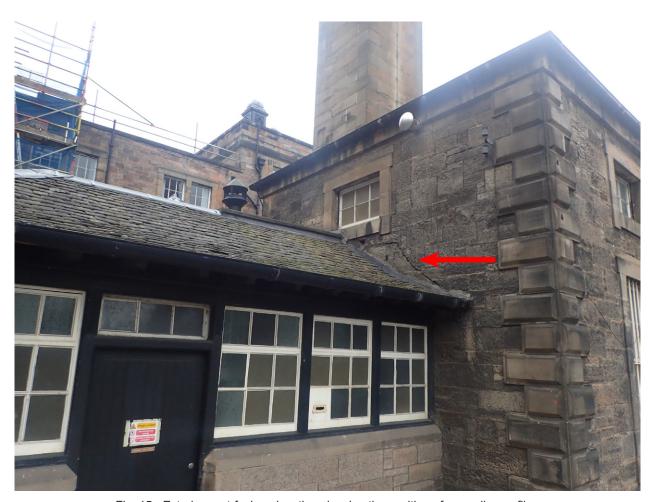
Fig. 15 - Exterior east-facing elevation showing the position of an earlier roofline
