# Land North of Drumshoreland, Pumpherston, West Lothian

Archaeological Evaluation Report No. 3645

**Archaeological Evaluation**

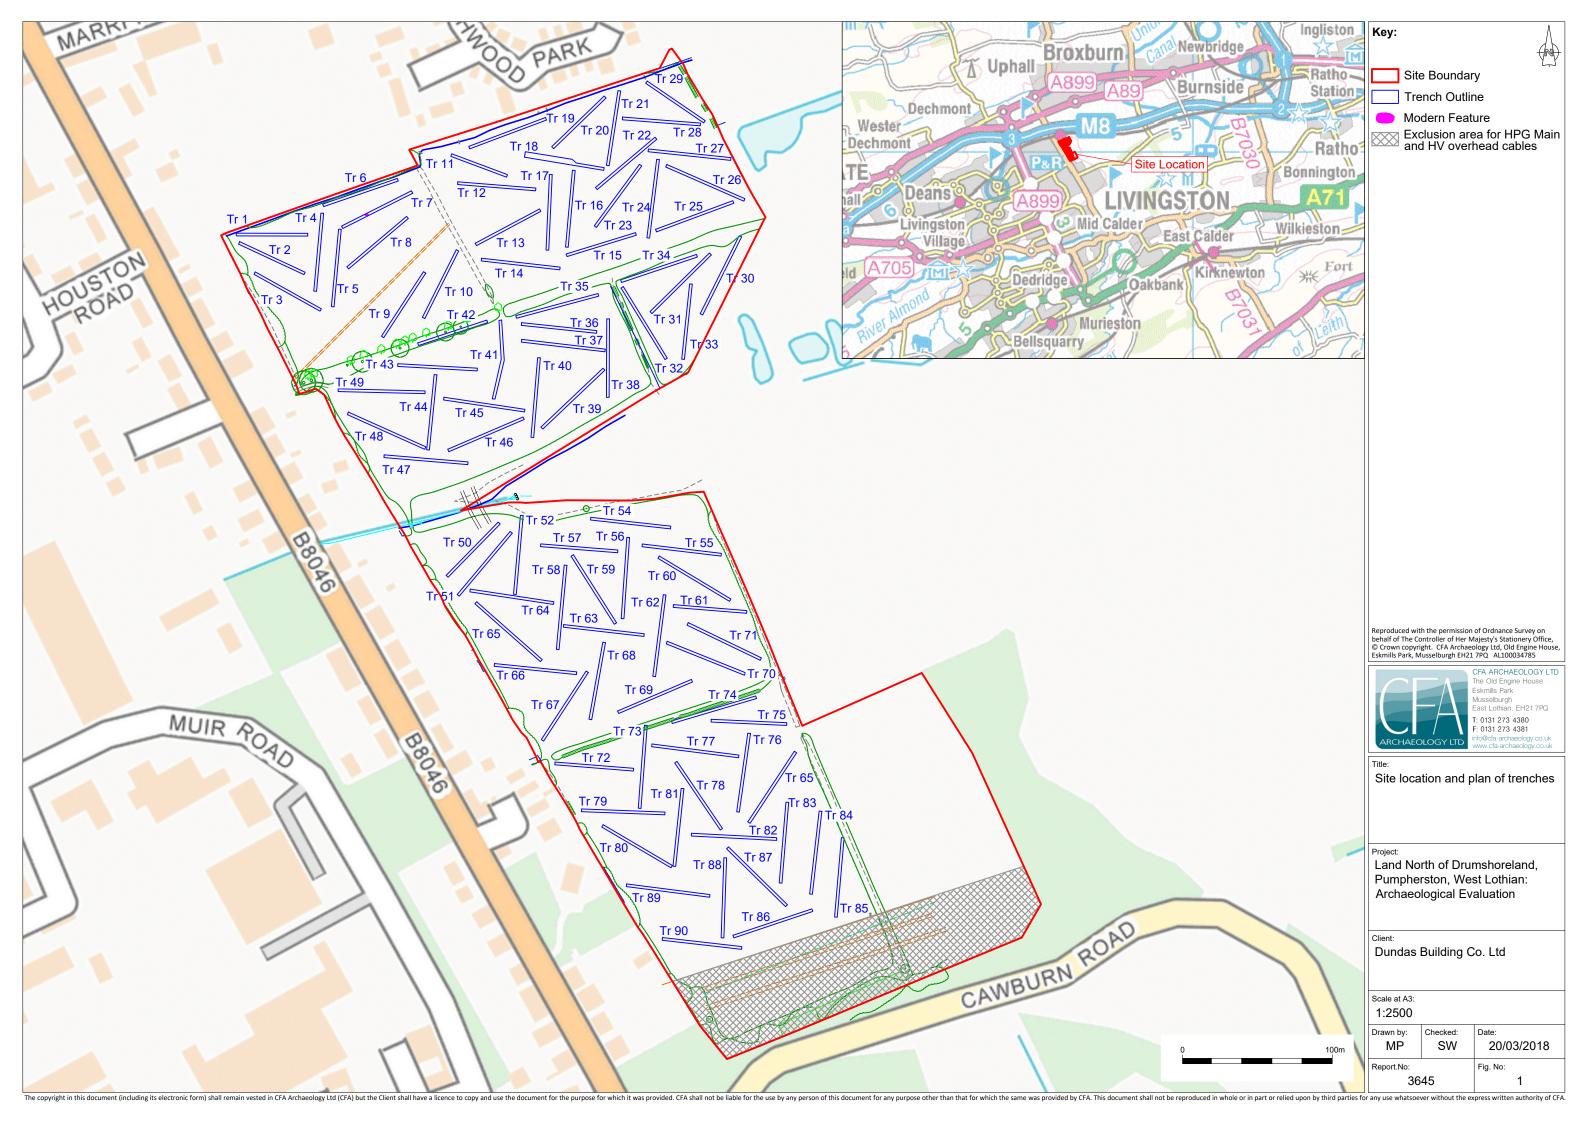
The site ran to 25 acres and ninety trenches (Tr.1-90) were to be excavated totalling 8,100m<sup>2</sup> (c.8% of the available area) (Fig.1). An area of around 1.3ha at the south-east corner of the site was missed but the 90 trenches were excavated in the remaining, slightly smaller area. Following consultation WoSAS agreed that the evaluation that had been undertaken was sufficient to characterise the area as being of low potential and no further evaluation was requested.

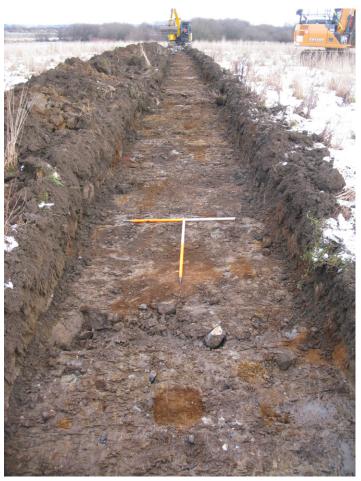
Topsoil (001) was generally 0.2 to 0.4m deep. Where present, the underlying subsoil (002) was 0.1m to 0.2m deep comprising orange-brown sandy clays. The natural substrate (003) generally comprised pale orange and blue-grey mixed sandy clays, thoroughly distorted with lignite, manganese and degraded stone inclusions.

Fig. 3 - Trench 62, facing West, showing shallow depth of trench and mixed composition of the natural

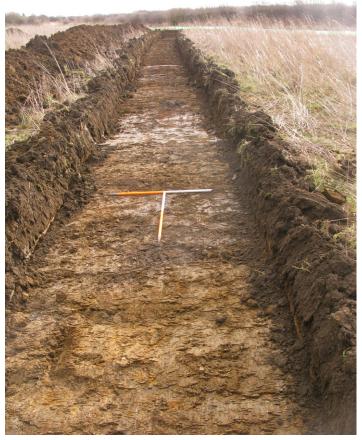
The trenches contained no features other than field drains and occasional rig and furrow (Fig. 4). Appendix 1 contains a tabulated summary of all the trench dimensions and a description of the trench. Numbers in bold and parentheses are context numbers and are described in Appendix 3.

Fig. 4 - Trench 14, facing East; minimal traces of clay field drains
