Minor Archaeological Services Call-Off Contract Linlithgow Palace and Peel (PIC155)

Drainage Installation
Trial Trenching Evaluation, March 2018
Report No. HES-PIC155-2018-01

Drainage Installation Trial Trenching Evaluation, March 2018

Report No. HES-PIC155-2018-01

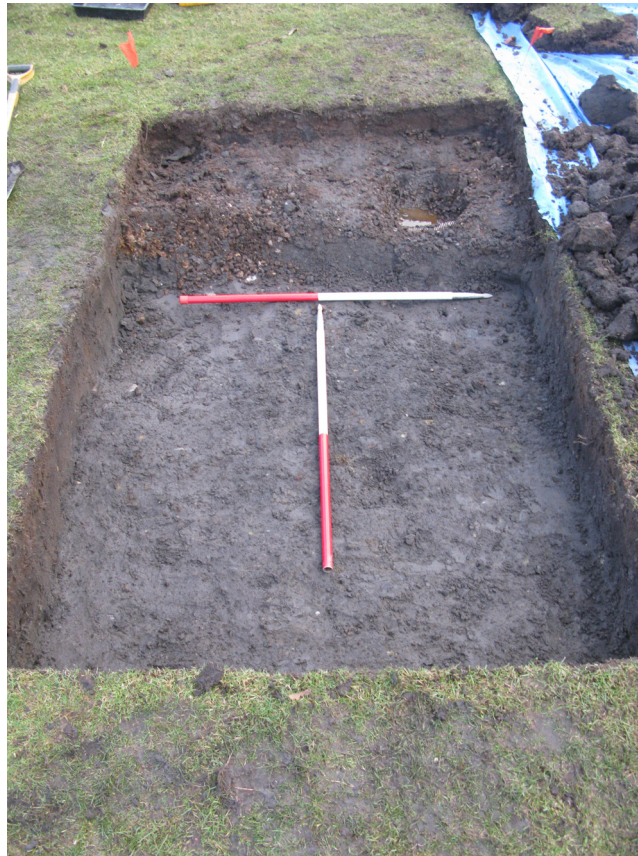
In the eastern end of the trench a modern plastic drain pipe, with a pebble gravel fill, was uncovered (Fig. 2, 4). This was not excavated as the drain was still in use. Trench 1 contained no archaeological features.

Fig. 2 - Trench 1 showing modern pipe

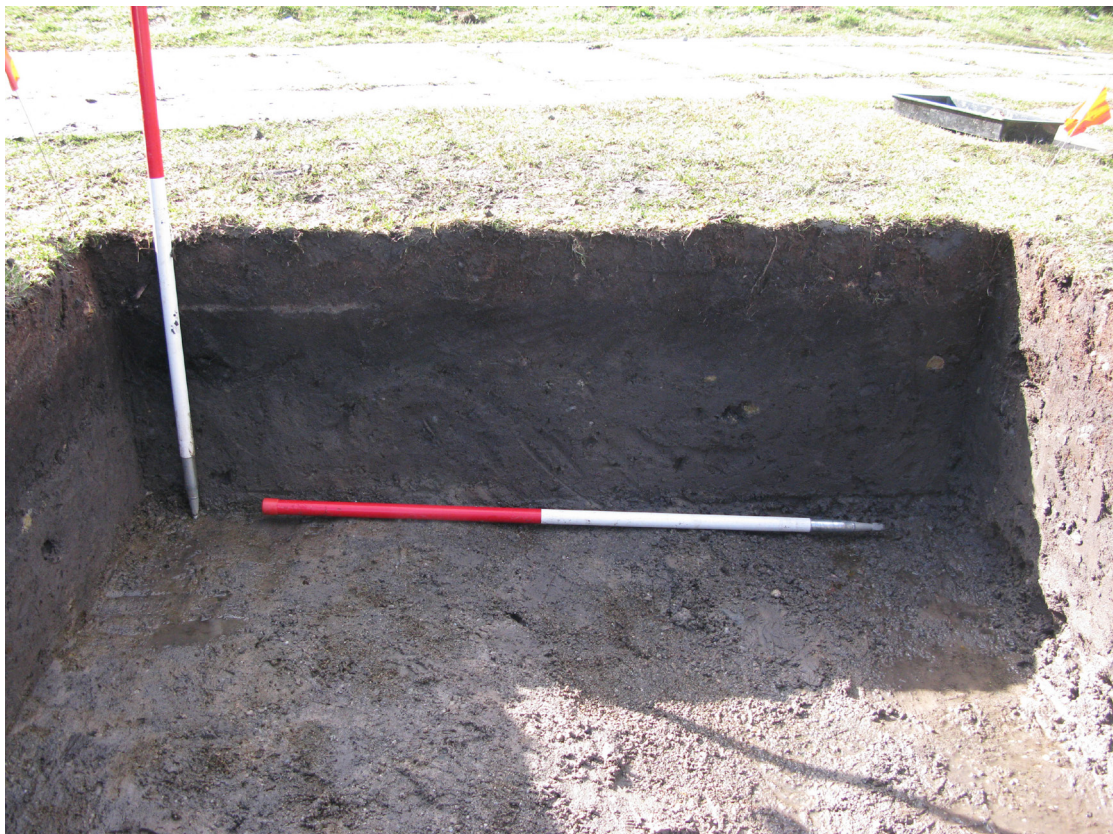
The turf and topsoil layer (**101**) was 0.2-0.3m in depth, with a thin lens of modern sand (**102**) directly beneath. Below this was a homogenous dark grey silt layer (**103**), likely to be a recent deposit of buried topsoil. This lay above a mid grey sandy silt deposit (**104**), around 0.35m thick, well sorted with occasional pebble inclusions and likely to have been deposited by water. This layer had clear horizons between the overlying buried topsoil (**103**) and the sandy gravel natural (**000**) below it.

Excavation stopped at natural, with the trench 0.6m deep (Fig. 3).

Fig. 3 - Trench 1 east facing section

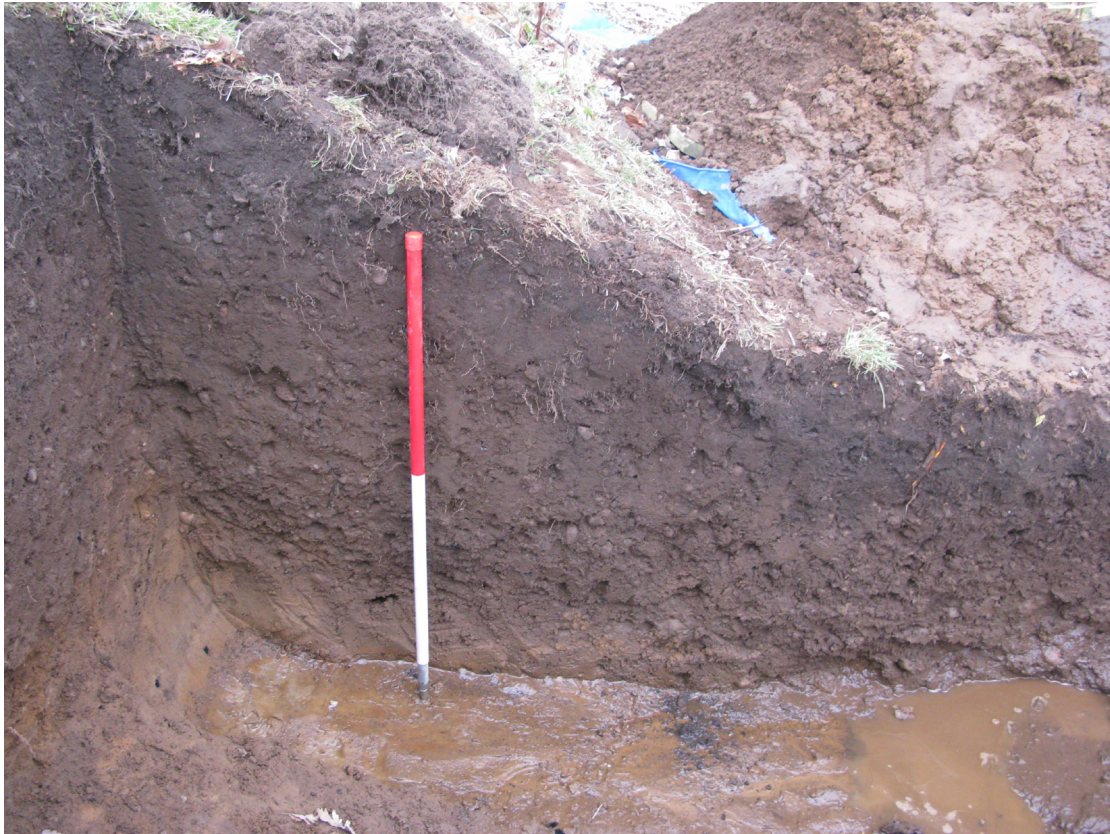
The removal of 0.2-0.3m of topsoil and turf (**301**) revealed a dark grey silt deposit (**302**). This was 0.7m thick and overlay (**303**) which was indistinguishable aside from the presence of coal and pebble inclusions. This lower deposit was 0.2m thick and overlaid the natural sand (**000**) (Fig. 5-7).

Natural was encountered at a depth of 1.1m and excavation extended into the natural by 0.5m to test the nature of the deposit, with the trench overall being 1.6m deep at maximum.

There were no archaeological features recorded in the trench, and the deposits are likely to be water lain and/or slopewash. Waterlogging occurred during excavation of the trench.

Fig. 5 - Trench 3, South east facing section showing bank material and flooding

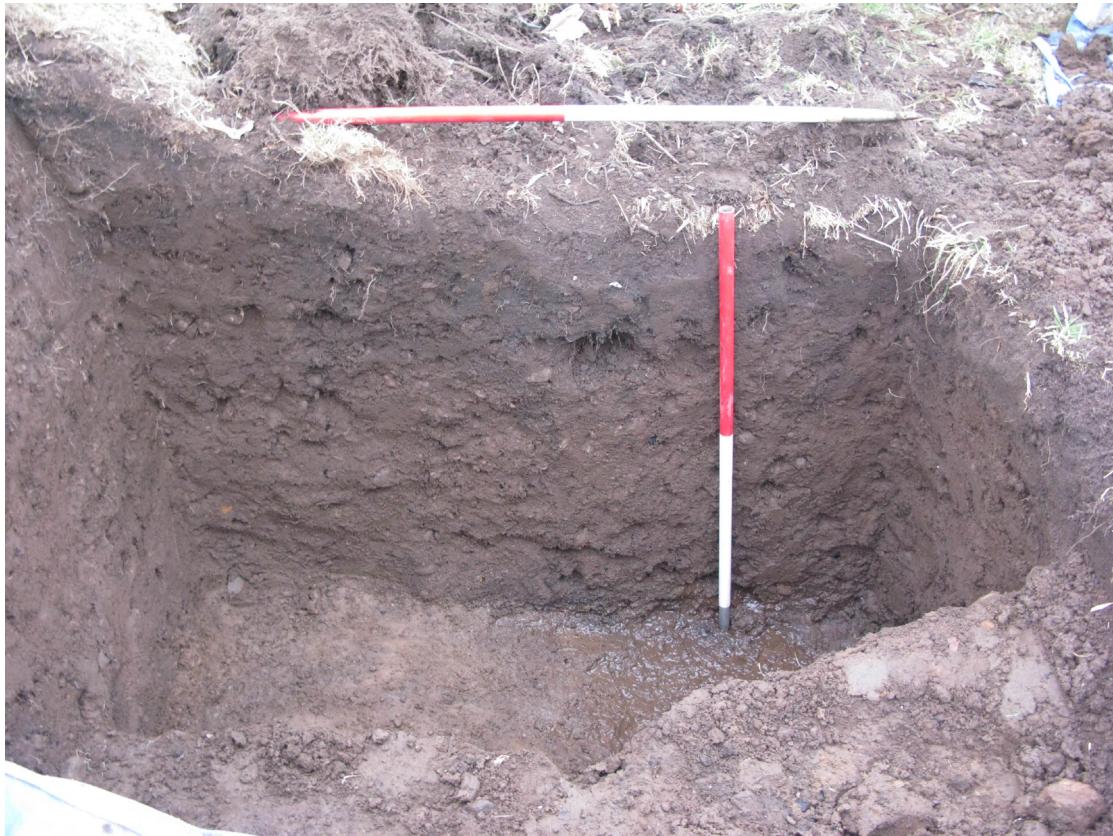
Trench 4 was 2.5m x 1.5m and orientated NW-SE. As with Trench 3 a thin layer of topsoil (**401**) covered two grey silt deposits (**402** and **403**), with the latter being characterised by frequent inclusions of coal; **402** was 0.75m thick, **403** was 0.2m thick.

Natural was orange sand (**000**) which contained a few flat water rounded pebbles (Fig. 8). Excavation stopped at natural, with the trench 1.3m deep at maximum.

Fig. 8 - Trench 4 South east facing section

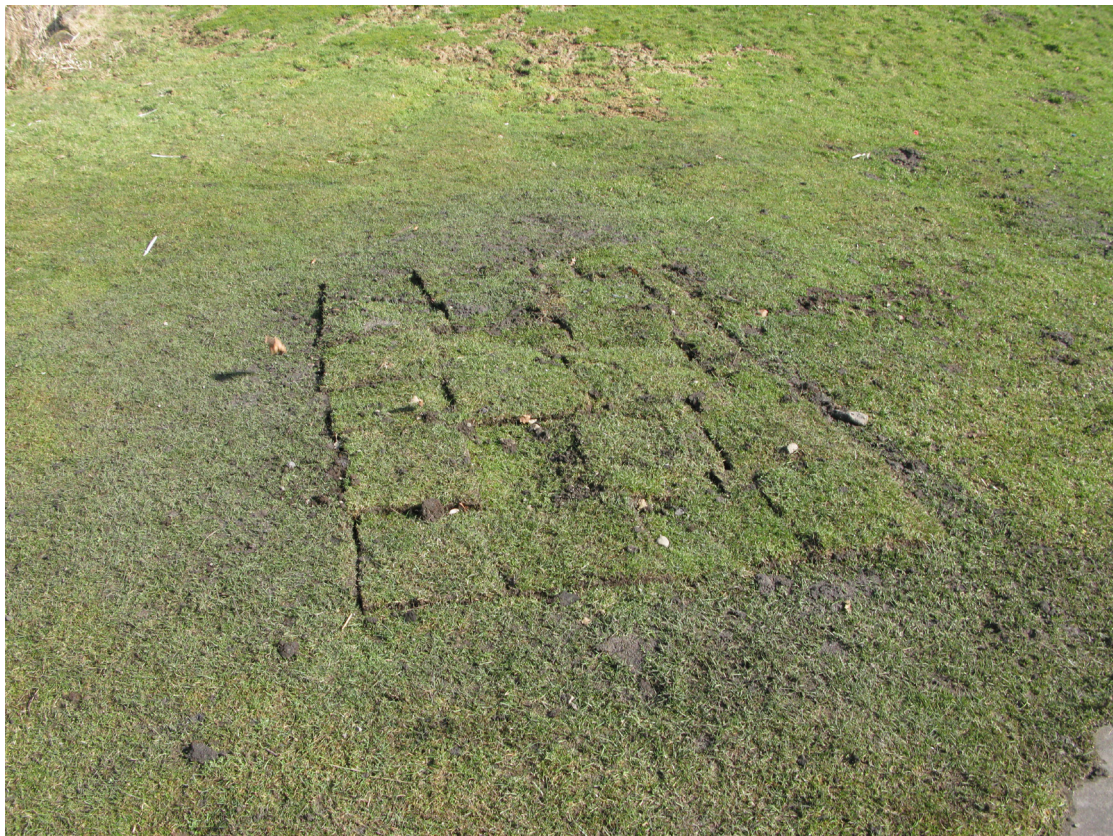
Fig. 9 - Trench 1 turf replaced

Turf was carefully removed and stored prior to reinstatement in order to minimise the visual impact of the works. Two trenches (2 & 3) became waterlogged and were soft when backfilled; these were fenced off with Netlon to protect the public and to allow the ground to settle and firm up.

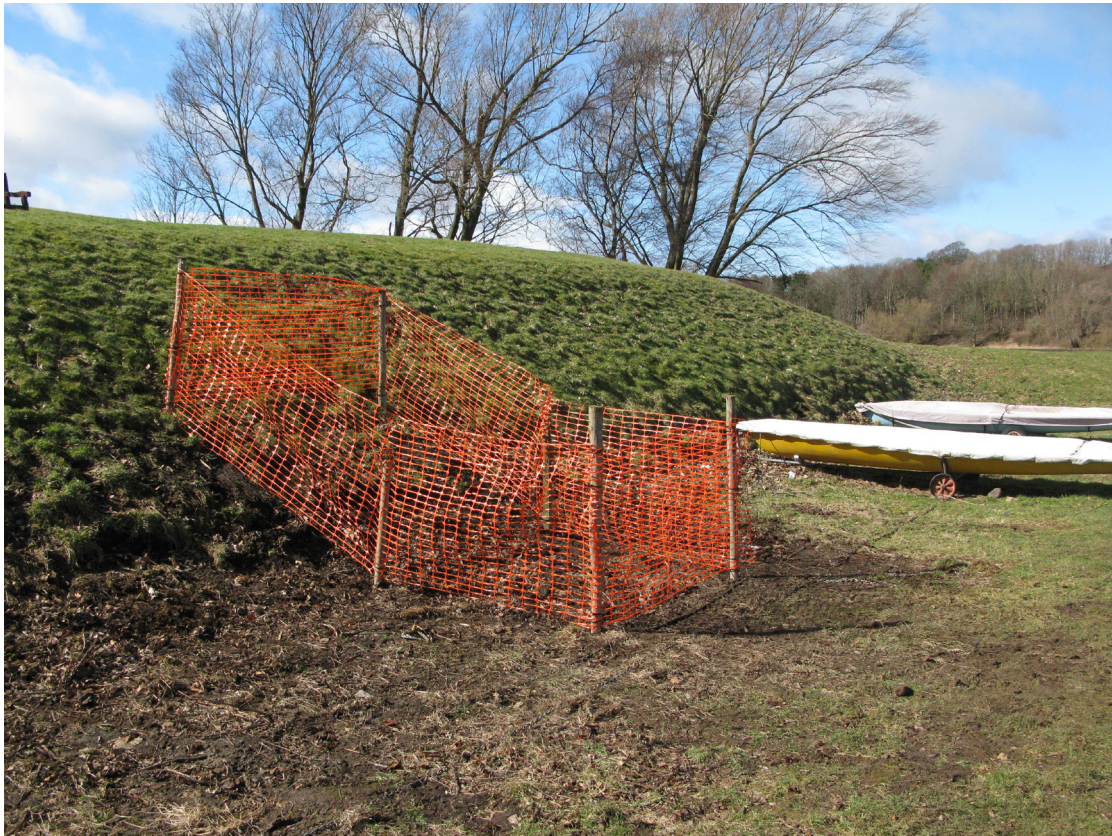
Fig. 10 - Trench 3, post excavation and netlon fencing

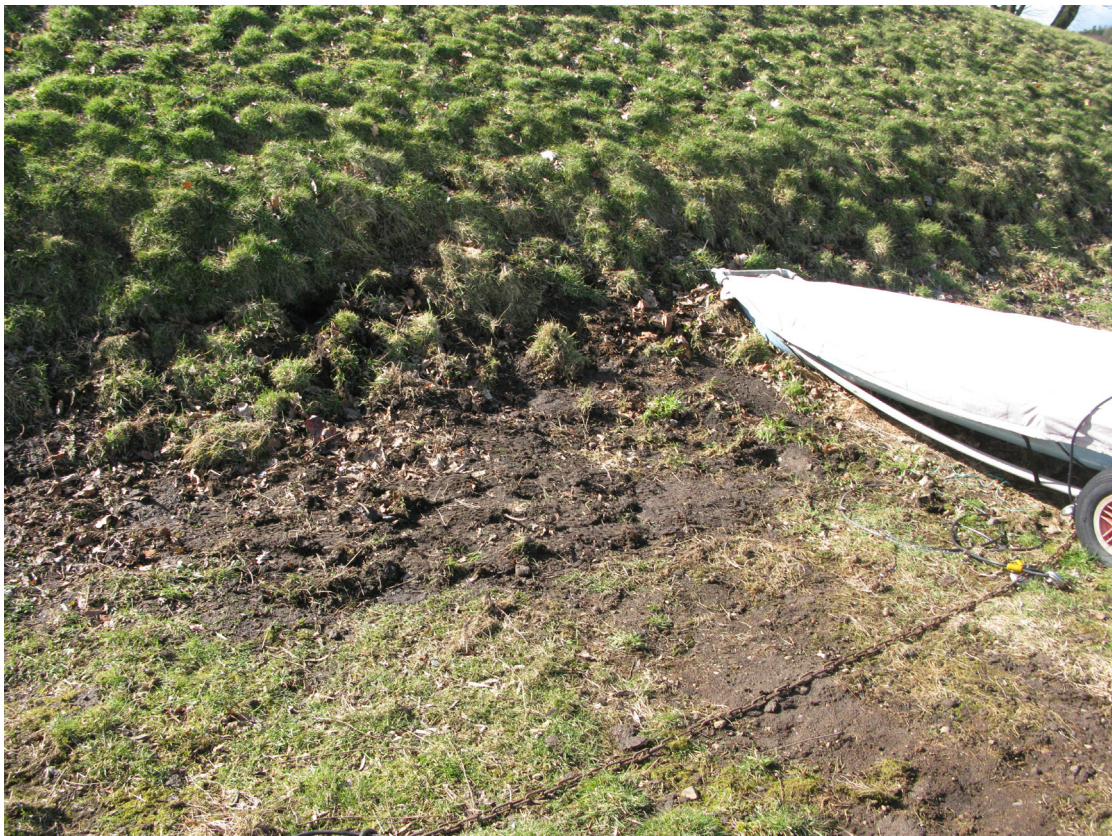
Fig.11 - Trench 4, post excavation and re turfing
