The Falcon Hotel, Chapel Street, Stratford- Upon-Avon: Archaeological Watching Brief

Report No. MK064/16

This document presents the results of an archaeological watching brief on a series of small engineering test pits at the Falcon Hotel, Stratford-Upon-Avon, Warwickshire which is centred on NGR SP 20040 54770. The work (site code FHSW) was carried out over three days between the 14th and 21st of September 2016.

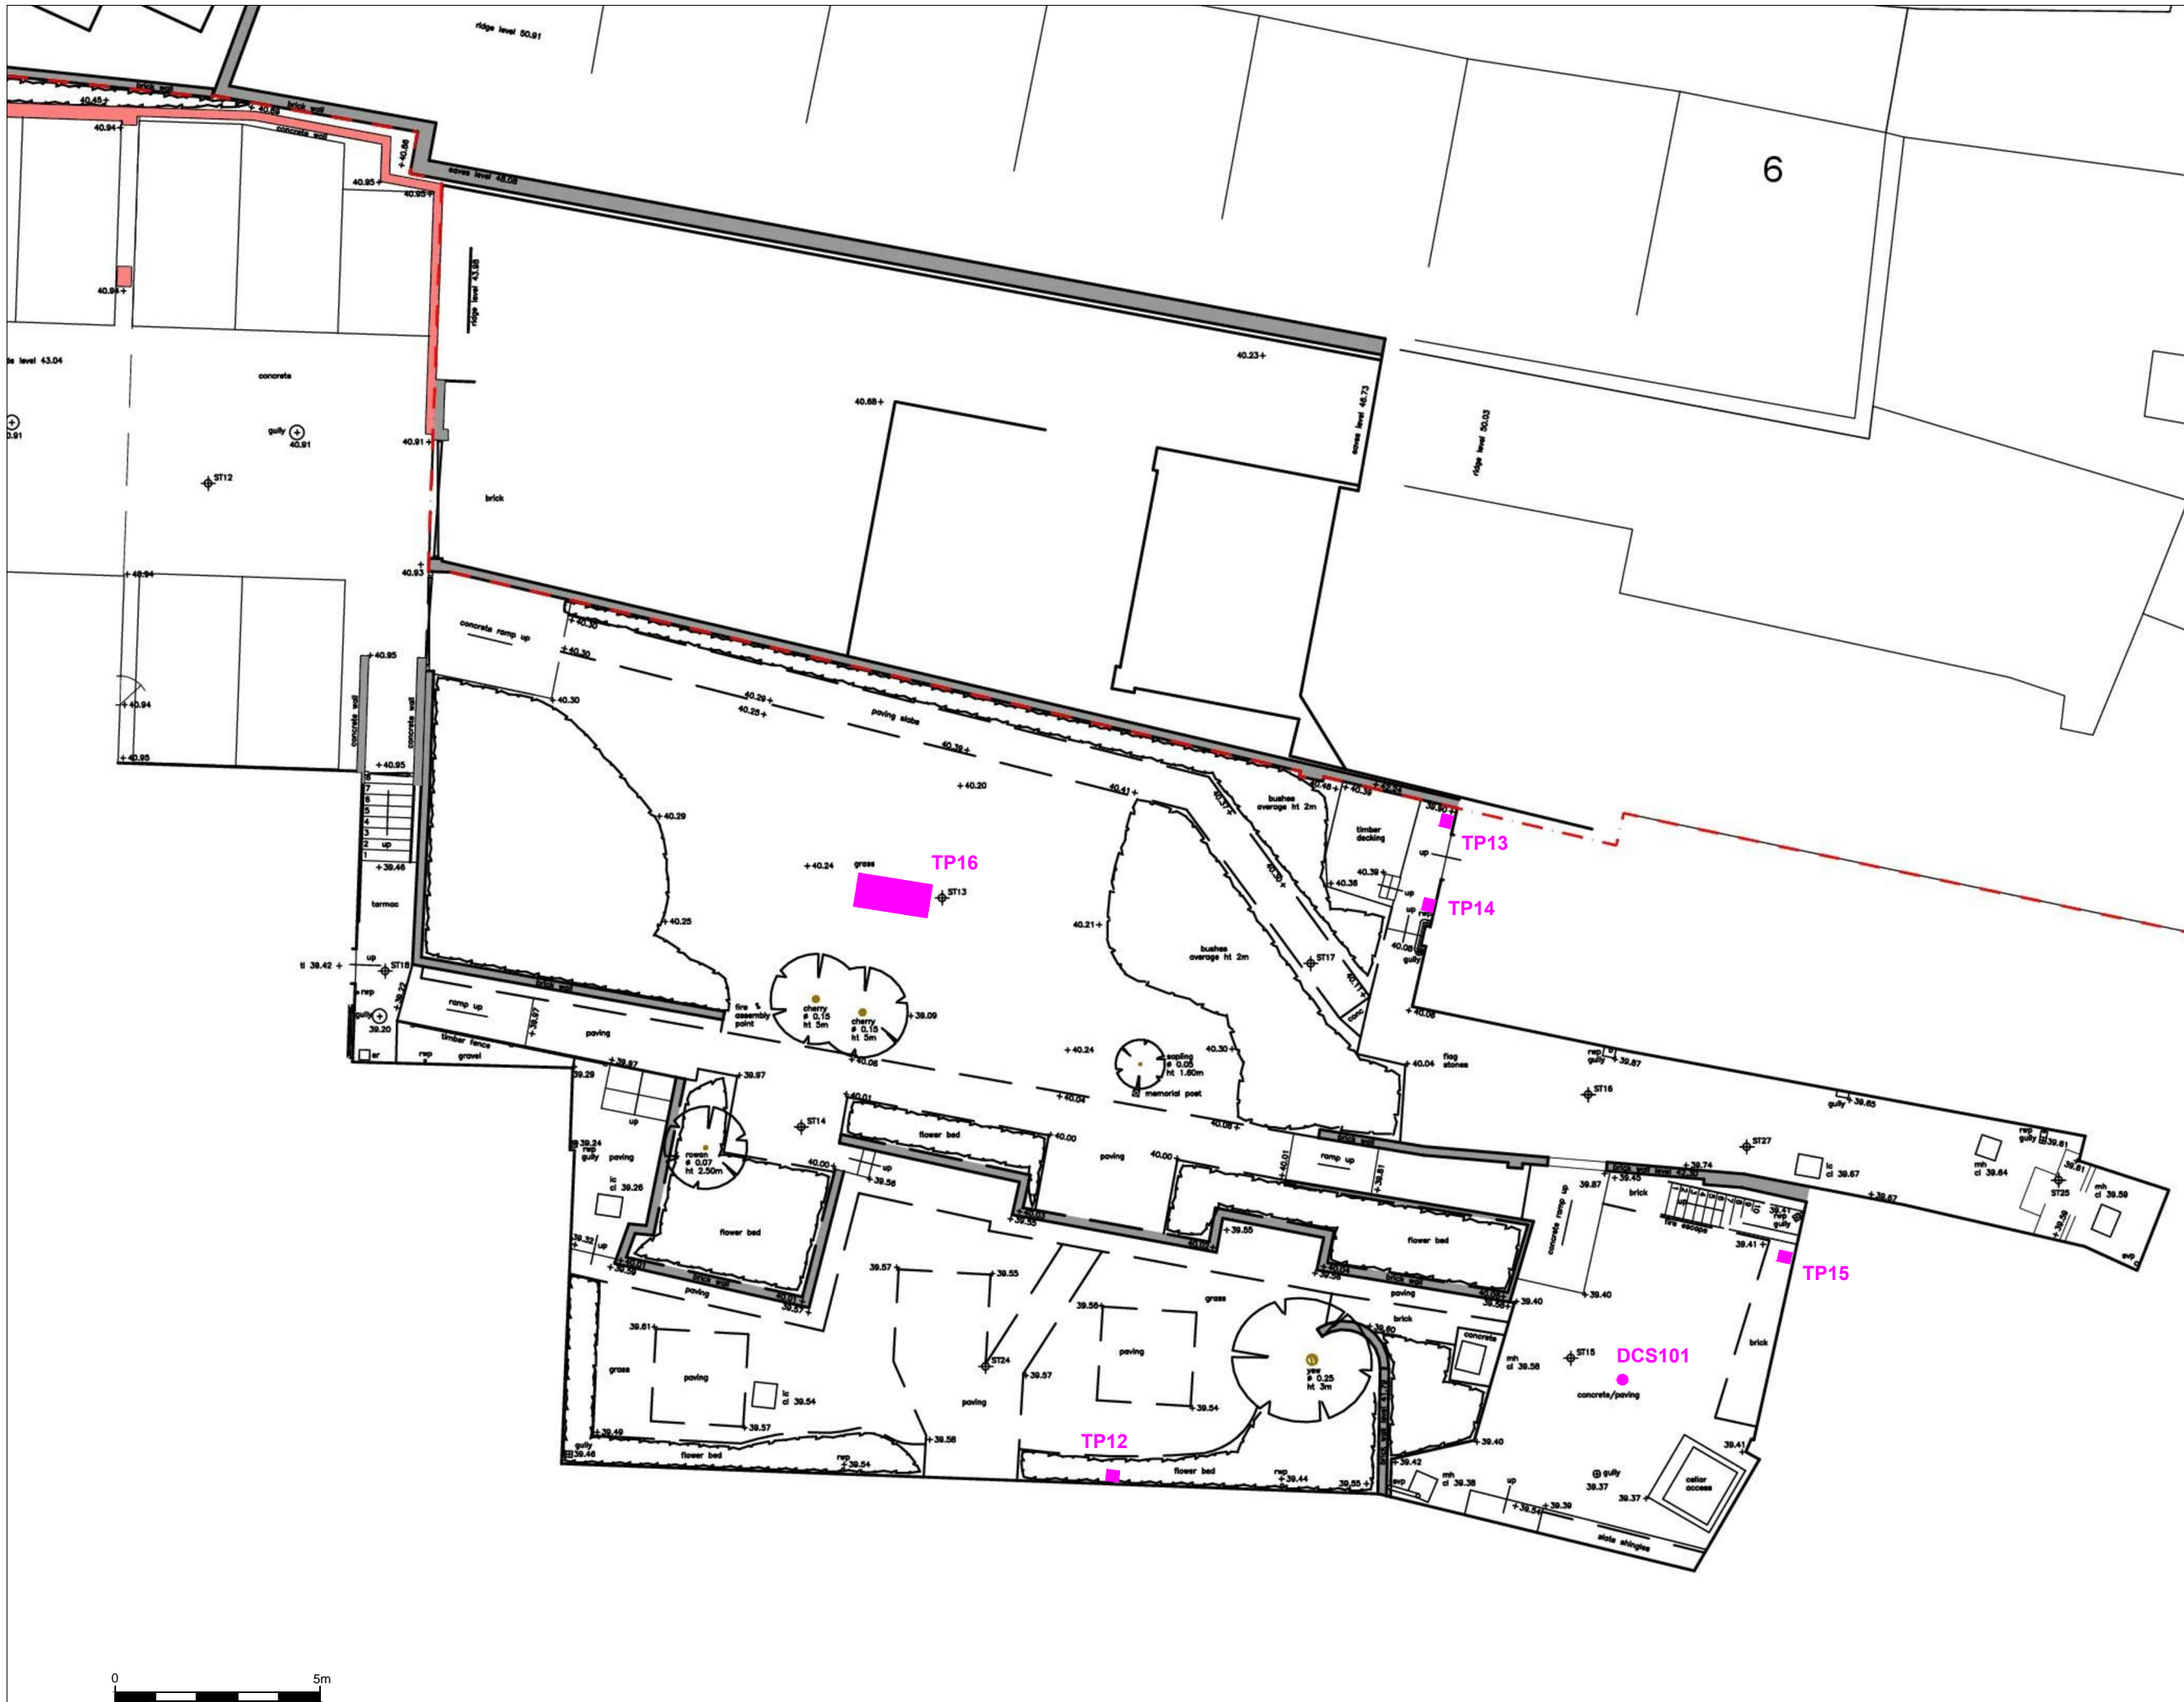
Report No: MK064/16	Fig. No: 3
------------------------	---------------

Title:
 Location of Test Pits monitored,
 western area

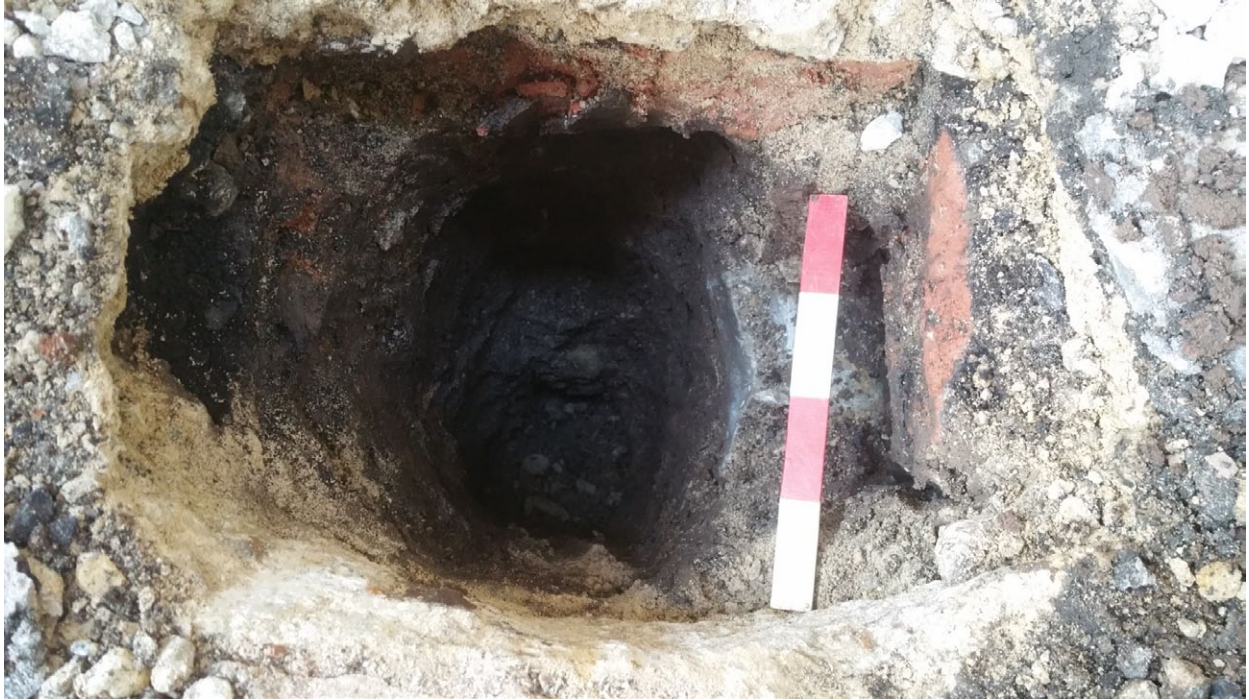
3.2. Test Pit 8 (Fig. 4 and 13)

Concrete paving slabs next to the carpark entrance (**035**) overlay a layer of red brick and mortar for the wall foundation of No 38 Scholars Lane (**038**). Beneath this was a 0.15m thick layer of stone rubble and dark brown silt (**039**). Below was a medium compact, dark-mid reddish brown sand and clay with stone rubble, flecks of charcoal and coal (**036**), 0.5m thick overlying a natural loose red sandy gravel. A 19th century / early 20th potted meat jar was retrieved from **068**.

Fig. 4 - Test pit 8, from the E

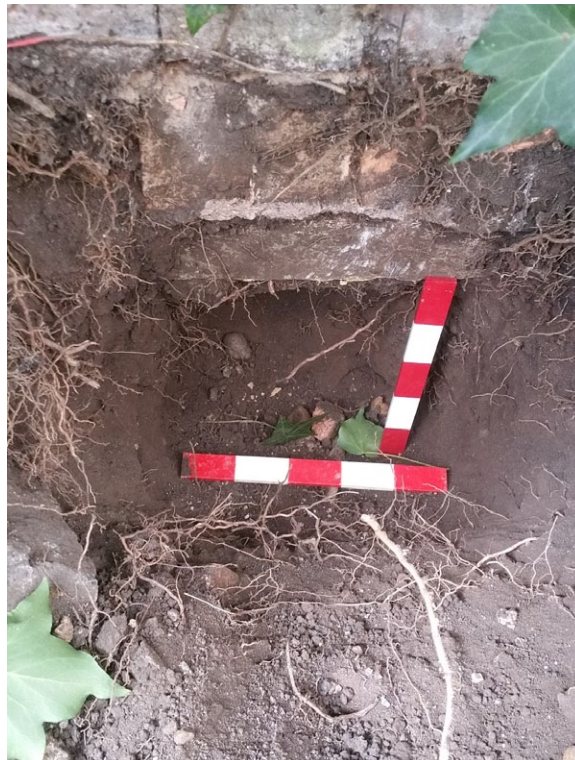
3.3. Test Pit 9 (Fig. 5 and 13)

This was excavated in a garden bed on the west side of the carpark entrance to assess the foundations of a 19th century boundary wall. A soft-friable light brown silt 0.1m thick (**018**) lay above a light brown silt containing brick, 0.1m thick (**019**). This overlay a layer of light brown silt with a medium compaction which contained small lumps of mortar (**020**), a layer that extended under the boundary wall. The test pit ended 0.2m into this layer.

Fig. 5 - Test pit 9, from the E

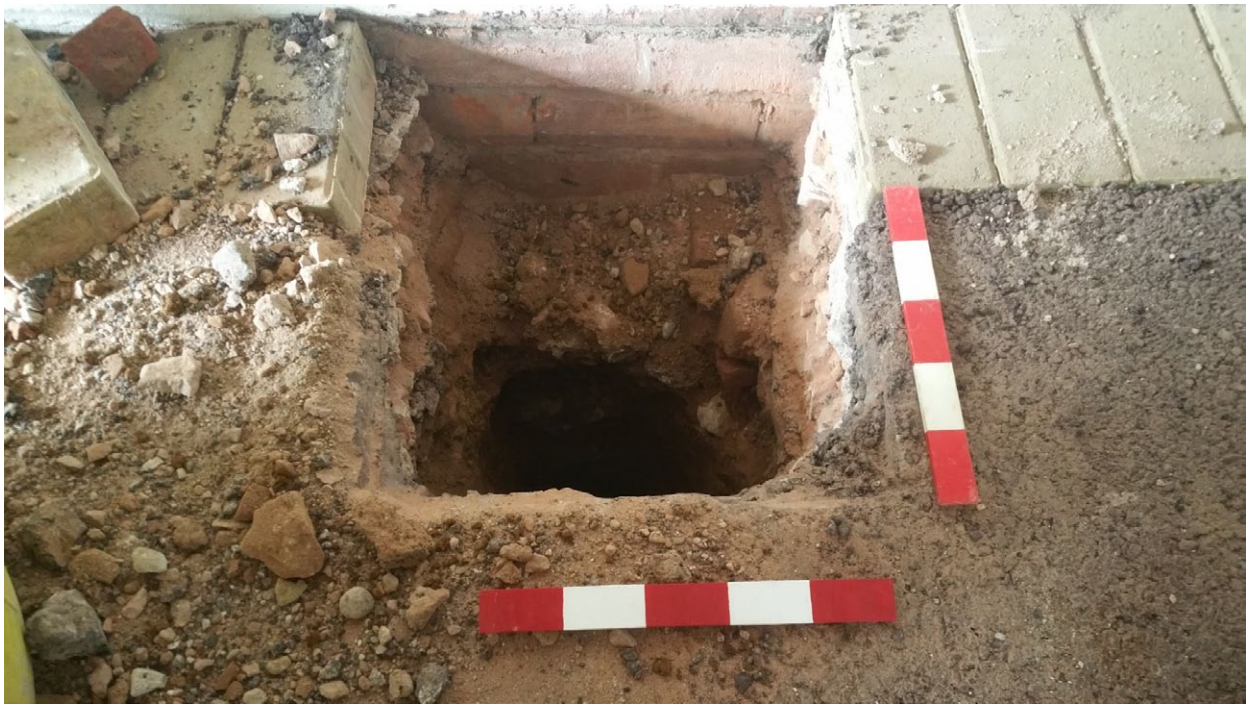
3.4. Test Pit 11 (Fig. 6 and 13)

This was situated near to the hotel entrance in the foyer area. Below the brick surface and tarmac surface (**040**) was a 0.17m deep layer of grey-white concrete (**027**). Beneath this was a 0.07m deep layer of black tarmac (**028**), covering a layer of modern brick (**029**). The brick was built on top of the pale grey concrete for the foundations of the 1960s car park (0.24m thick **030**). This in turn was set on a natural loose red sandy gravel (**031**).

Fig. 6 - Test pit 11, from the S

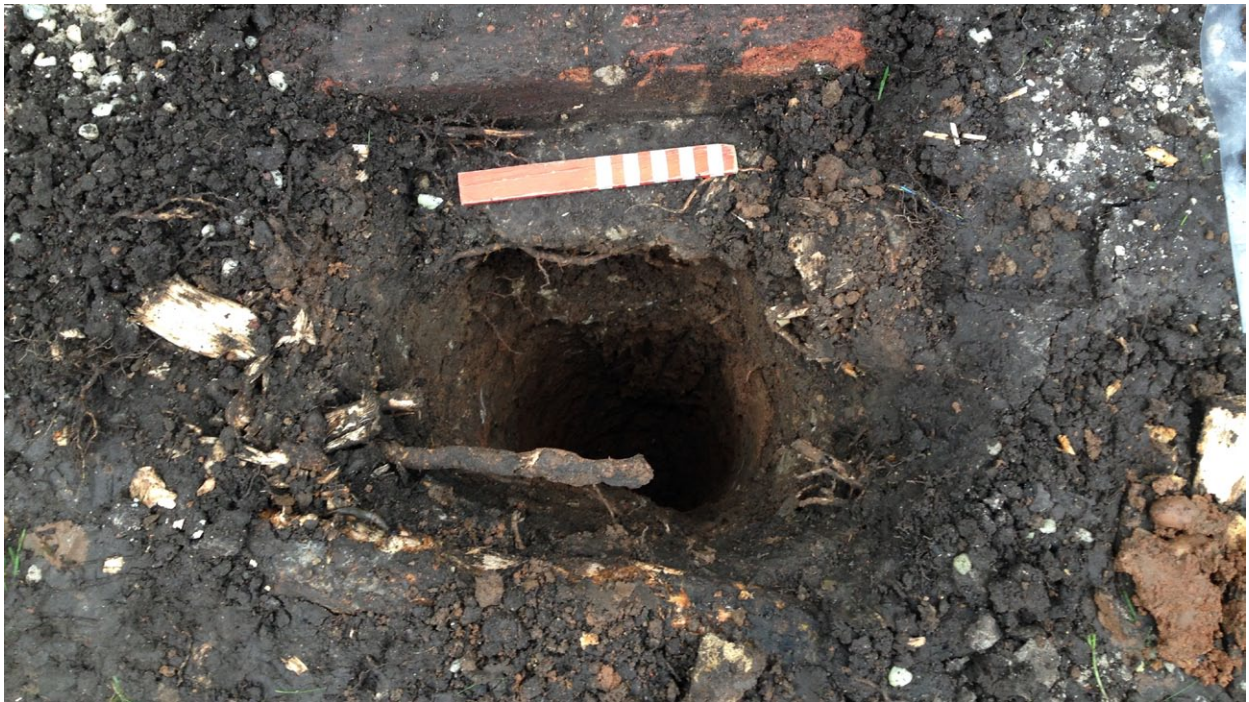
3.5. Test Pit 12 (Fig. 7 and 13)

This was dug in a flower bed in the garden area of the hotel yard to assess the foundations for a glass walled corridor. A loose black silty topsoil, 0.16m thick (**001**) overlay the brick footing for the hotel which was mortared with Portland Cement (**002**), 0.09m thick. Below this was a layer of grey concrete

(003) 0.16m thick. A firm grey-brown former cultivation soil (004), 0.21m thick lay below this containing fragments of coke. Beneath 004 was a firm grey silt with flat limestone fragments (005), 0.05m thick and below was natural loose red sandy gravel (006).

Fig. 7 - Test pit 12, from the N

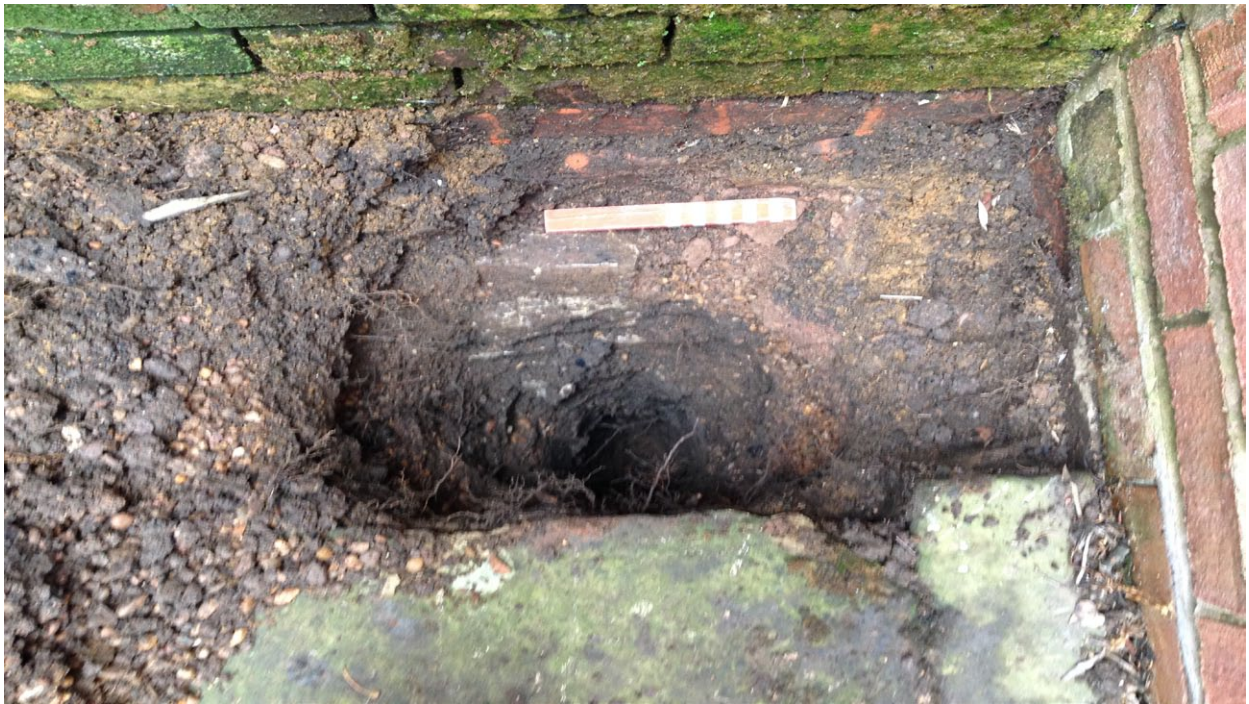
3.6. Test Pit 13 (Fig. 8 and 13)

This was excavated in the yard at the rear of the hotel close to modern bedrooms infilling gaps in the older hotel building to test the load bearing capacity of the modern walls. A 0.2m thick grey sandstone slab (007) overlay a 0.6m thick layer of loose black silty loam topsoil (008) with a worked stone fragment. This lay directly on the natural red sandy gravel (009).

Fig. 8 - Test pit 13, from the S

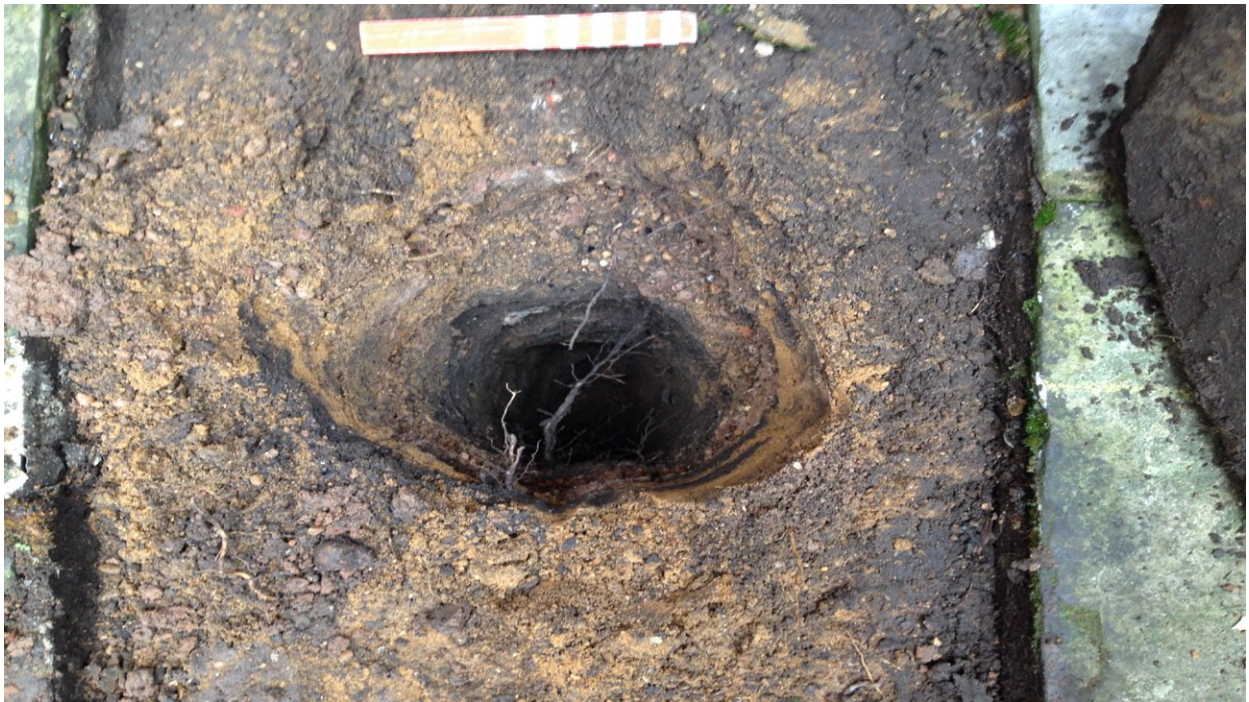
3.7. Test Pit 14 (Fig. 9 and 13)

This test pit was dug next to TP13 beside a mid 19th-century workshop now a modified extension to the hotel to test the strength of the older wall. Below a 0.22m thick concrete slab and layer of pea grit (010) was a 0.5m deep loose silty black loam topsoil (011) containing 18th- and 19th-century finds. Below were the concrete foundations of the wall of the hotel extension (013), the concrete probably dating to the 1950s, and set on mortared limestone and sandstone rubble, the foundation for the Victorian wall. The mortar bond was identical to the southern boundary wall of the former property which was made of Georgian bricks. Below the black topsoil was natural red sandy gravel (012).

Fig. 9 - Test pit 14, from the S

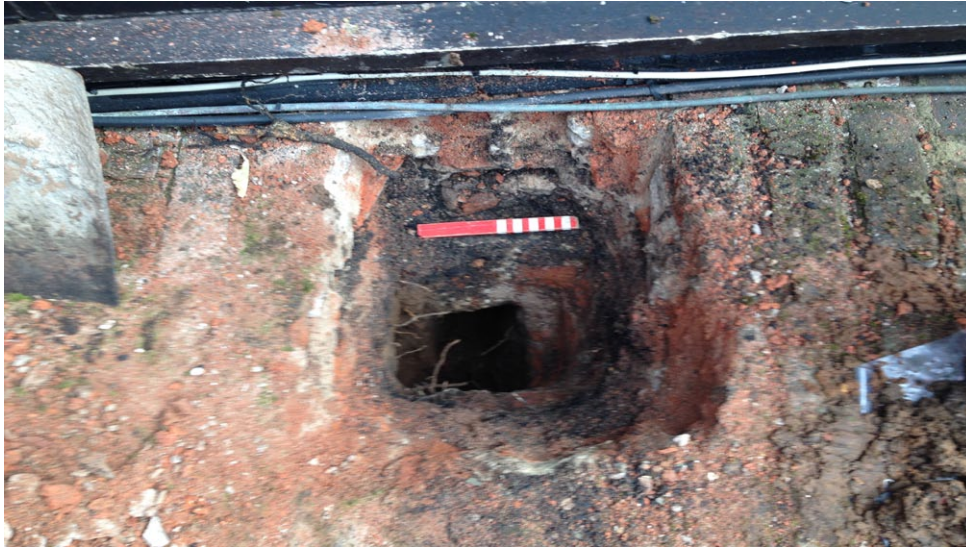
3.8. Test Pit 15 (Fig. 10 and 13)

This was located close to borehole DCS101 at the rear of the hotel. Brick and concrete, 0.5m deep (014) formed the foundation for the hotel extension. At right angles to the hotel extension was a brick wall which was mortared with Portland cement (015), which was 1.06m deep and abutted by wall 014. Below 014 was a 0.45m thick loose silty loam with no inclusions (016). At the base of this deposit was loose red sandy gravel natural (017). Brick wall 015 was not a part of the current cellars of the hotel. A brief examination of 6'' OS maps from 1885 to 1938 did not reveal an obvious building to which the wall might belong. There is a range of buildings shown on the mapping but the wall lay in the middle of the range (Fig. 13) and it would seem unlikely that a wall would be built, postdating the structure and right in the centre of it. No trace of these buildings was detected in the small test pit presumably they had been removed when the area was lowered as evidenced by the exposed foundations of the former boundary wall to the north and the higher ground level to the north of it.

Fig. 10 - Test pit 15, from the W

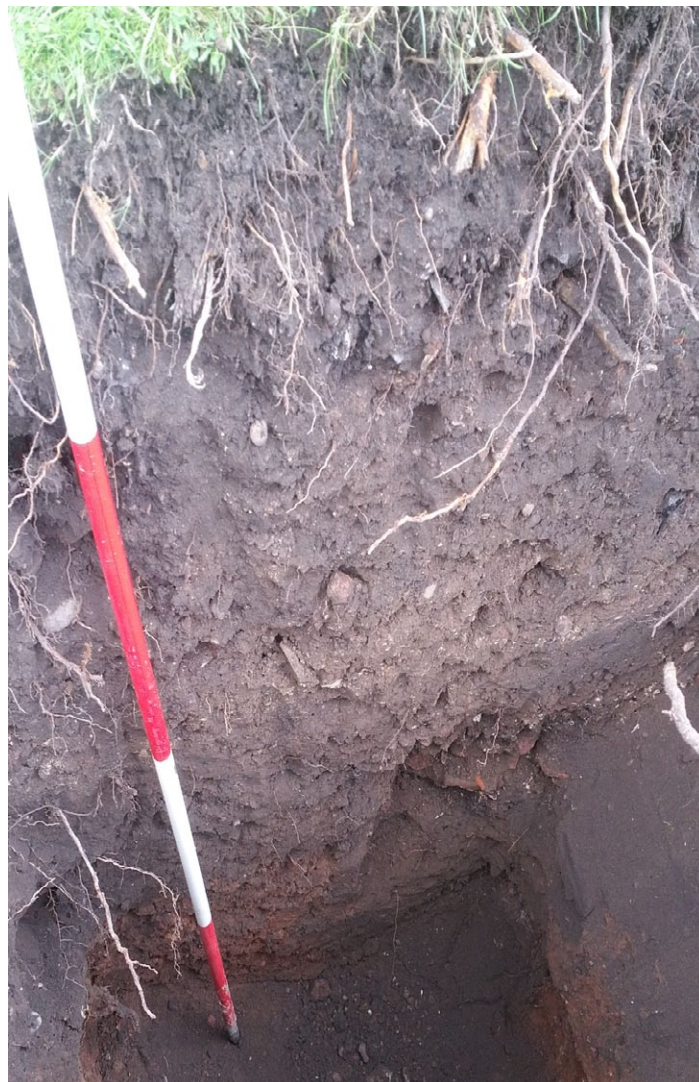
3.9. Test Pit 16 (Fig. 11 and 13)

This pit measured 0.8m by 1.8m and was excavated by a tracked machine on a lawn on a terraced part of the courtyard behind the hotel. The turf and topsoil, a thin dark brown sandy loam (**023**), was 0.22m thick above a layer of made ground (**024**). This deposit, a mid-dark-grey loose fine sand 0.65m thick, contained stones and gravel with crushed mortar, frequent pottery, charcoal and coal. The made ground lay above a dark brown silty loamy sand with a moderate compaction containing with frequent brick, ceramic building material and bone (**033**). This deposit filled an undulating cut (**032**) into the natural red sands and gravels (**026**) representing general rear-plot disturbance of 19th century date. The fill contained a lens of loosely packed tile and mortar (**034**).

Fig. 11 - Test pit 16 showing backyard activity cut 32, deposit 33 and roof tile deposit 34, from the N

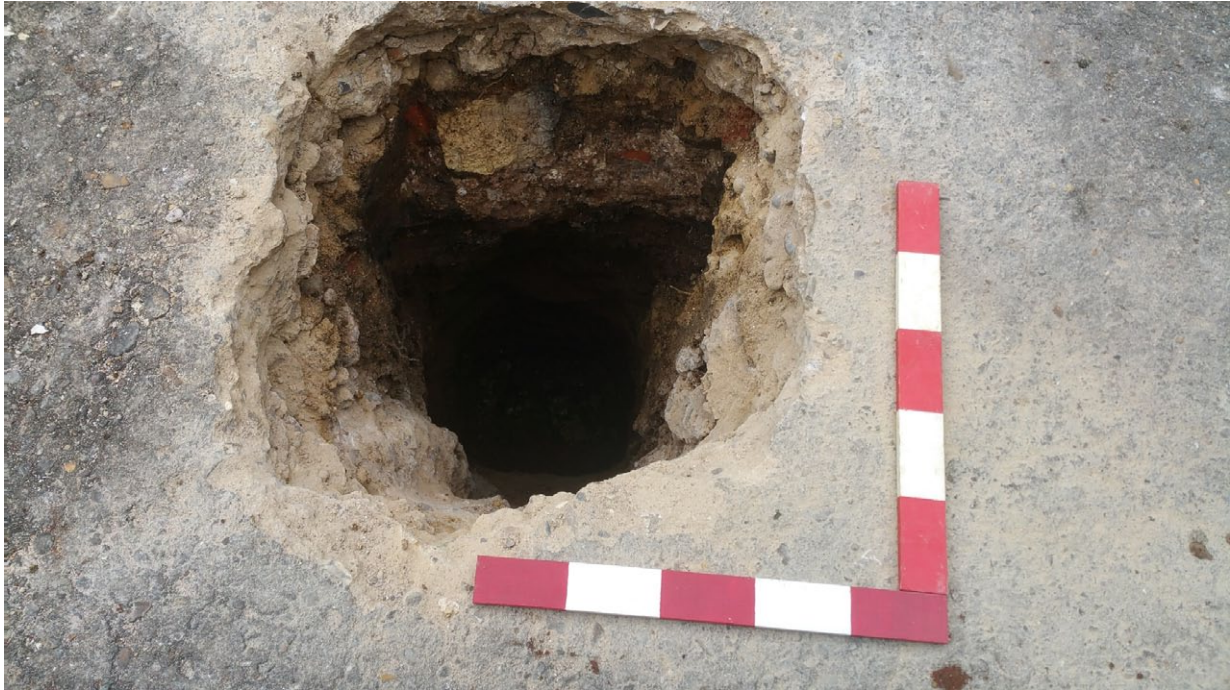
3.10. Borehole DCS101 (Fig. 12 and 13)

A layer of grey stony concrete 0.1-0.6m thick (**021**) overlay a layer of friable light brown sandy silt containing some lumps of concrete (**022**), 0.24-0.3m deep. Below this was loose red sandy natural gravel (**025**).

Fig. 12 - Borehole DCS101 prior to drilling, from the W

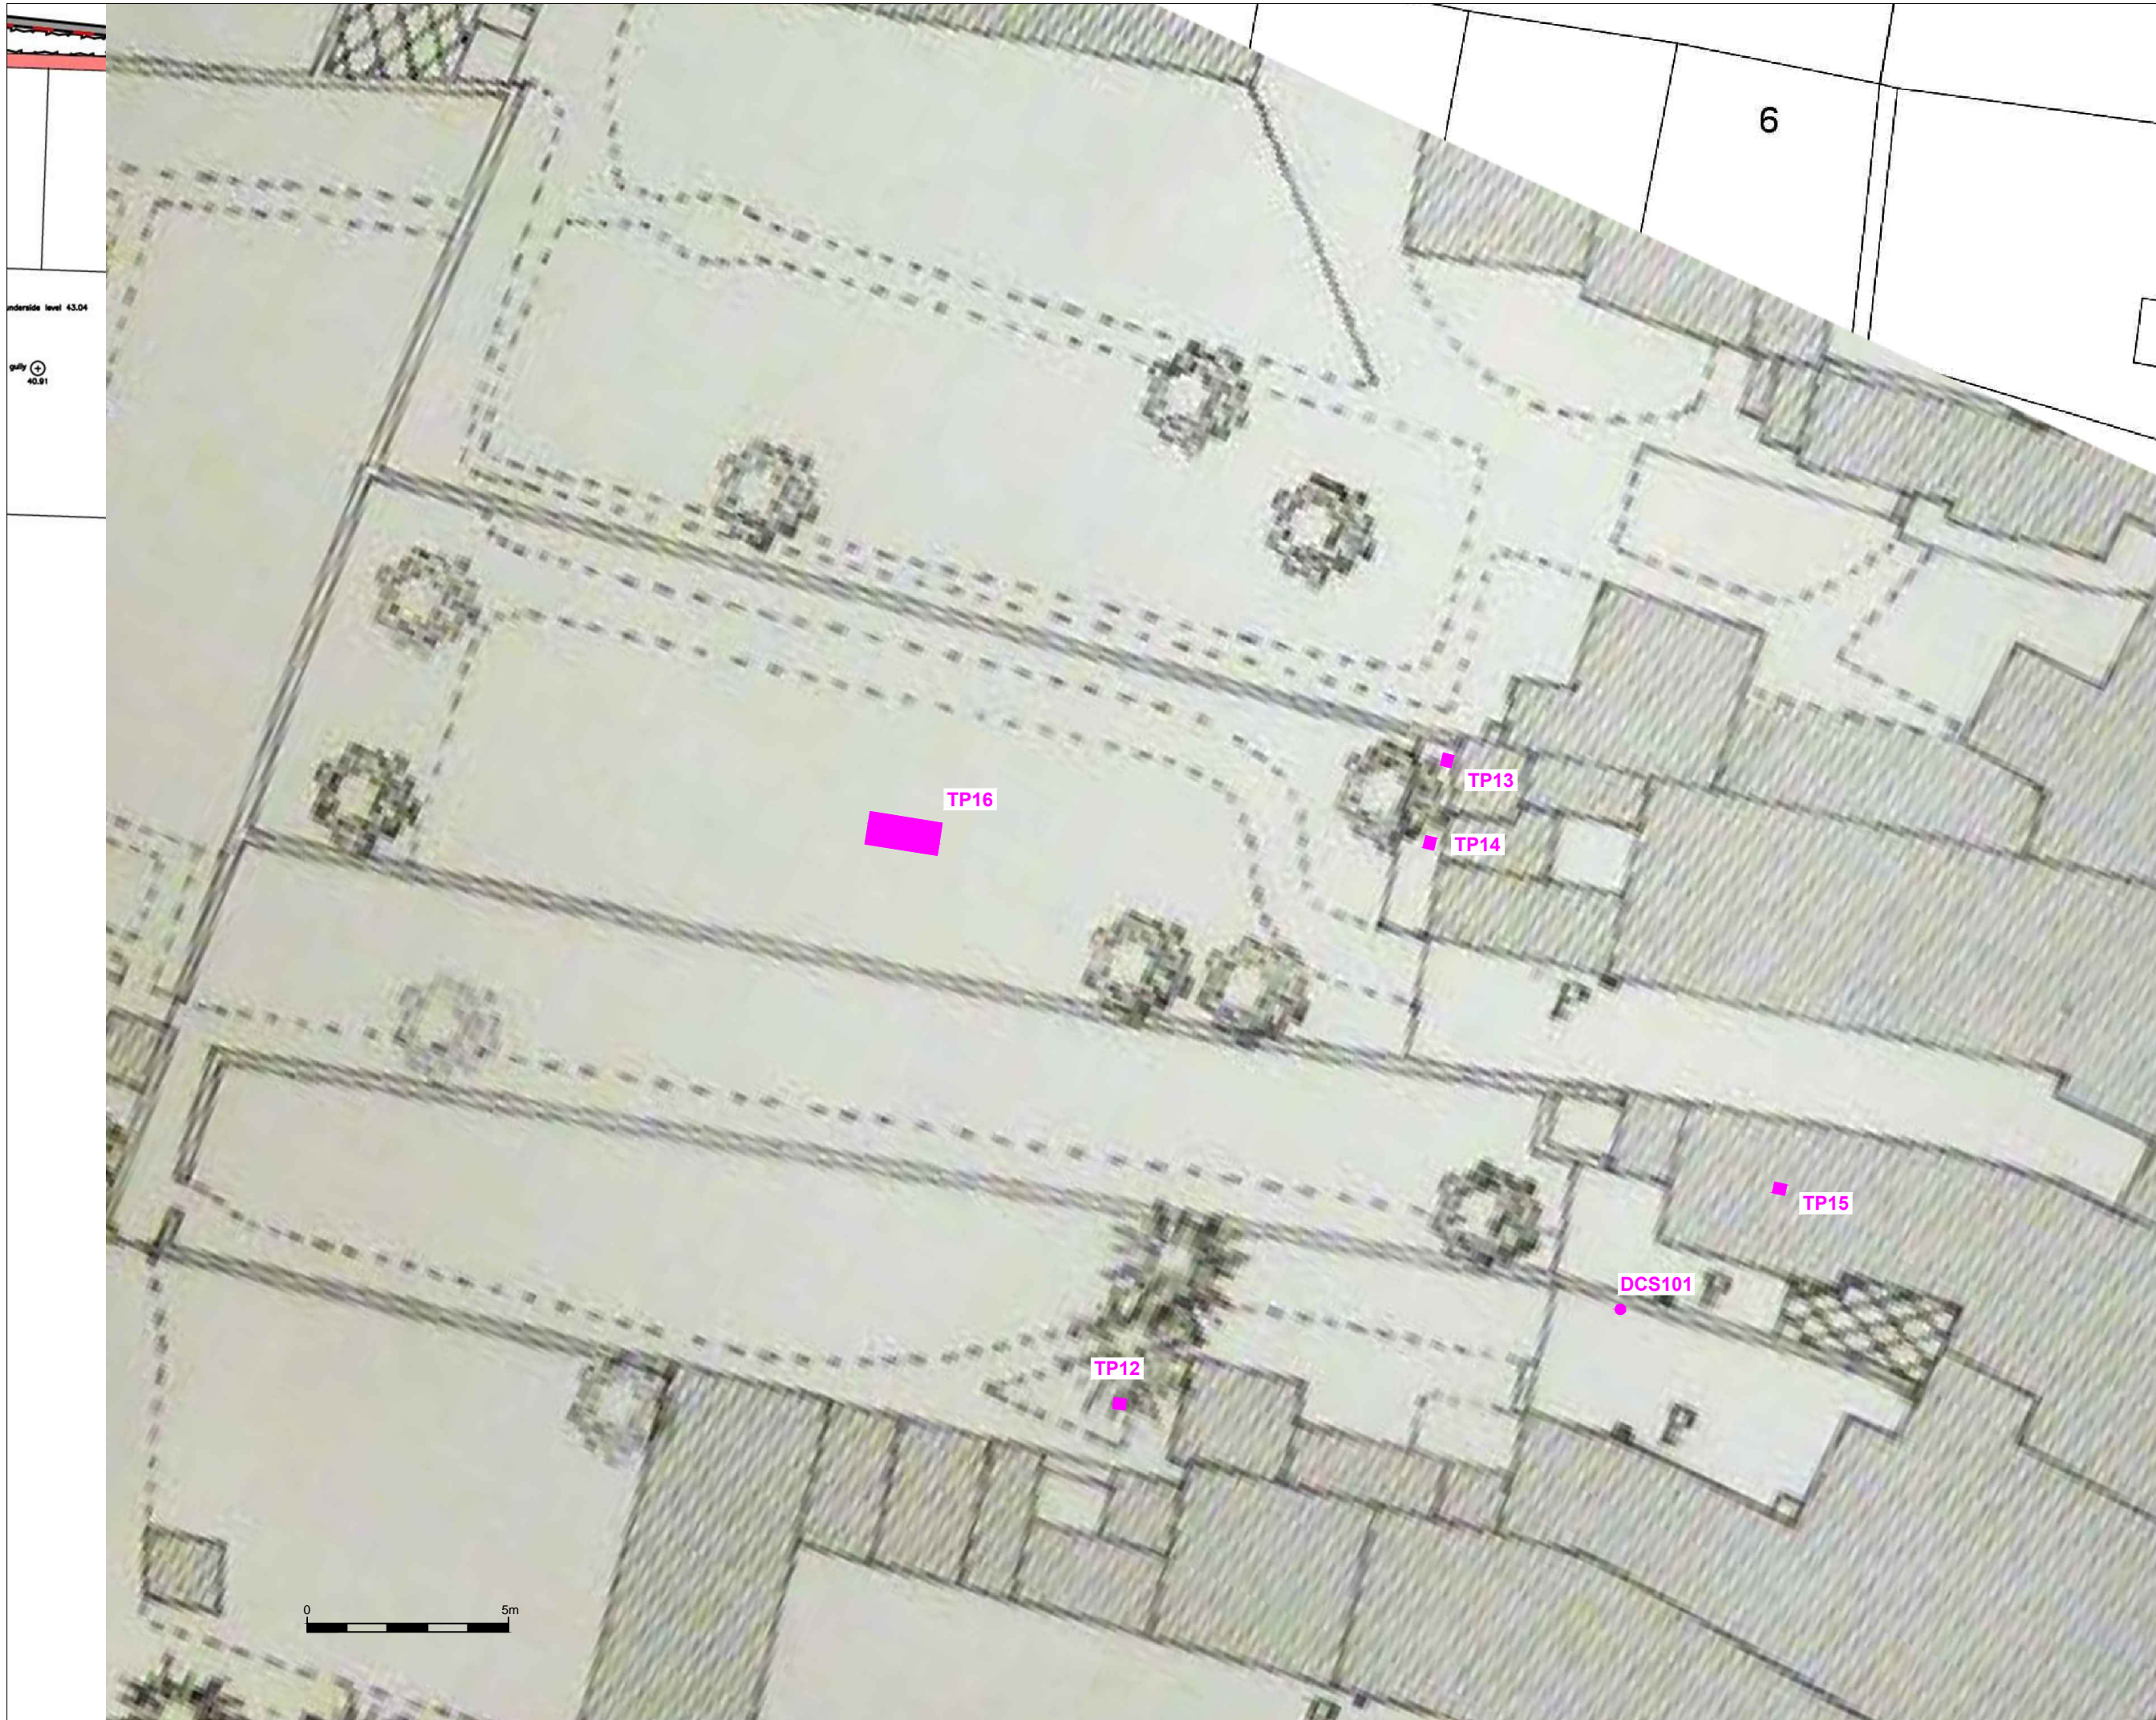
Report.No: MK064/16	Fig. No: 13
------------------------	----------------

Title:
 Test pits shown on the 1887 OS map
