# Land to the Rear of 10/10a Market Place, Egremont:

Archaeological Watching Brief Report No. 3660

# Land to the rear of 10/10a Market Place Egremont, Cumbria

**Archaeological Watching Brief**

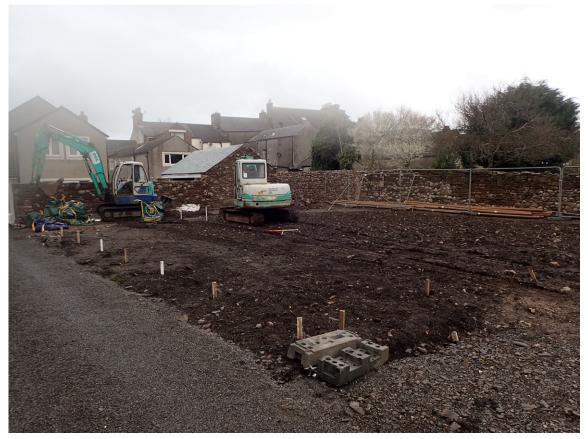
Fig. 2 - The proposed devlopment site

The site was bounded to the east by Egremont Parish Church Hall, to the south by St. Mary and St. Michaels parish Church, and to the west by existing residential buildings looking onto Main Street (Fig. 2).

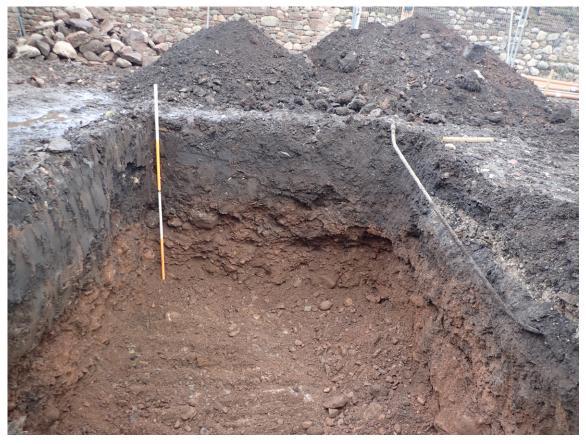
Fig. 3 - North-facing section of soakaway

Across the development site was approximately 0.4m of made-ground, which consisted of mixed dark brown sandy silt and gravel (001). The ground had been raised as a result of the construction of the pre-existing house and gardens situated to the west. Underlying the mixed deposit was approximately 0.5m of buried garden soils which consisted of dark brown sandy silt (002). Lying directly underneath the garden soil was reddish brown sandy gravel natural (003).

A soakaway which measured 3.2m x 2.1m, and 1.75m deep was excavated (Fig. 3). Foundation trenches were excavated around the perimeter and across the middle of the site. The trenches were approximately 0.7m wide were excavated to a depth of 0.8m, revealing the natural (Fig. 4 & 5).

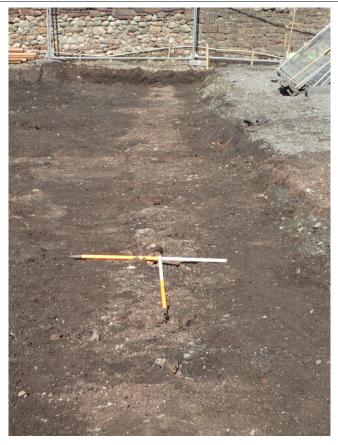
Fig. 6 - Robber trench [004]

A north-north-west by south-south-east aligned ditch that appeared to be a robber trench (004) where a former wall line had been removed was identified at the eastern edge of the development site (Fig. 6). As exposed it was 15m long and was approximately 0.5m wide. A section revealed that it was 0.15m deep. The fill (005) consisted of a mixture of mortar and sandstone fragments (Fig. 7). It had been cut through the garden soils (002). A small length of another robber trench (006), aligned east-north-east by west-south-west, was also identified. It measured 3m in length and 0.5m in width and survived to a depth of 0.15m. The trench petered out at its western end.

A watching brief was carried out during excavations of building footings, service trenches and a soakaway on land to the rear of 10/10a Market Place, Egremont. The remains of robber trenches for former walls were identified during the groundworks. The trenches were cut through the buried garden soil (002) and the walls were not considered to be of any great antiquity.
