Land North and West of Hillcrest, East Ord, Northumberland

Archaeological Evaluation
Report No. 3773

Archaeological Evaluation

Report 3773

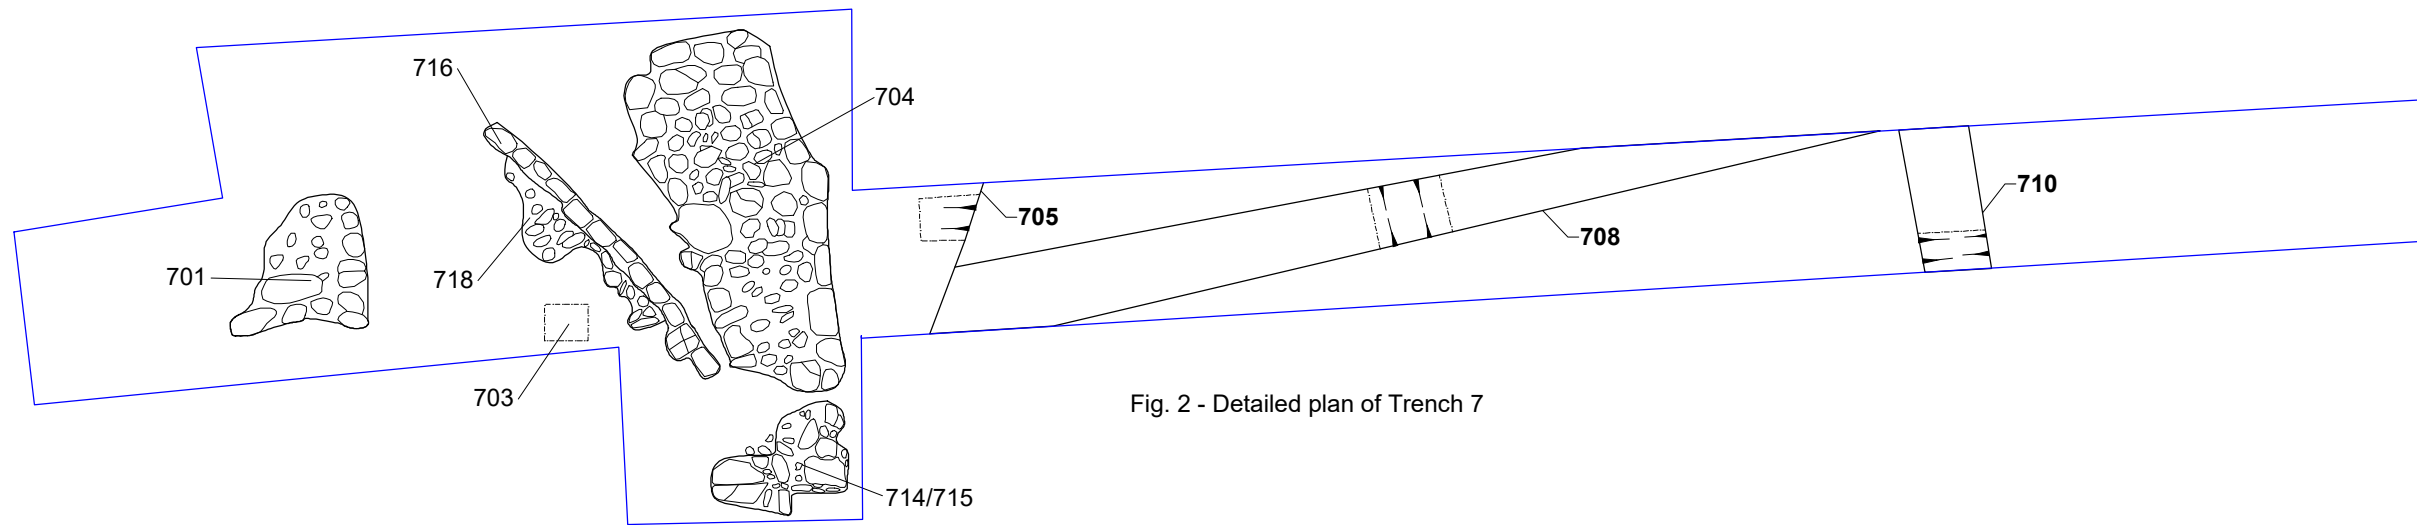
Fig. 2 - Detailed plan of Trench 7

Trench 7 (Fig. 2) measured 30m by 1.8m before being extended by a further 26m² and deposits consisting of 0.25m of grey silt topsoil and 0.3m of orangey-grey sandy-silty-clay subsoil overlay orange-brown sandy-clay natural. The features within this trench consisted of a fragmentary cobble surface which appeared to be set on the subsoil, and because of its fragmentary nature it was given a number of contexts during the evaluation (**701, 704, 714, 715 716, 718**). A possible pebbled surface (**703**) was identified in a test pit through the subsoil below the cobbled surface. Three ditch features (**705, 708** and **710**) were also identified.

The fragments of cobble surface all appeared to survive at the same level and its disparate parts are all considered to be related. Within the surviving remains of the surface possible edges to parts of the surface could be identified, where larger flat cobbles border areas apparently in-filled with smaller stones. An ashy deposit (**713**) lay below the topsoil and partially covered the cobbled surface. This contained 19th Century ceramics, Glass, CBM, Clay Pipe fragments and an iron nail.

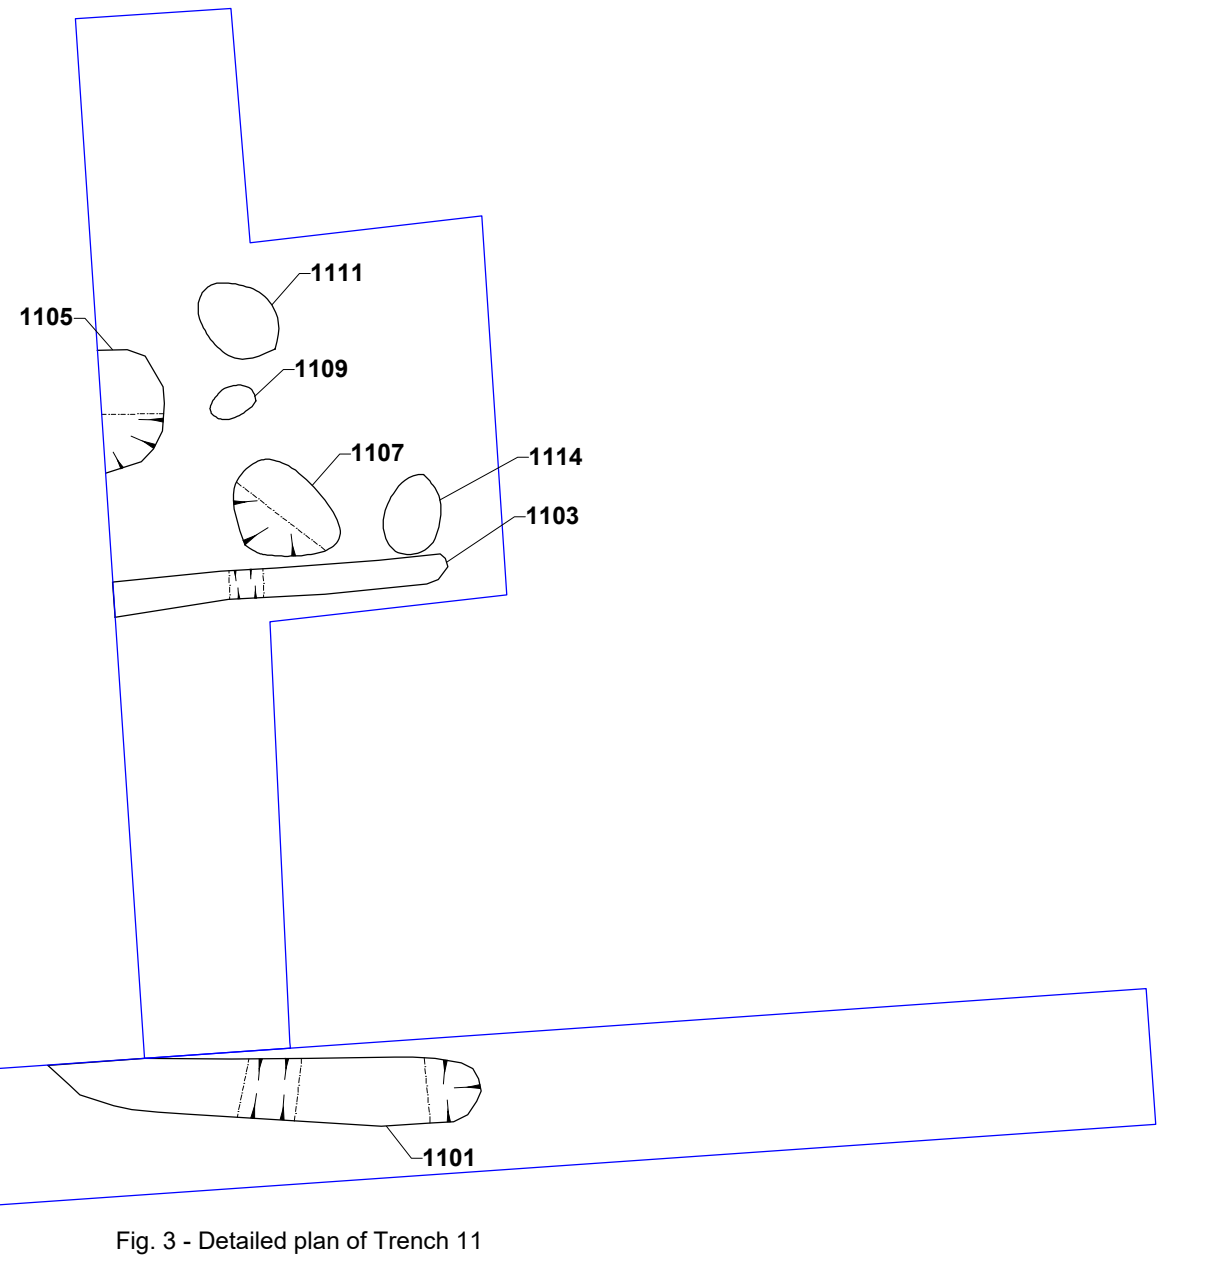
Fig. 3 - Detailed plan of Trench 11

Trench 11 (Fig. 3) measured 30m by 1.8m and was further extended to the north by a further 45m² (Fig. 19). The deposits within this trench consisted of 0.3m of grey silt topsoil and 0.25m of orangey-grey sandy-silty-clay subsoil overlying orange-brown sandy-clay natural. A single shallow ditch (**1101**) was identified within the main trench, while the trench extension contained a further shallow ditch (**1103**) and five pit features (**1105, 1107, 1109, 1111 & 1114**). The area around these features was boxed out in order to expose them further.

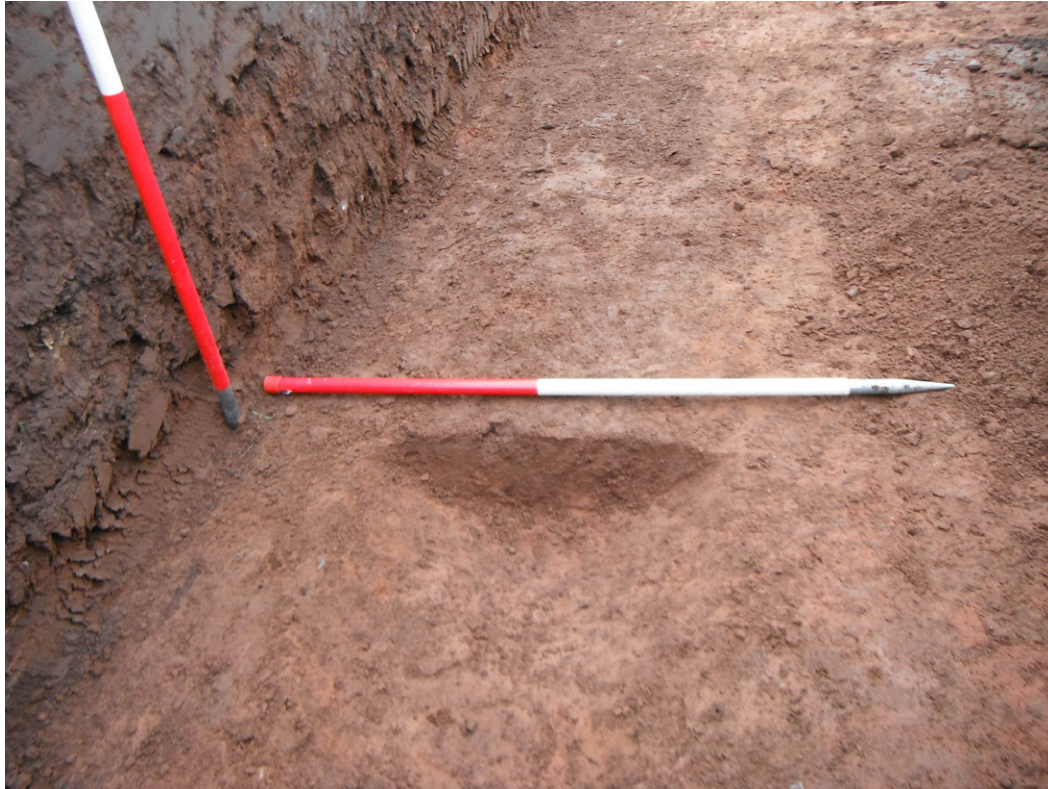
Trench 4 measured 30m by 1.8m and deposits consisting of 0.25m of grey silt topsoil and 0.1 to 0.6m of orangey-grey sandy-silty-clay subsoil overlay orange-brown sandy-clay natural. Cut in to the natural was a single WSW to ENE aligned ditch feature (**401**) with steeply sloping sides and a flat base was identified within this trench (Fig. 4). It had a width of 0.6m and a depth of 0.15m. The fill (**402**) of this feature consisted of light orange-brown sandy-silt.

Fig. 4 - Ditch 401, ENE-facing section

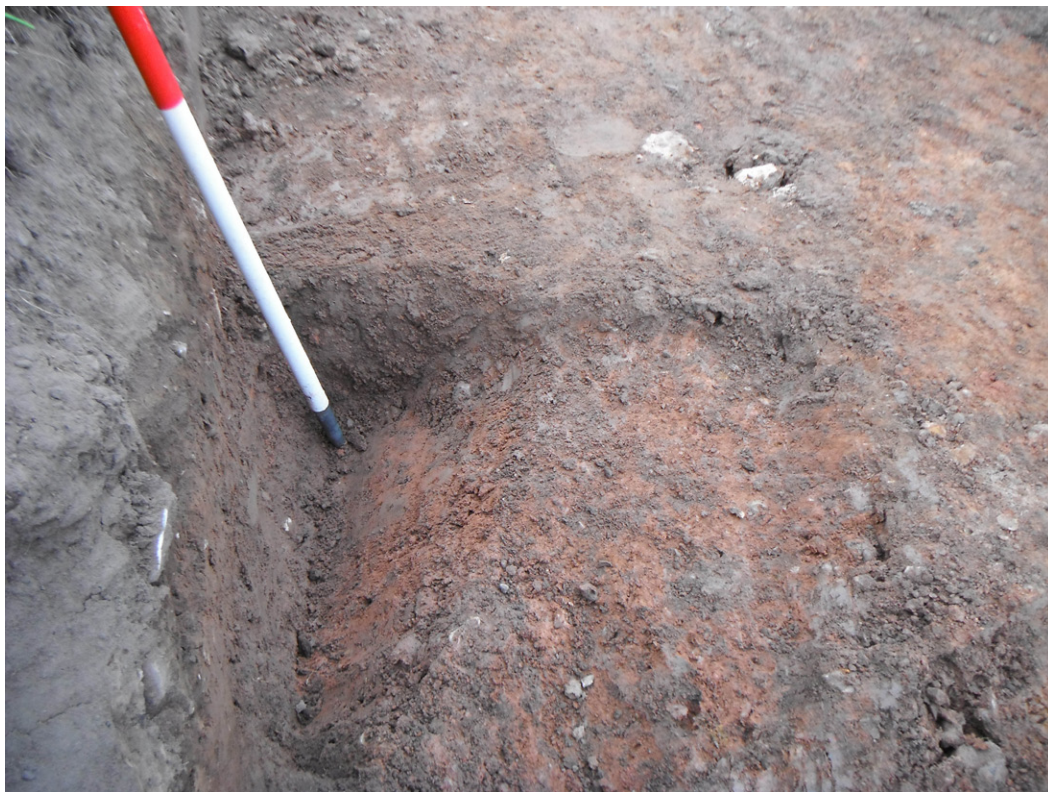
Ditch **501** was partially uncovered at the southern end of the trench. It was NE to SW aligned, had a width of >1.8m, and a depth of >0.3m (Fig. 5). The fill (**502**) of this feature consisted of mid pinkish-brown silty-sand and stones.

Fig. 5 - Ditch 501, NNE-facing section

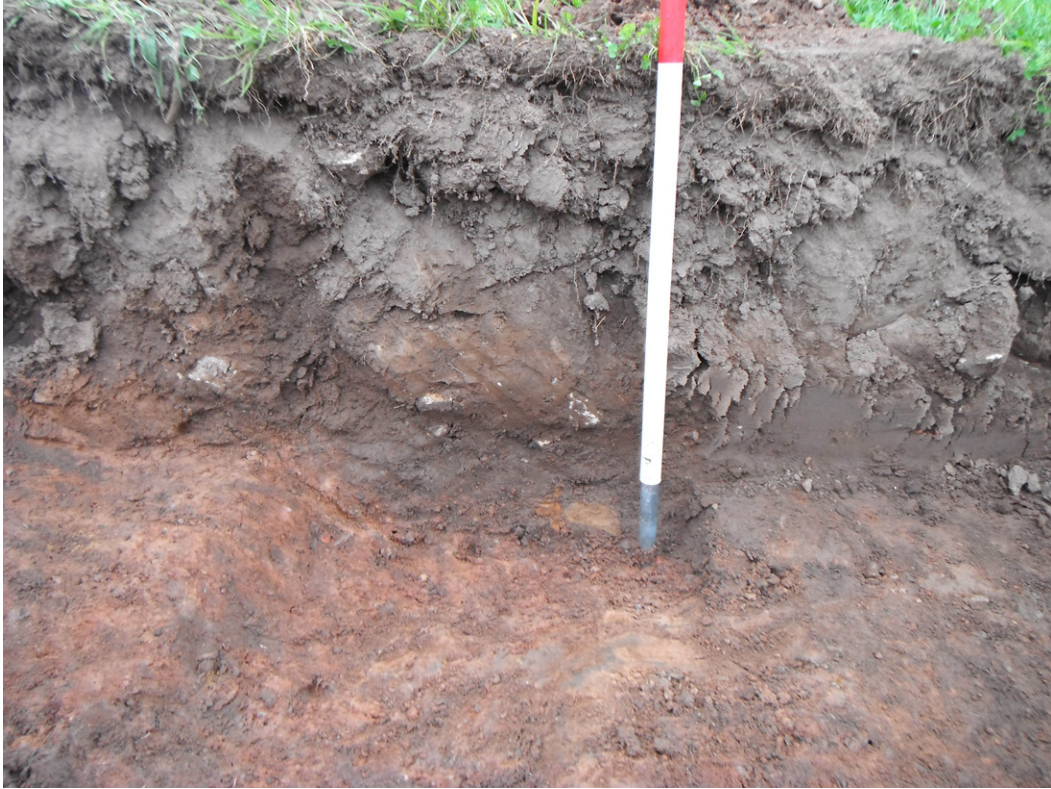
Ditch **503** was situated just to the north of Ditch **501** and was NW to SE aligned. It had sloping sides and a concave base, and measured 0.4m in width and 0.2m in depth (Fig. 6). The fill (**504**) of this feature consisted of mid pinkish-brown silty-sand and stones.

Fig. 6 - Ditch 503, W-facing section

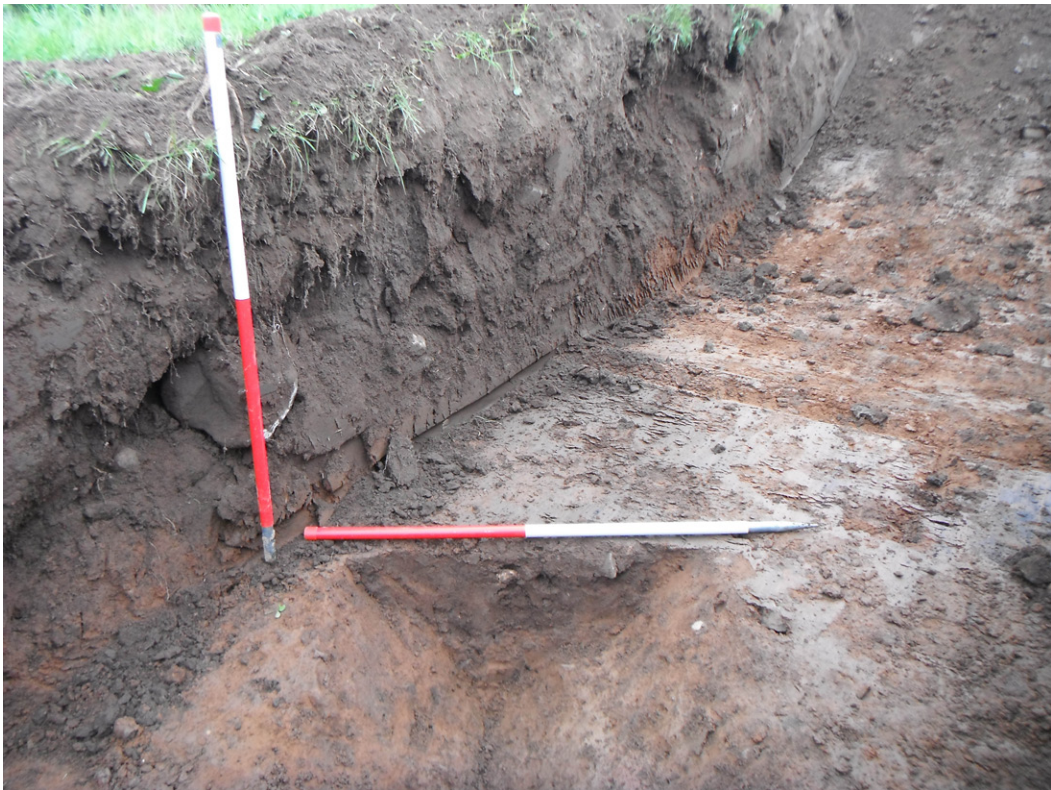
Ditch **507** was NW to SE aligned. It had sloping sides and a concave base, and measured 0.8m in width by 0.35m in depth (Fig. 7). The fill (**508**) of this feature consisted of mid pink-brown silty-sand.

Fig. 7 - Ditch 507, SSE-facing section

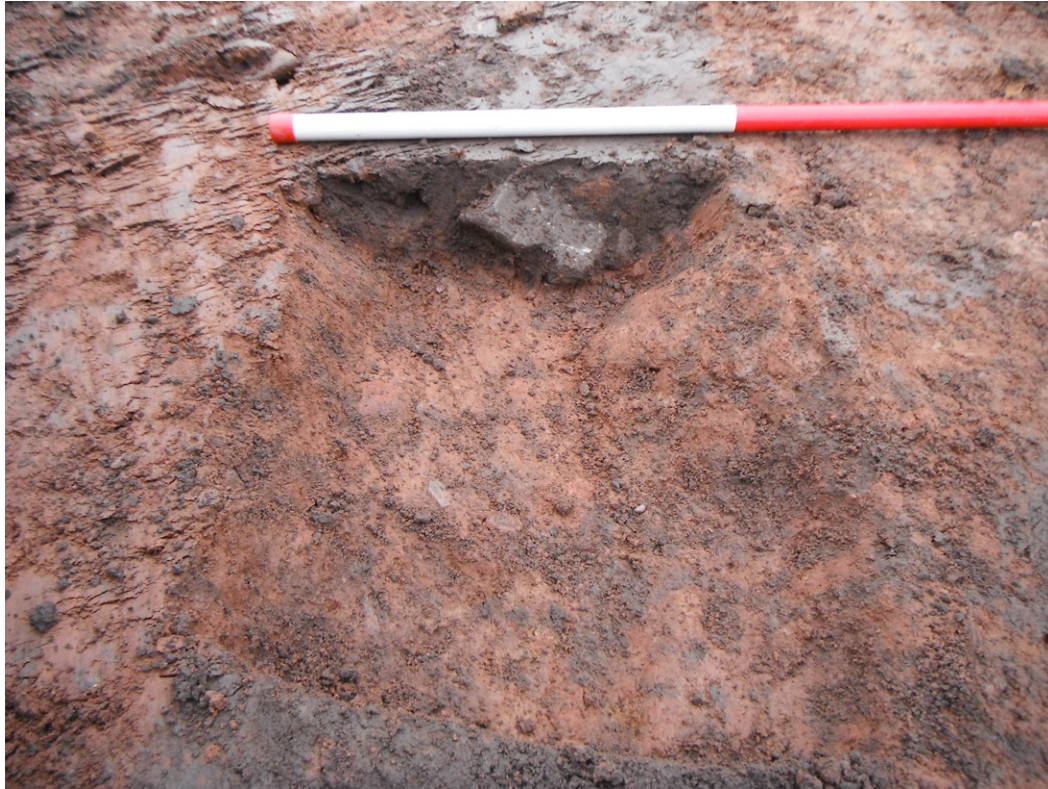
Ditch **510** was SSW to NNE aligned, had a width of 0.5m, and a depth of 0.15m (Fig. 8). The fill (**511**) of this feature consisted of mid pink-brown silty-sand.

Fig. 8 - Ditch 510, SSW-facing section

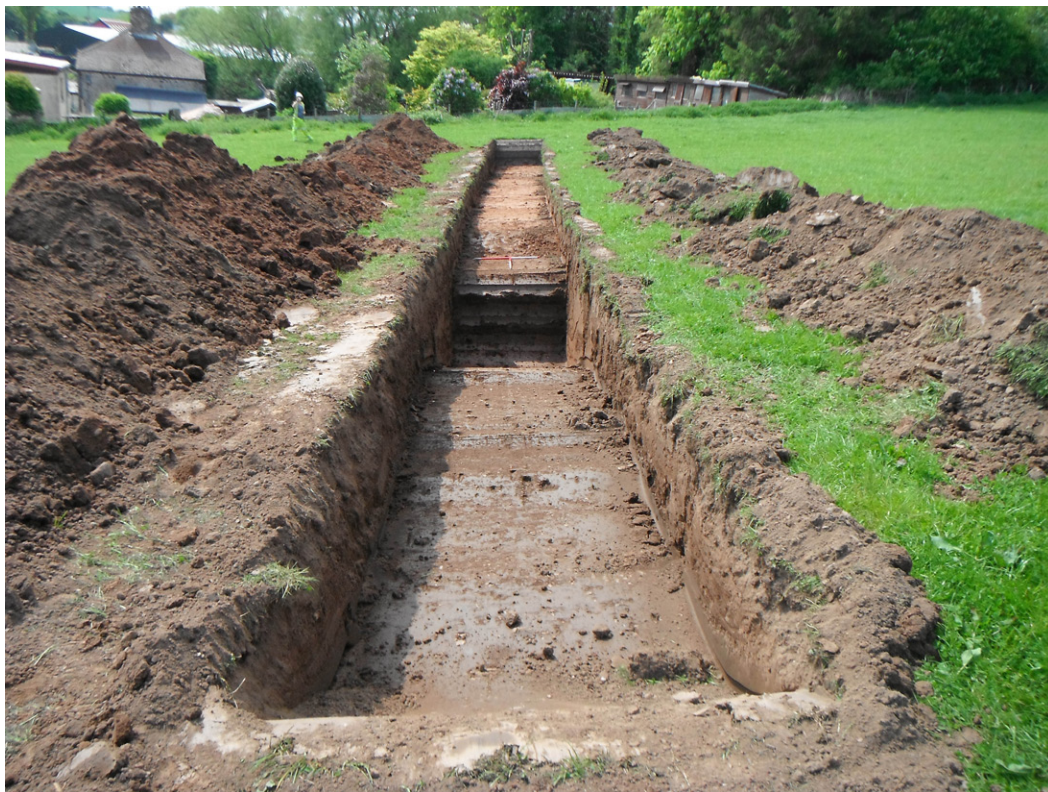
Trench 6 measured 30m by 1.8m and deposits consisting of 0.4m of grey silt topsoil and 0.2m of orangey-grey sandy-silty-clay subsoil overlay orange-brown sandy-clay natural. In the eastern half of the trench the depth of overburden to natural increased to about 2m. It is thought that this area may have been subject to some form of quarrying (Fig. 9).

Fig. 9 - Trench 6, general shot showing area of quarrying

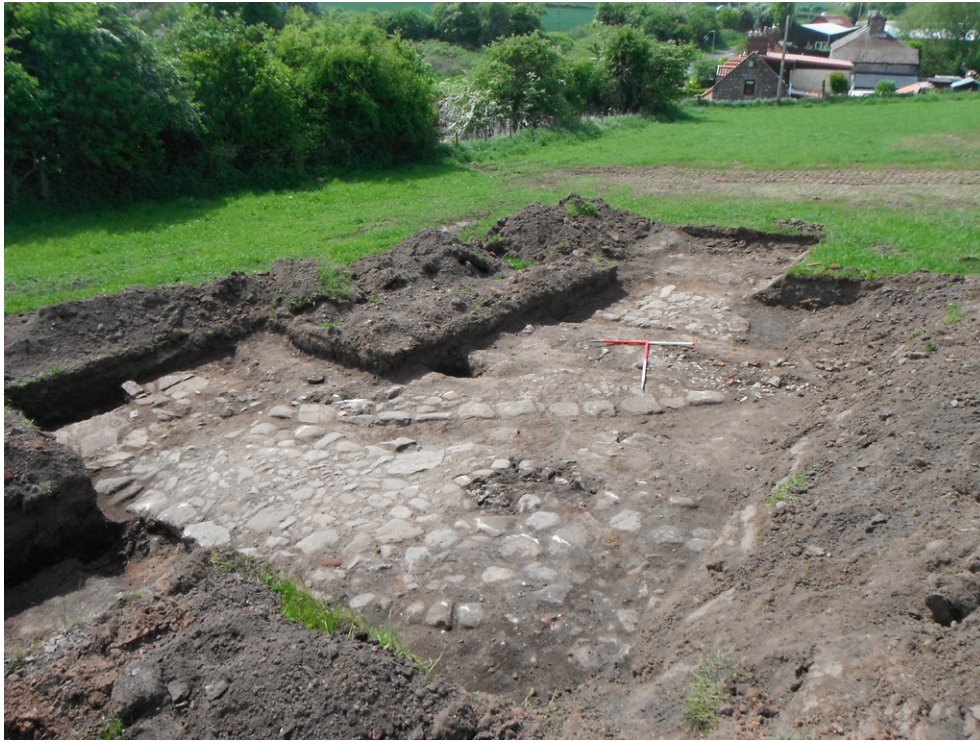
Fig. 10 - Trench 7 extension showing areas of cobbles

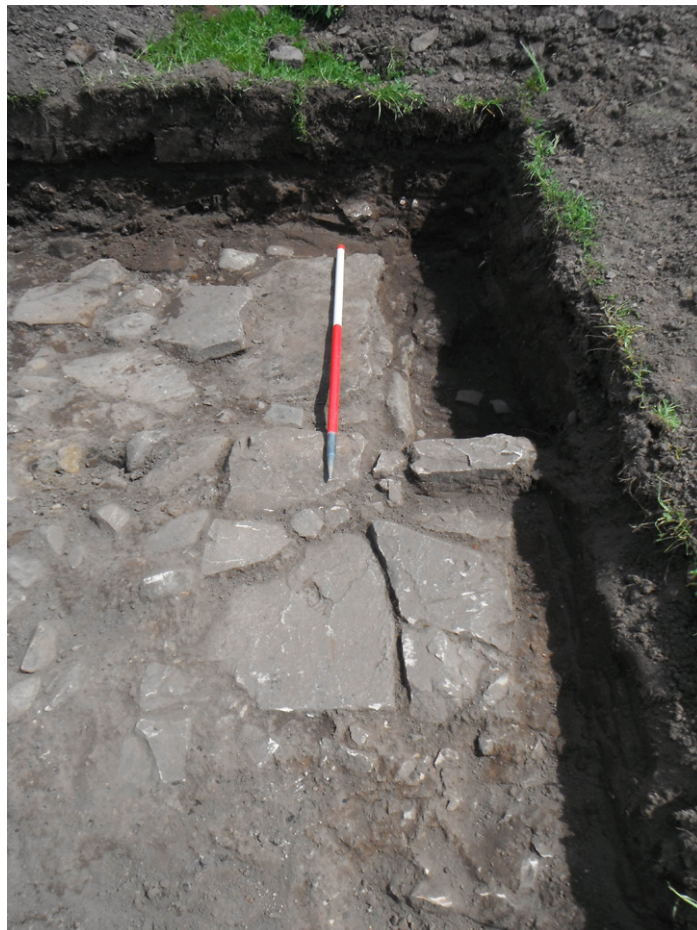
Fig. 11 - Paving 714/715

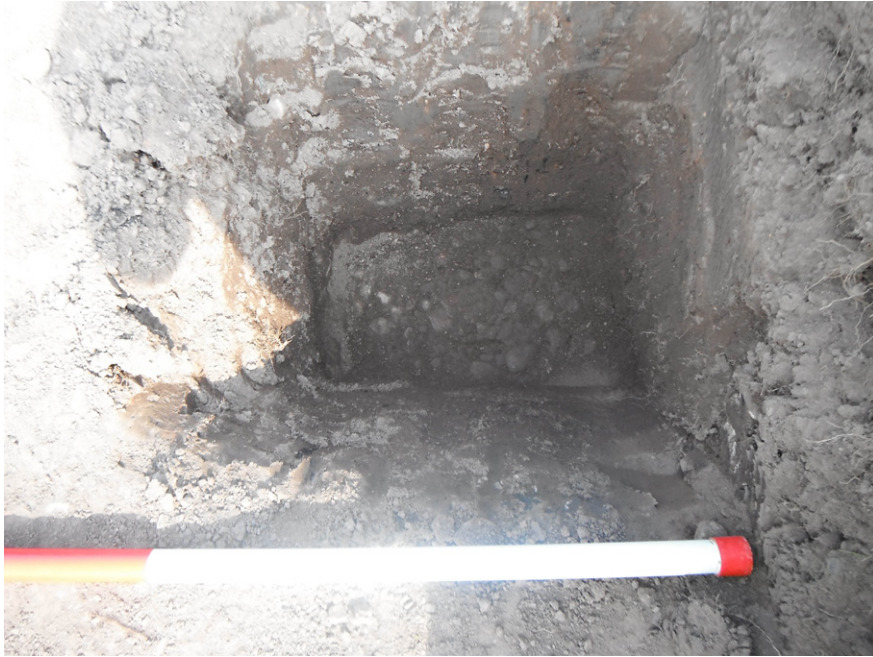
A deeper sondage was excavated in to the subsoil like material that these were set upon and a possible pebbled surface (**703**) (Fig. 12) was identified at the base of this.

Fig. 12 - Pebbled surface 703

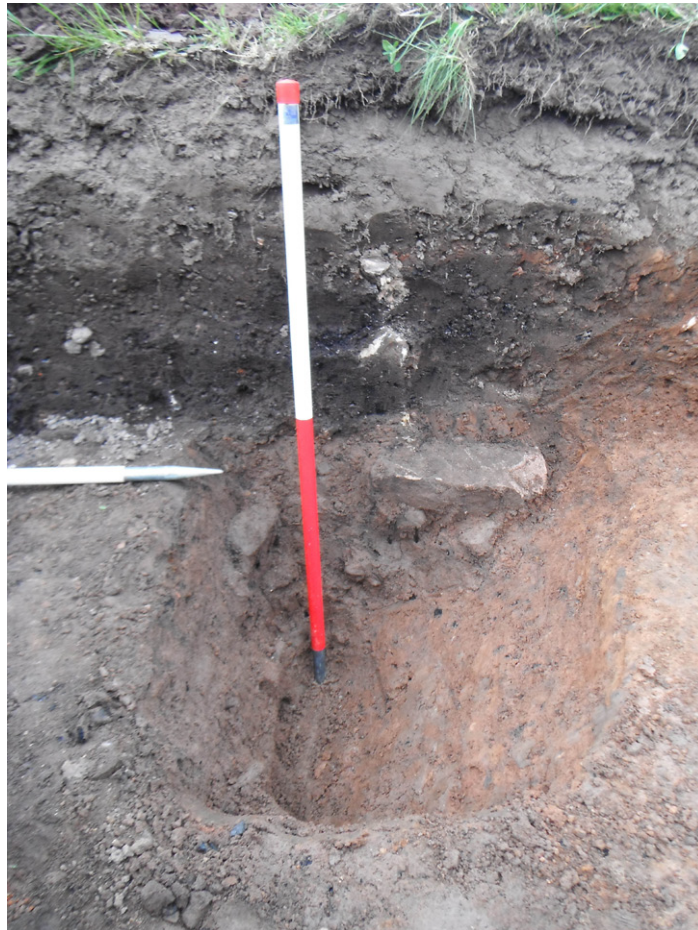
Ditch **705** was N to S aligned. Its eastern edge was possibly defined by the cobbled surface. It had a width of >0.75m, and a depth of >0.6m (Fig. 13). The fill (**712**) of this feature consisted of mid pinkish-brown silty-sand.

Fig. 13 - Ditch 705, S-facing section

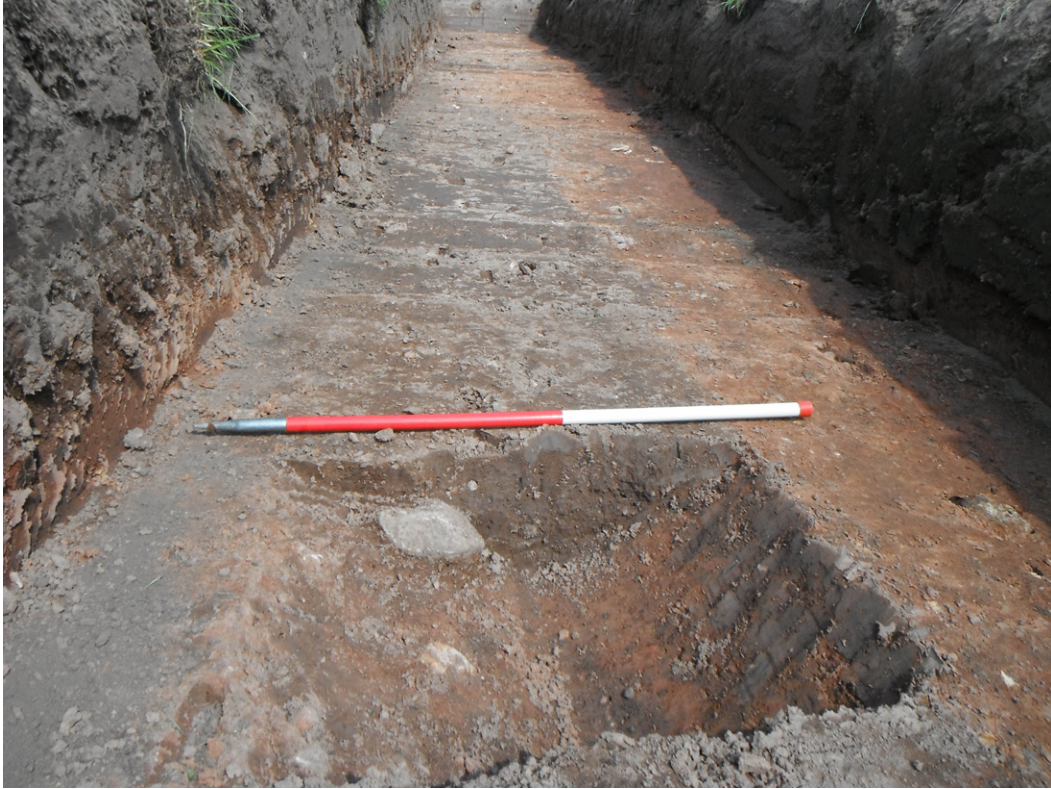
Ditch **708** was WSW to ENE aligned with steeply sloping sides and a V-shaped base. It had a width of 0.9m and a depth of 0.35m (Fig. 14). The fill (**709**) of this feature consisted of greyish-brown silty-sand.

Fig. 14 - Ditch 708, WSW-facing section

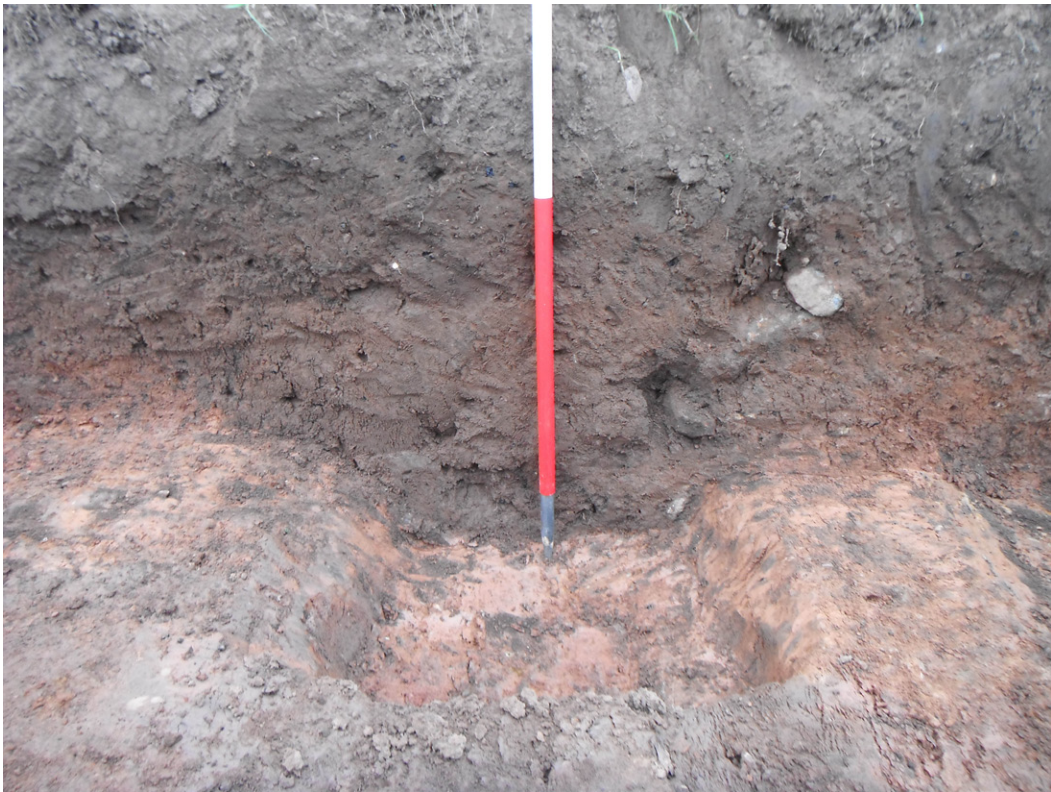
Ditch **710** was N to S aligned with steeply sloping sides and a flat base. It had a width of 1.1m and a depth of 0.34m (Fig. 15). The fill (**711**) of this feature consisted of greyish-brown silty-sand.

Fig. 15 - Ditch 710, N-facing section

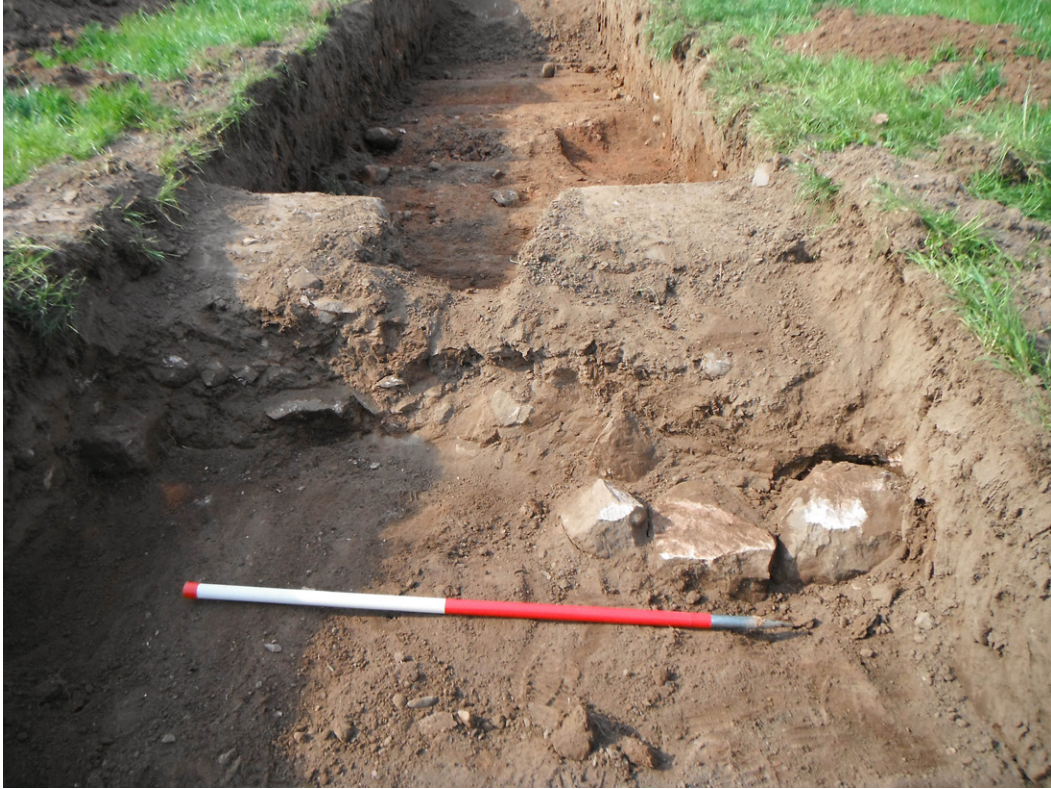
An E to W alignment of unbounded rubble (**804**) was identified crossing the trench. Behind this subsoil like material may have formed a possible bank (**805**) (Fig. 16). It had an overall width of 2m and a height of c.0.3m. Sherds of 19th century pottery were recovered from possible bank material **805**. However, this interpretation is very uncertain as the field has been ploughed and this would likely destroy any feature like this that might have survived. It is possible that the movement of subsoil / topsoil through agricultural ploughing has caused a build up of subsoil or topsoil behind the rubble stonework, thus causing a bank like feature.

Fig. 16 - Possible wall and bank 805

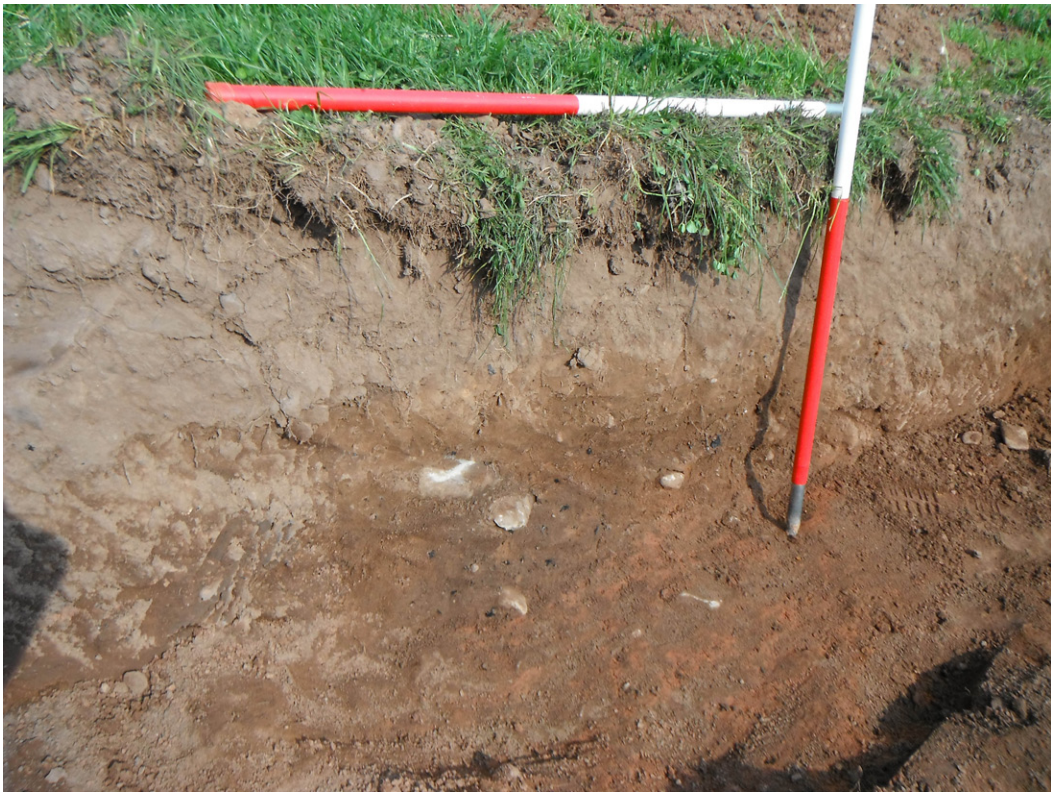
Ditch **806/808** was E to W aligned. Cut **806** had an estimated width of 0.7m and a depth of 0.25m, while re-cut **808** had a width of 0.72m and a depth of 0.25m (Fig. 17). The fill (**807**) of ditch **806** consisted of slightly orangey-brown silty-sand, while the fill (**809**) of the re-cut **808** consisted of slightly lighter orangey-brown silty-sand.

Fig. 17 Ditch 806, W-facing section

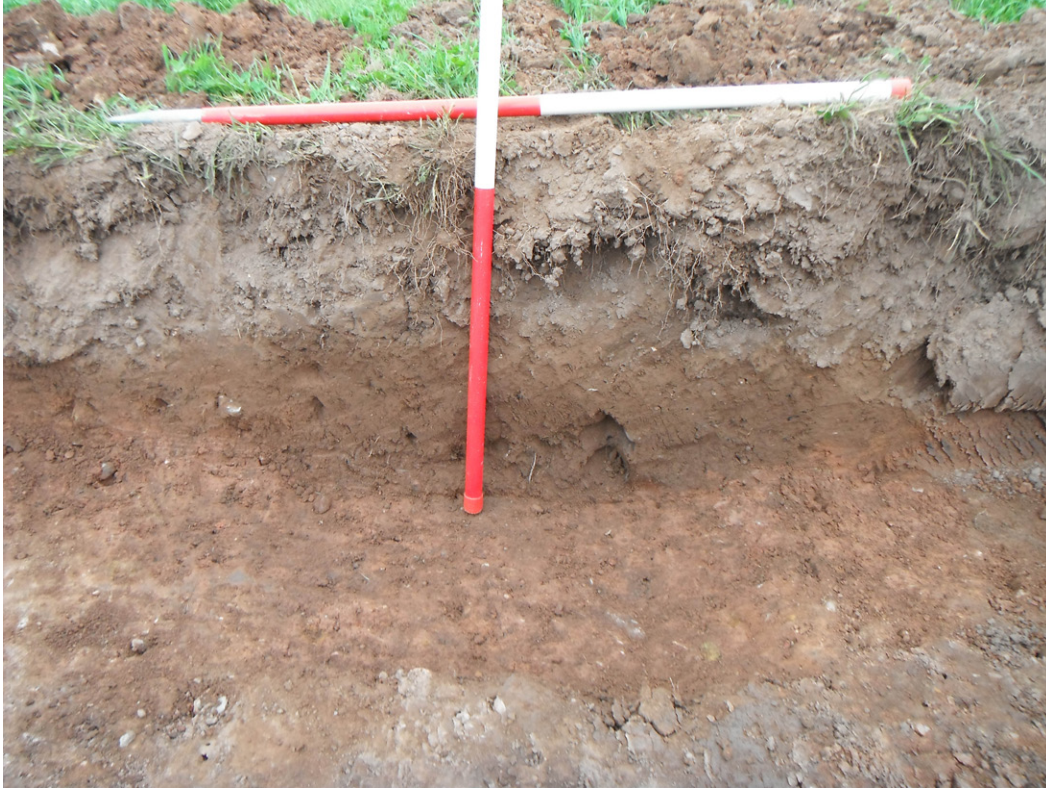
Trench 10 measured 30m by 1.8m and deposits consisting of 0.25m of grey silt topsoil and 0.1m of orangey-grey sandy-silty-clay subsoil overlay orange-brown sandy-clay natural. A single E to W aligned ditch feature (**1001**) was identified within this trench. It had a width of 0.8m and a depth of 0.1m (Fig. 18). The fill (**1002**) of this feature consisted of mid pink-brown clay-silt with pebbles and coal fragments

Fig. 18 - Ditch 1001, E-facing section

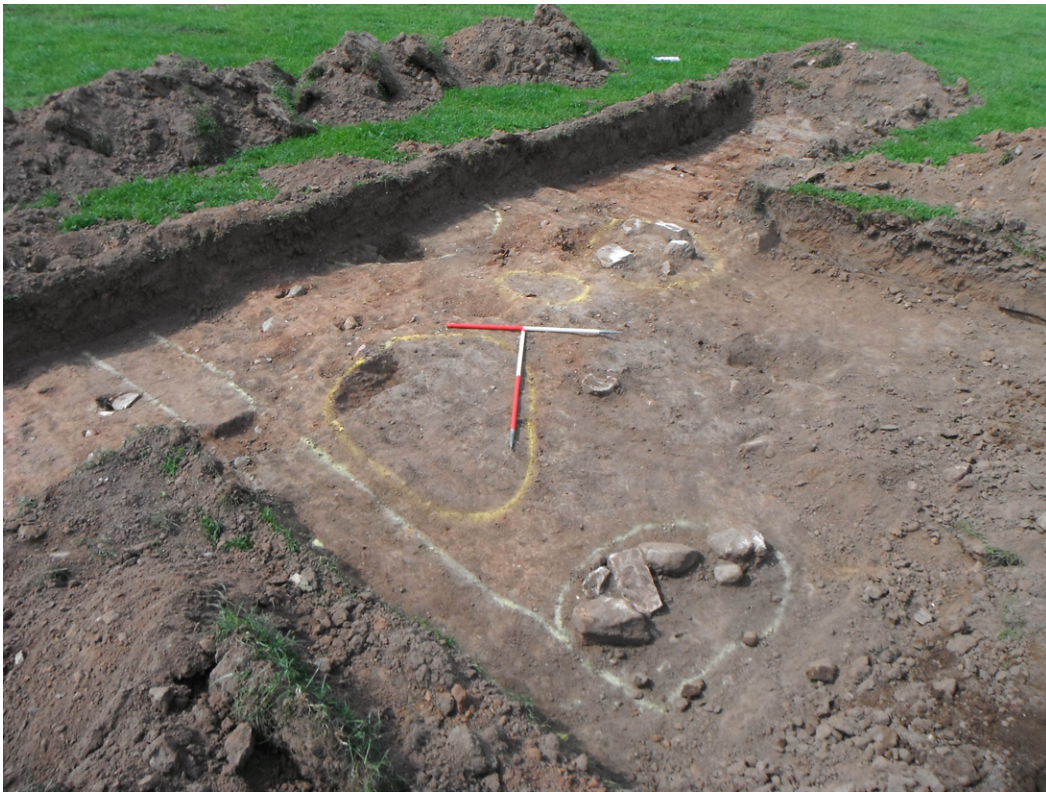
Fig. 19 - Trench 11 extension showing pit features 1105, 1107, 1109, 1111, 1114 and linear feature 1103

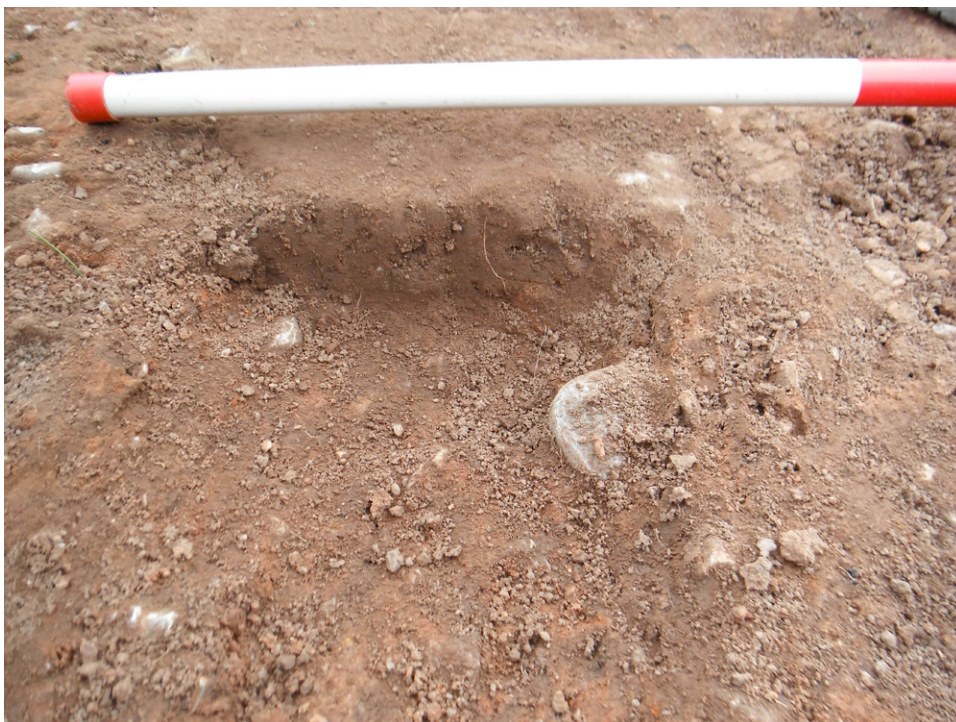
Ditch **1103** was E to W aligned with sloping sides and a concave base. It had a width of 0.35m and a depth of 0.1m (Fig. 21). The fill (**1104**) of this feature consisted of mid pink-brown sandy-silt. Sherds of late medieval oxidised ware were recovered from fill **1104**.

Fig. 21 - Ditch 1103, E-facing section

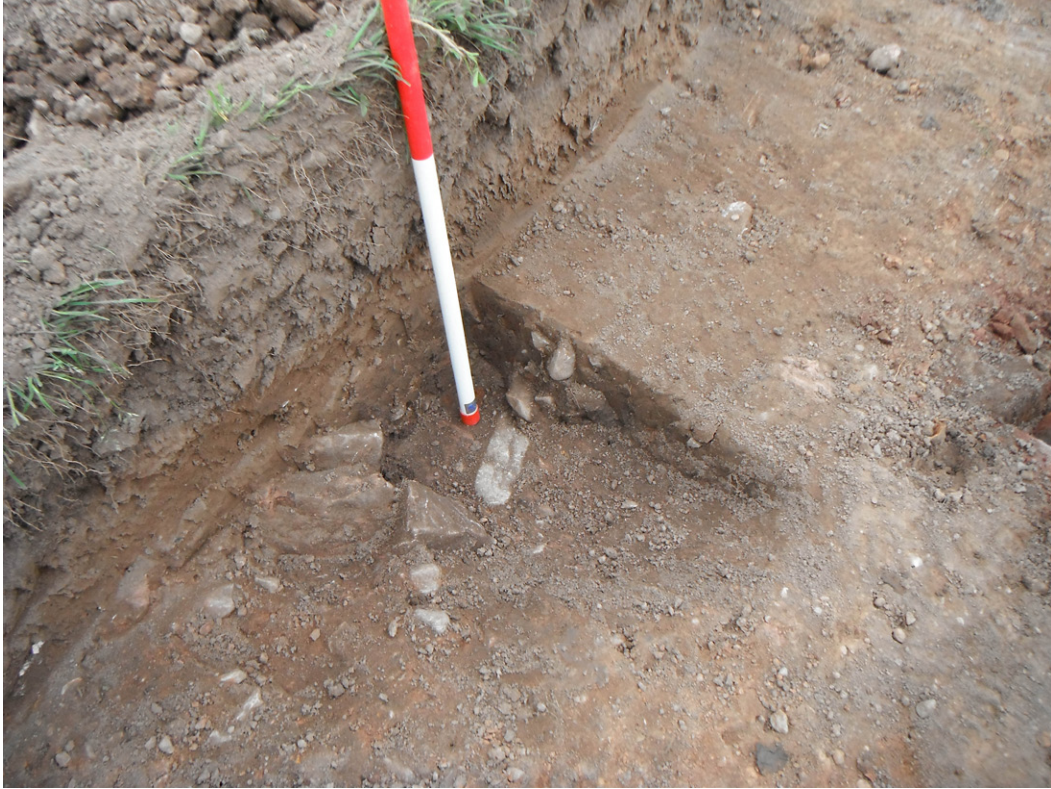
Pit **1105** was not fully uncovered. It measured 1.5m N to S by >0.6m E to W by 0.2m deep (Fig. 22). The fill (**1106**) of this feature consisted of mid pink-brown sandy-silt. Sherds of late medieval oxidised ware were recovered from fill **1104**.

Fig. 22 - Pit 1105, S-facing section

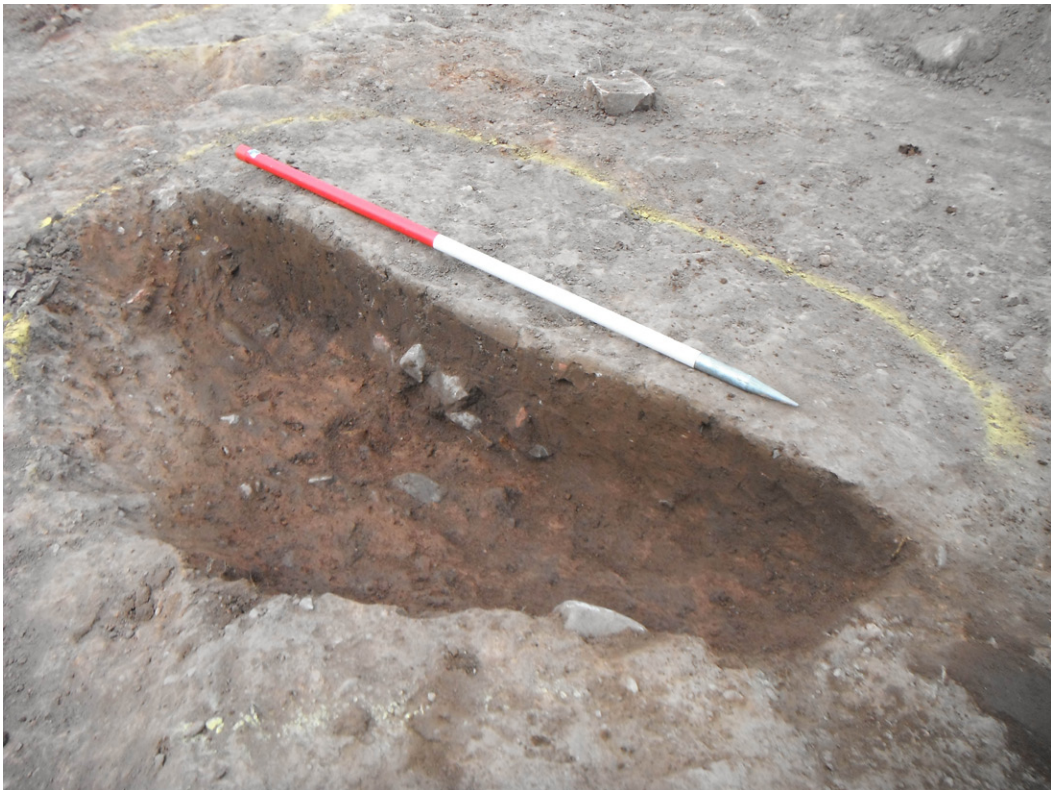
Pit **1107** was sub-circular in plan measuring 1.4m N to S by 1.3m E to W, by 0.25m deep (Fig. 23). The primary fill (**1108**) of this feature consisted of pinky-brown silty-sand and re-deposited natural, while the secondary fill (**117**) consisted of pinkish-brown silty-sand with occasional small stones.

Fig. 23 - Pit 1107, S-facing section

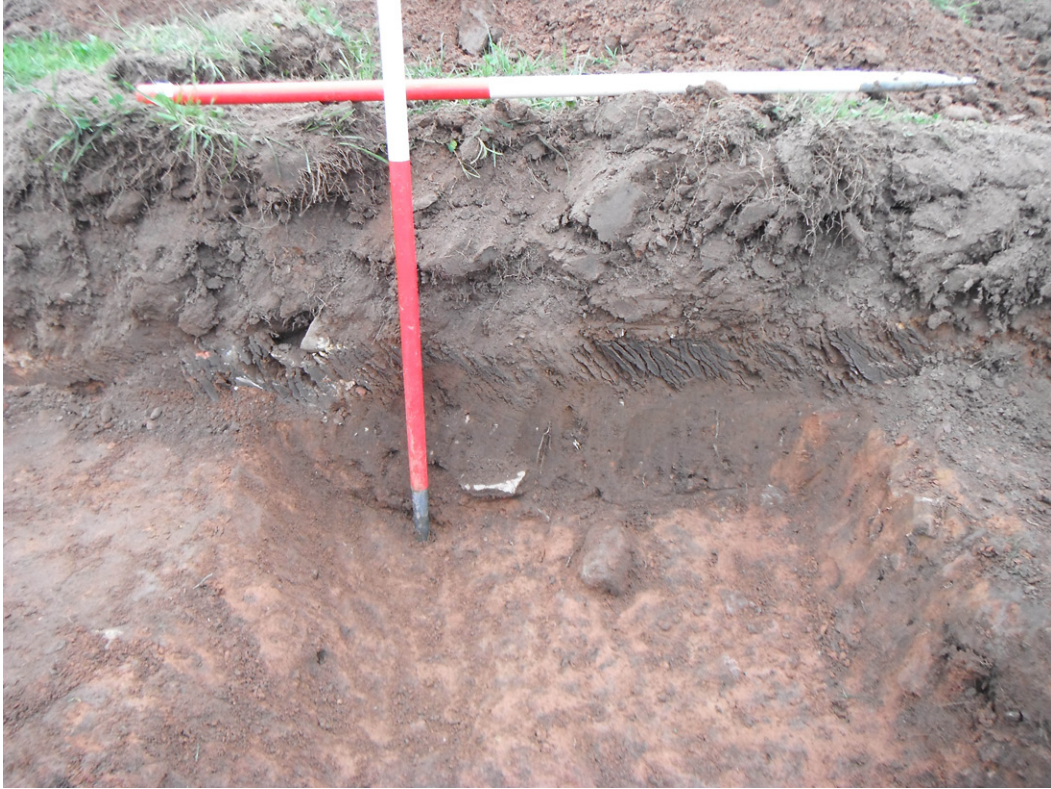
Fig. 24 - Ditch 501, E-facing section

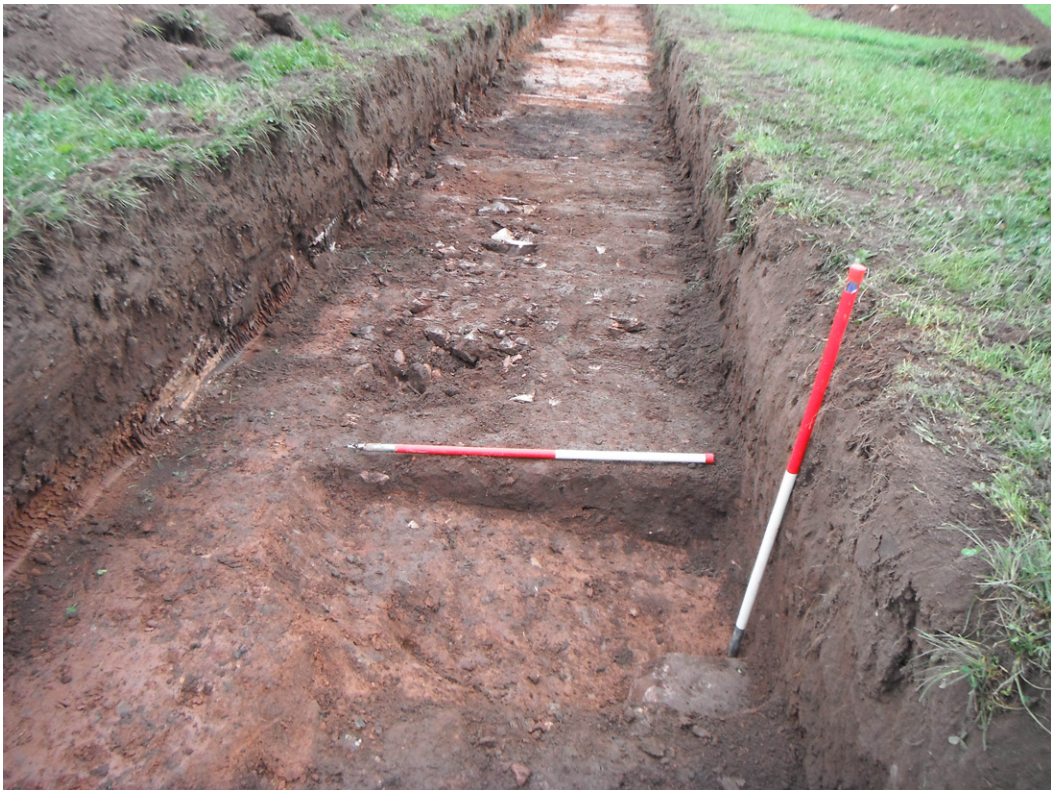
Trench 16 measured 30m by 1.8m and deposits consisting of 0.2-0.25m of grey silt topsoil and 0.2-0.35m of orangey-grey sandy-silty-clay subsoil overlay orange-brown sandy-clay natural. A large feature was partially uncovered cut into the natural at the base of this trench. It measured 11m east to west by >1m north to south, and had a depth of at least 0.3m (Fig. 25). The fill (**1602-1604**) contained of coal ash, burnt coal, 19th Century pottery, Glass and clay pipe fragments

Fig. 25 Feature 1601, W-facing section

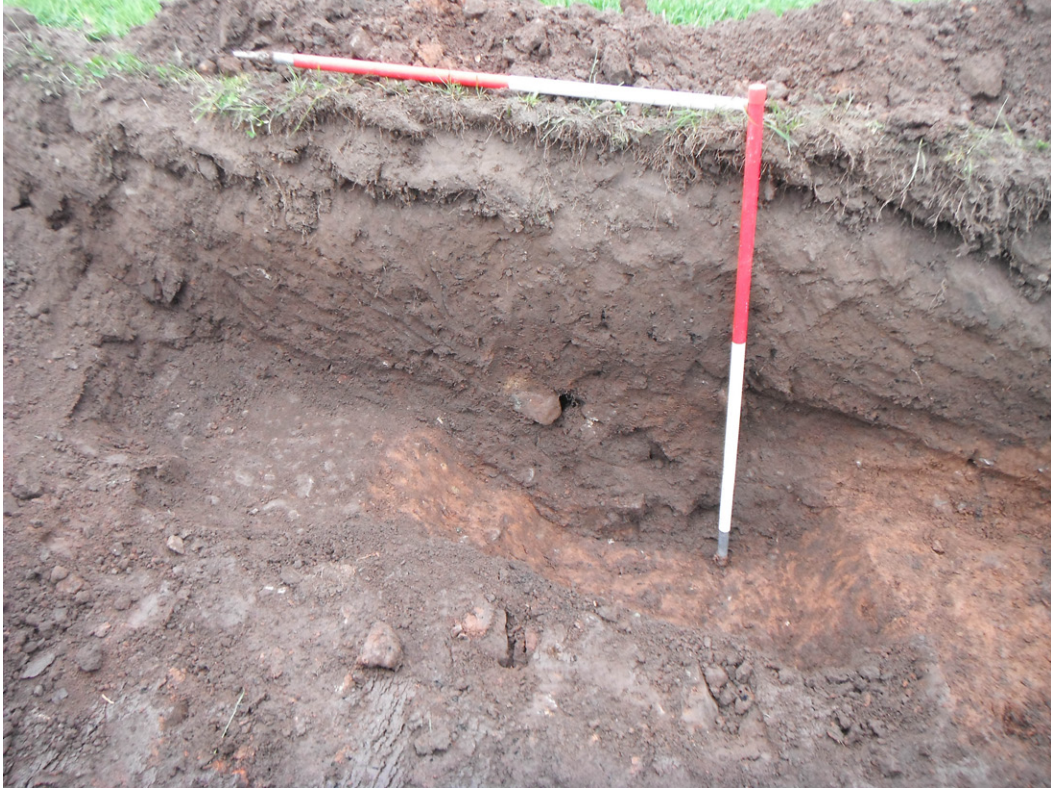
Ditch **1701** was E to W aligned and had sloping sides and a slightly concave base. It had a width of 1.1m and a depth of 0.3m (Fig. 26). The fill (**1702**) of this feature consisted of dark grey-brown sandy-silt and cobbles. Finds consisting of CBM, Glass and 19th Century pottery were recovered.

Fig. 26 - Ditch 1701, WNW-facing section
