Land North and West of Hillcrest, East Ord, Northumberland

Archaeological Evaluation
Report No. 3773

Archaeological Evaluation

Report 3773

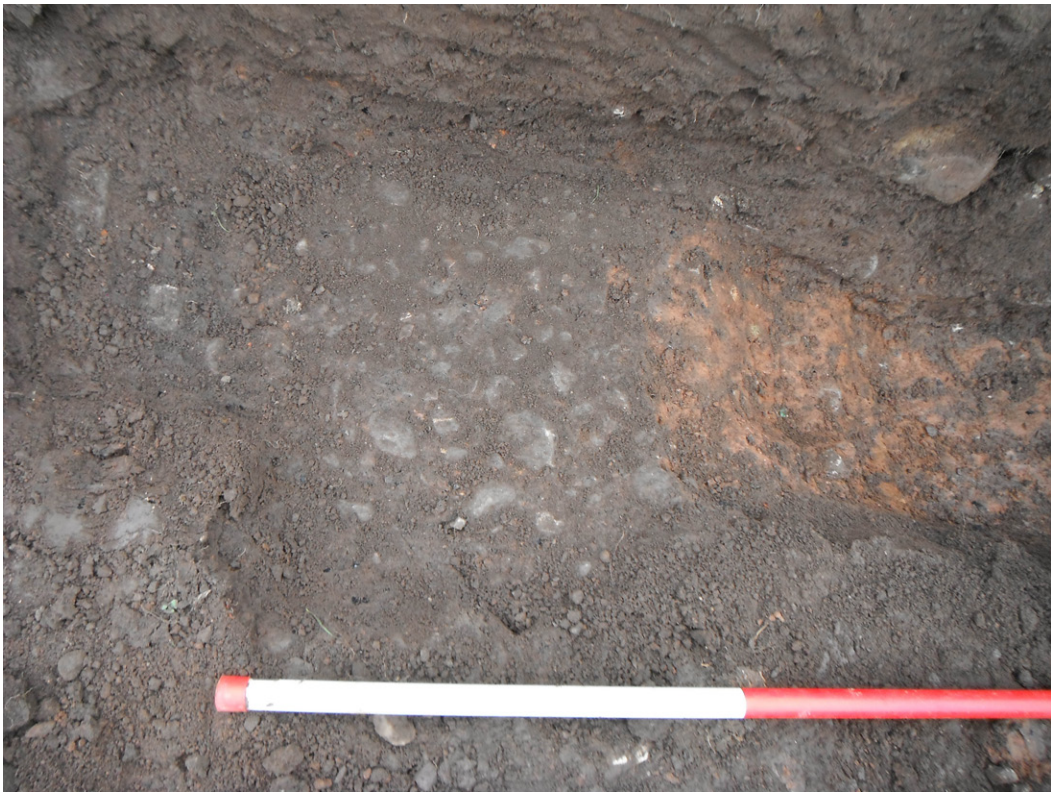
A possible pebbled surface **1703** was uncovered immediately to the north of ditch **1701**. It measured >0.5m N to S by >0.5m E to W (Fig. 27). This was only exposed in a small area and appeared to be thin; one pebble deep overlying natural. The natural itself at this location had a fair stone content but this did appear to be more compacted.

Fig. 27 - Possible pebbled surface 1703

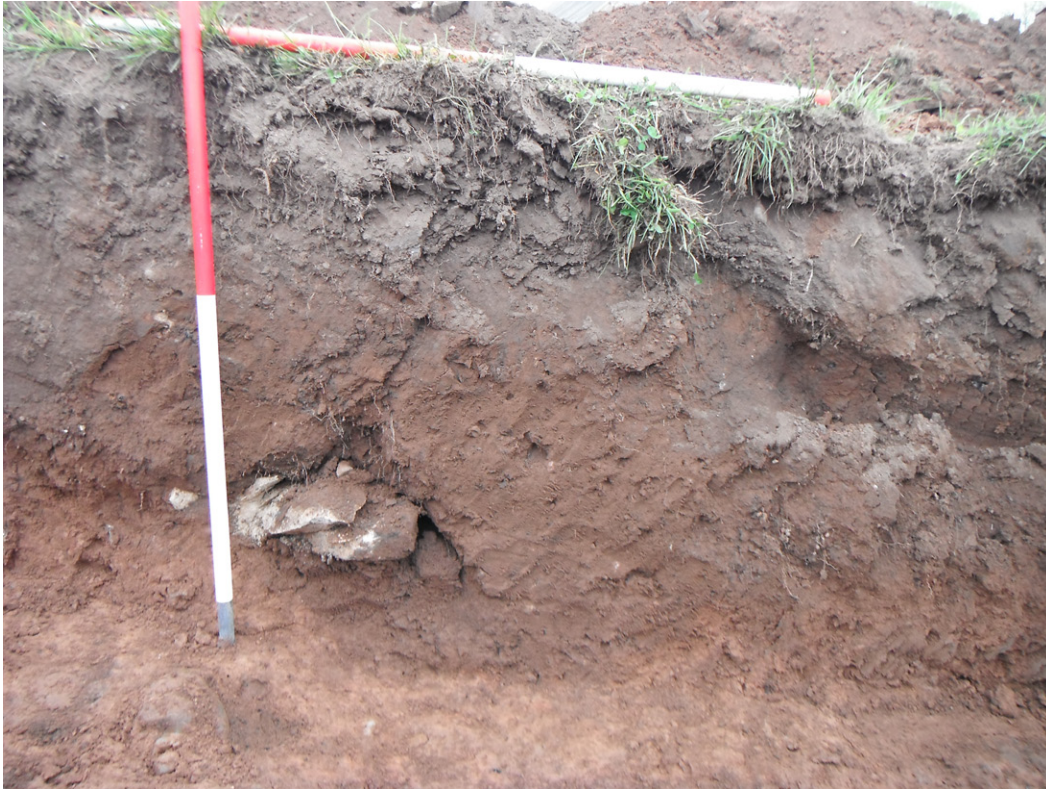
Ditch **1704** was E to W aligned and had sloping sides and a fairly flat base. It had a width of 0.8m and a depth of 0.15m (Fig. 28). The fill (**1705**) of this feature consisted of mid pink-brown silty-sand.

Fig. 28 - Ditch 1704, WNW-facing section

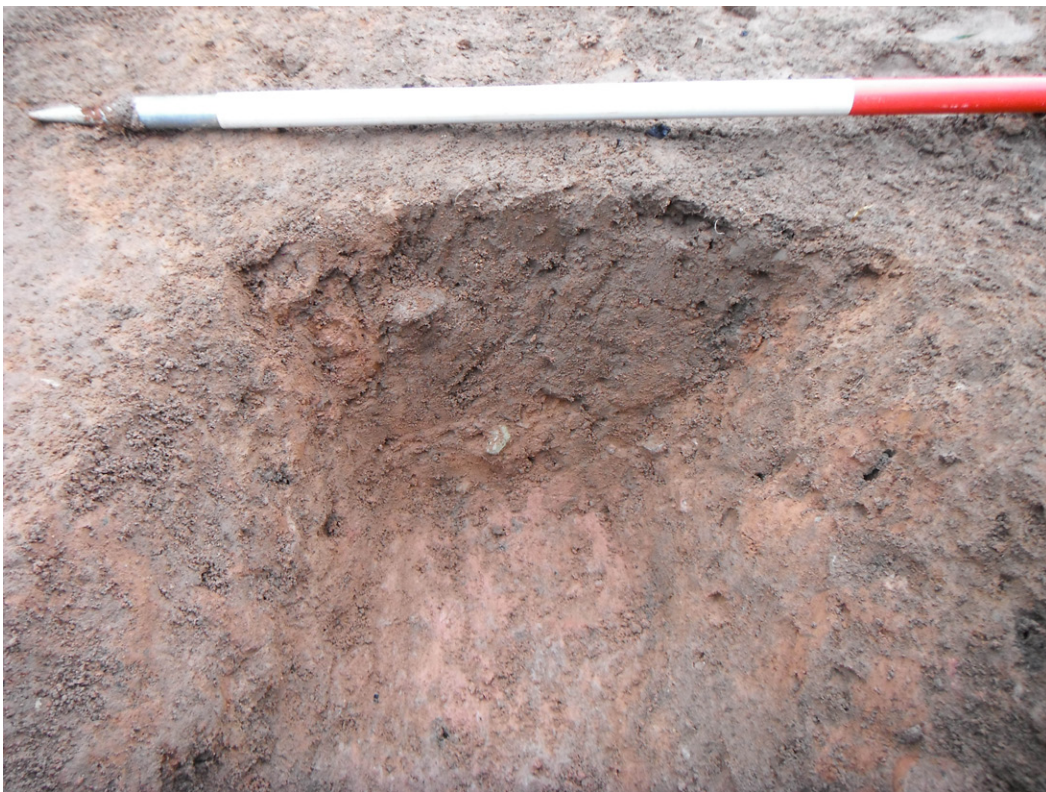
Ditch **1706** was N to S aligned and had sloping sides and a rounded base. It had a width of 0.4m and a depth of 0.15m (Fig. 29). The upper fill (**1707**) of this feature consisted of mid pink-brown silty-sand, and the primary fill (**1708**) consisted of a mixture of re-orange-brown sandy-clay deposited natural and pink-brown silty-sand.

Fig. 29 - Ditch 1706, S-facing section

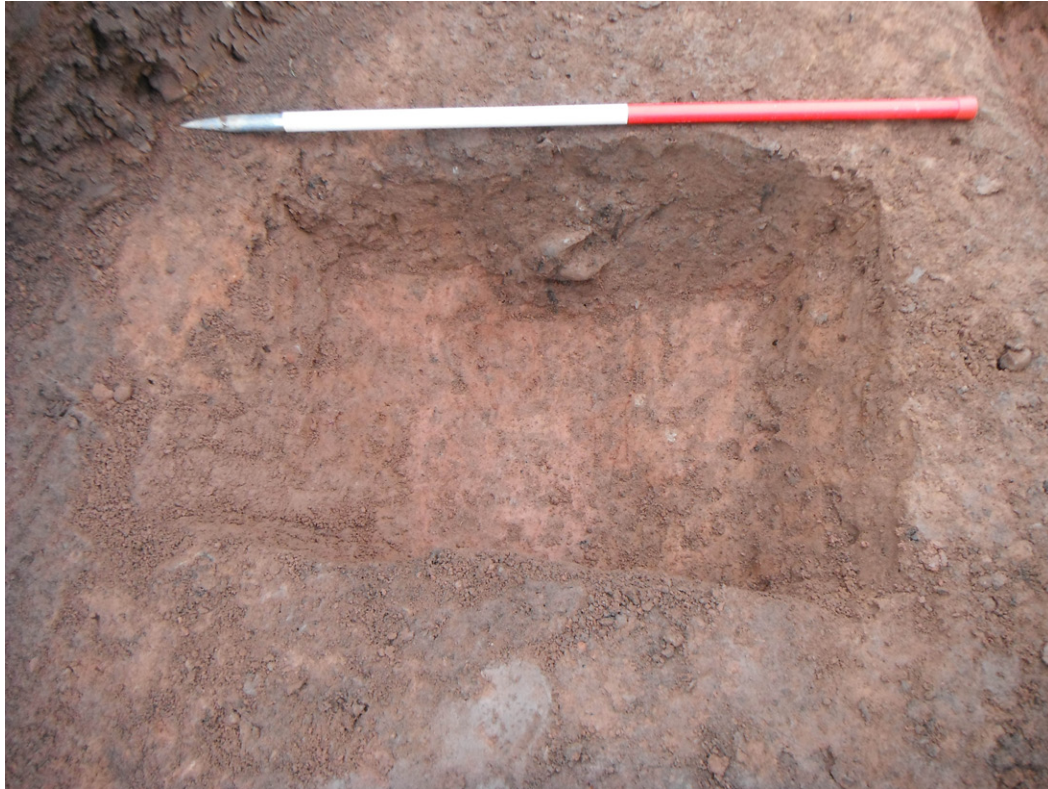
Ditch **1709** was aligned parallel with ditch **1706** and had sloping sides and a rounded base (Fig. 30). The fill of this feature (**1710**) consisted of light pink-brown silty-sand and re-deposited natural. Slight traces of a possible re-cut (**1711**) were visible within this ditch. The re-cut was filled with a mixture of orange-brown sandy-clay deposited natural and pink-brown silty-sand (**1712**).

Fig. 30 - Ditch 1709, S-facing section

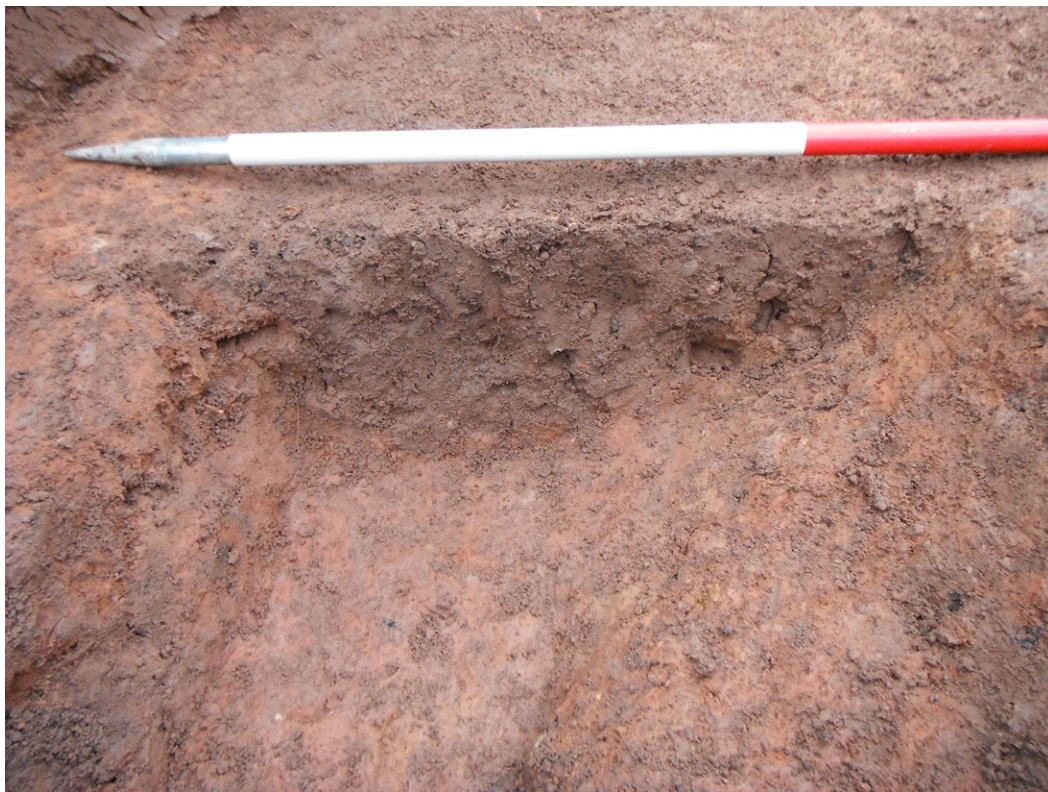
Ditch **1713** was aligned parallel with ditch **1709** and had stepped sloping sides and a rounded base (Fig. 31). The fill of this feature (**1714**) consisted of light pink-brown silty-sand.

Fig. 31 - Ditch 1713, S-facing section

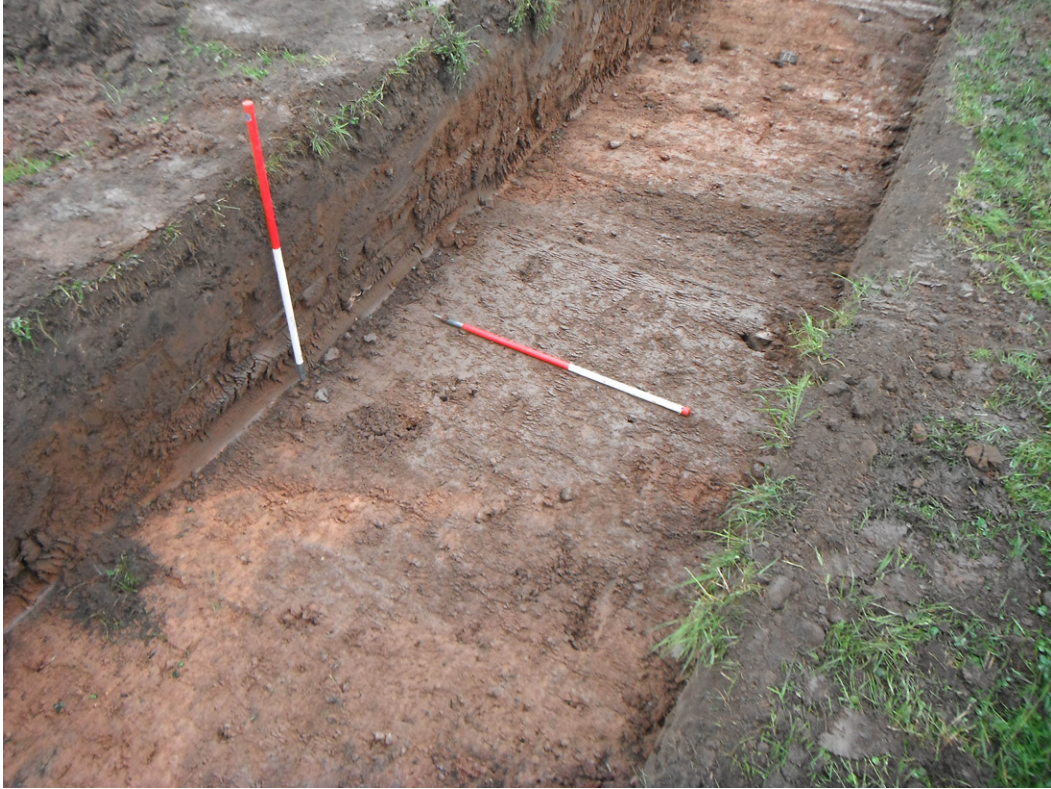
Ditch **1715** was aligned E to W and had a width of 2m (Fig. 32). The fill of this feature (**1716**) consisted of mid to dark-brown pink-brown silty-sand.

Fig. 32 - Ditch 1715, general view

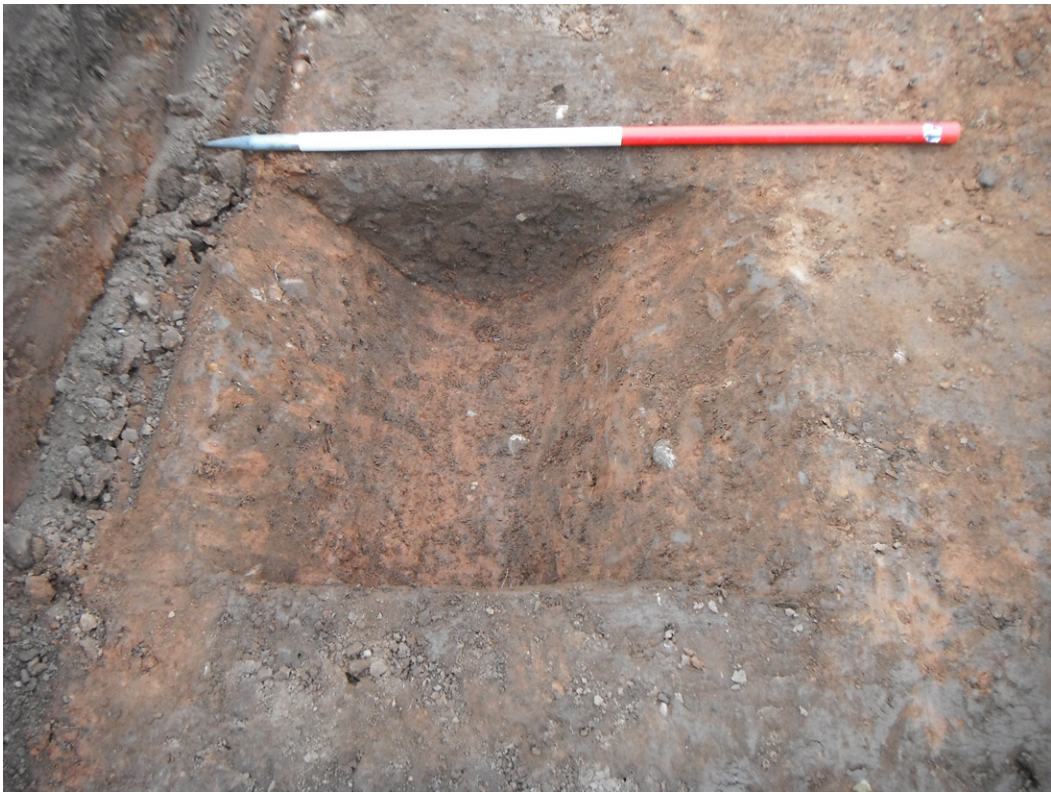
Fig. 33 - Ditch 1801, N-facing section

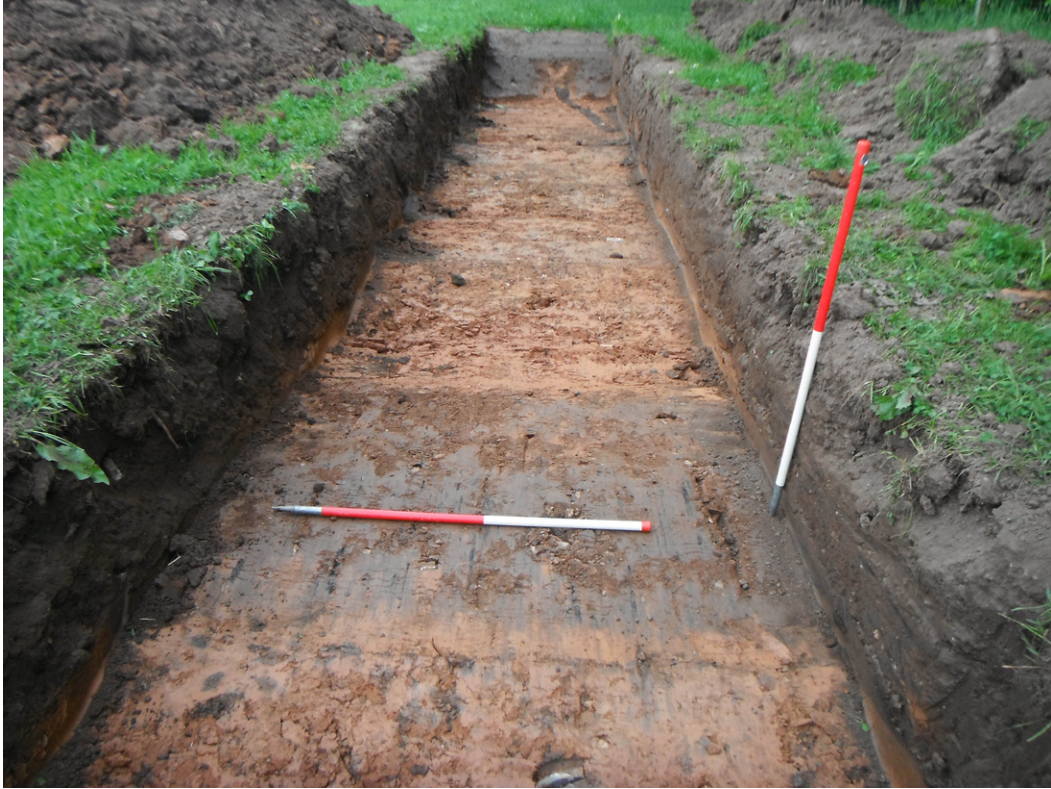
Fig. 34 - Furrow 2101, general shot

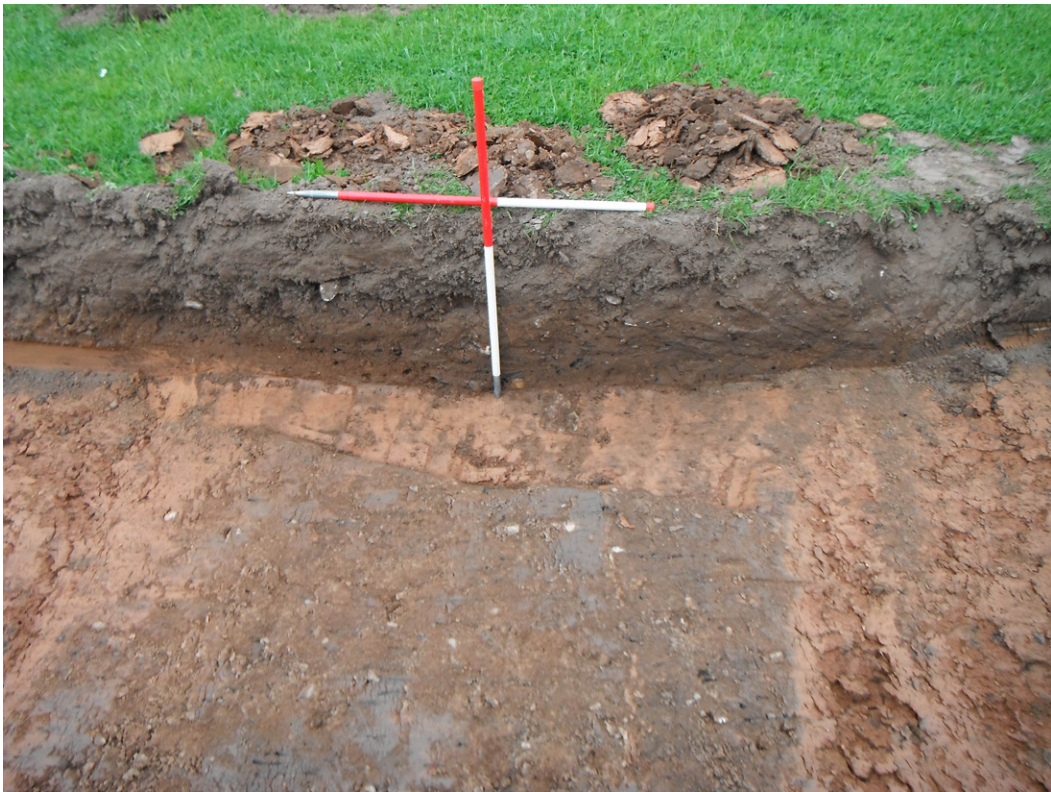
Fig. 35 - Furrow 2501, S-facing section

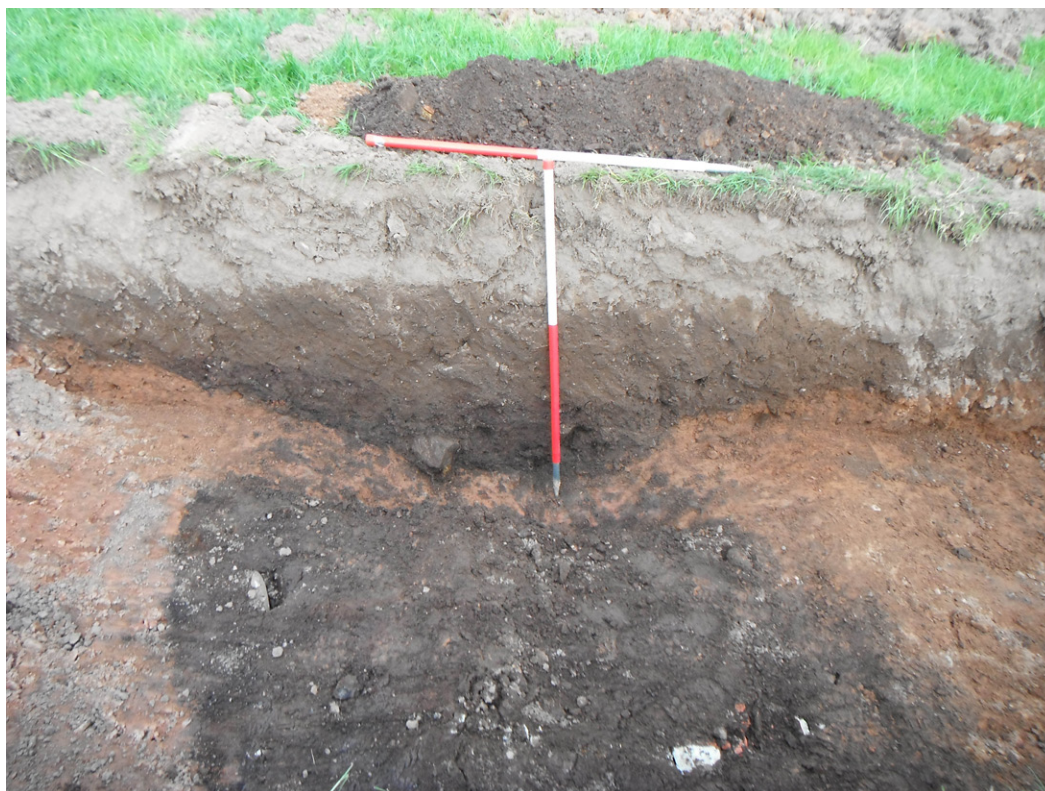
Pit **801** was not fully uncovered. It measured >1.8m E to W by 1.6m N to S by 0.25m deep (Fig. 36). The fill (**802**) of this feature consisted of grey-black gritty silt. 19th Century pottery, glass clay pipe fragments and CBM were recovered from this feature.

Fig. 36 - Pit 801, W-facing section
