Minor Archaeological Services Call-Off Contract Lochmaben Castle, Dumfries & Galloway (PIC203)

Evaluation for Research Purposes, July-August
2018

Report No. HES-PIC203-2018-01

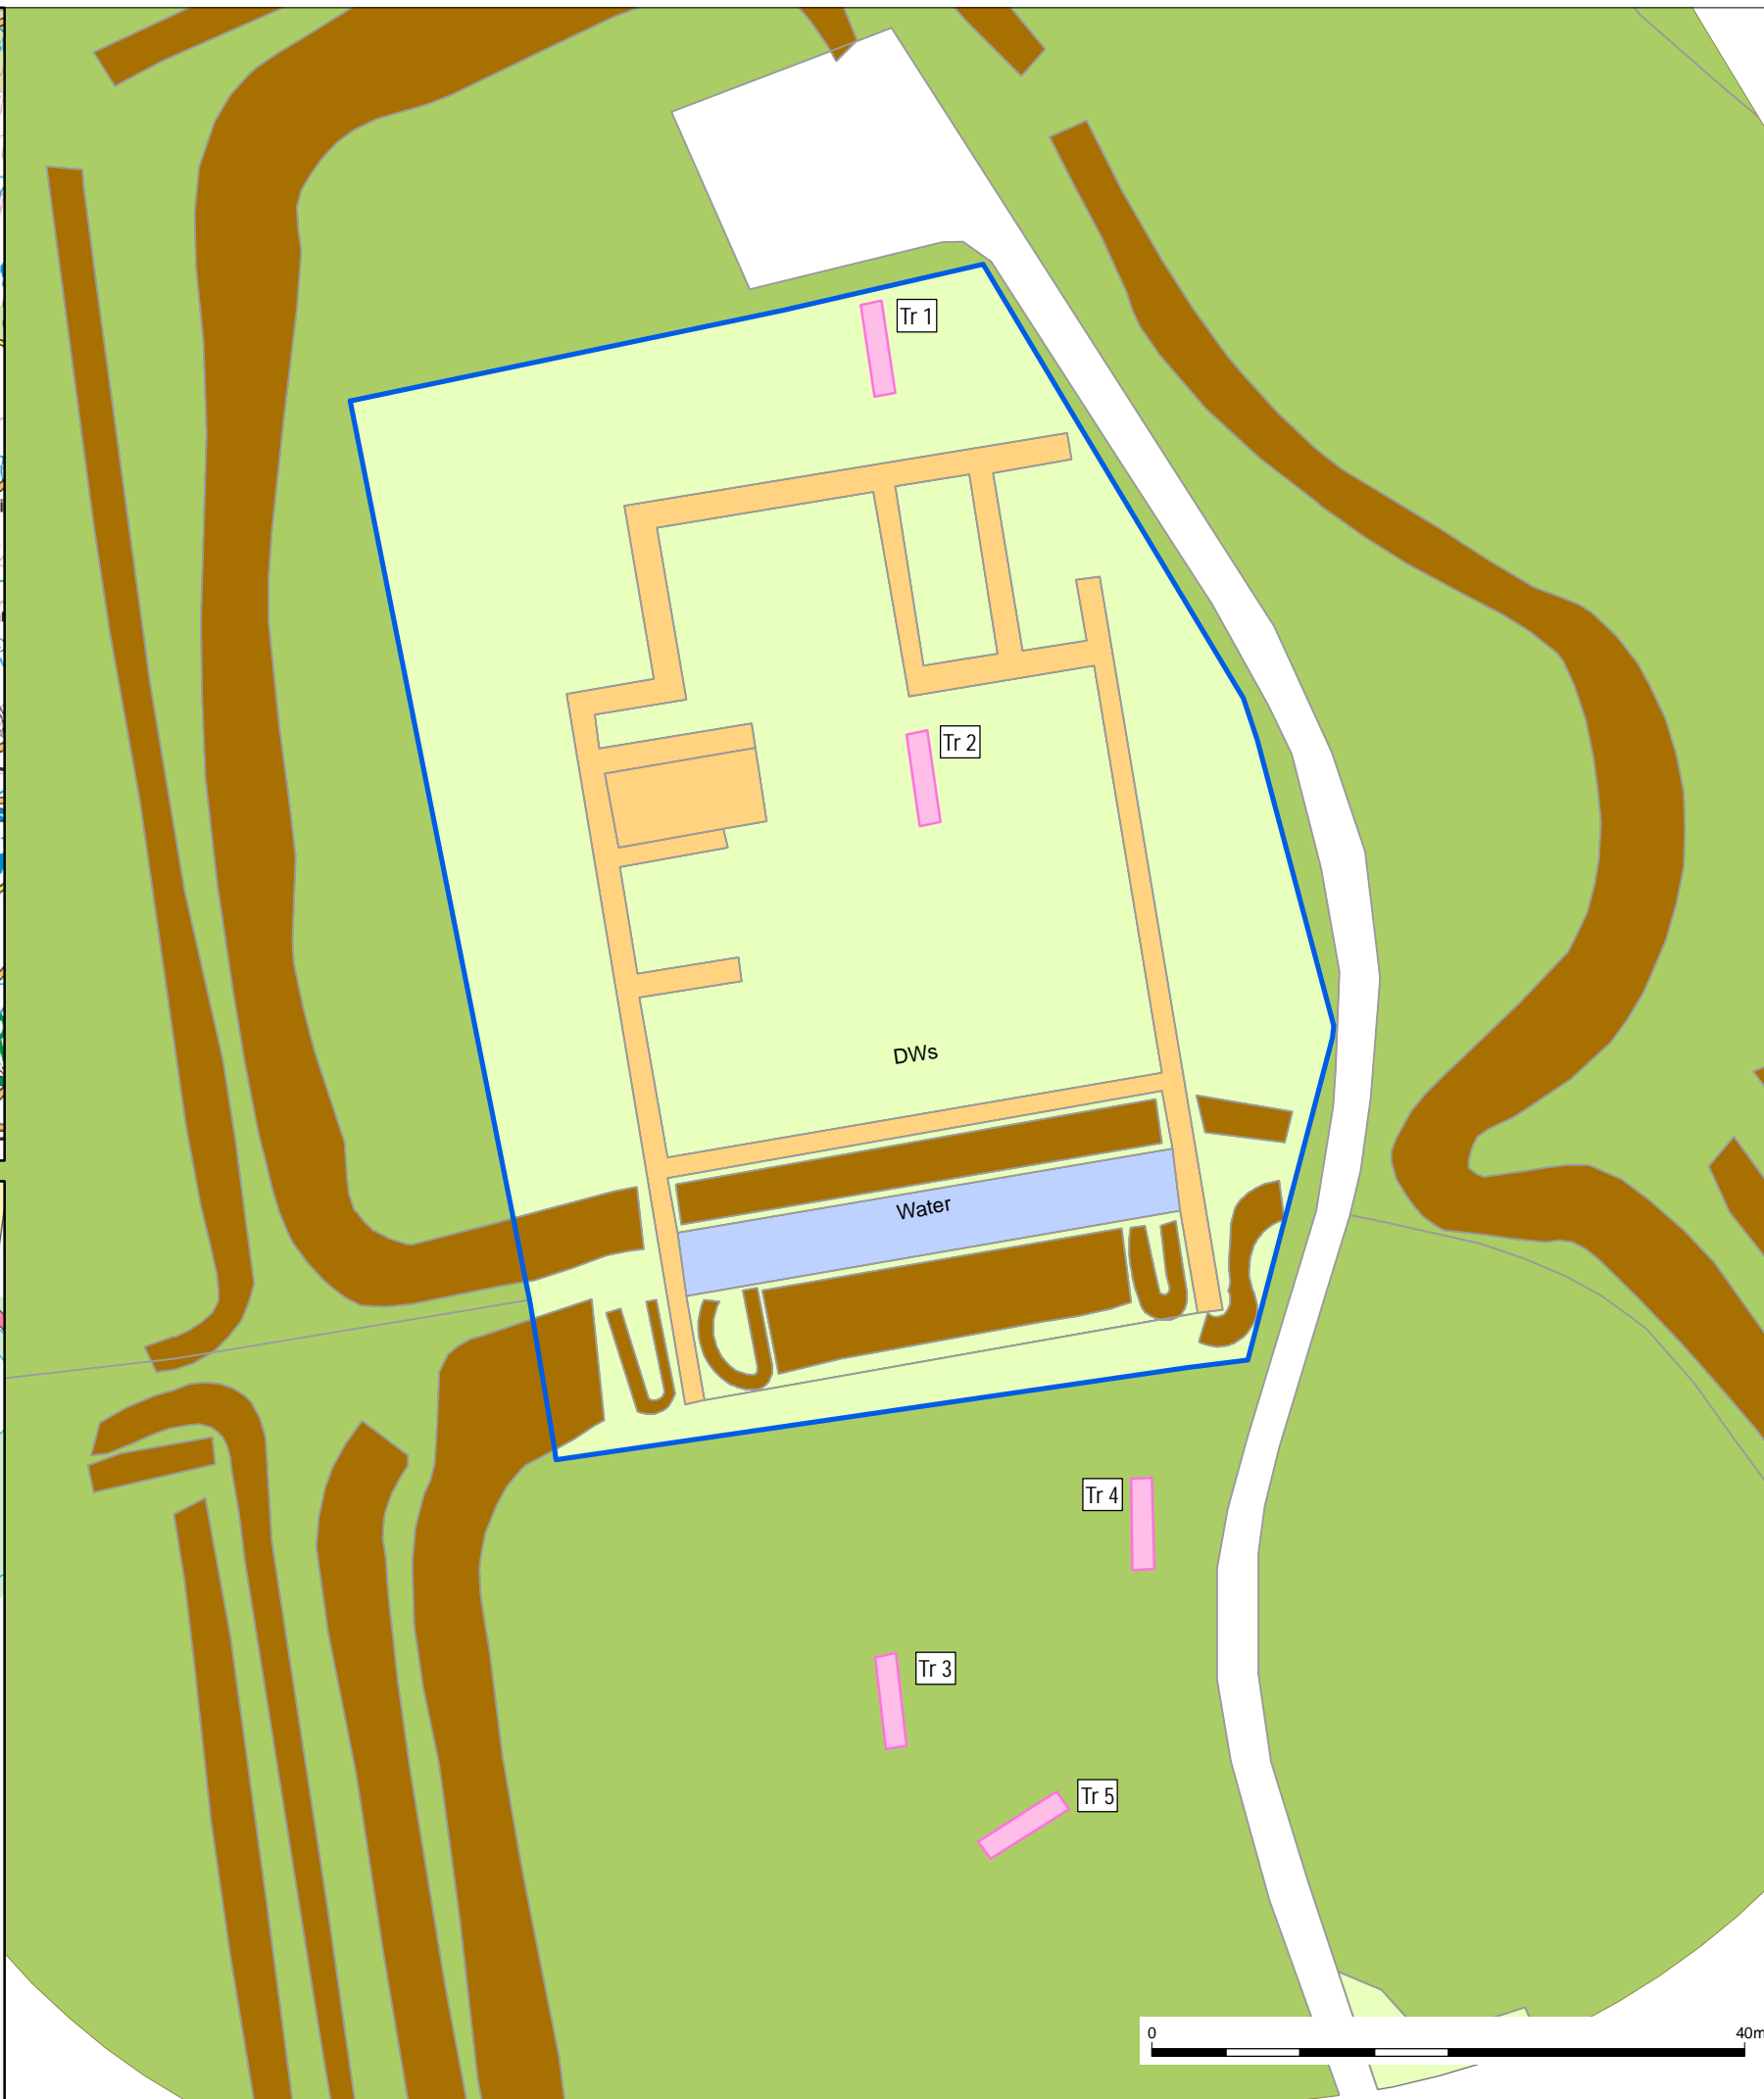
Drawn by: MP	Checked: MJ	Date: 05/10/2018
Report No: 3787	Fig. No: 1

- Trench Location
- PIC Boundary
- Scheduled Monument

Five trenches were proposed (Fig. 1). The locations were determined by HES based upon the results of the geophysical survey. In order to evaluate the results of this survey work and to more deeply examine the research questions, while keeping the impact upon the site's archaeology to a minimum, these trenches were excavated by hand with community involvement. Excavations tested the presence, absence, nature and extent of any surviving archaeological deposits and features.
