Charlestown Limekilns, Fife Landscaping Works

Archaeological Watching Brief Report No. 3782

Archaeological Watching Brief

Report No. 3782

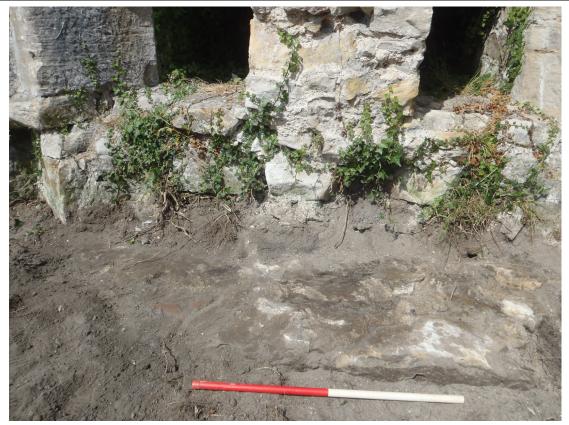
Fig. 2 Stone surface 003

A sandstone feature (003) was uncovered to the east of Kiln 1, which may be the protruding foundation for its wall, with dimensions of 3m x 2m and exposed to a depth of 0.2m (Fig. 3). This feature was not removed by the works.

All features uncovered were appropriately recorded and were unaffected by any further landscaping work undertaken. It was agreed with Historic Environment Scotland that the path would be moved in the case of it affecting the buried archaeology or the features would be covered over first with an appropriate membrane to protect them prior to the installation of the path.

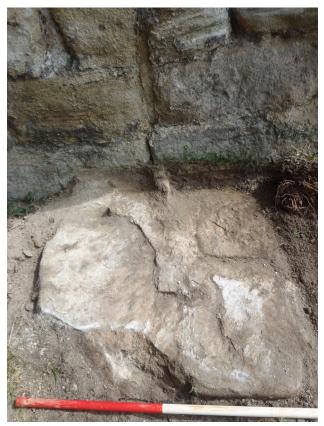
Fig. 3 Stone surface 004

At Kiln 10, a possible foundation stone / threshold stone for a gate or door was uncovered (**004**). It had previously been covered with tarpaulin and preserved in situ. The foundation stone comprised two blocks of sandstone with a vertical metal pin emerging from the stone. It measured 2.5m x 2.8m x 0.15m (Fig. 4). This feature was not removed by the works.

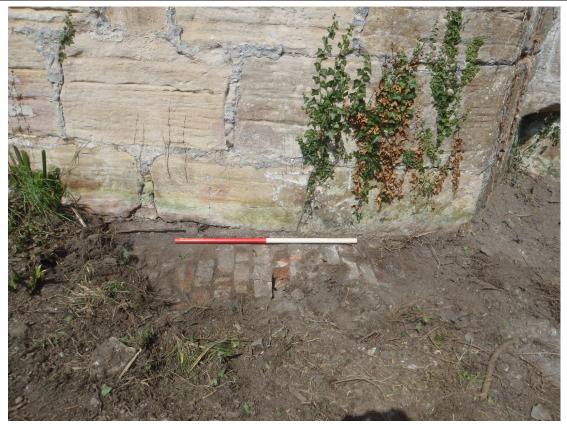
Fig. 4 Brick surface 005

Also within close proximity to Kiln 1 was a brick surface (005) laid in a rough stretcher bond with the bricks laid perpendicular to the kiln wall. The bricks were not mortared. The brick surface was located adjacent to the eastern wall of Kiln 1, with dimensions of 2m x 2.5m (Fig. 3 and 5). This feature was not removed by the works.
