Minor Archaeological Services Call-Off Contract Caerlaverock Castle, Dumfries & Galloway (PIC182)

Boardwalk Renewal: Soil Investigation
Watching Brief, August 2018
Report No. [HES-PIC182-2018-03](#)

**Boardwalk Renewal: Soil Investigation
Watching Brief, August 2018**

Report No. HES-PIC182-2018-03

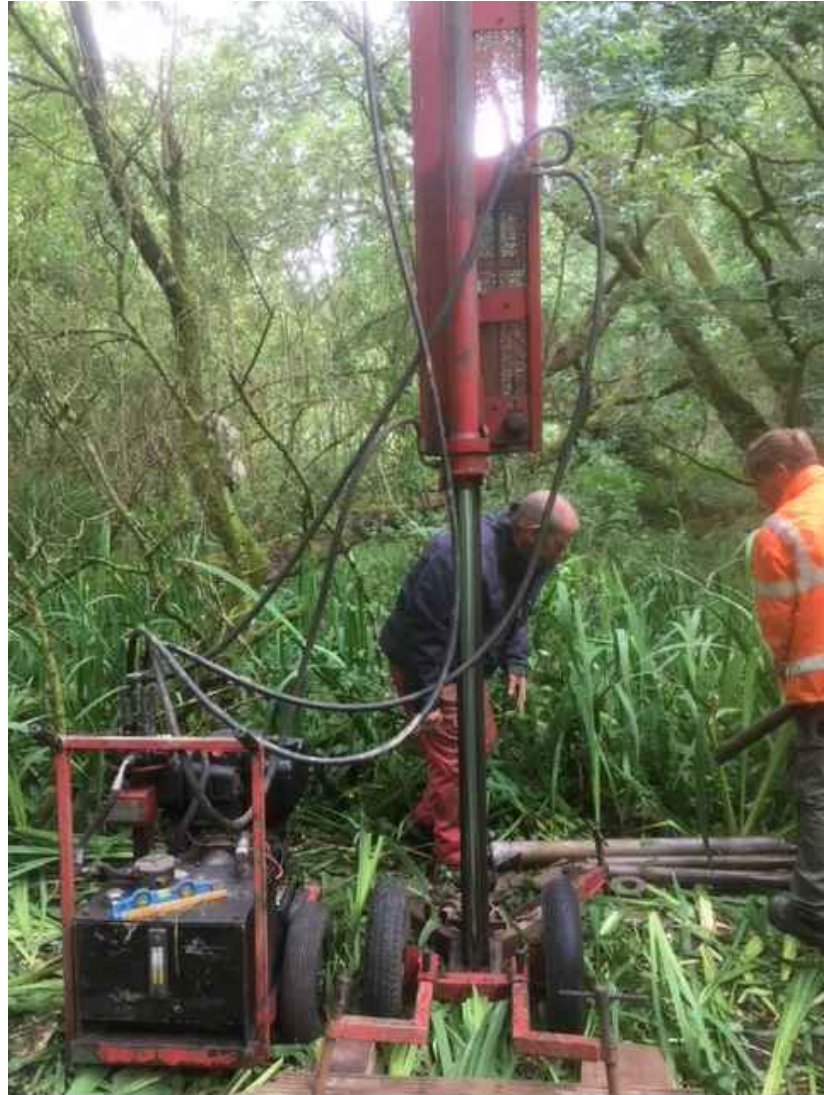
Fig. 2 - Competitor Dart Percussion Rig used to take borehole window samples

The coring device used was a Competitor Dart Percussion Rig (Fig. 2) used to take window samples by hammering in contiguous steel barrel casings (1000mm long x 100mm diameter) each containing clear plastic sample tubes that were split open with a sharp blade to allow the contents to be recorded whilst fresh. A second smaller sampler called an SPT probe (Standard Penetration Test) with a 500mm x 25mm chamber was also used. The main purpose of this test was to provide an indication of the relative density of granular deposits, such as sands and gravels, from which it is virtually impossible to obtain undisturbed samples.

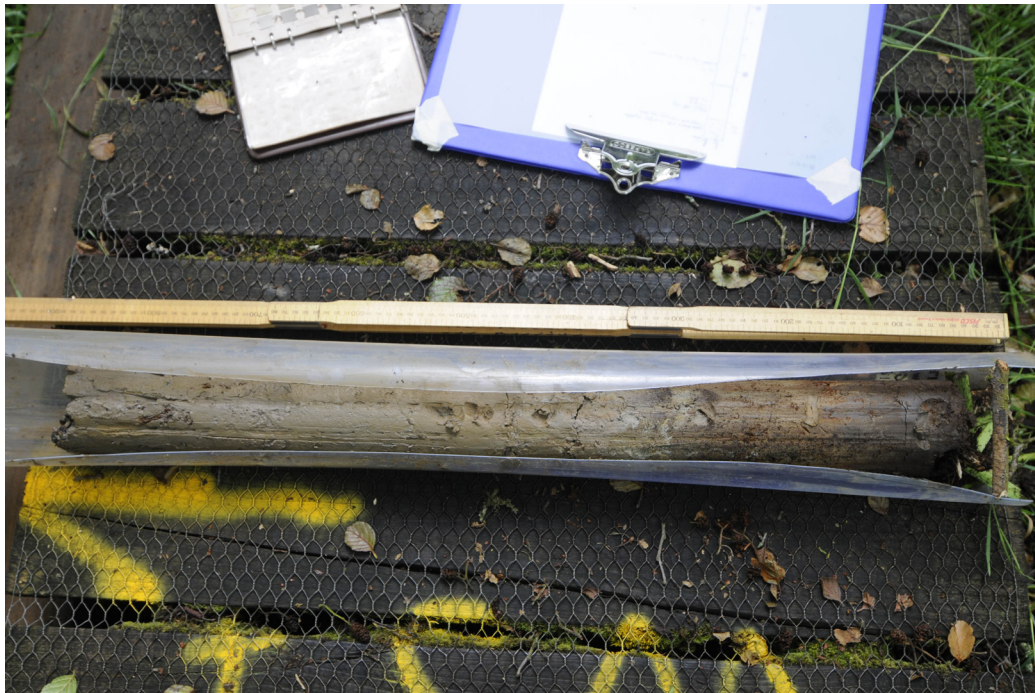
Unit 1 (Figs 3 & 4) was a fairly well humified shallow layer of fen peat formed by the slow breakdown of surface litter. The shallowness of this unit was surprising as in some cases fen deposits can have a rapid accumulation rate. However, the slow input of organic matter may have been controlled by the dominance of yellow flag iris (*Iris pseudacorus*) which is a bulbous perennial tolerant of submersion, low pH, and anoxic soils. The depth of Unit 1 allowing for compaction suggests that the marsh is relatively recent (c.200 years).

Unit 2 (Figs 3 & 4) was fairly homogenous, compact gleyed clay below the organic surface horizon. The gleying had resulted in the formation of bright orange mottles and was a result of oxidation and reduction driven by the presence of near surface ponding

Fig. 4 - Top of the core (-1-2m) in the window sample tube showing Unit 1 the fen peat

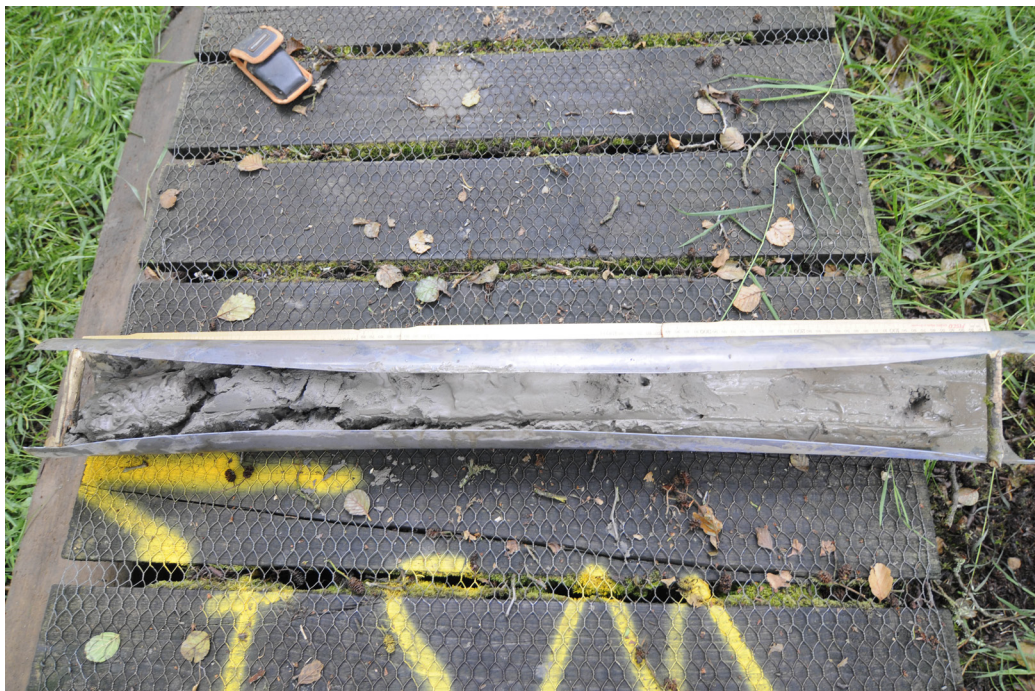
Unit 3 (Figs 3 & 5) was very uniform grey marine clay (carse clay) with a plastic consistency at its upper end becoming increasingly more compact with depth. The texture also became more gritty due to the presence of sand particles giving rise to compaction at the base of this unit.

Fig. 5 - Middle of the core (-2-3m) in the window sample tube (Unit 3)

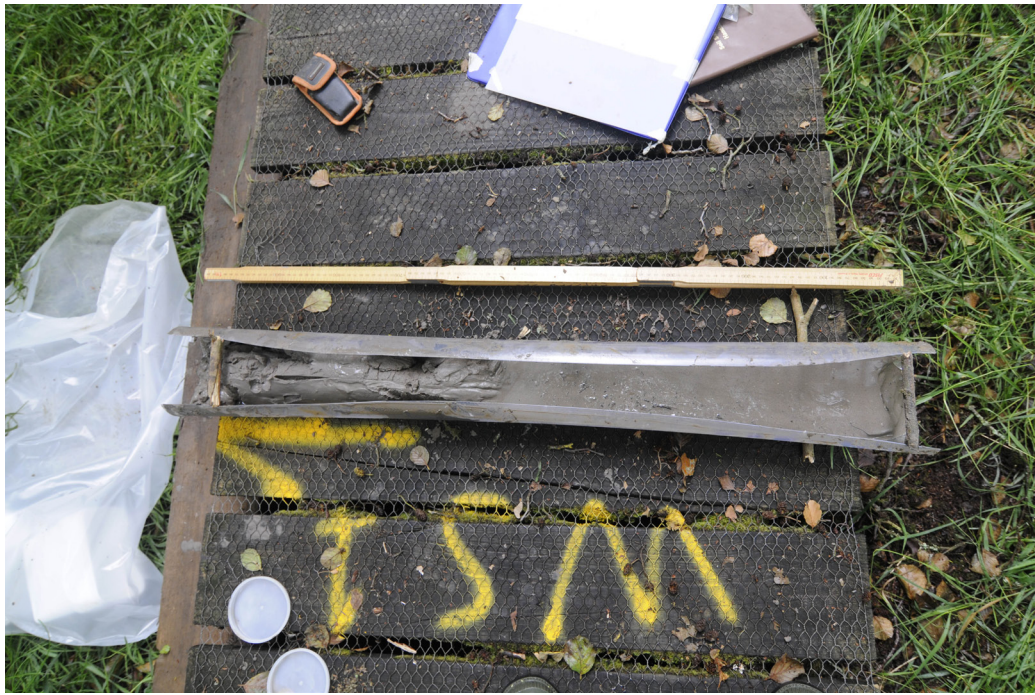
Unit 4 (Figs 3 & 6) was continuous homogenous dark grey carse clay that became increasingly more saturated towards its base where it met Unit 5, the bed rock layer. The clay was almost liquefied at this point and was difficult to contain in the barrel. This was particularly evident at c.-3.4m bgs.

Fig. 6 - Bottom of the core (-3-3.6m) in the window sample tube (Units 3-4)

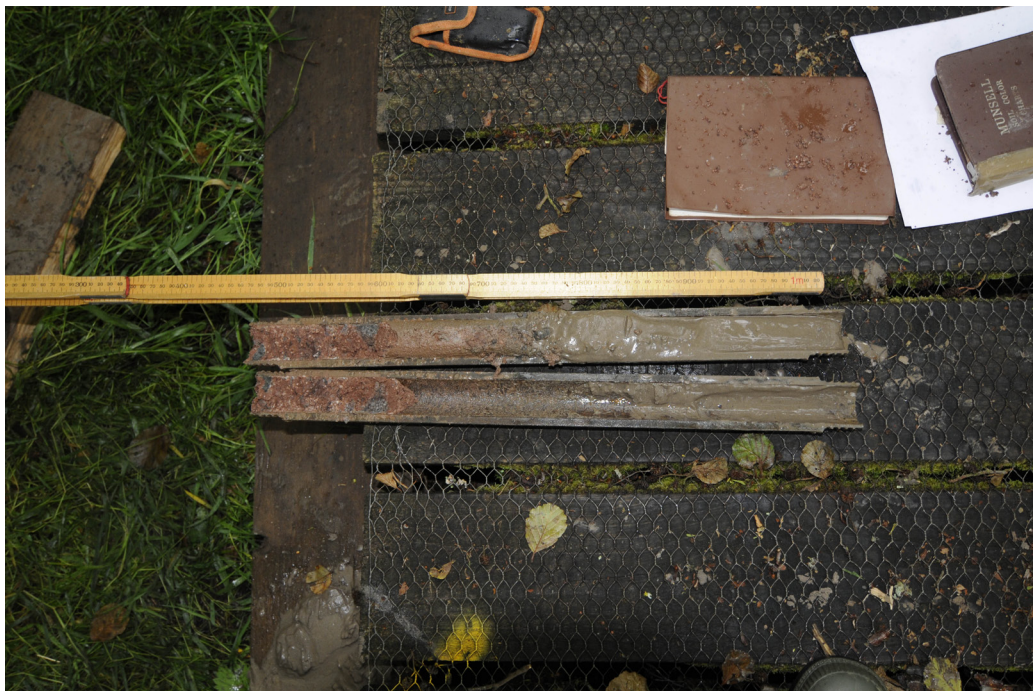
Unit 5 (Figs 3 & 7) contained angular and sub-rounded clasts ranging between 4-6mm with occasional large angular fragments. This is interpreted as a weathered Permian age volcanic conglomerate or breccia classified by the British Geological Survey as the Doweel Breccia Formation of Permian Age (299-251mya).

Fig. 7 - Fractured bedrock exposed in the SPT sampler barrel at -3.6m
