Minor Archaeological Services Call-Off Contract Dundonald Castle, South Ayrshire (PIC194)

Floodlighting Removal, Watching Brief, August 2018 Report No. HES-PIC194-2018-02

Floodlighting Removal Watching Brief, August 2018

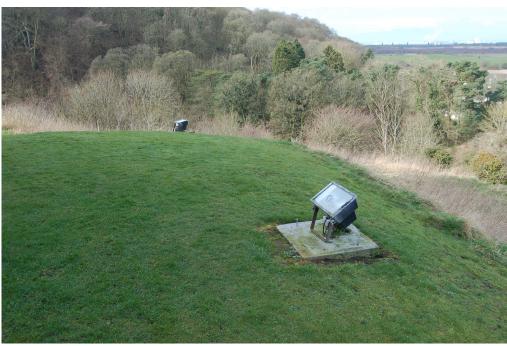
Fig. 2 - Pre Excavation of Floodlighting

Floodlights 1-6 and 11 were all outwith the barmkin wall, with 7-10 on the interior of the castle (Fig. 1). The floodlights were bolted to concrete slabs (Fig. 2). The cables were not contained within ducting.

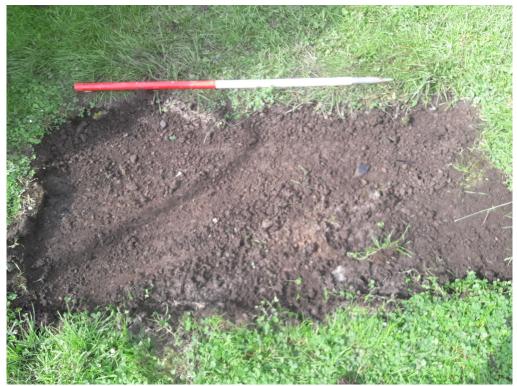
Fig. 3 - Plan of Floodlight base 9/10

The excavation at each location measured generally no more than 0.6m by 0.6m in size (Fig. 4-5), apart from the combined area of bases 9 and 10 (Fig. 3) which measured 1.5m by 1m, and they were all no more than 0.2m in depth.

The watching brief on the floodlight bases outwith the castle and base 9/10 within the barmkin wall revealed turf and topsoil only (001). Loose stone within a silty deposit (002) was noted below the topsoil within bases 1-4.
