## Water Main Access, High Street Perth

Archaeological Watching Brief  
Report No. 3805

**Water Main Access,  
High Street, Perth  
Archaeological Watching Brief**

**Report No. 3805**

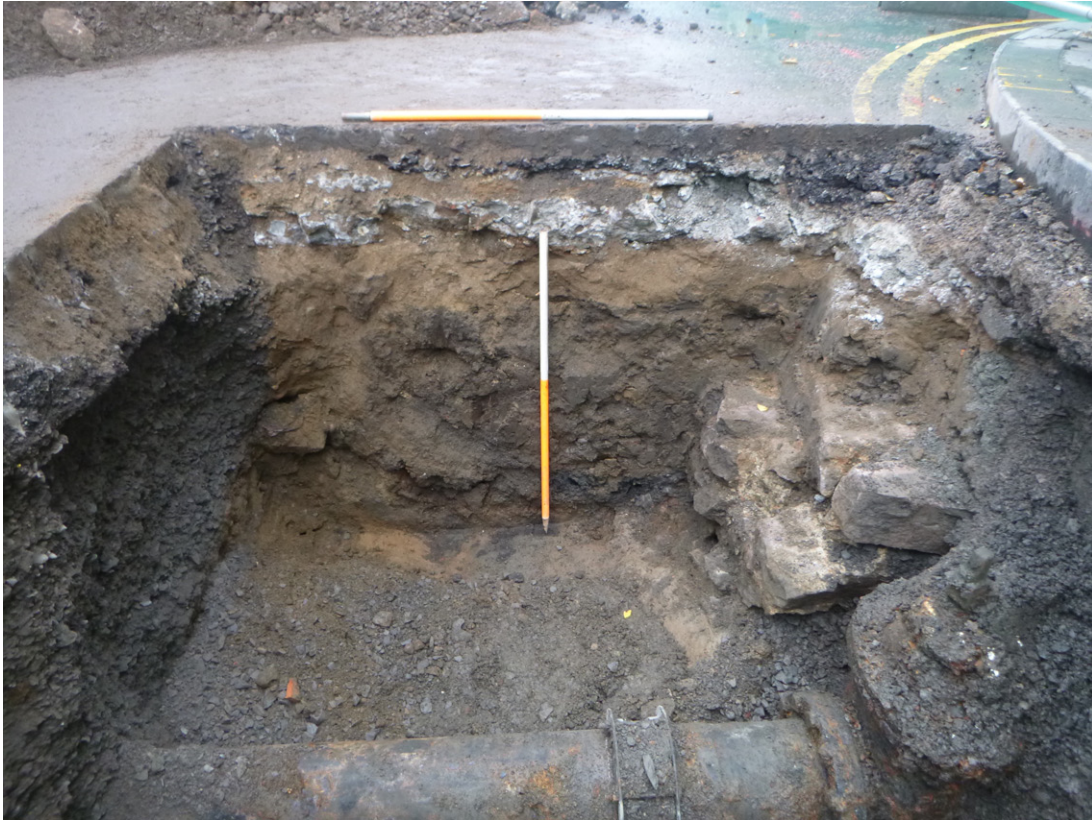
Fig. 2 - West-facing section of Trench 1 showing surviving deposits

The tarmac street surface (**001**) lay 0.54m thick atop a modern sealing deposit of light yellow sand (**002**) measuring up to 0.28m deep. The underlying profile was almost entirely truncated by disused and modern services, a cut for which extended for 1.1m of depth (**005**). This was cut into a layer of made ground (**006**) confined to the SE corner of the trench where it lay 0.85m deep, comprising mixed sandy silt with ash and charcoal inclusions (Fig. 2).

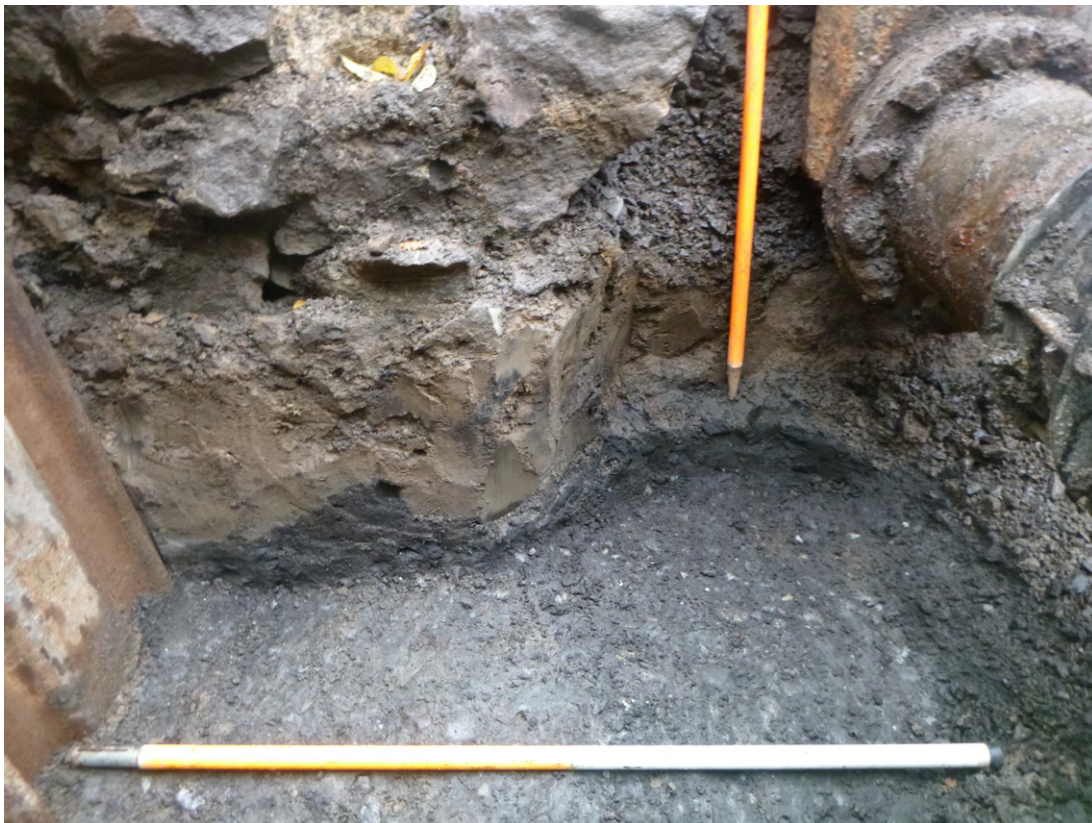
Fig. 3 - North-facing section of deposits (008-009) overlying metallised surface

A stone wall (**007**) underlying the made ground extended 0.9m from the SE corner of the trench, aligned E-W and cut by the water main. Three courses of bonded stone blocks were exposed at 0.5m width, with concrete mortar and a rubble foundation. This overlay a 0.2m deposit of light grey sand, undisturbed by services (**008**). A 0.14m layer of dark sandy-silt refuse (**009**) lay beneath. These two lowermost contexts extended across the trench, underlying the existing services to a total depth of 1.7m. To the SE, a metalled surface of rounded cobbles (**010**) was partially exposed that likely continues throughout the trench yet lay beneath the desired depth for the remainder of the area (Fig. 3).
