Spencerfield, Inverkeithing, Fife

Archaeological Evaluation Report No. 3810

Archaeological Evaluation

Report No. 3810

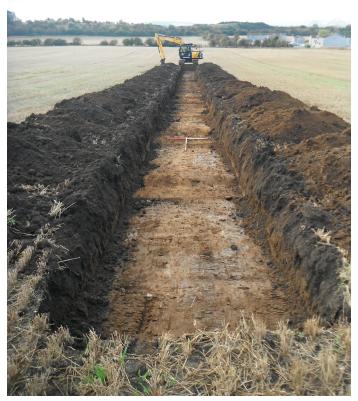
Fig. 4 - Trench 36 general view

The trenches were excavated by machine under direct archaeological supervision to remove topsoil and other soil deposits down to natural subsoil or the first significant archaeological horizon, whichever was reached first. Topsoil and subsoil were bunded separately on either side of the trench (Fig. 4).

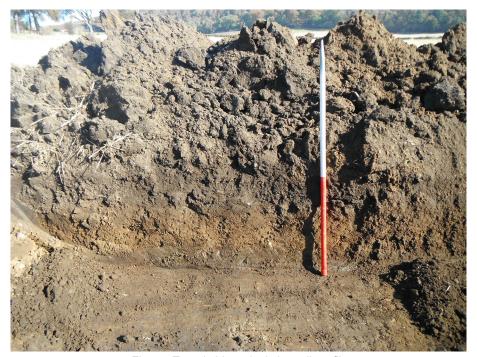
Fig. 5 - Trench 20, typical site soil profile

In general, the evaluation revealed that topsoil (**001**) with a depth of 0.3m overlay an agricultural subsoil (**002**) with a depth of 0.1m to 0.3m (Fig. 5). In several places however, no subsoil was present and topsoil overlay the natural. The natural subsoil (**003**) was very varied, with clay or boulder clay in the northern and southern parts of the site and more sandy silt and clay with stones in the central part of the site.

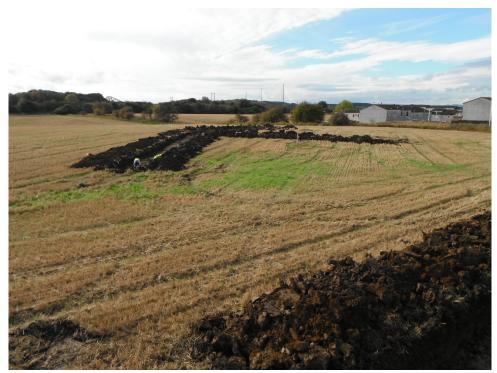
Fig. 6 - Trench 41, (located over DBA Site 3) from the North-East

This site was situated on a low knoll was evaluated in Trench 41 (Fig. 6). The centre point provided for the site (NT 13930 82766) lies only c.2m within the development site boundary and Trench 41 was centred on that point.

Over most of the trench, topsoil (001) overlay natural subsoil (003). Field drains and furrows (4101) were present. Two features which might relate to the Barrage Balloon installation were recorded.

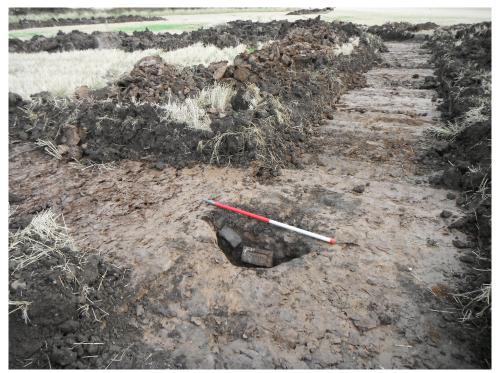
Fig. 7 - Trench 41, Pit 4103, West facing section

In the West end of the trench, a pit (4103) was exposed. Pit 4103 (Fig. 7) was subsquare in plan and around 1m in across by 0.3m deep. It was filled with backfilled deposits of clay, soil and angular volcanic rocks(4104). Fragments of glazed ceramic and window glass were present as were three WEMYSS bricks. These were partly painted white and had numbers 9, 20 and 23 stencilled in red on the headers.

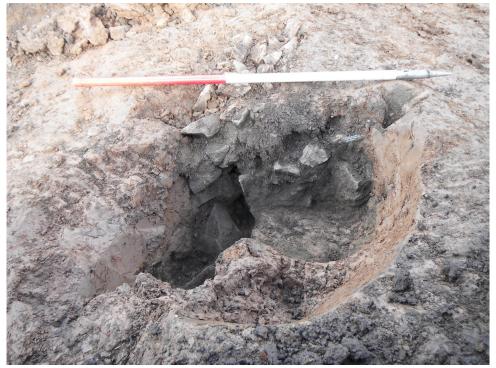
Fig. 8 - Trench 41, Pit 4105, cutting drain 4108, South-East facing section

In the East end of the trench, a second pit feature (Fig. 8) was recorded. This feature (4105) cut a stone-filled field drain (4108) and was oval in plan, measuring 0.6m NE-SW by 0.45m by 0.35m deep. It was filled with soil and angular volcanic rocks (4106) overlying a brownish sand, also with angular volcanic rocks (4107). No finds were recovered.

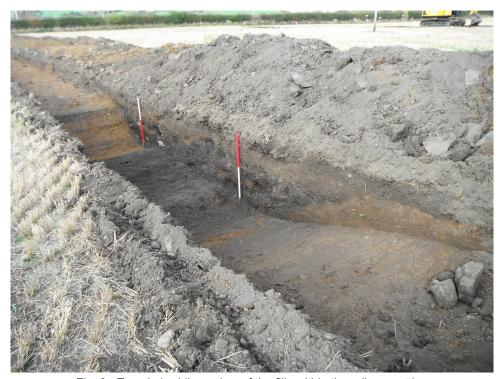
Fig. 9 - Trench 1, oblique view of the fills within the railway cutting (DBA Site 4) from the South

The railway alignment was crossed by Trenches 1, 2, 51 and 52. Trench 1 (Figs. 1, 9) revealed that the railway cutting (101) was 7.5m in width and 0.9m in depth. In the base was a deposit of cinders and blocks of cinder/iron concretion (103) which may have been *in-situ* track bed material. This was overlain by deposits of a similar material mixed with orange-brown soil (102). The upper fill was an orangey brown clayey silt (104) similar to the agricultural subsoil. Modern bricks stamped METHIL and BLAIRADAM (made in Kelty) were recovered from the fills. The alignment of the railway looking WSW from Trench 52 is shown in Fig. 10.

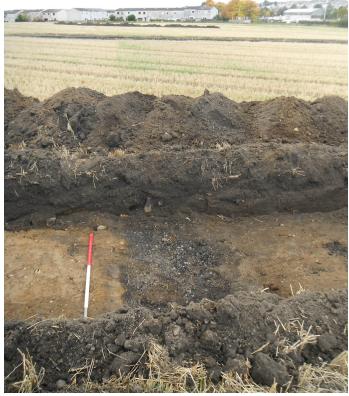
Fig. 10 - Trench 52, view WSW along the line of the railway.

In Trench 52 the cutting (5203) was identified and was filled with a deposit of cinders and ash (5204).

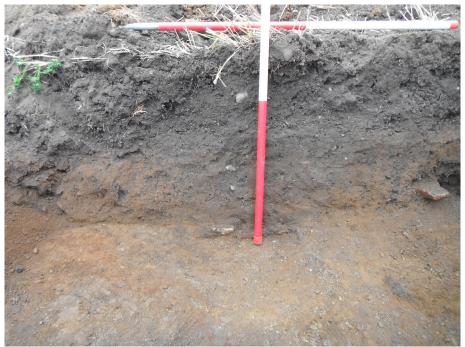
Fig. 11 - Trench 13, Ditch 1301 cutting subsoil 002, ENE facing section

Historic Ordnance Survey maps show that the larger northern field was once subdivided. Shallow ditches which may have formed elements of these divisions were recorded in Trenches 13 and 17. In Trench 13, a ditch (1301) was ENE-WSW aligned, 1m wide and 0.35m deep (Figs. 1, 11). This was excavated through the subsoil (002) and only cut into the natural by 0.05m. It was filled (1302) with a homogeneous dark orange-brown clay-silt with black silty inclusions. No finds were recovered.

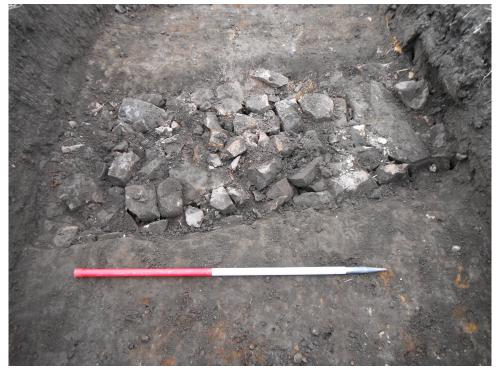
Fig. 12 - Trench 31, culvert 3101 from the WSW

A sandstone box drain was recorded in Trenches 16, 31, 37 and 39. This feature (1603, 3101, 3703, 3901) was aligned NNW-SSE. It measured 0.8m in width. The sides and lintels were of quarried sandstone and above this the cut was filled with angular sandstone rubble (Fig. 12). In Trench 37, the feature (3703) cut one of the furrows (3701).

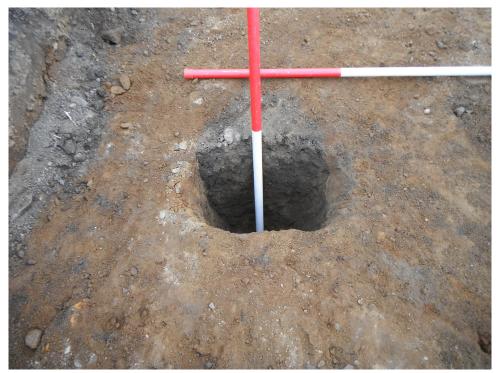
Fig. 13 - Trench 10, post-hole 1003, WSW facing section

In Trench 10, a single possible post-hole (1003) (Figs. 1, 13) was identified. It was sub-oval in plan and measured 0.5m by 0.4m by 0.45m deep. A possible packing deposit of grey clay and small stones (1004) was present around the perimeter of the feature and the centre contained the shadow of a possible post-pipe which was filled with a mixture of grey clay and a yellow sandy clay (1005). No finds were recovered.

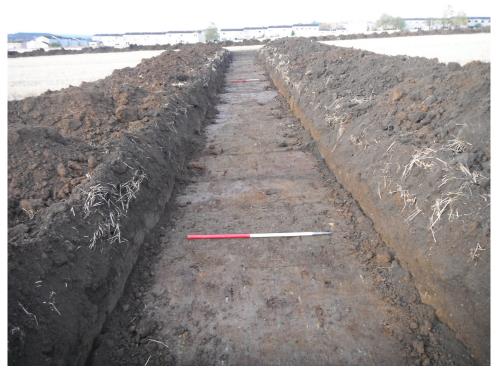
Fig. 14 - Trench 27, rig and furrow

Traces of furrows from Rig & Furrow cultivation were recorded in Trenches 7, 9, 10, 11, 14, 15, 16, 17, 18, 21, 22, 26, 27, 28, 29, 34, 37, 41, 43, 44, 45, 46, 48 and 52. In both fields, these features were aligned between NW-SE and NNW-SSE and the wavelength (centre to centre) was around 12m (Fig. 14). Each furrow was in general between 1m and 2m in width and the excavated sections showed them to be less than 0.1m deep (Fig. 15). No finds were recovered.

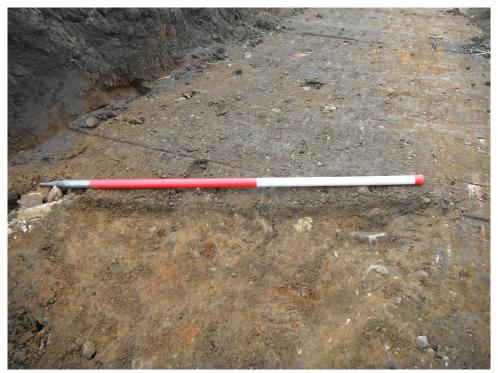
Fig. 15 - Trench 9, furrow 901, SSE facing section
