Killievair Standing Stone, Barrelwell Smithy, Brechin, Angus

Archaeological Investigation and Re-erection
Report No. 3807

Report No. 3807

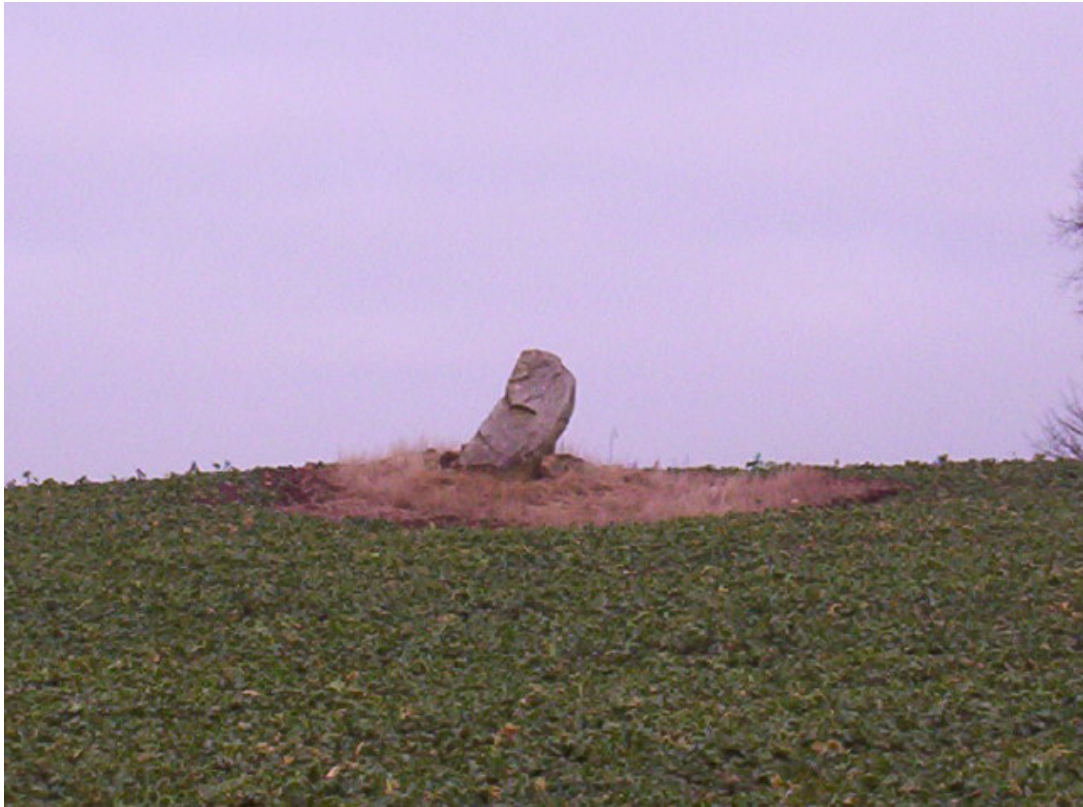
Fig. 3 - Killievair Stone, post-1991 slump, pre-collapse

Photographic records held by NRHE and other readily available sources were consulted prior to fieldwork and used to ascertain the correct orientation of the stone for its re-erection (Fig. 3).

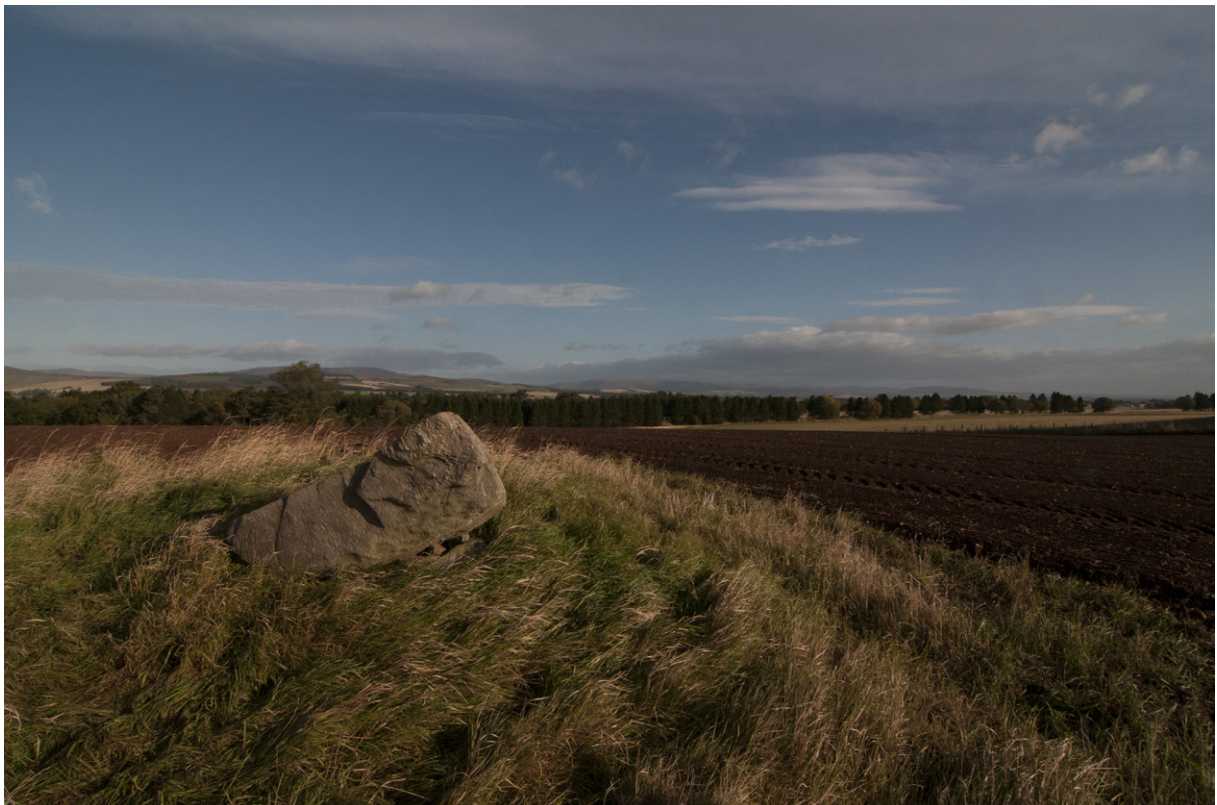
Fig. 4 - Killievair stone in collapsed position

The stone has not been subject to any prior archaeological investigation and its date and origin are unclear. It is depicted on the 1865 edition Ordnance Survey map (Fig 2). In 1991 the stone slumped which gave it a pronounced lean towards the east (Fig 3). More recently it collapsed completely, exposing a shallow socket (Figs 4-5).

After Scheduled Monument Consent for the works had been obtained by the CFA, the prone position of the stone was recorded (Fig. 4-5) and the stone moved under the direction of Stockdale & Lyall. The stone was removed without damage and placed on wooden battens nearby.

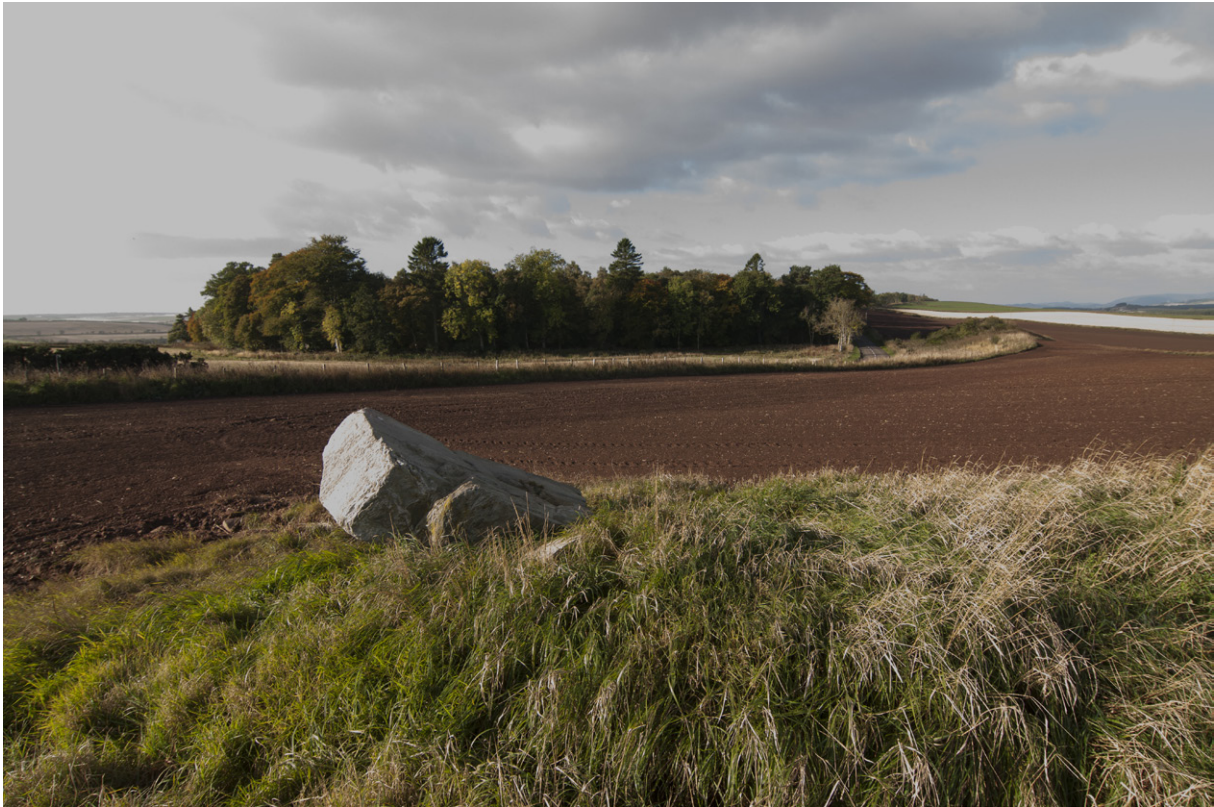
Fig. 5 - Killievair stone in collapsed position

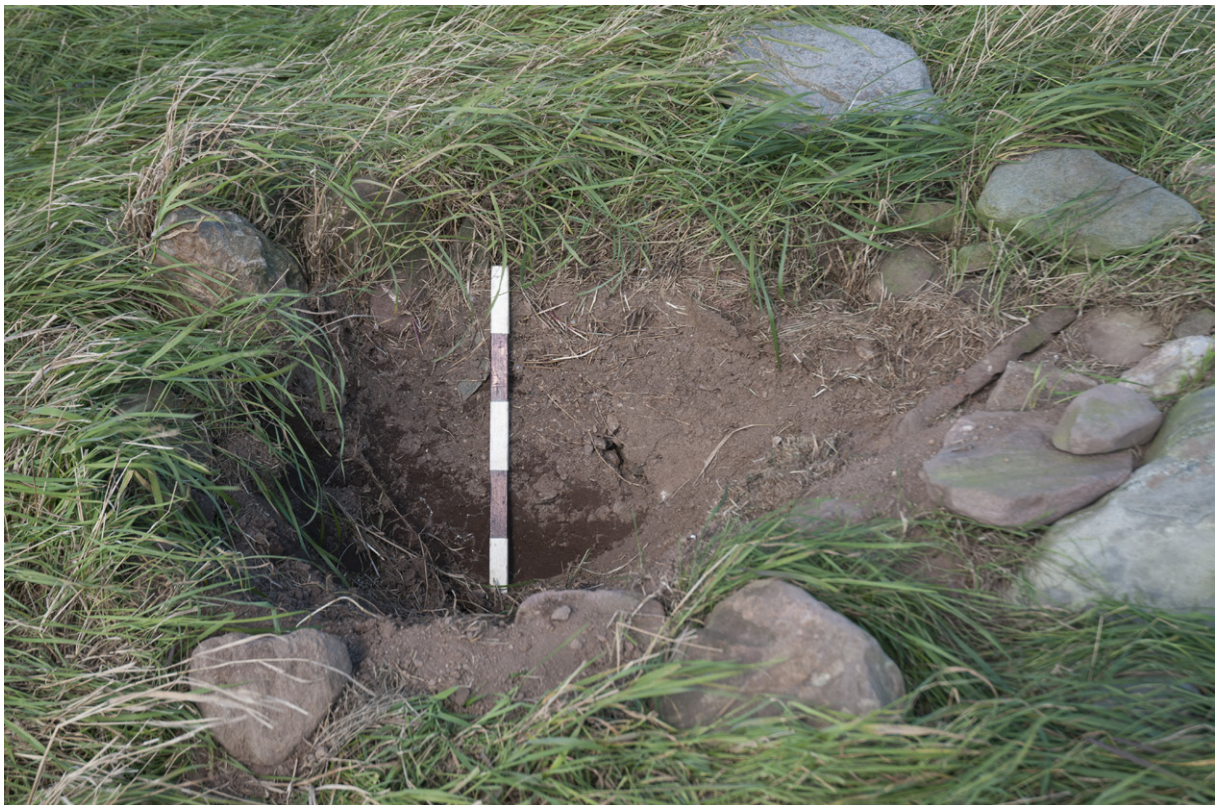
The removal of the collapsed stone revealed a socket measuring 1.1m by 0.9m and 0.6m deep (Fig 6). It had straight, angled sides mirroring the shape of the base of the stone and was entirely within the topsoil deposits.

Fig. 6 - Socket as revealed by collapsed stone

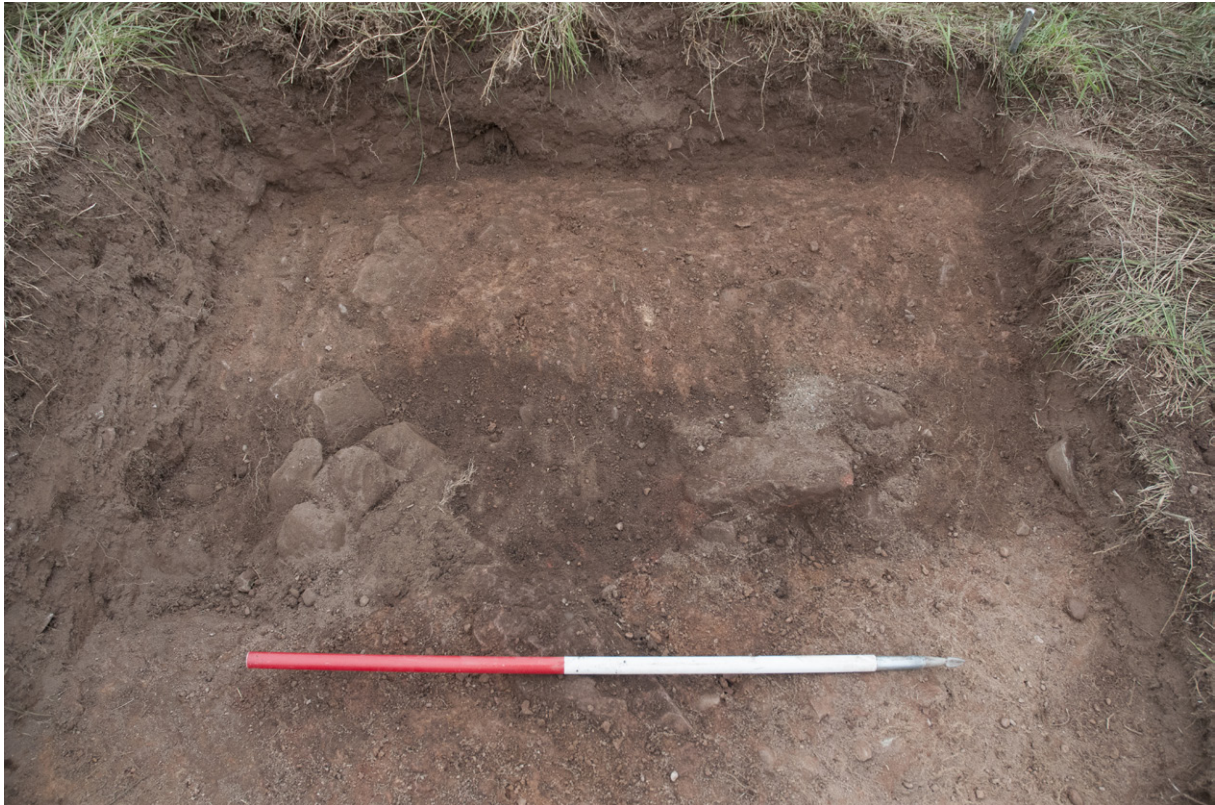
Once fully excavated the cleaned surface of the natural subsoil (000) revealed a linear ditch (003) crossing the trench, running north to south (Fig. 7). The ditch ran in a straight line and was 0.35m to 0.4m wide. In section its cut had steep straight sides and a flat base, and was 0.2m deep (Figs 8-10).

Fig. 7 - Trench showing ditch (003)

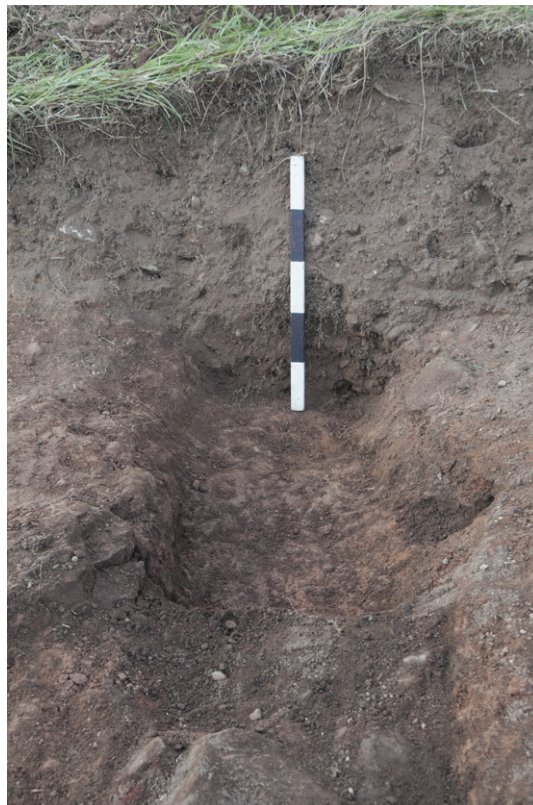
Fig. 8 - Section of ditch (003) and profile of south facing section of the trench showing animal burrows

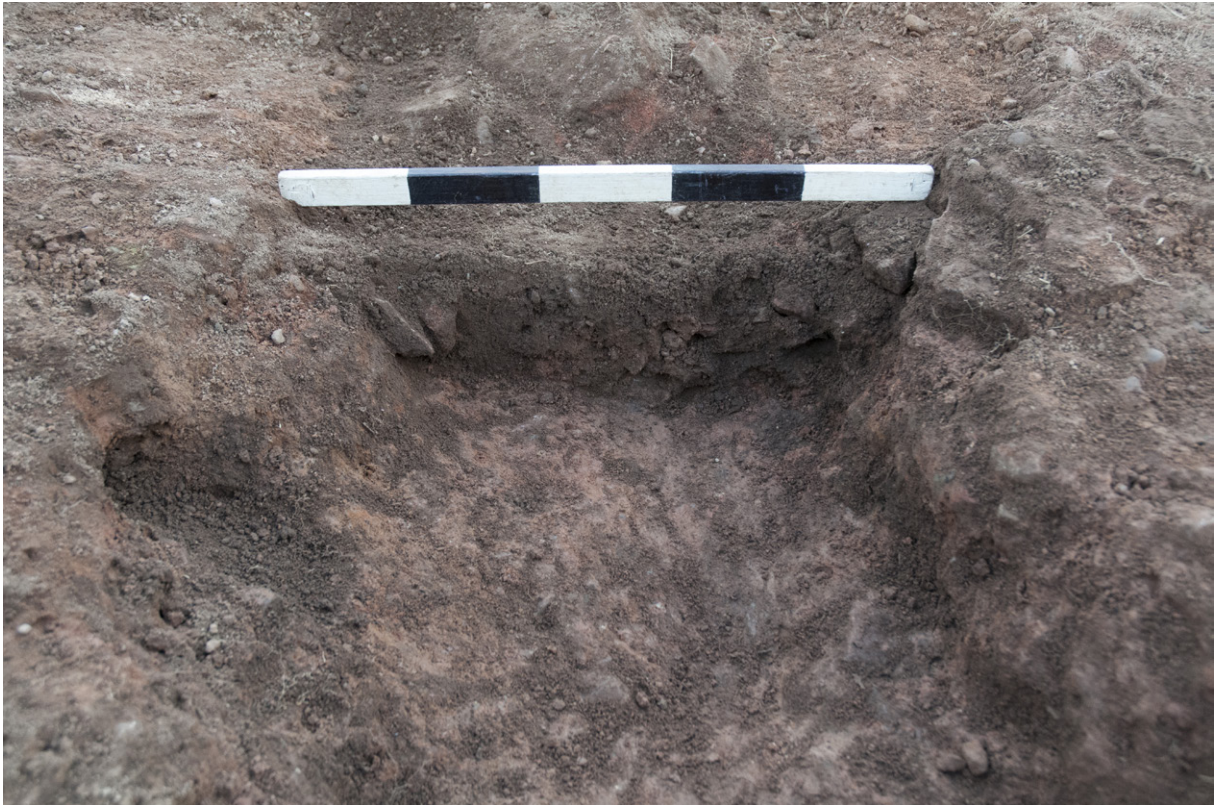
The fill (004) of the ditch was variable and may indicate a setting or socket for the stone, though it seems unlikely. Both ends of the ditch as exposed were filled with mid grey silt which was indistinguishable from the subsoil. The central part of the fill had slightly darker grey silt which contained few small stones. Differences in colour and texture within the fill were however minimal; extensive burrowing by rodents was evident and had diffused any horizons which may have existed. Furthermore, the darker central area contained a high concentration of millipedes which were absent from the paler grey soil at the ends. A concentration of sub-angular stones was contained within the fill, mostly situated around the edges of the darker central part, although these were floating within the fill rather than set into the edges or base of the cut.

Fig. 9 - Section through centre of ditch (003) showing fill (004) and animal burrow in the left edge of the cut

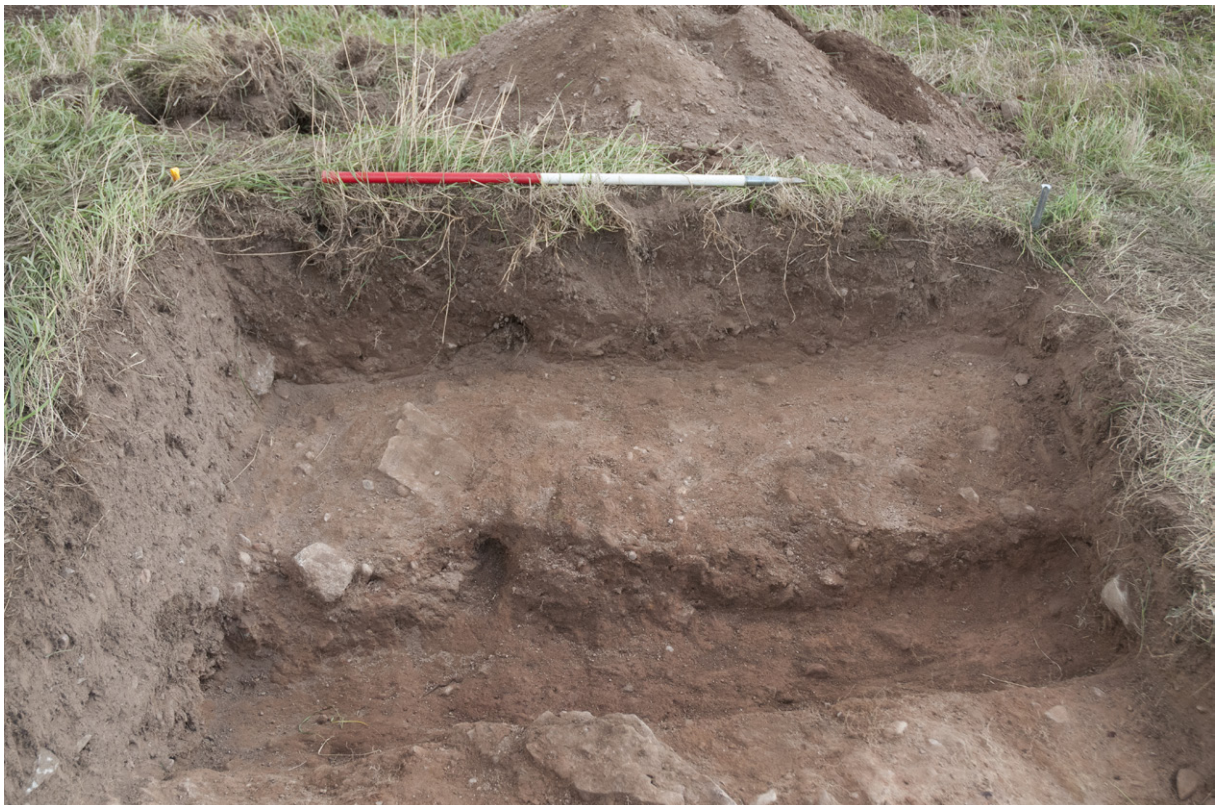
Fig. 10 - Fully excavated ditch (003)

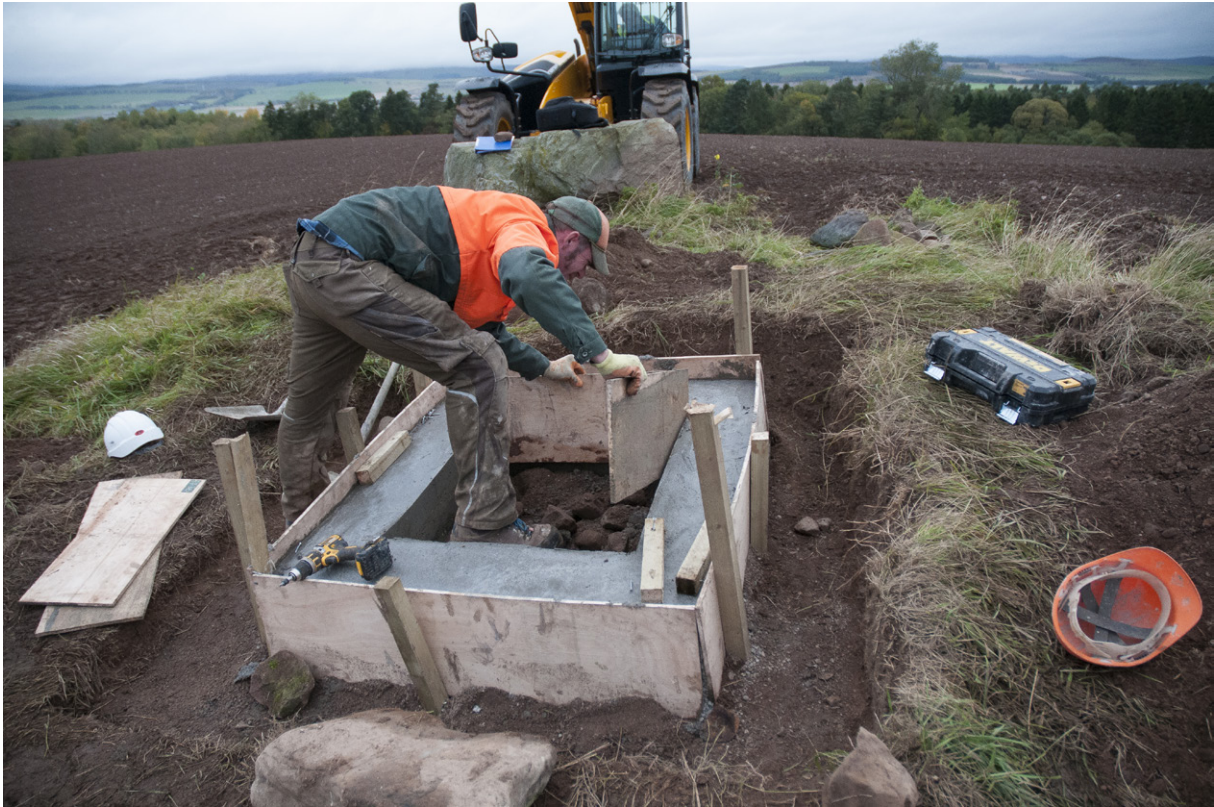
Fig. 11 - Formwork for the new stone socket

The socket was shuttered and a ring of concrete was poured to create a socket into which the stone could be received and then packed with stone to make it rigid but to still allow drainage into the subsoil without compromising the fabric of the stone itself.

The reinforced concrete socket was poured to create a secure setting into which the stone could be re-instated (Fig. 11), and then packed with stone and slow-setting limecrete to hold the stone in place but allow drainage into the ditch and subsoil without compromising the fabric of the stone itself.

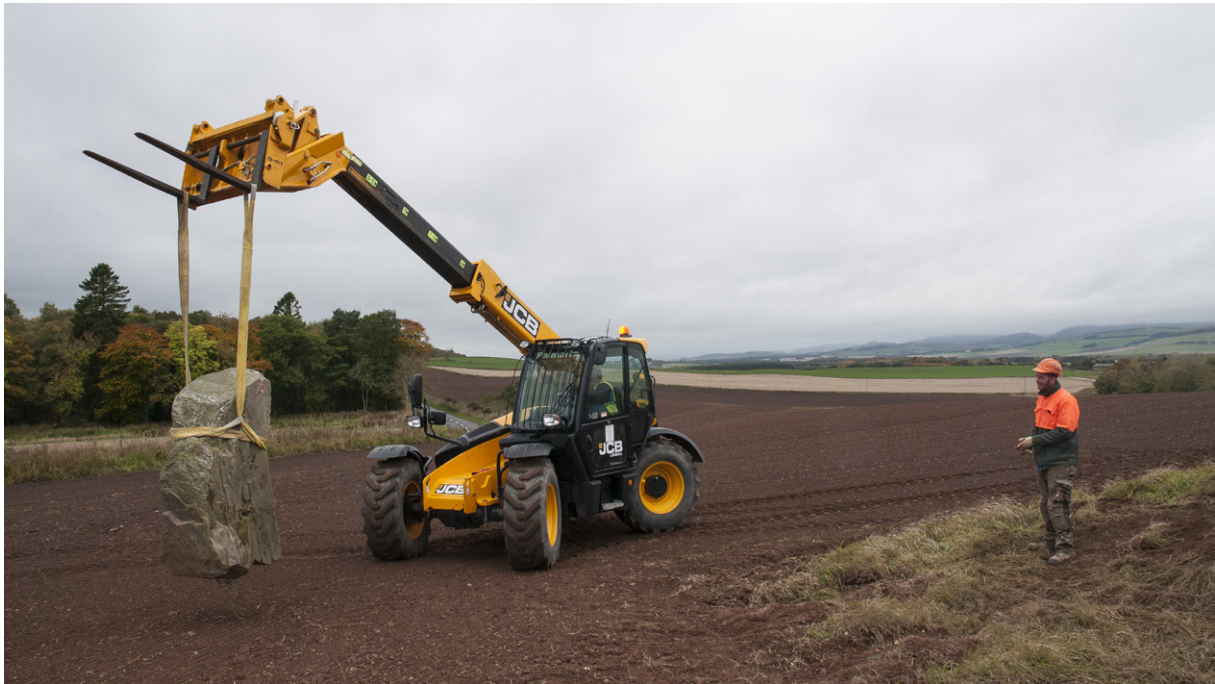
Fig. 12 - Lifting the stone into position

The stone was lifted into a vertical position using a telehandler with appropriate straps and lowered into the excavated socket. The stone was held in place by the machine before packing it firmly using slow-setting limecrete and stones recovered from the contexts immediately surrounding the stone's original location.

The stone was lifted into a vertical position using telehandlers with appropriate straps and lowered into the excavated socket (Fig. 12). The stone was held in place by the machine before packing and fixing with limecrete (Fig. 13-14).

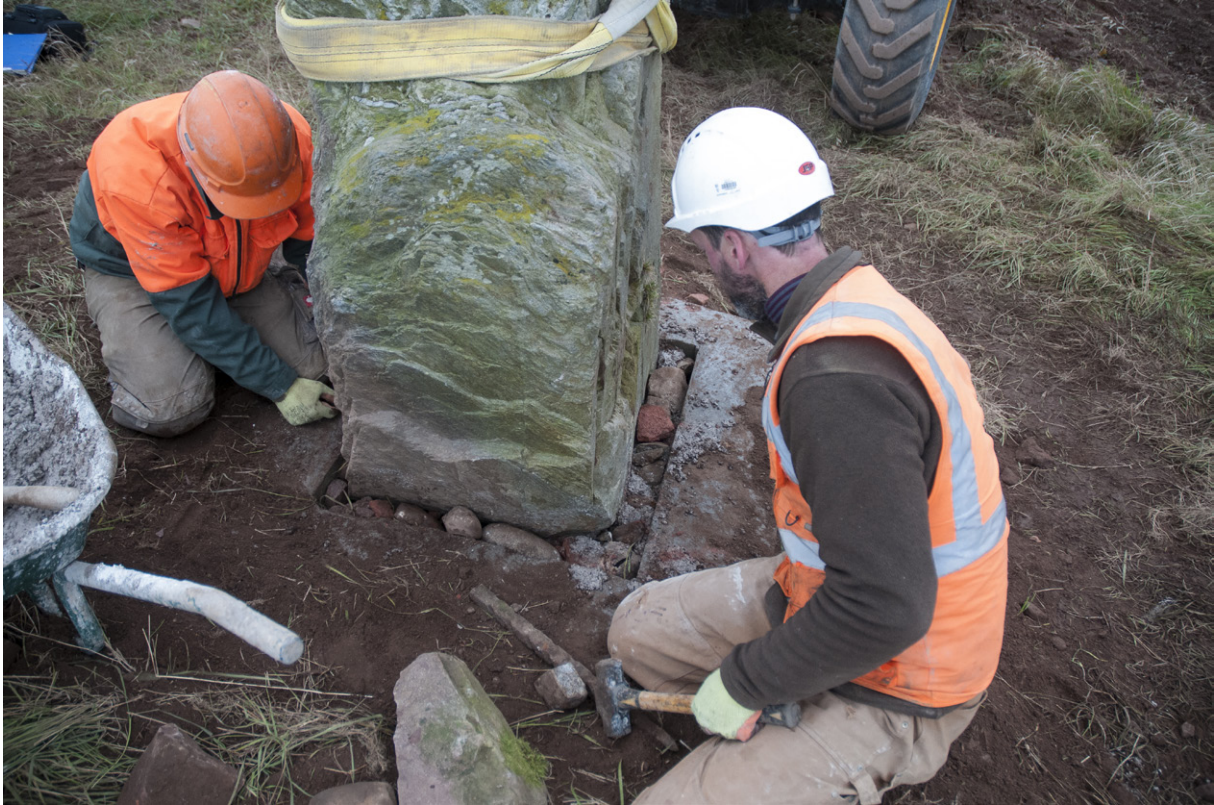
Fig. 13 - Packing the base of the stone

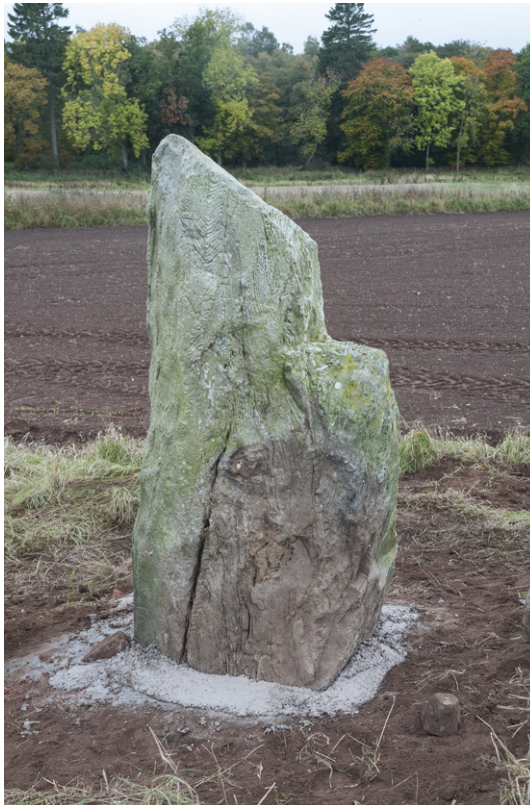
Fig. 14 - Killievair stone in new setting prior to reinstatement of ground surface

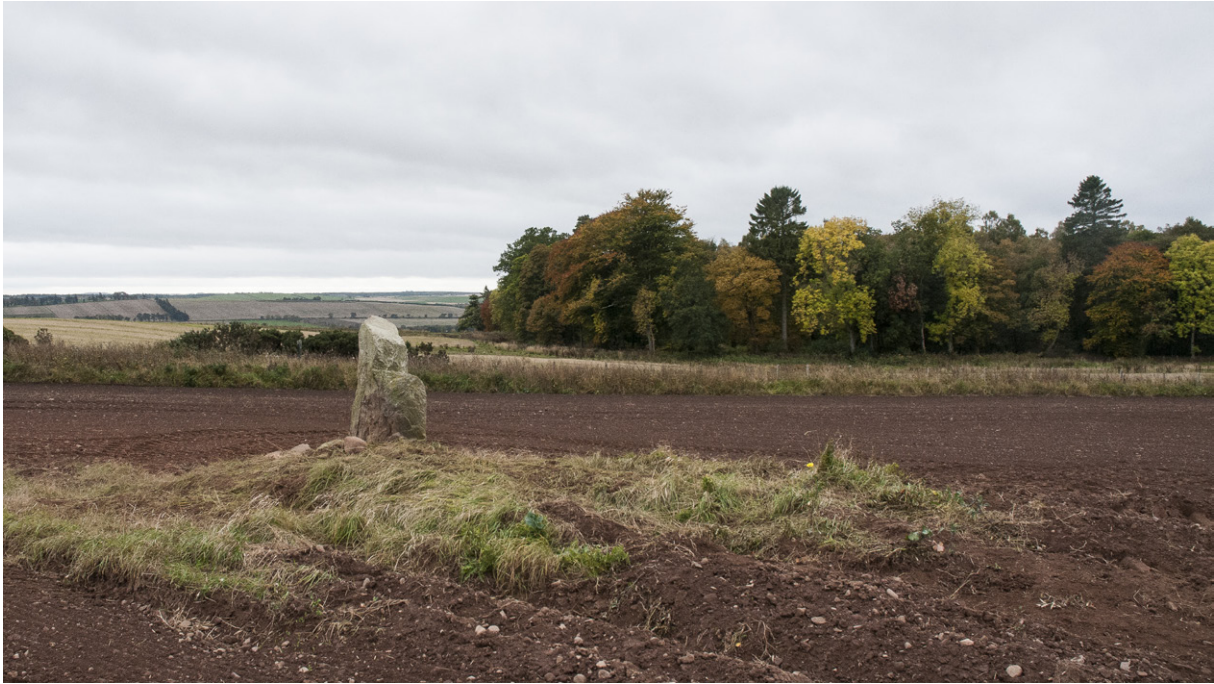
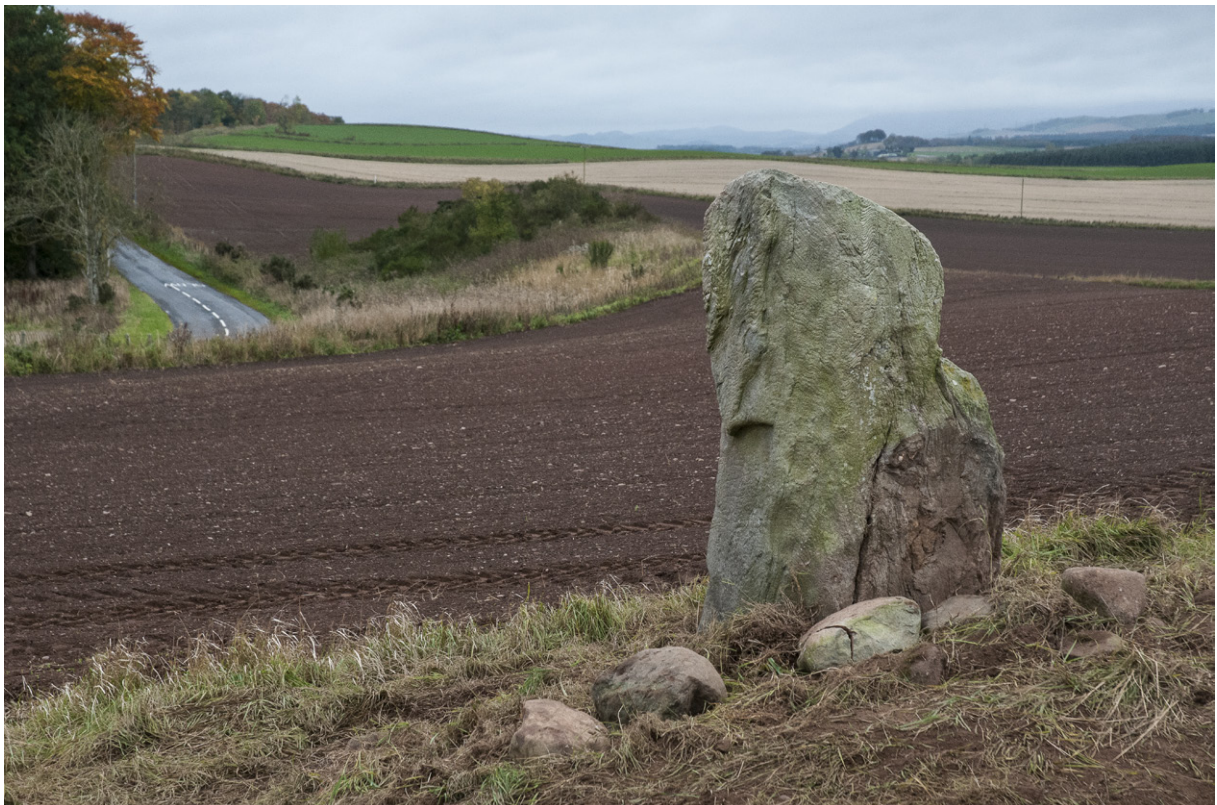
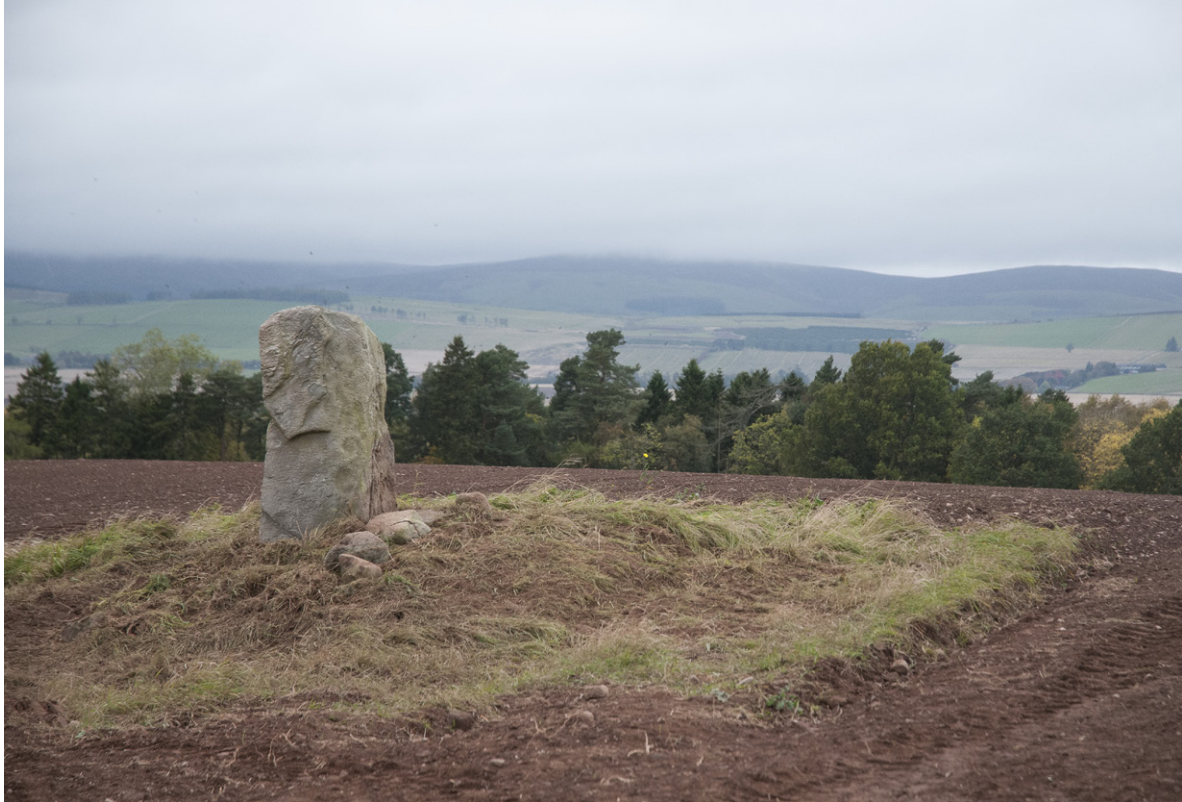
Fig. 15 - Killievair stone fully re-erected

Fig. 16 - Killievair stone fully re-erected

Fig. 17 - Killievair stone fully re-erected

The trench was backfilled on completion of excavation with as dug material, and the site left in a tidy condition (Fig. 15-17). It is anticipated that a single winter and growing season will settle the topsoil and re-establish ground cover which will mask any visual sign of the work.
