## Minor Archaeological Services Call-Off Contract St Andrews Cathedral, Fife (PIC035)

Floodlighting Installation, Watching Brief,  
November 2018

Report No. [HES-PIC035-2018-02](#)

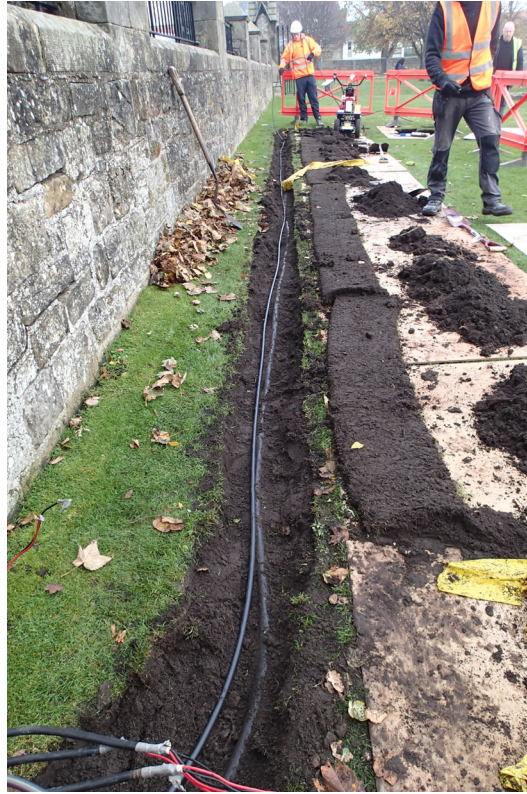
A total of around 350m of cable trench and 15 light plinths were excavated. The cable lay between 0.1m-0.15m deep in the ground and lay entirely within dark brown topsoil. The previous trench was only 0.1m wide, with metal mesh being laid atop the cable and then yellow warning tape (Fig. 2-4). This enabled the workers to follow the old cable route exactly and so no new ground was ever broken along the cable trench. The trench was backfilled and re-turfed following the laying of the cable.

Fig. 2 - General shot of cable trench along the western boundary wall

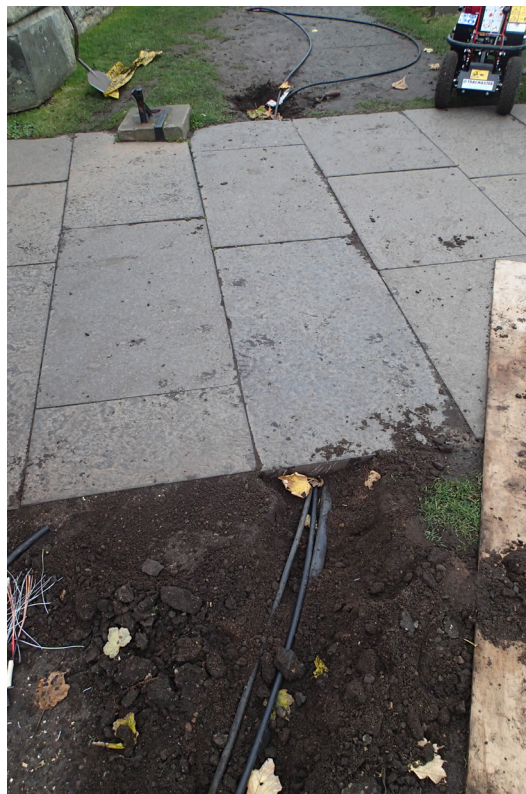
Fig. 3 - Cable being pulled beneath slabs at W entrance

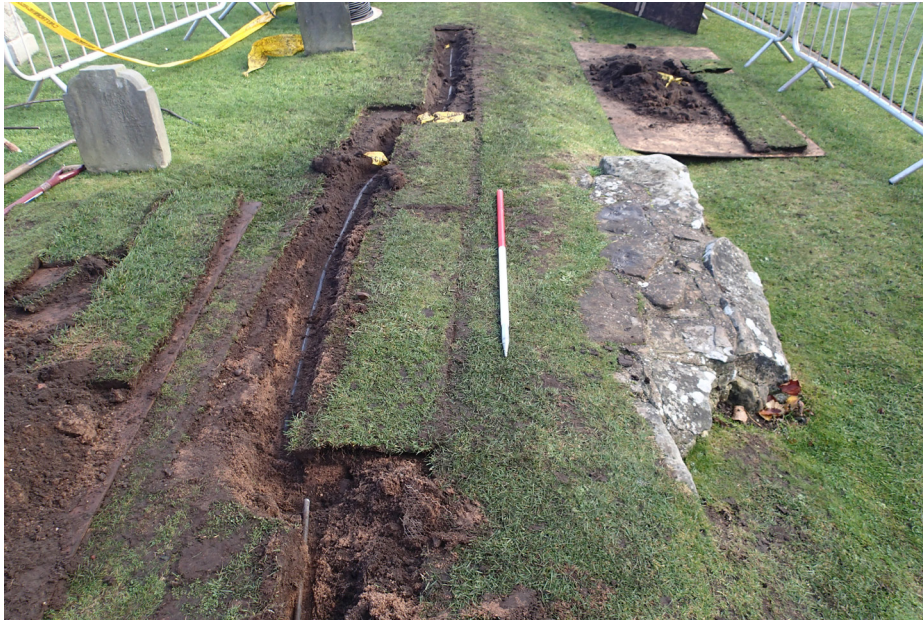
Fig. 4 - Cable trench being diverted around foundations at north side of Cathedral

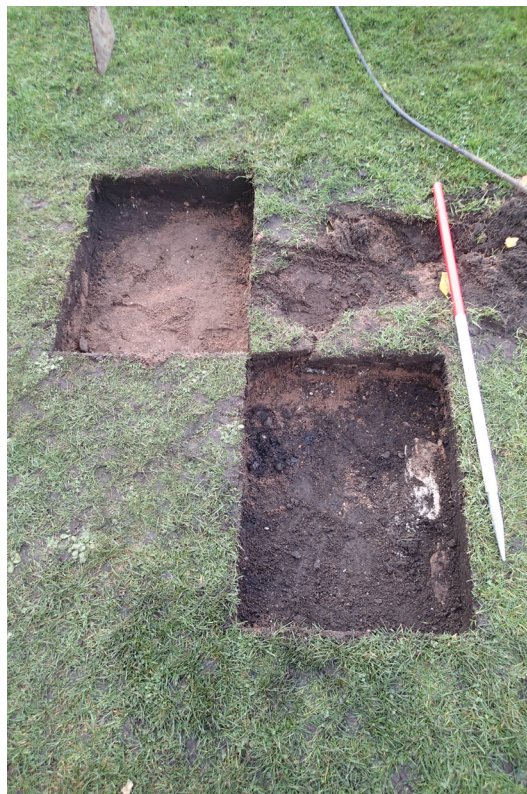
In total there were 15 light plinths, each measuring 0.7m x 0.52m x 0.1m, which were placed as best as possible at the location of the previous lights. Due to this a small area at each plinth broke new ground (Fig. 5).

Fig. 5 - Plinths for lights 1 and 2 at SW corner of Cathedral

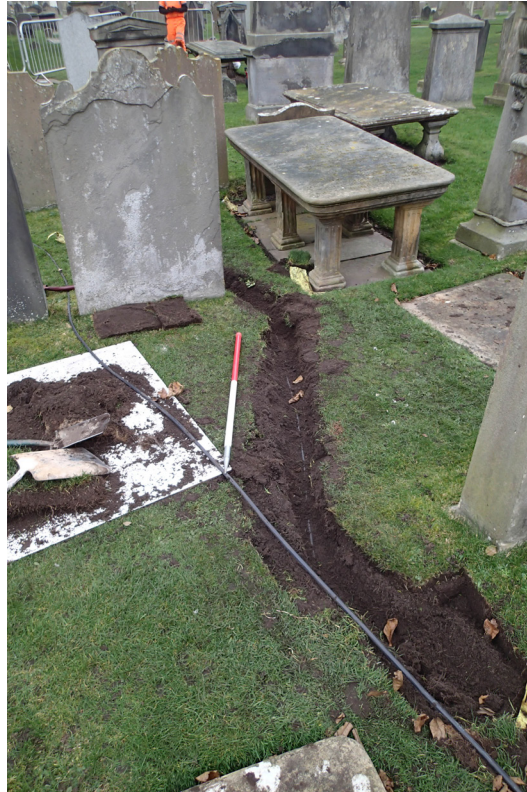
The cable trench was laid between graves within parts of the graveyard (Fig. 6). A small quantity of unstratified human bone was recovered from the topsoil during the watching brief. This was collected and buried all together on site on completion of all the works, in the centre of the area excavated for light plinth 12, where it would be sealed securely beneath the plinth (Fig. 7). No in situ graves were disturbed during the work.

Fig. 6 - General shot showing cable trench weaving between graves at SE corner of St Rules Tower

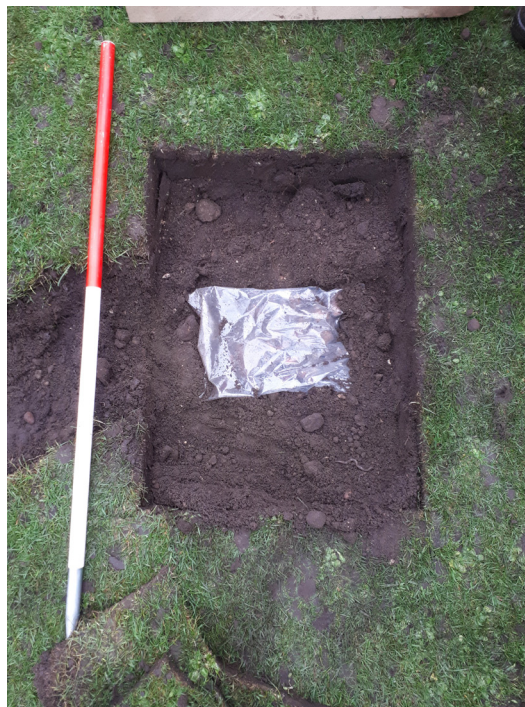
Fig. 7 - Human bone collected during duration of job reburied beneath plinth for light 12

Previously disturbed human remains were found within the cable trench. These were collected and reburied underneath the plinth for light 12. This was to minimise possible future disturbance should any further works occur regarding the floodlighting.
