**Bonnington Mill,  
70-72 Newhaven Road.  
Desk Based Assessment  
and Standing Building Assessment**

**Report No.3357**

Author	Michael Cressey BA MSc PhD MifA FSA Scot
Illustrator	Shelly Werner MA PhD
Editor	Bruce Glendinning BSc Pg Dip MifA
Commissioned by	Queensberry Properties Ltd
Date issued	May 2017
Version	1
NGR:	NT 2603 7603

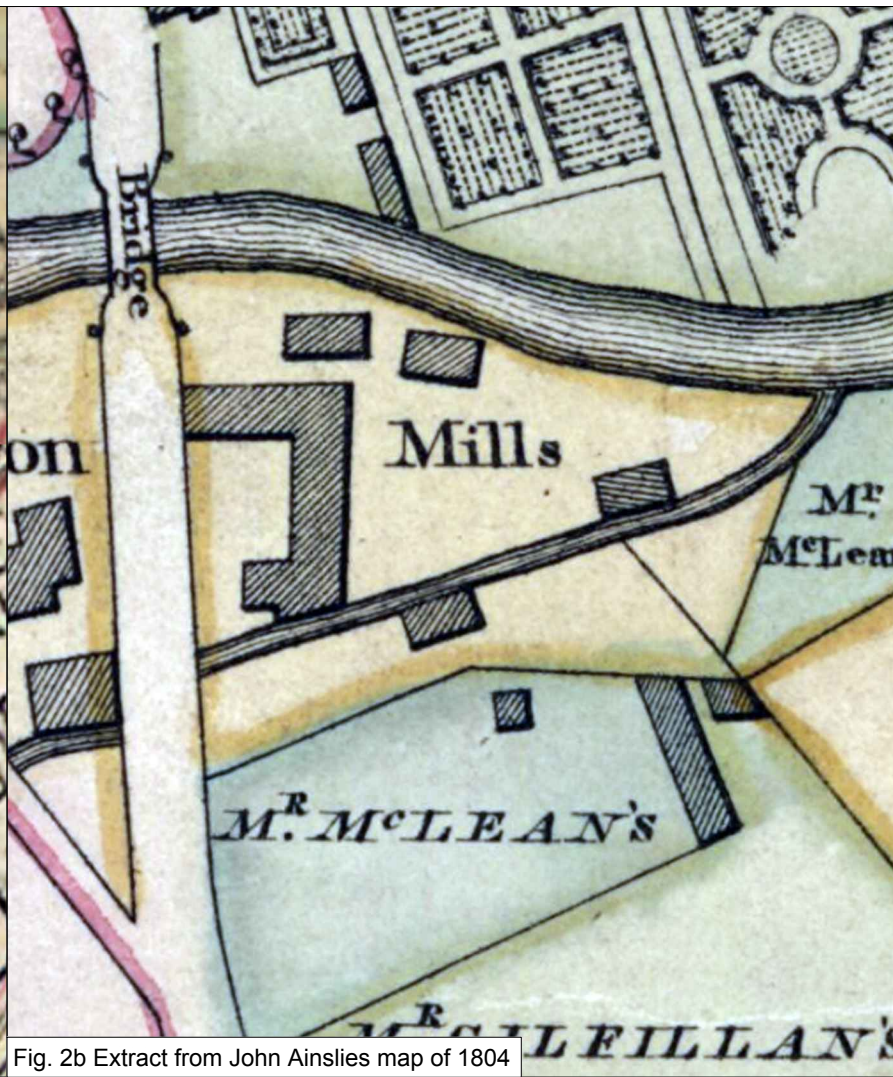
John Ainslie's map of 1804 (Fig 2b) first names the site as Bonnington Mills. The study area was part of a much larger holding under the ownership of a family named Cunningham. Bonnington Bridge is shown crossing the Water of Leith. The mill complex is shown on either side of what would become Newhaven Road. Within the study area, on the east side of the road, five buildings are depicted. The largest is an inverted L-shaped building and the rest are rectangular. A mill lead running west to east through the site from the Water of Leith is also depicted.

Fig. 2b Extract from John Ainslies map of 1804

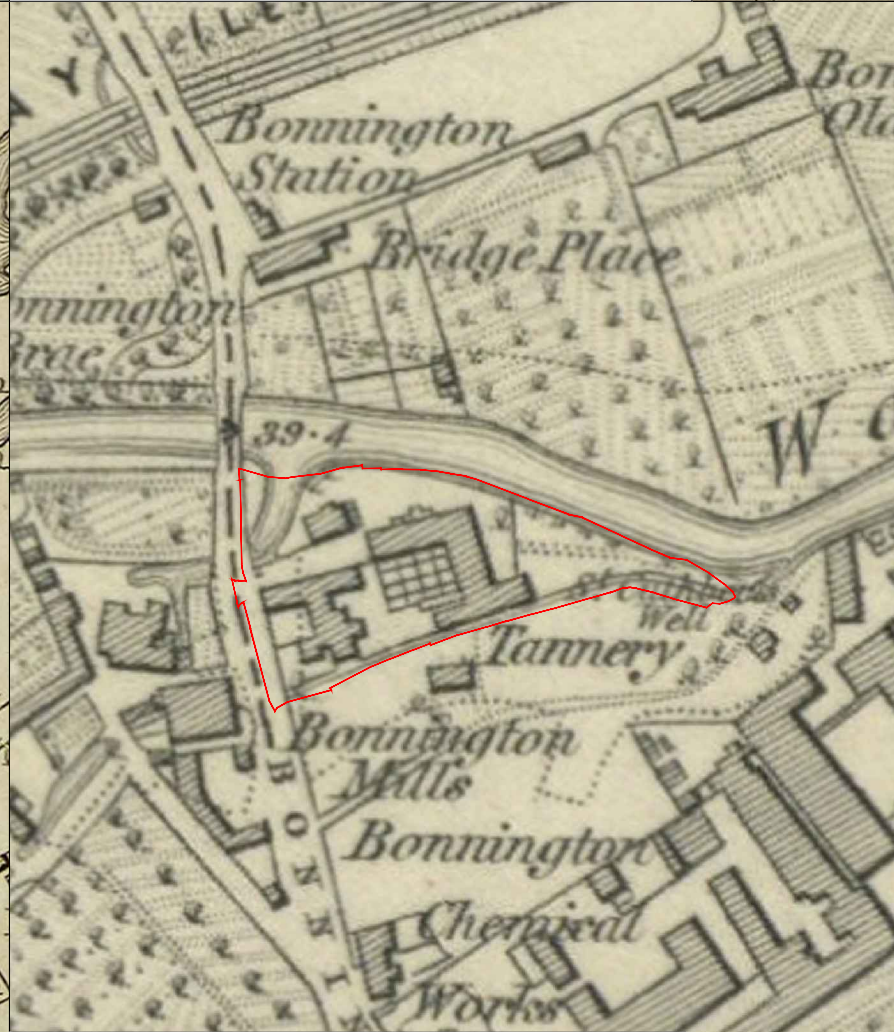
The First Edition 1852 Ordnance Survey map (Fig 2f) shows that the site was extensively developed as Bonnington Mills on the north side of the mill lead. Within the proposed development boundary the largest building on the site was part of the tannery complex built around a grid of tanning pits. A single square building (Building A) was present with what appears to be an external staircase on its north side. Further west was a corn and flour mill with a granary building. A T-shaped building was present on its west side adjoining Newhaven Road. The footprint of this building may be associated with Building D and G which are more or less on the same alignment.

Fig. 2f Extract from 1852 First Edition Ordnance Survey map

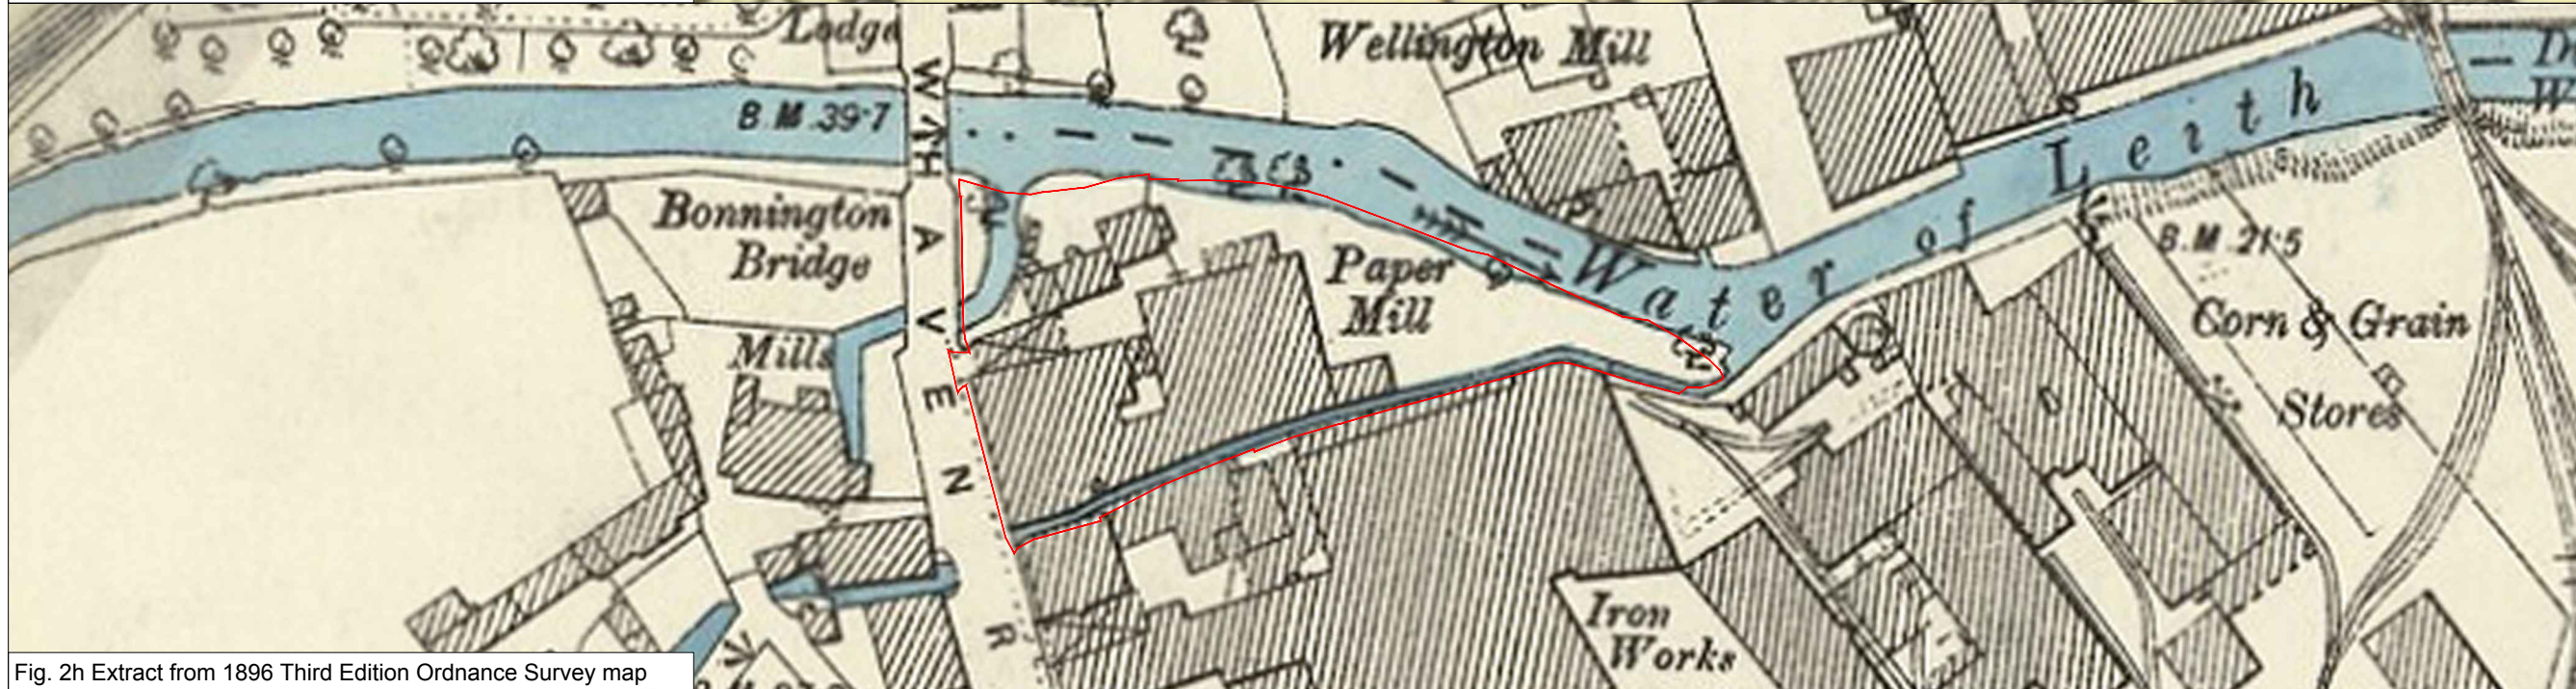
The Third Edition 1896 Ordnance Survey map (Fig 2h) shows an increase in buildings that are now depicted in block-layout. The courtyard at the centre of the complex has been altered slightly. The lead is still extant. The buildings on the north side of the main complex appear to be the same.

Fig. 2h Extract from 1896 Third Edition Ordnance Survey map

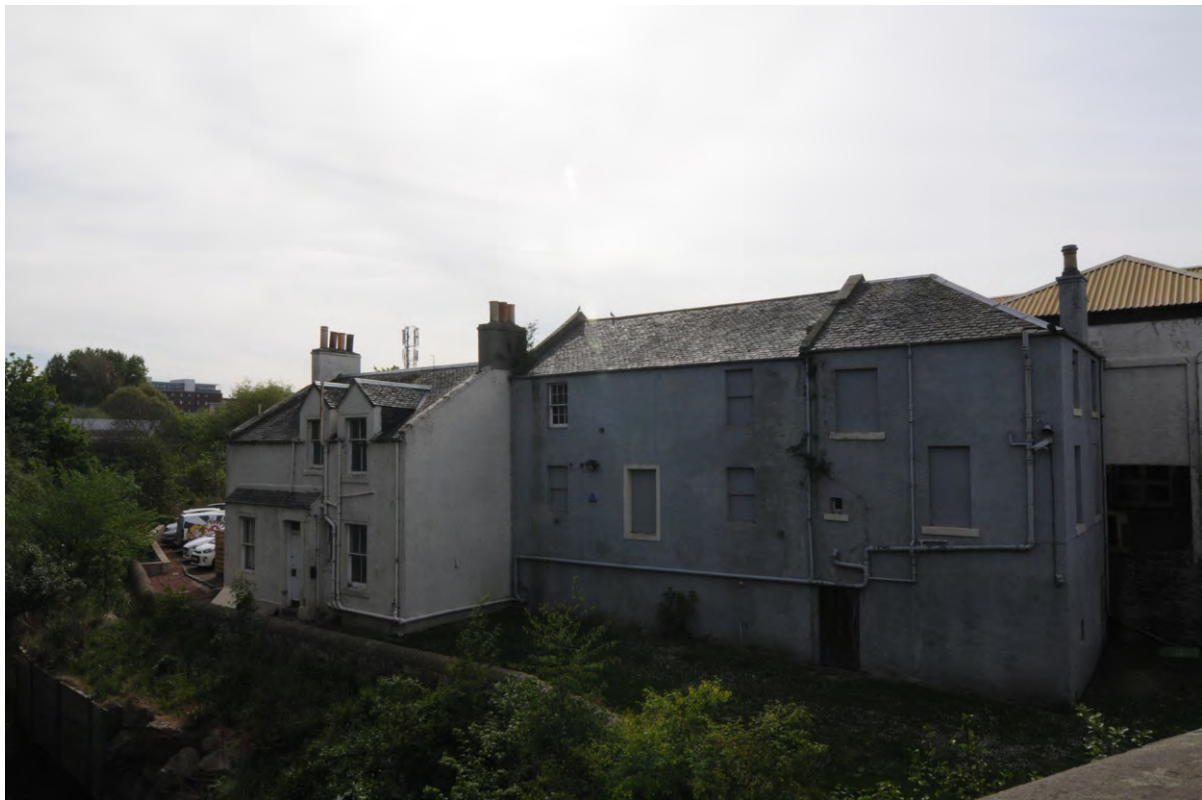
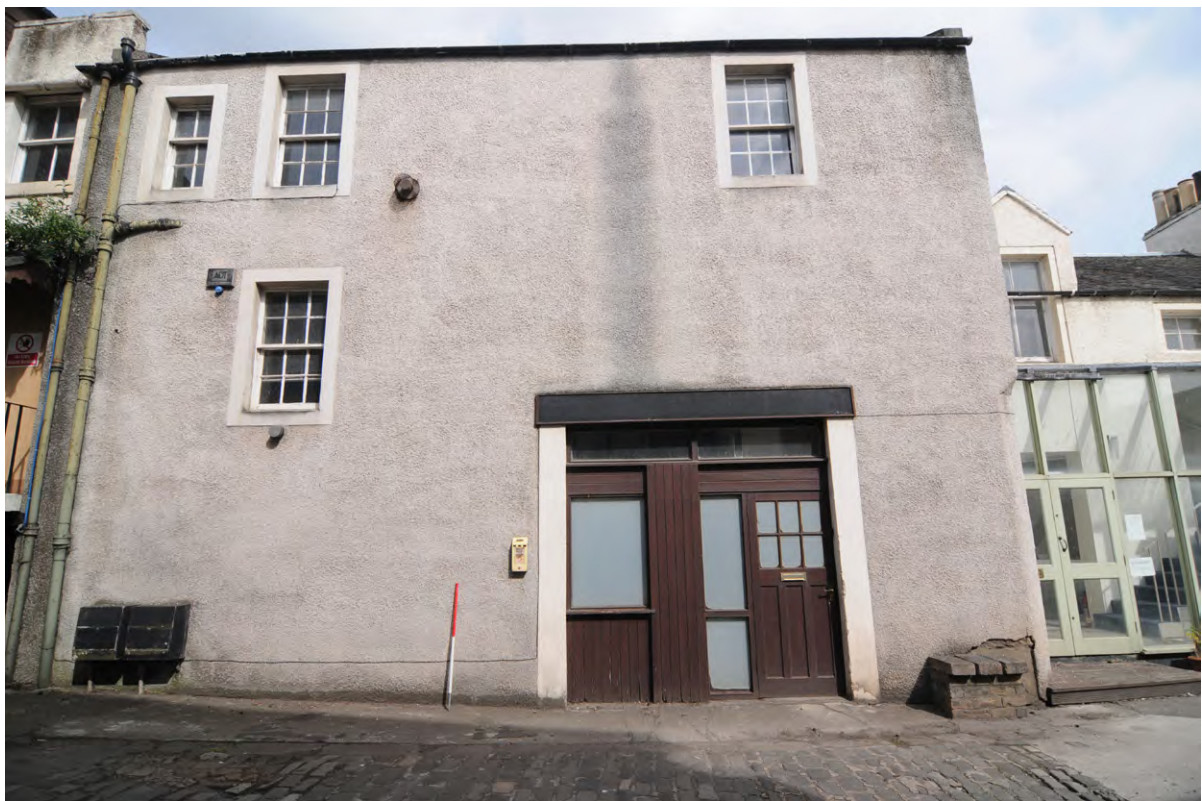
Building	Summary Description	Period
A (Figs 3 &4)	This building comprised a large blue-painted three-storey house with a pitched roof at its east end and a hipped roof at the west end. The eastern end was built before 1852 and the west end was added by 1876. The north-facing elevation had five bays; the earliest part had three bays with two windows on	Early 19 <sup>th</sup> century

either side of a doorway, formerly accessed by an external staircase. On the same elevation the addition had a door at the ground floor and first and second floor windows. The west-facing gable had five windows. The south-facing elevation had two doorways, one at ground floor (east end) and one at the top of a forestairs (west end). The fenestration was mainly boarded. Sash-and-case windows within raised margins were present on the south-facing elevation. The interior of the building was not seen.	
B (Fig 5)	Building B comprised a two storey former mill house with a pitched slate roof. Dormer windows were present on its north and south-facing elevations. The east gable had two first floor windows with a smaller window at the ground floor. The west gable was featureless. On the south-facing elevation a timber-framed glass porch covered the doors to the ground and first floor levels. Three fireplaces were seen within the modern interior. These included two late 19 <sup>th</sup> -early 20 <sup>th</sup> century cast iron fireplaces with corbelled mantelpieces and a smaller cast-iron mantelpiece probably dating to the Edwardian period.	Late 19 <sup>th</sup> century

Fig.3 Building A, North-facing elevation with pitched and hipped roofline

Fig.4 Part of Building A, south-facing elevation and fenestration

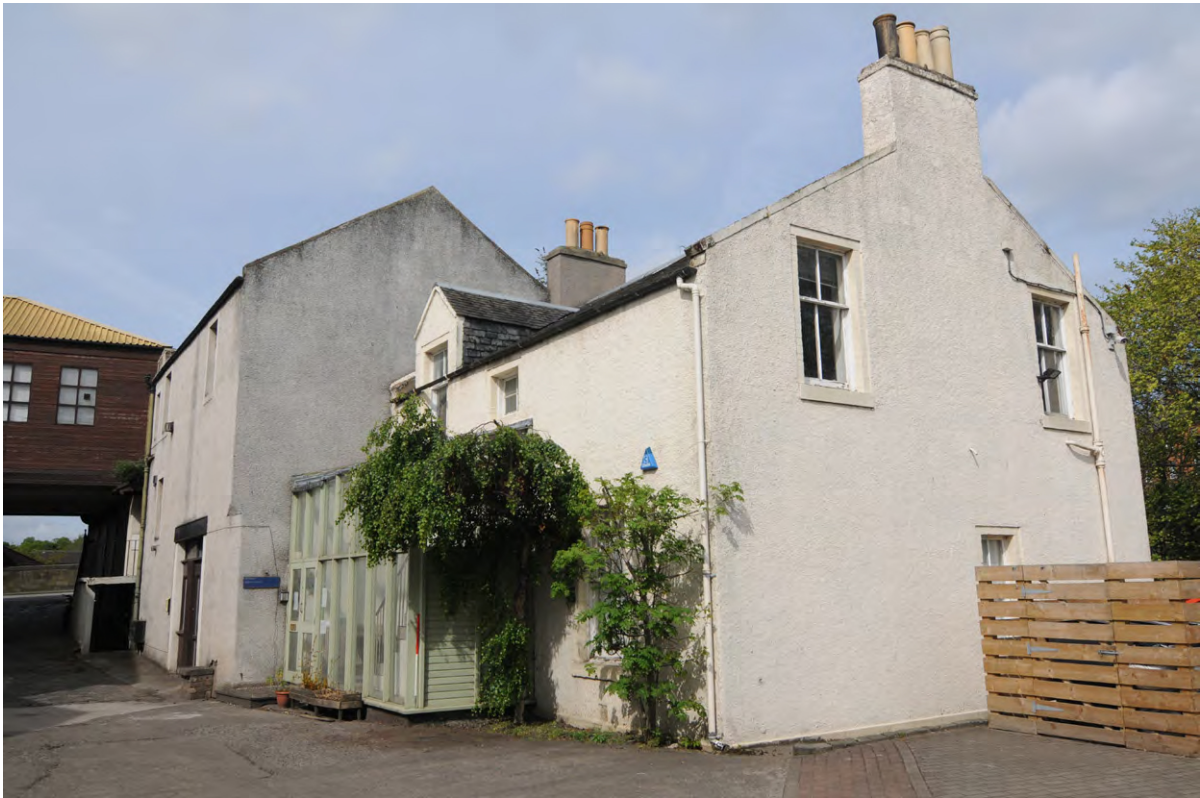
Fig.5 Building B, south and east-facing elevations

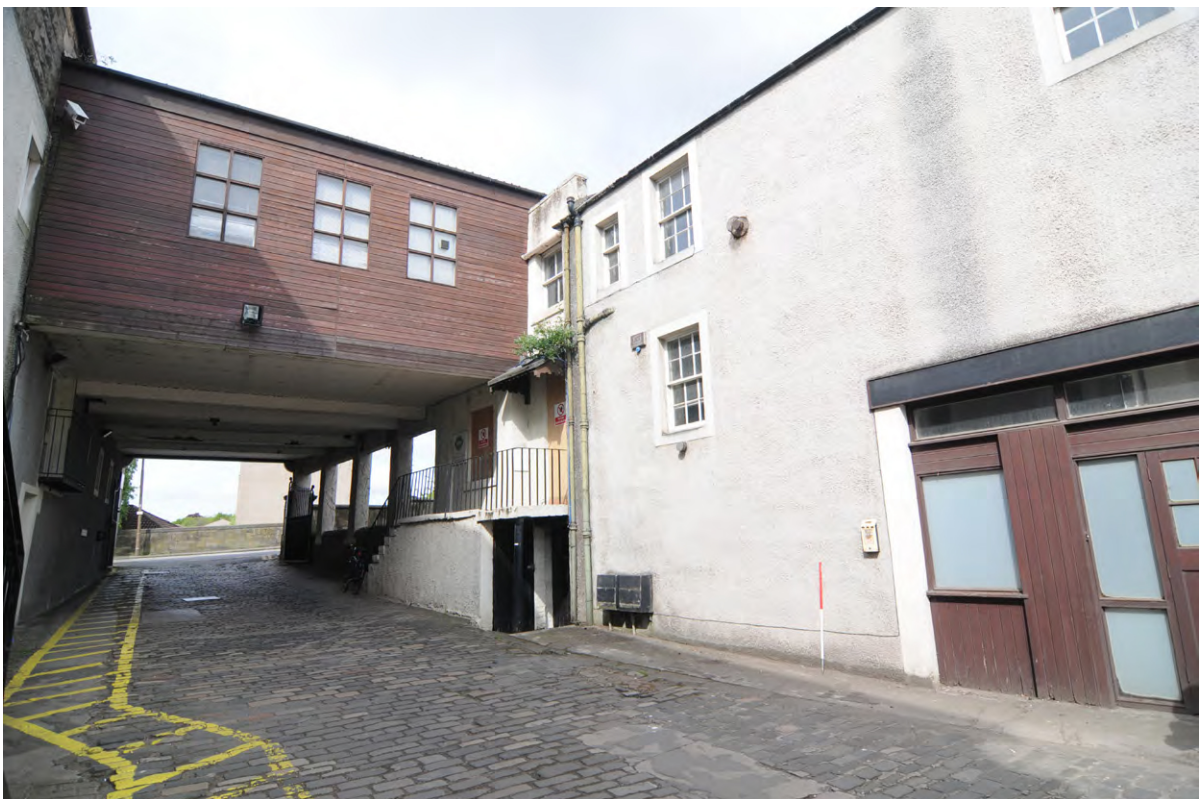
C (Fig 6)	Building C comprised a first-floor level building with an underpass to the rear of the building complex. The building had a pair of steel-clad hipped roofs. The building was supported in concrete columns built on top of a low wall flanking the underpass. The eastern side of the building was timber-clad. The interior of the building was not seen.	Late 19 <sup>th</sup> century
D (Figs 7-8)	Building D was a long rectangular former four-storey brick-built mill building with a hipped roof at its west end and a pitched gable at its east end. The interior of the building was not seen.	Late 19 <sup>th</sup> century
E (Fig 9)	Building E was a pair of rectangular brick-built two-storey buildings. The principal elevation fronted Newhaven Road. The fenestration was modern and the roof was clad with metal sheeting. The interior was not seen.	Late 19 <sup>th</sup> century
F (Fig 10)	Building E was a short rectangular two storey building with a brick-built pitched gable visible within a small courtyard. The interior was not seen.	Late 19 <sup>th</sup> century

Fig.6 Building C supported by pillars and underpass

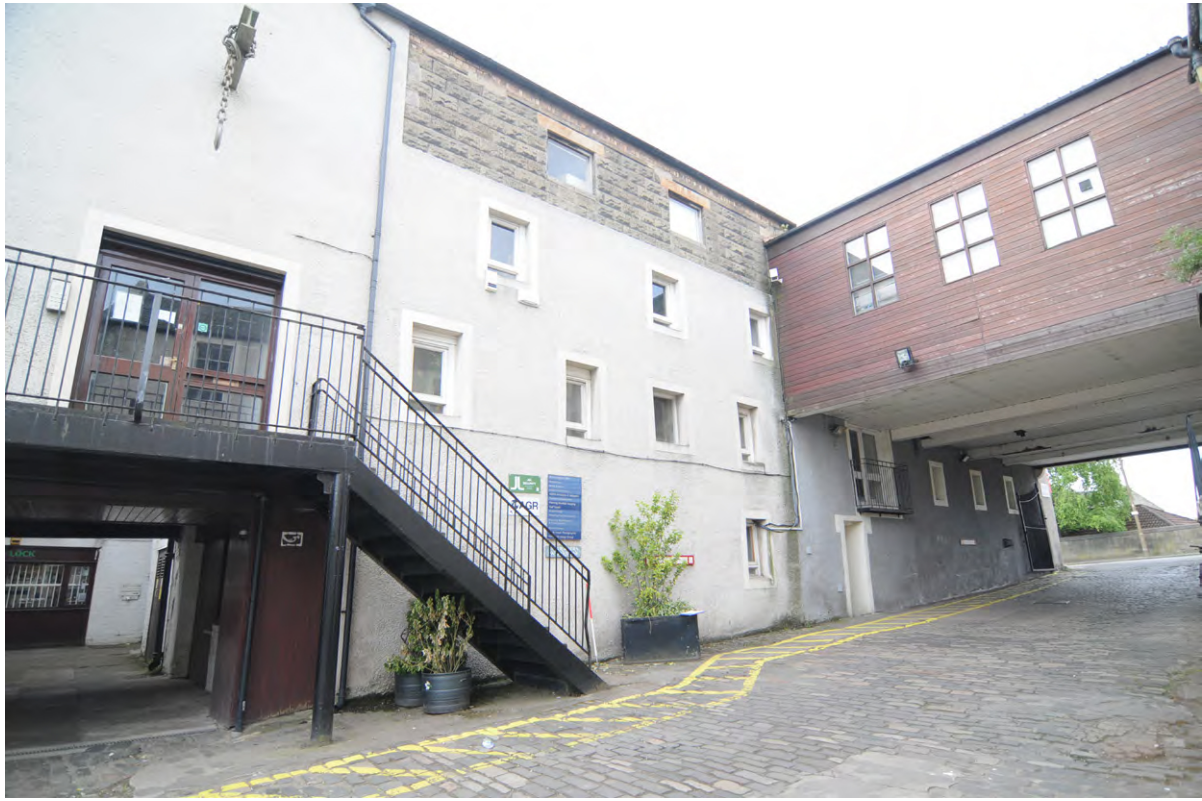
Fig.7 Building D, north-facing elevation with connecting Building C

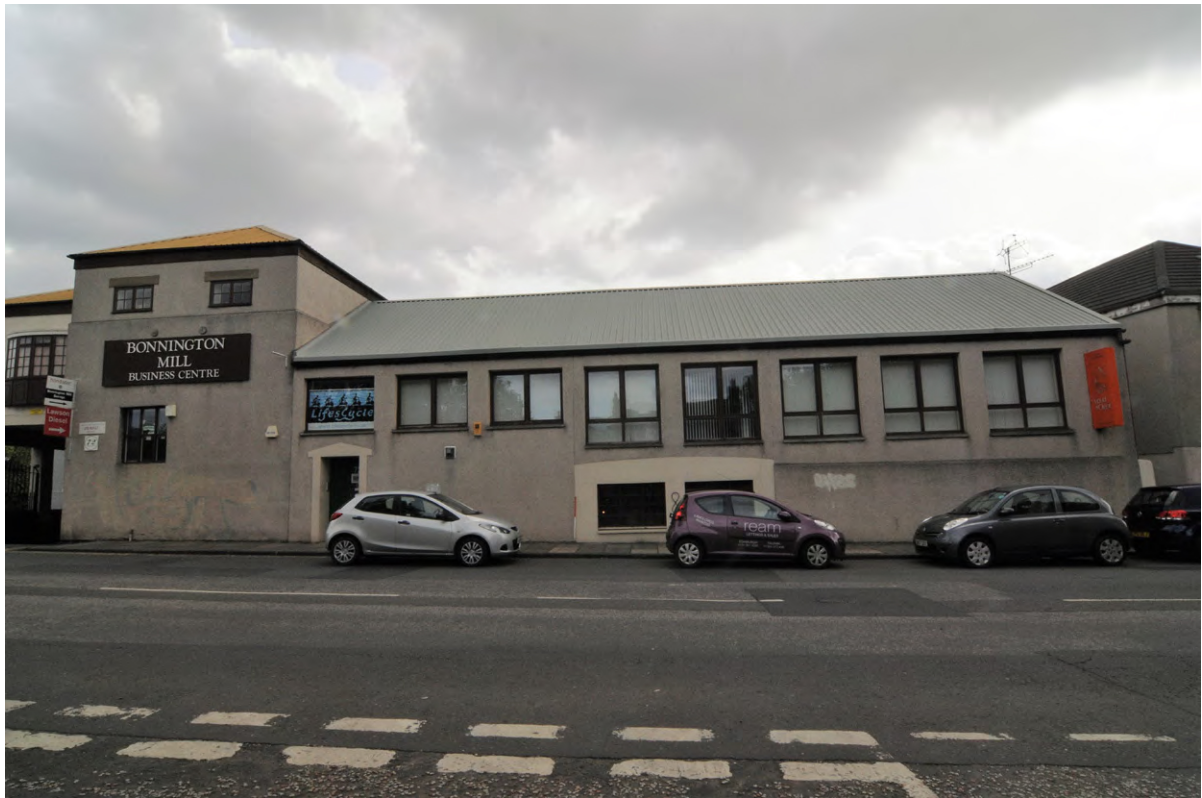
Fig.8 Building D and E street-frontage elevations

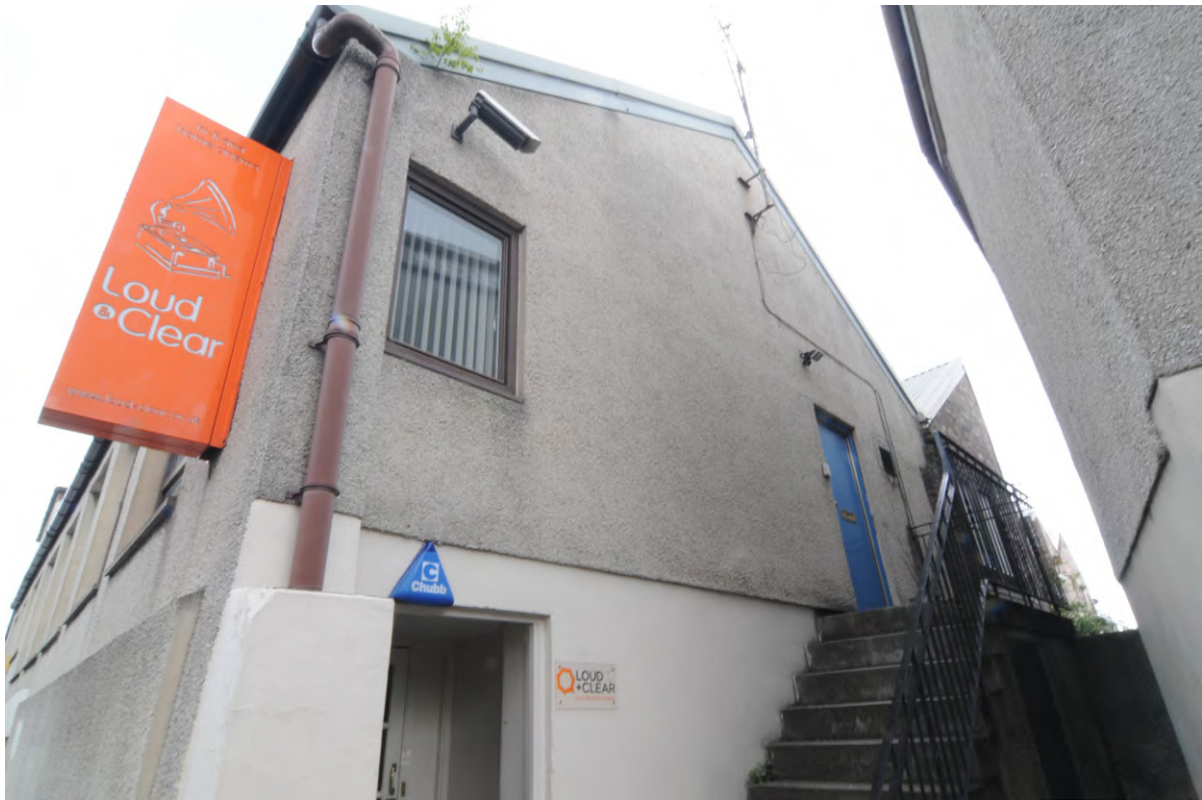
Fig.9 Building E south-facing gable walls

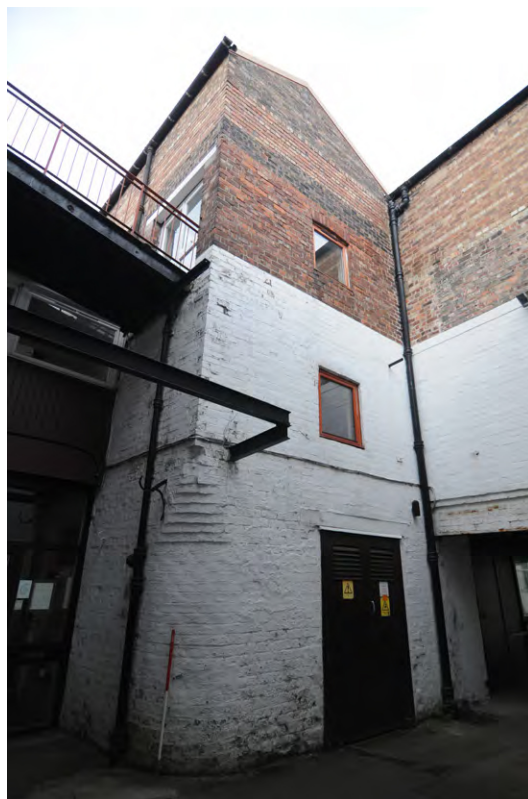
Fig.10 Building F, brick-built gable within the courtyard

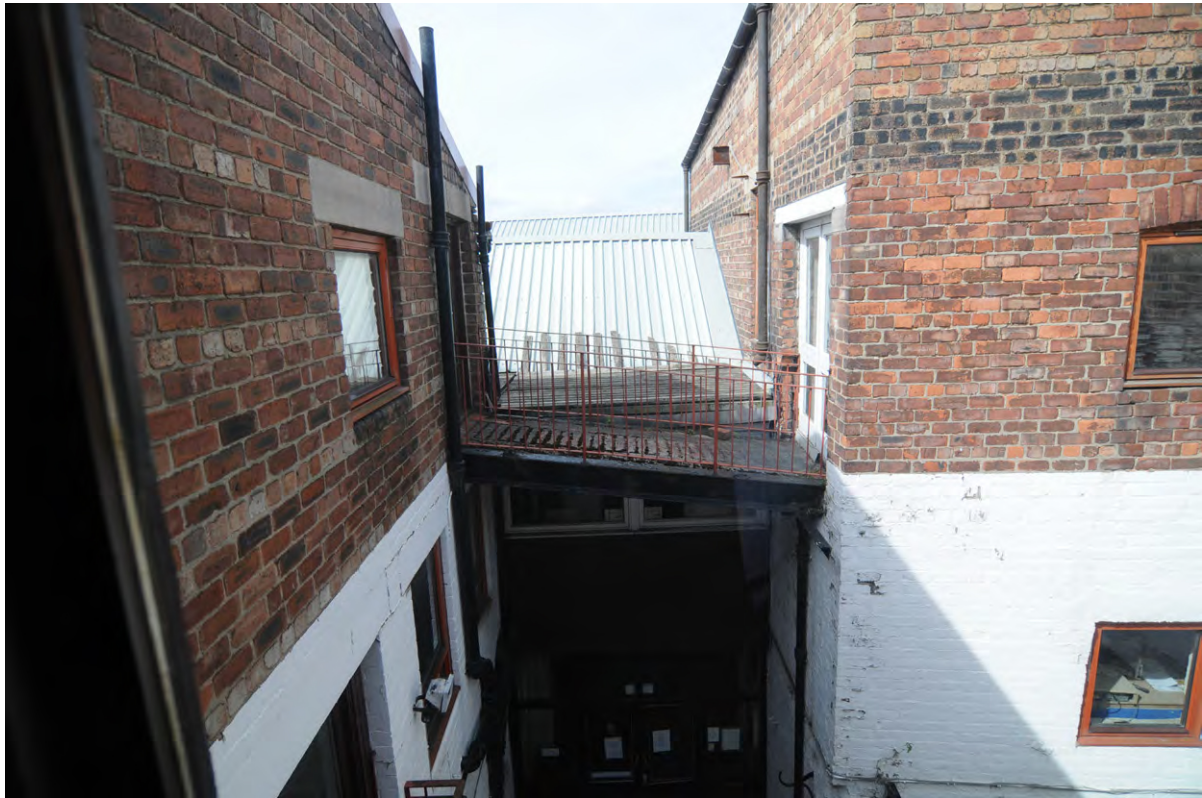
G (Fig 11)	Building G was a brick-built rectangular two storey building with a skewed footprint and pitched roof. The interior of the building was not seen.	Late 19 <sup>th</sup> century
H (Fig 12)	Building H was a two storey brick-built structure with a pitched roof. The roof trusses comprised composite bolted steel dual-pitch roof. The roof space (now an office) was well lit by roof lights.	Late 19 <sup>th</sup> century
I (Fig 13)	Building I was a large rectangular brick-built three storey building with a pitched roof. The interior was modern and used as offices and workshops. The roof trusses at second floor level were composite angle-iron supported on steel I-beams. The interior of the roof was clad with timber boards supported on steel	Late 19 <sup>th</sup> century

Fig.11 Building G behind a first floor gantry

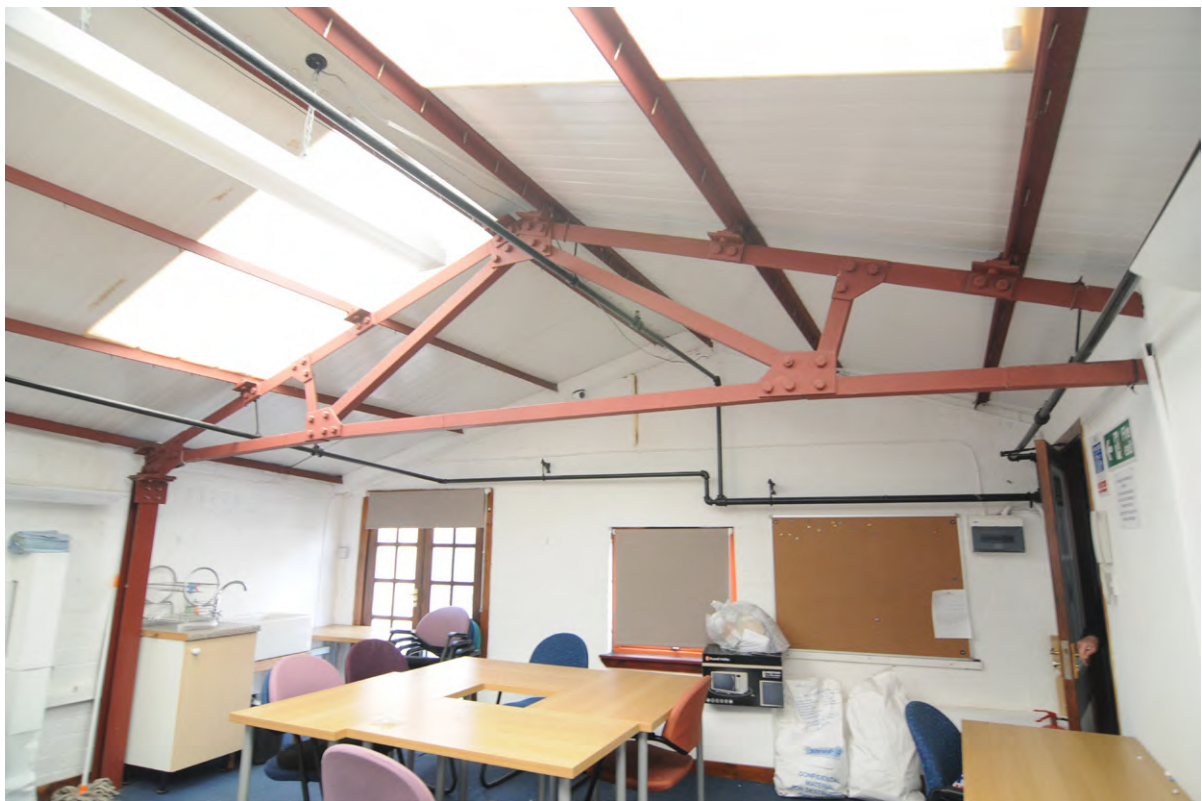
Fig.12 Building H interior composite steel roof truss

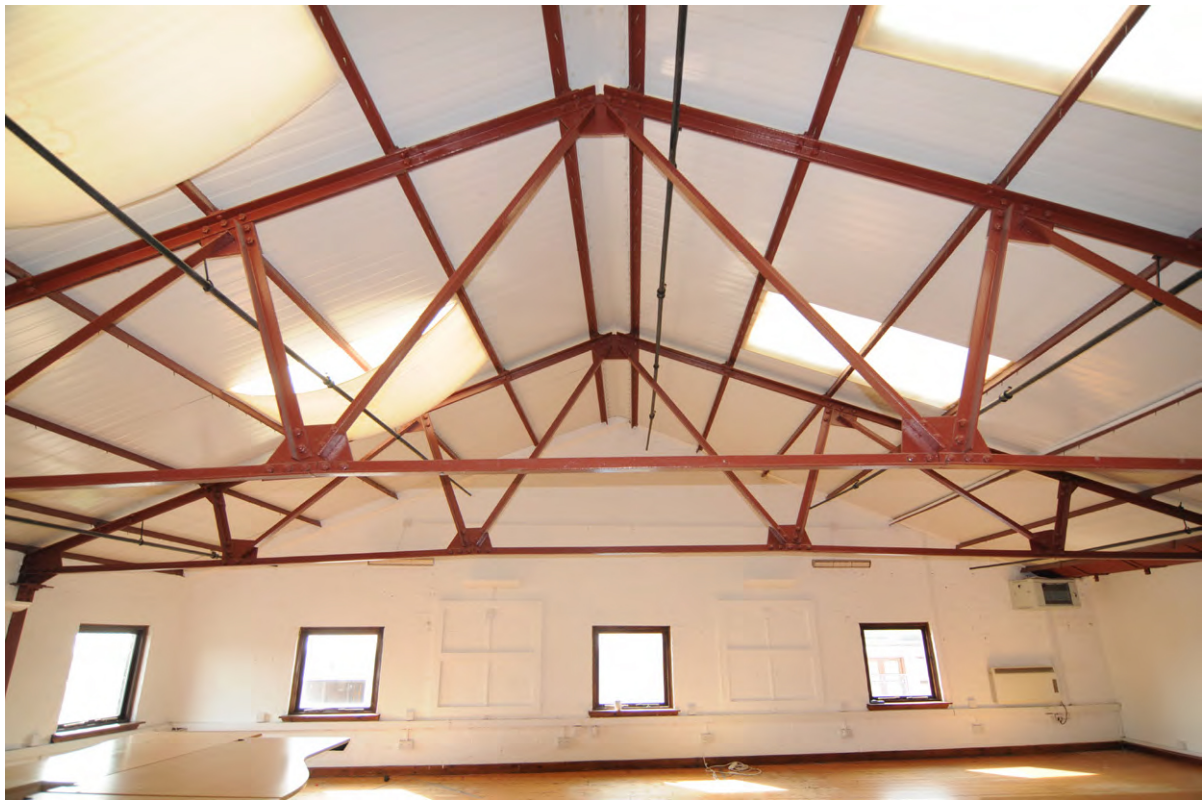
Fig.13 Building I, interior composite steel truss

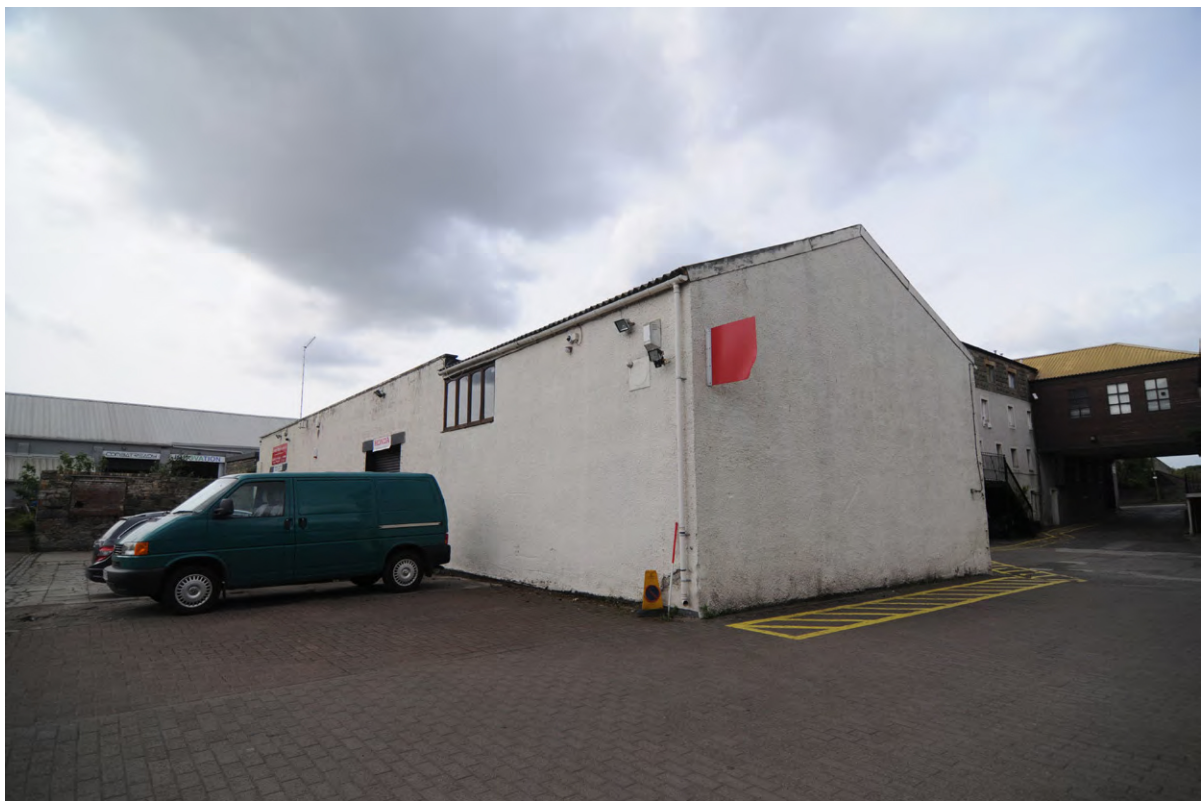
purlins.	
J (Fig 14)	Building J was a large rectangular brick-built structure forming a series of modern garages and offices. The ground floor of at the north end of the building had been converted into a two-storey office with a timber-clad frontage. The rear (east-facing elevation) has two garage doors.	Late 19 <sup>th</sup> century
K (Fig 15)	Feature K comprised a section of wall measuring c.8m x 3.5m and c.0.5m thick and constructed of random rubble. At its east end was a brick-blocked window surmounted by a rudimentary brick-arch. This section of wall is all that remained of a much larger factory building that was still standing in 1958 according to the aerial photographic record.	Late 19 <sup>th</sup> century

Fig.14 Building J, north-facing gable and east-facing elevation

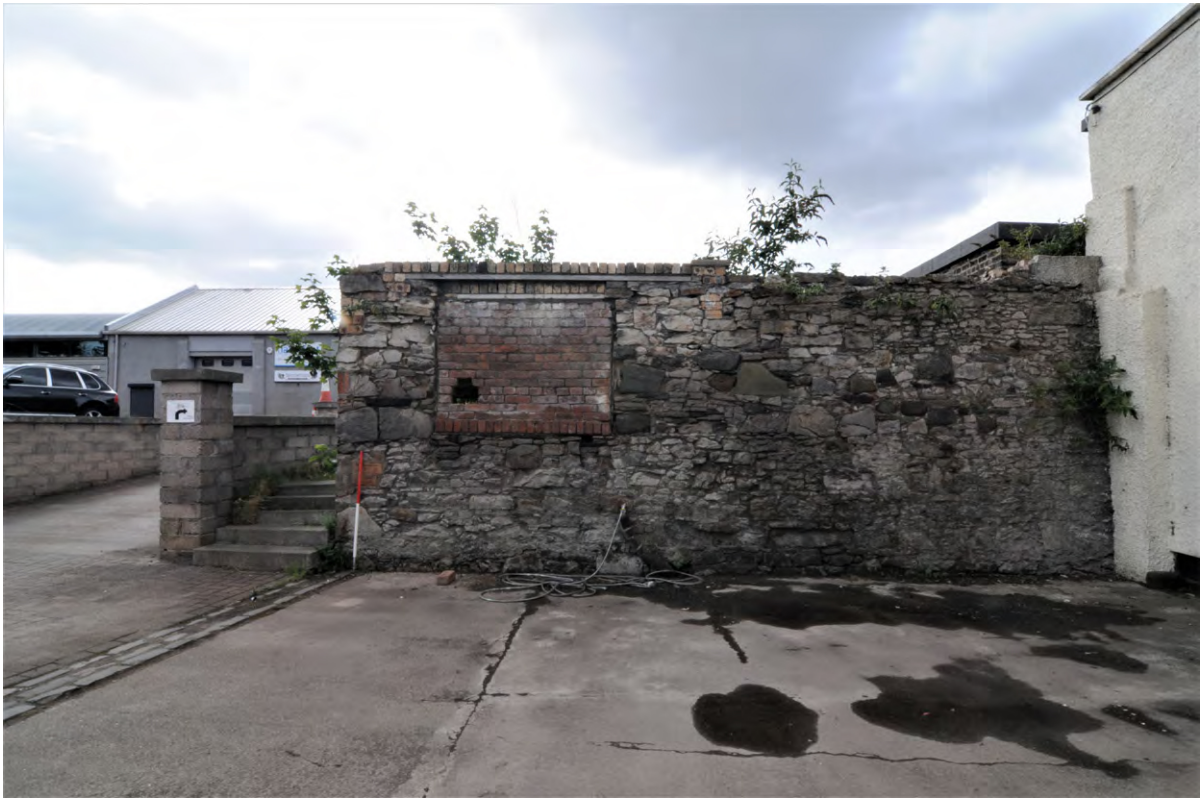
The short length of rubble-built wall (K) is all that remains of a much larger L-shaped building that was extant in the 1960s according to aerial photographs.

Fig.15 Section of north-facing upstanding wall (K)
