Minor Archaeological Services Call-Off Contract Threave Castle, Dumfries & Galloway (PIC217)

Signage Lectern Removal, Watching Brief and
Survey of Badger Damage, February 2019
Report No. HES-PIC217-2019-01

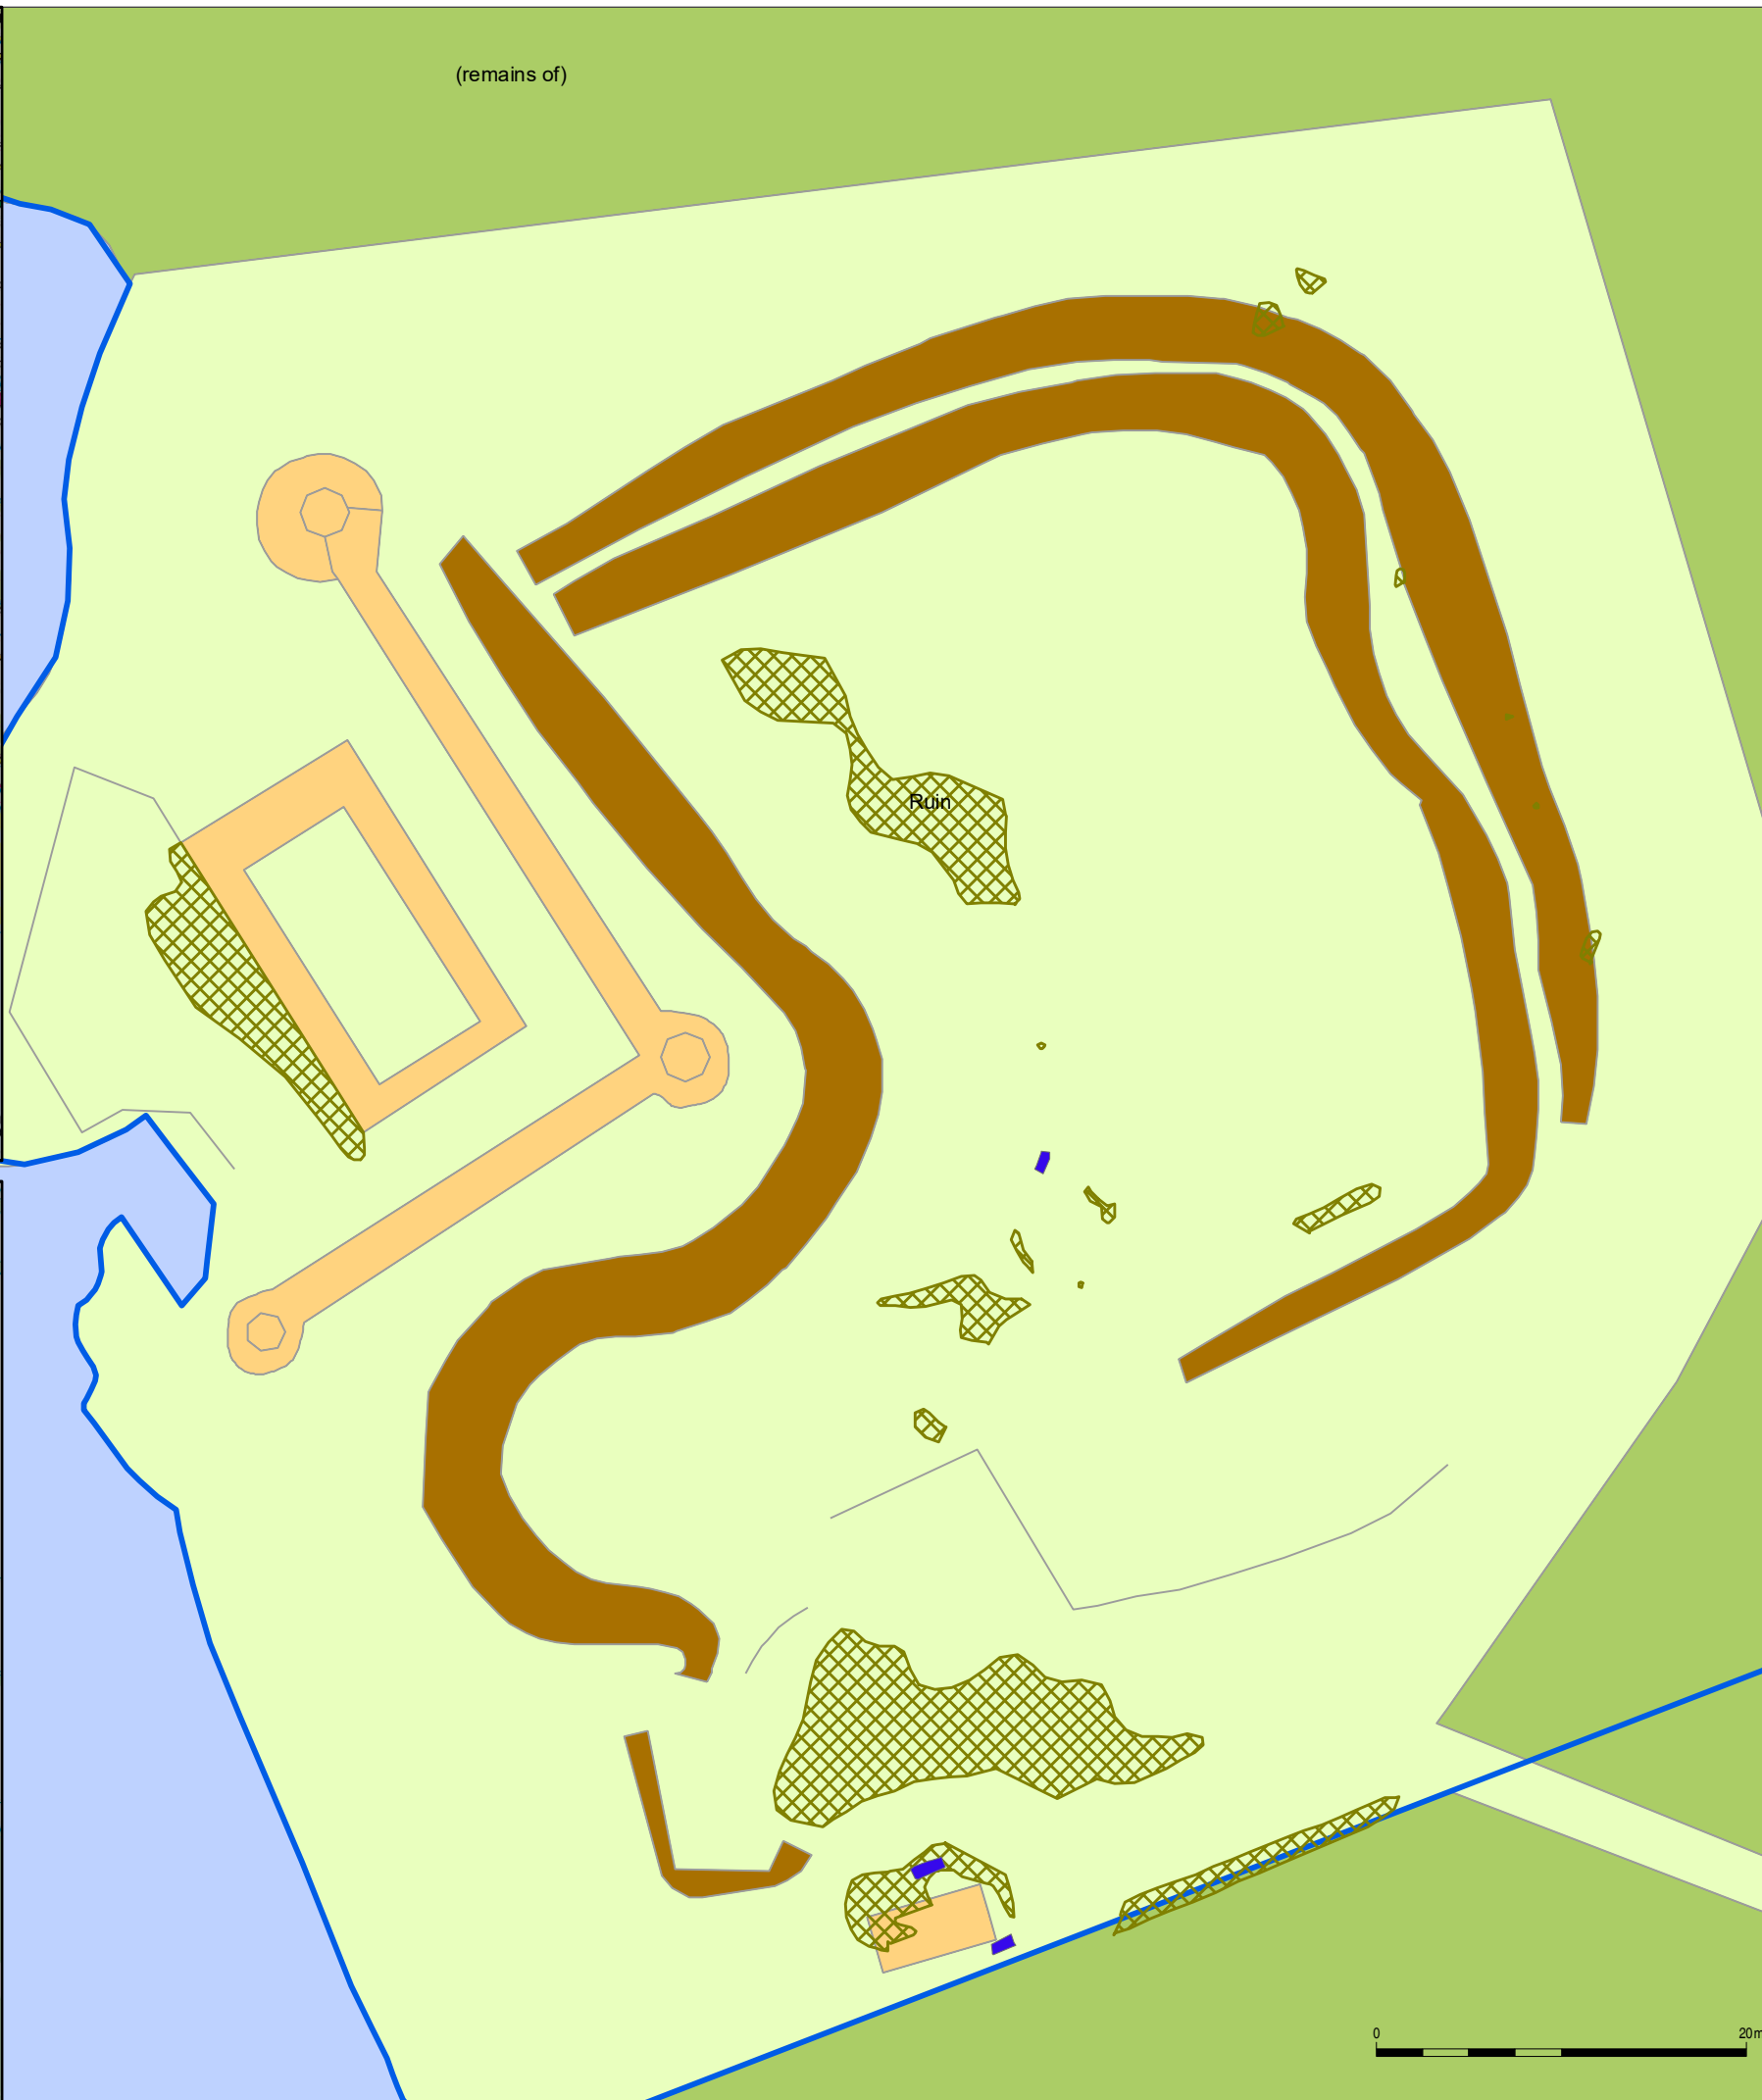
Report No: 3838	Fig. No: 1
--------------------	---------------

Title:
 Site location and location of lectern stones and areas of badger damage

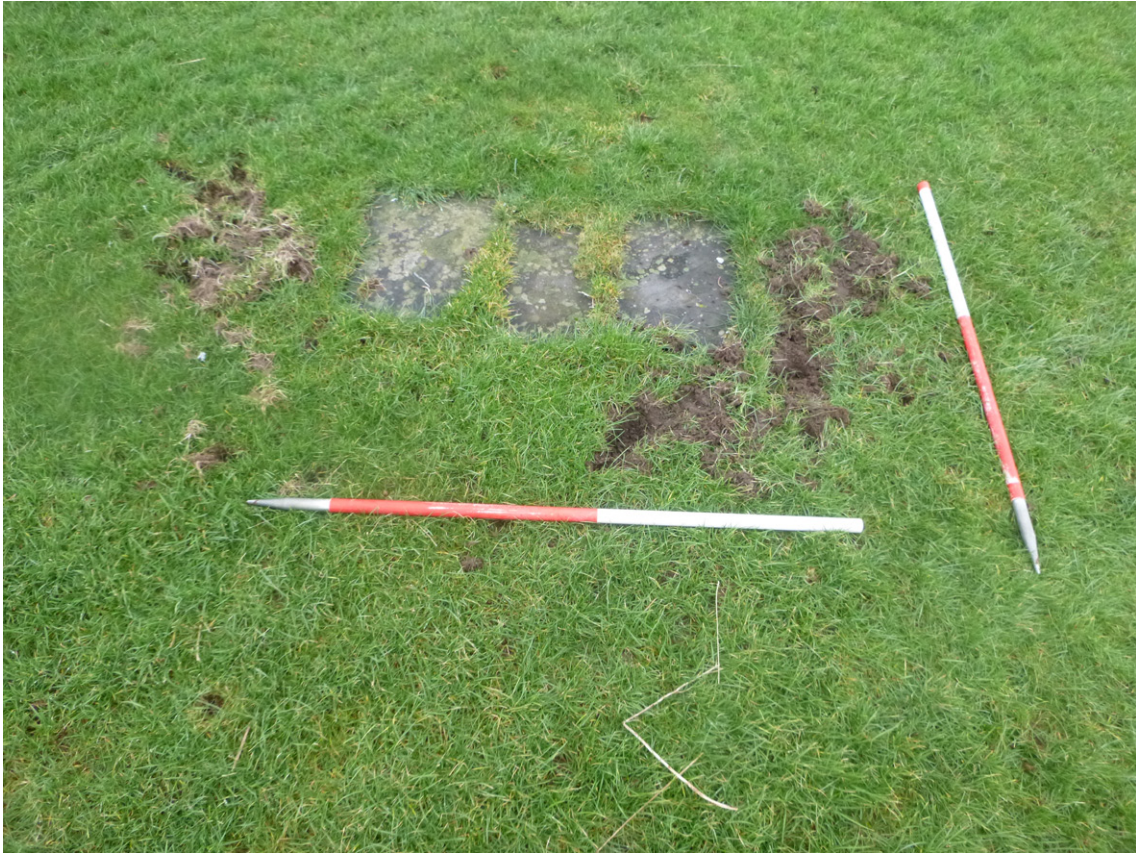
There were no in situ lecterns at the time of the watching brief. Twelve rectangular stone slabs, previously forming the standing platform for the lecterns, were removed from the turf. These were in two groups of three slabs and a single group of six slabs. The slabs were removed by hand or by placing a spade under a corner to lever the slab upright (Figs. 2 and 3).

Fig. 2: Pre-excitation shot lectern stones with badger scrape damage

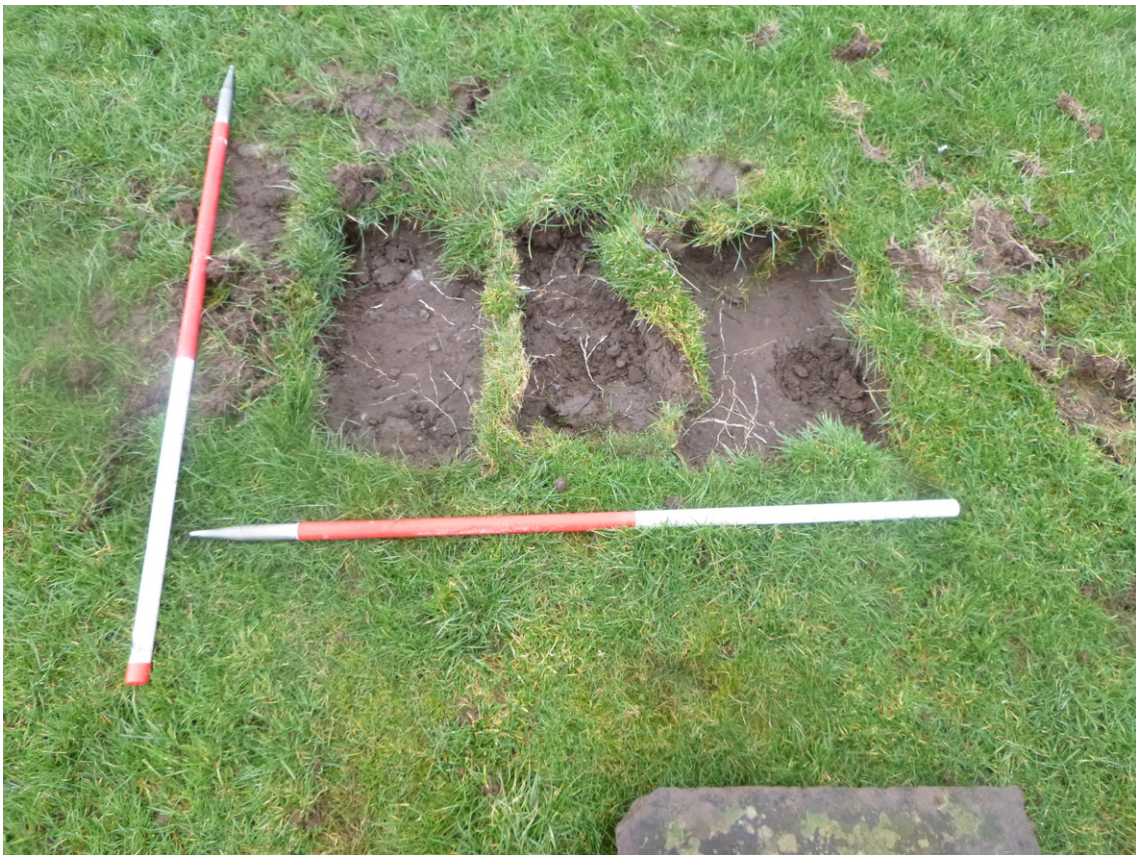
The slabs were in two groups of three slabs and a single group of six slabs. The slabs were of roughly similar size and shape, approximately 0.55m by 0.3m and 0.08m thick and were set within the turf and topsoil. Only one the groups appeared to have a small amount of levelling sand placed under them.

No archaeological features or deposits were noted under the slabs and the depth of excavation did not penetrate any further than topsoil.

Fig. 3: Post-excitation shot of lectern stones

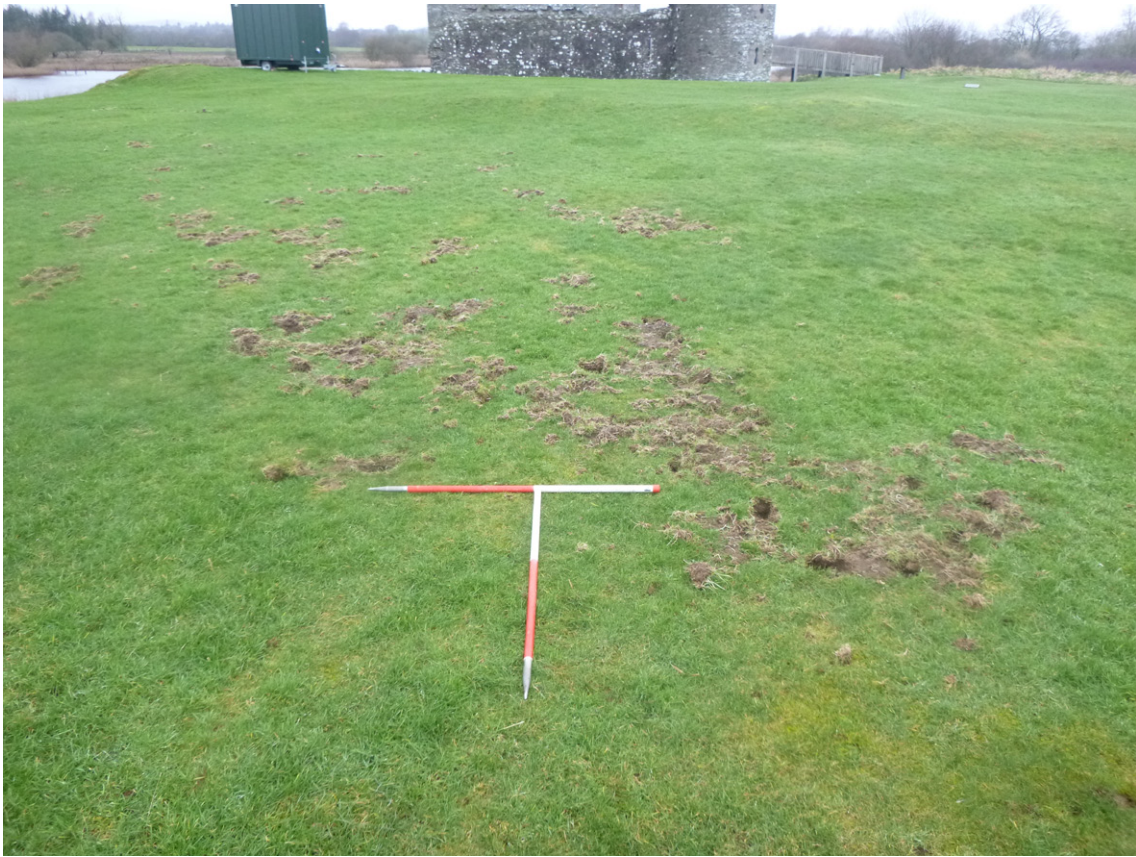
The areas of scraping damage caused by the badger were spread across the entire site and these were either individual scrapes into the turf and topsoil or were large areas of extensive scraping disturbance (Figs.4-6). These large areas were mainly on the west side of the castle tower and also in the grass area to the south and east of the castle.

Fig. 4: Badger damage along the southern edge of the castle complex

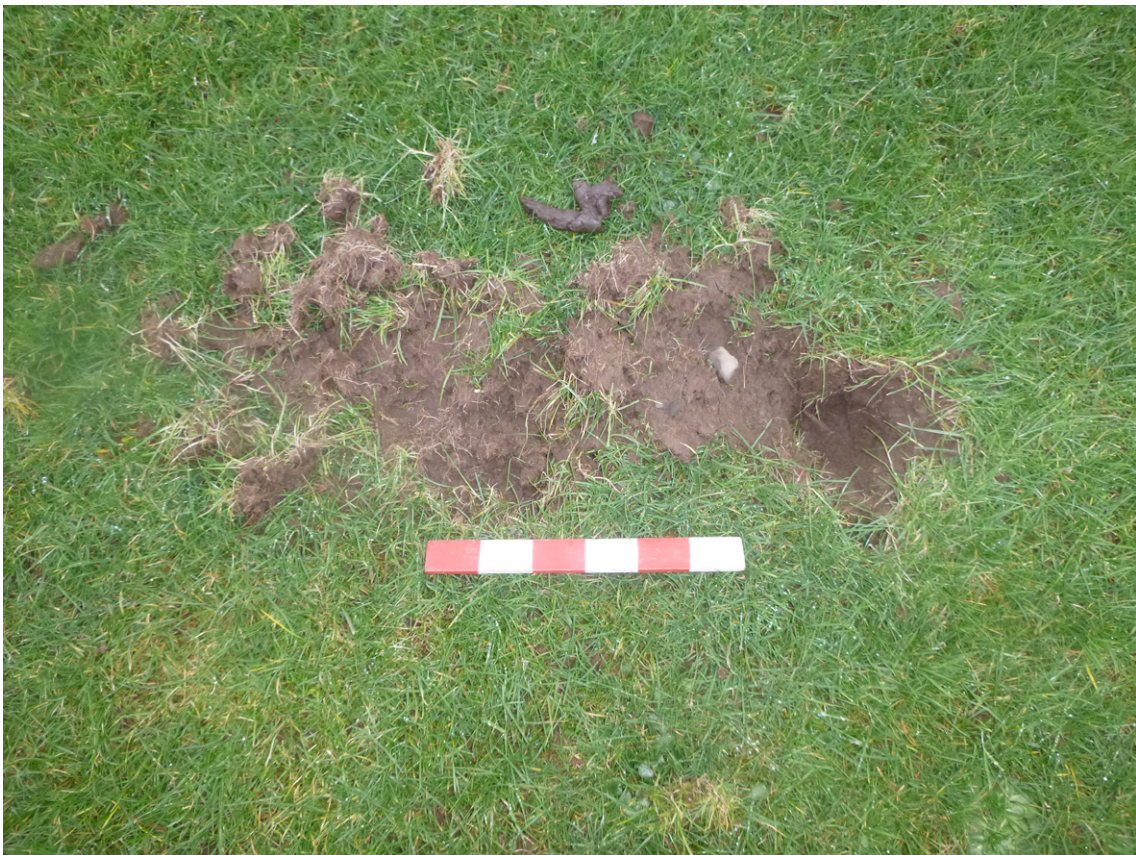
Fig. 5: Badger scrape with faeces on the grass area in front of the castle

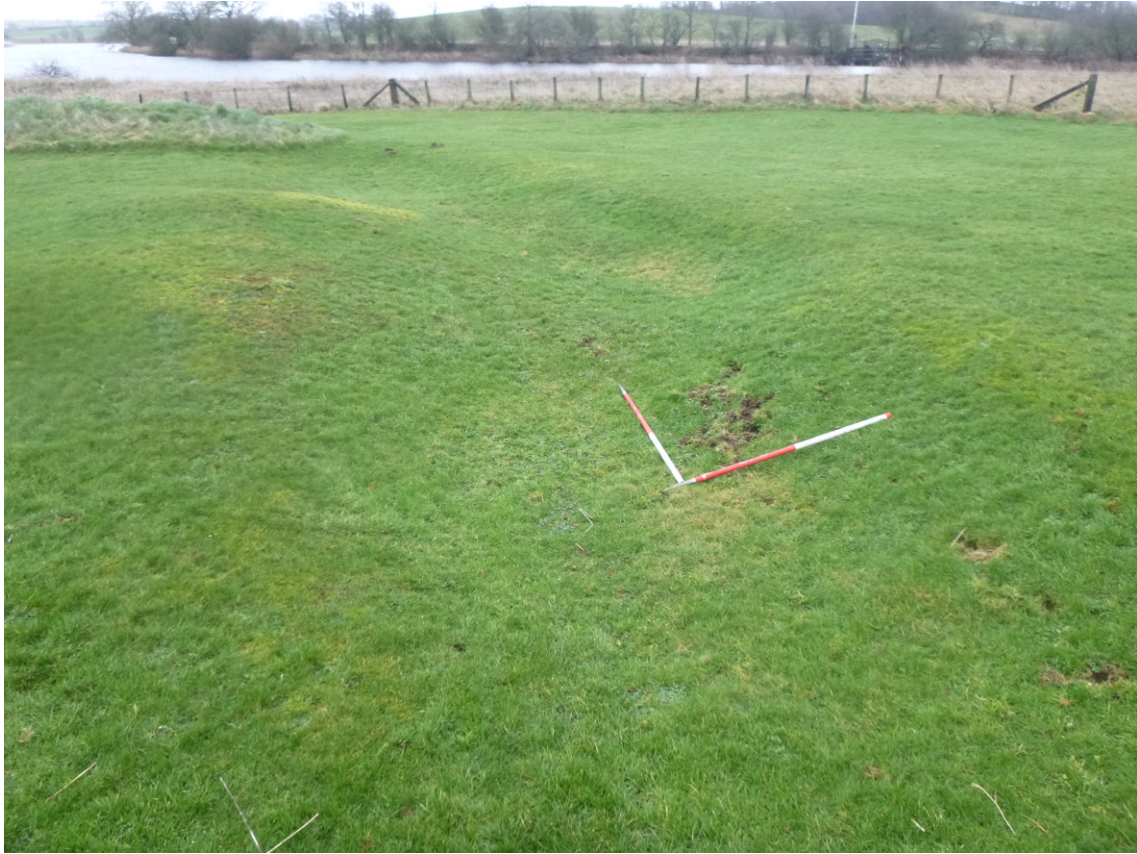
Fig. 6: Badger scrape damage within ditch feature in front of the castle

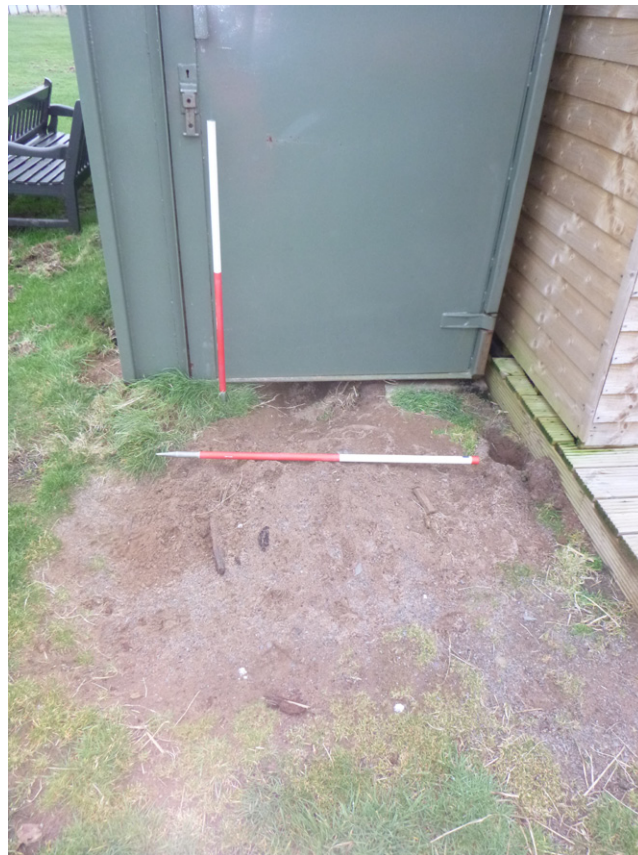
The burrowing damage had caused numerous holes and their resulting spoil heaps. Two of these were deemed to be occupation burrows by the ecologist from Scottish Natural Heritage. One was under the temporary cabins and sheds to the south of the castle complex (Fig. 7), and the other was at the base of the western tower wall (Fig. 8). The hole at the temporary cabins has a large spoil heap in front of it and a number of faeces-filled latrine pits around the entrance. The other was at a ground level opening within the tower western wall. In front of the opening was a pile of bedding material (Fig. 9).

Fig. 7: Badger burrow and spoil heap and faeces at temporary cabins

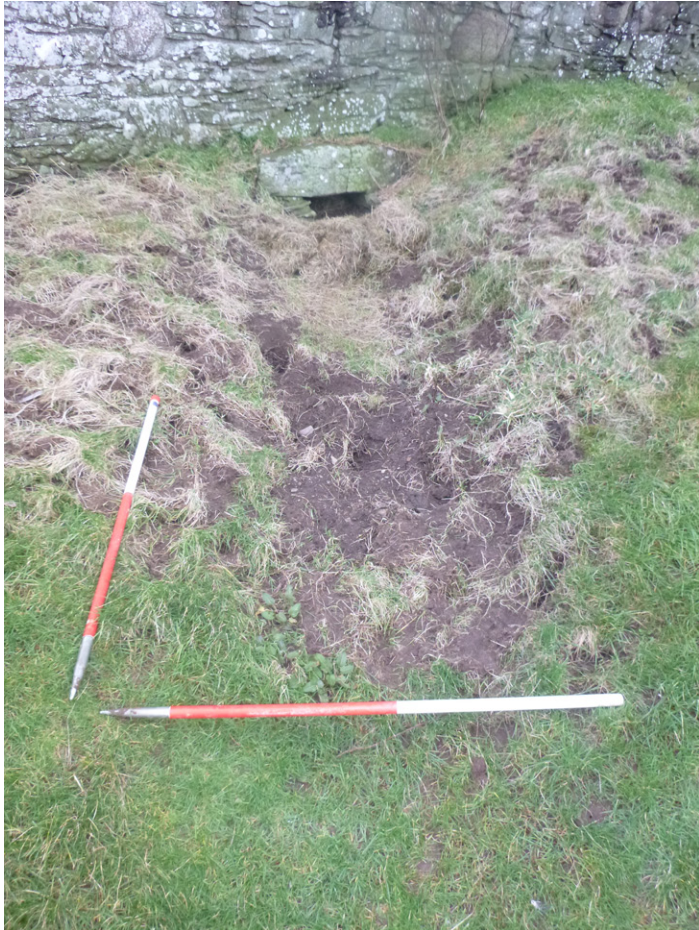
Fig. 8: Badger burrow and scrape damage at western wall of tower

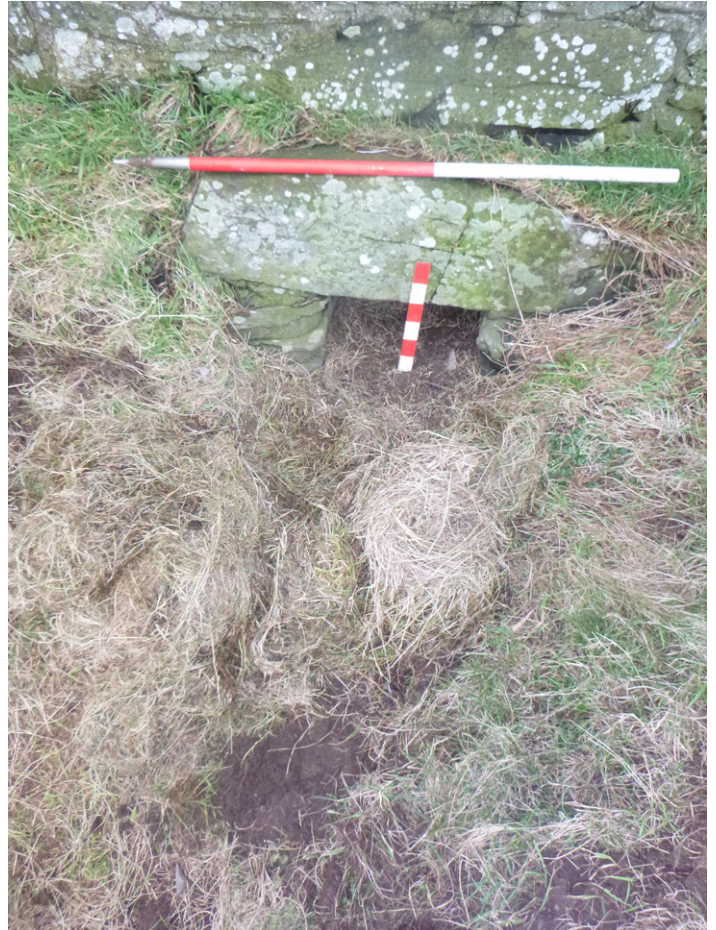
Fig. 9: Detail of burrow showing bedding material

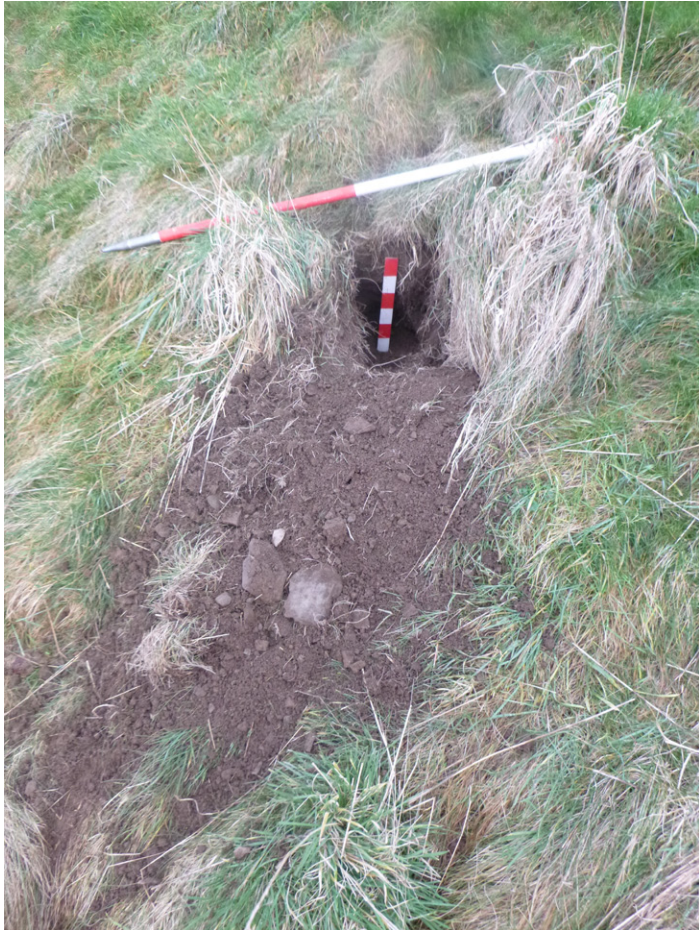
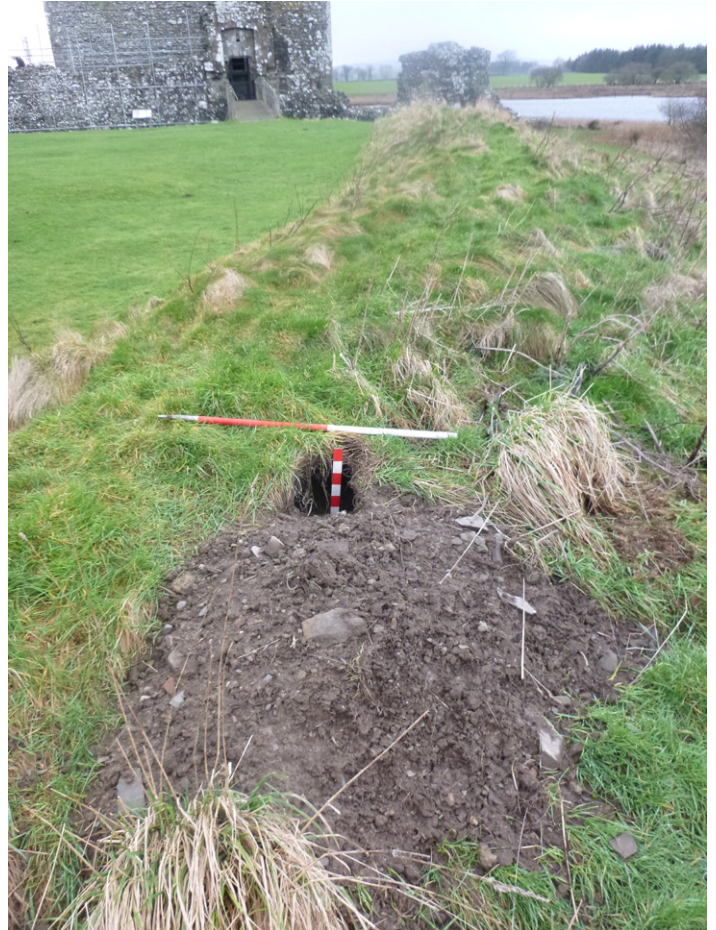
The remaining holes were test burrow holes, 0.25m to 0.45m deep, and were dug along the eastern and northern side of the embankment that runs around the east and north side of the castle complex (Figs. 10-11).

Fig. 10: Test burrows and spoil heap within bank

Fig. 11: Test burrows and spoil heap within bank
