Kendoon to Tongland 132kV Reinforcement Project A713 Old Polharrow Bridge, Dumfries & Galloway

Photographic Survey and Watching Brief
[Report No. 3892](#)

**Kendoon to Tongland 132kV Reinforcement Project,
A713 Old Polharrow Bridge,
Dumfries and Galloway**

Data Structure Report No. 3892

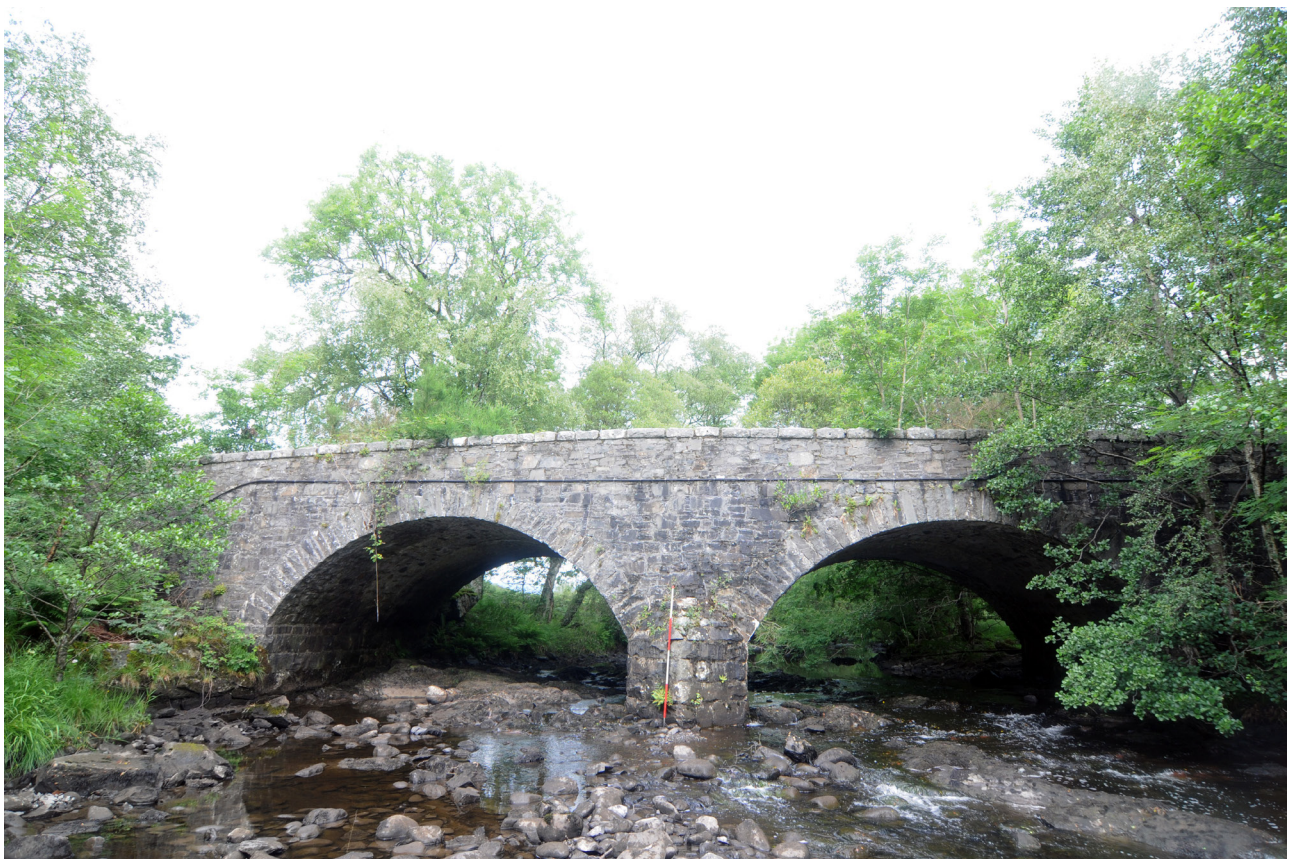
The A713 Old Polharrow Bridge was a three-span random masonry arched structure with dressed masonry voussoirs consisting of both sandstone and basalt (whinstone) supported on squared stone masonry abutments and piers (Fig 2). The wingwalls and headwalls were constructed from randomly coursed masonry and the parapets comprised of snecked masonry which ran the full length of the structure on both sides. The V cutwater buttress between the main arches was about 2m high rising to just above the springer level of the arches (Fig 3). The spandrels comprised a combination of snecked and coursed whinstone (Fig 4). The deck had been surfaced with tarmac and loose chippings.

Fig. 2: The bridge in its topographical setting, east-facing elevation

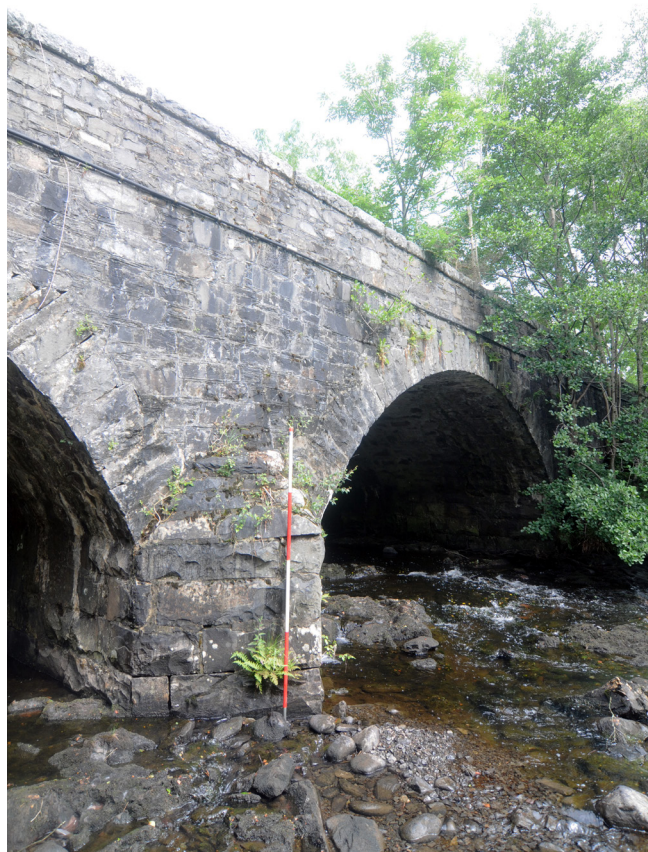
Fig. 3: Buttress detail between the two main arches on the east-facing elevation

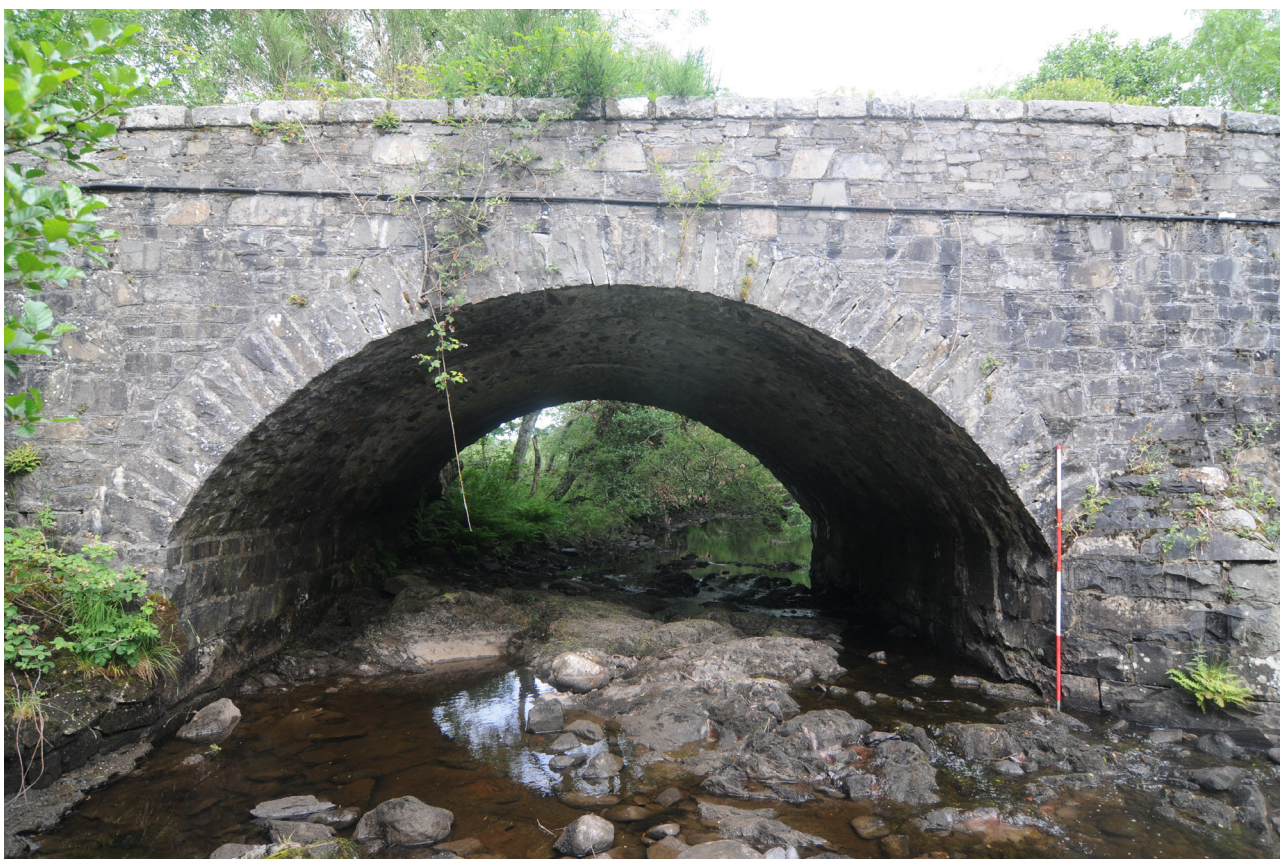
Fig. 4: South spandrel arch seen from the west

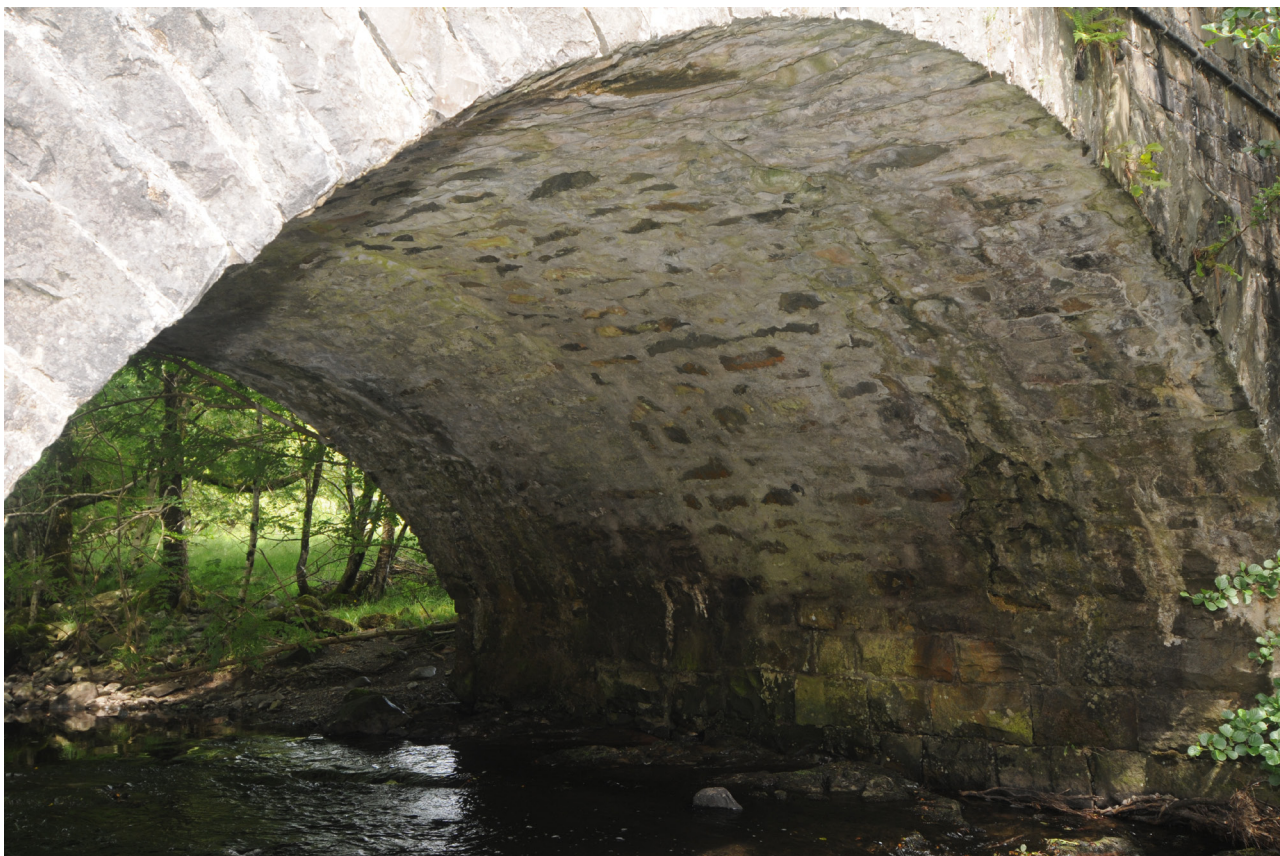
Below both arches there is a distinct vertical break delineated by a mortared band running round the vault. This parallel-widening connection-line marks the position between two distinct phases of construction (Fig 5 and Fig 6). The earliest is associated with a much narrower bridge (Phase 1) that was added to later (Phase 2) on its east or downstream side. The foundation stones for this narrower bridge were more randomly laid and built directly on to patches of exposed bedrock in contrast to the more coursed and dressed blocks used on the wider addition. The Phase 2 estrados were less carbonate encrusted than the earlier arch and contained more sandstone.

Fig. 5: Interior view of the arch showing two phases of construction

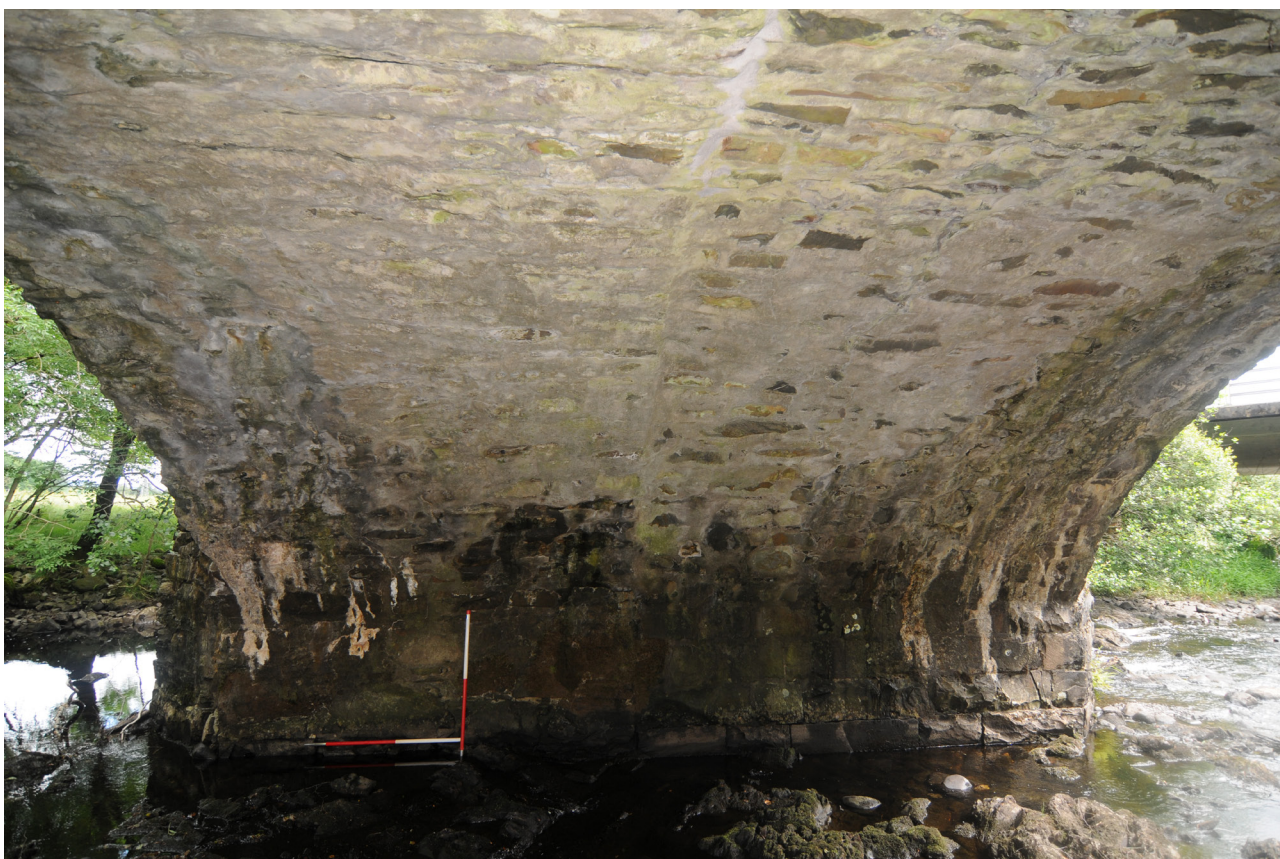
Fig. 6: Construction line running round the barrel vault marking the junction between the early and later construction

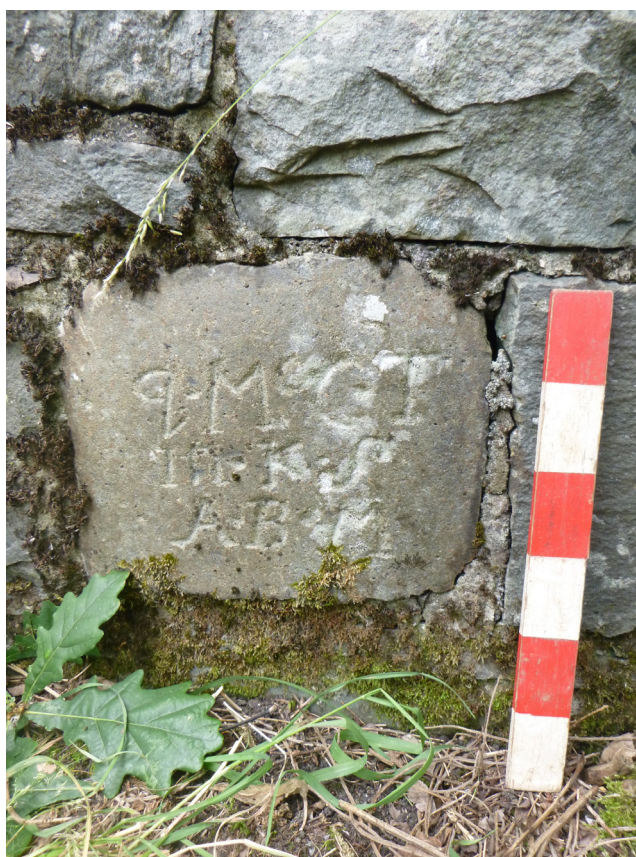
A stone inscribed *q-Mc Clirlk S A B M* (Fig 7) was found at the base of the inner parapet on the earlier western side and another was inscribed *Built by S Arnot AD 1841* (Fig 8) on the base of the inner parapet on the later eastern side.

Fig. 7: 18th century commemorative stone inscribed *q-Mc Clirlk S A B M*

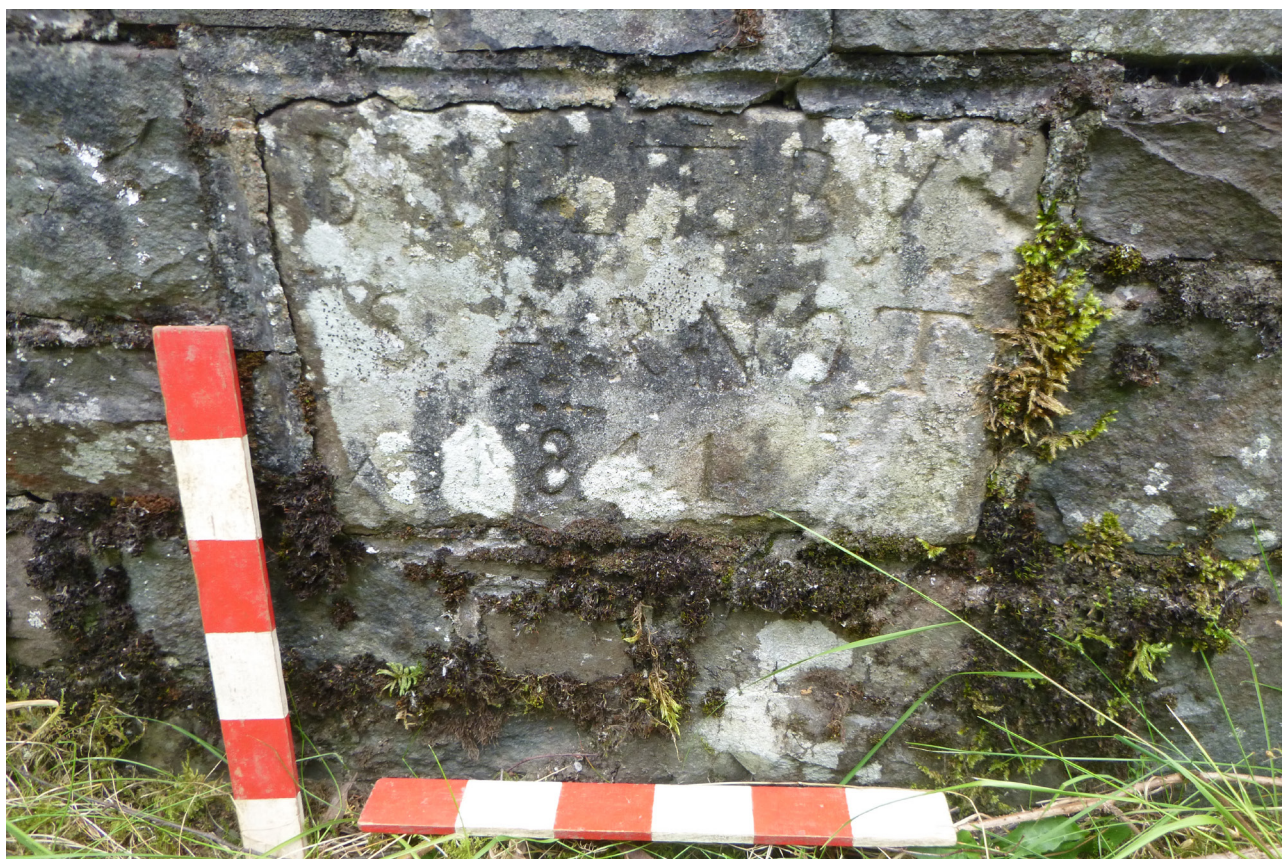
Fig. 8: Date stone inscribed *Built by S Arnot AD 1841*

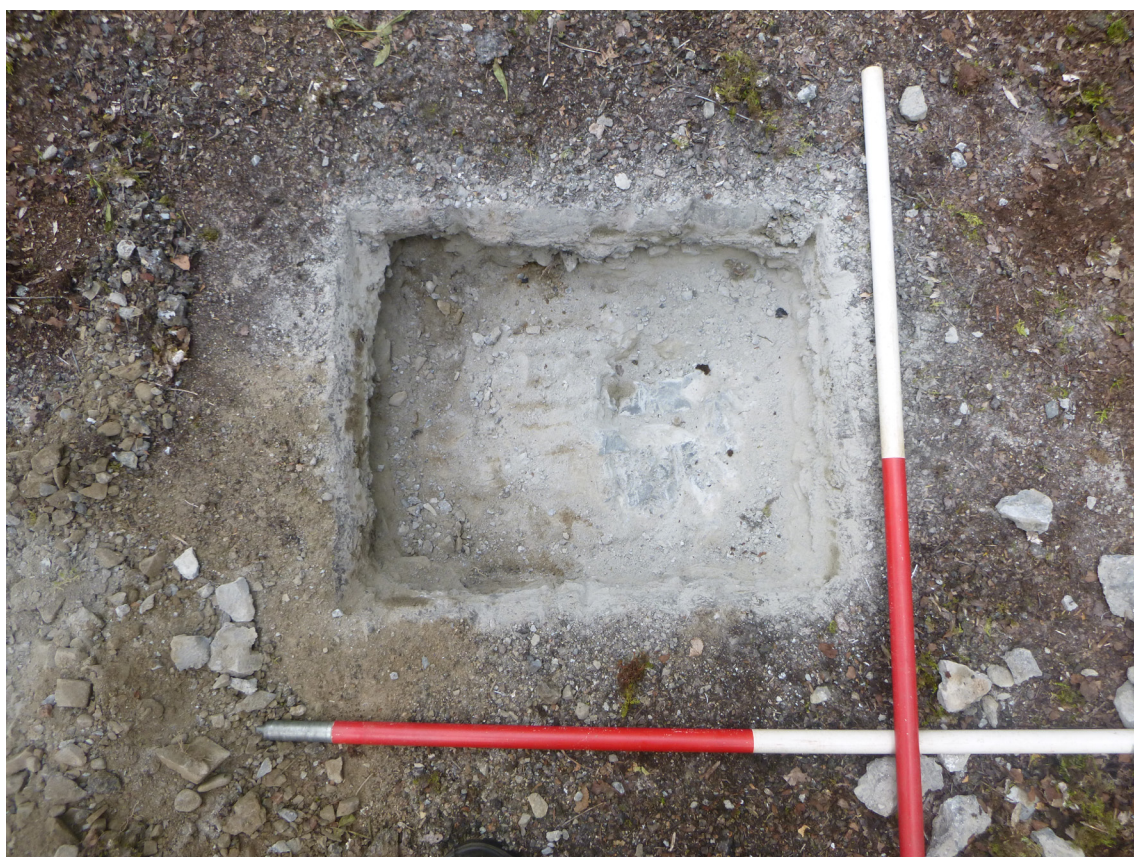
Fig. 9: Trial Pit 1

| Test Pit No. | Size (m) | Depth of Pit (m) | Description |
|---|---|---|---|
| 1 (Fig 9) | 0.5 x 0.6 | 0.25 | Located over arch 2. 0.1m of tarmac (001) over 0.1m of hardcore (002), over 0.05m of concrete (003), over stone blocks (004). Total depth of deposits over the top of the stone blocks is 0.25m. |

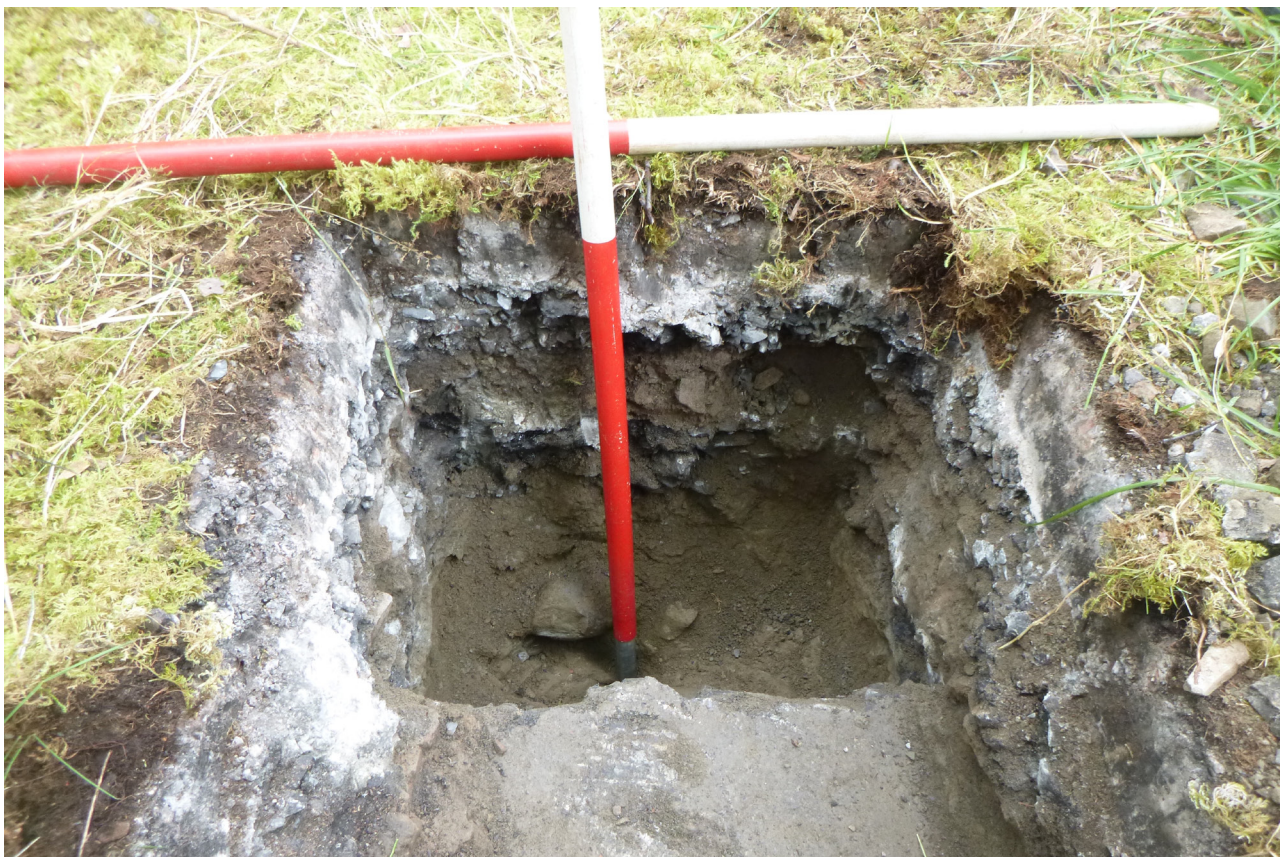
Fig. 10: Trial Pit 2

| Test Pit No. | Size (m) | Depth of Pit (m) | Description |
|---|---|---|---|
| 2 (Fig 10) | 0.75 x 0.6 | 0.55 | Located over abutment. 0.15m of tarmac (001), over 0.1m of hardcore (002), over 0.1m of tarmac (005), over 0.2m of hardcore (006), over boulders with voids (007). Total depth of deposits over the top of the stone is 0.55m. |

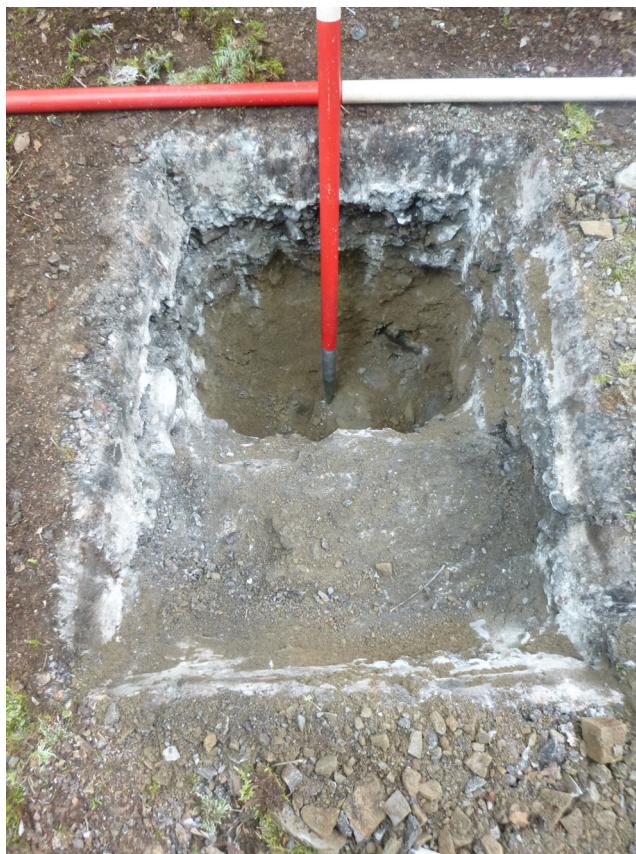
Fig. 11: Trial Pit 3

| Test Pit No. | Size (m) | Depth of Pit (m) | Description |
|---|---|---|---|
| 3 (Fig 11) | 0.7 x 0.5 | 0.4 | Located over pier. 0.17m of tarmac (001) over 0.23m of hardcore (002), over boulders with voids (008). Total depth of deposits over the top of the stone is 0.4m. |

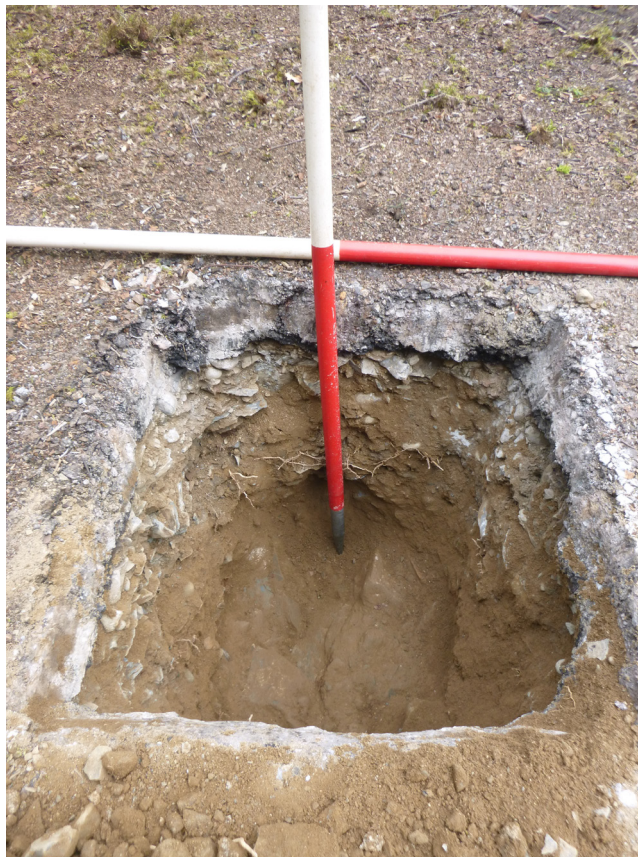
Fig. 12: Trial Pit 4

| Test Pit No. | Size (m) | Depth of Pit (m) | Description |
|---|---|---|---|
| 4 (Fig 12) | 0.55 x 0.5 | 0.6 | Located over pier. 0.1m of tarmac (001) over 0.2m of hardcore (002), over 0.3m of coarse sand and stones (009), over boulders (010). Total depth of deposits over the top of the stone is 0.6m. |

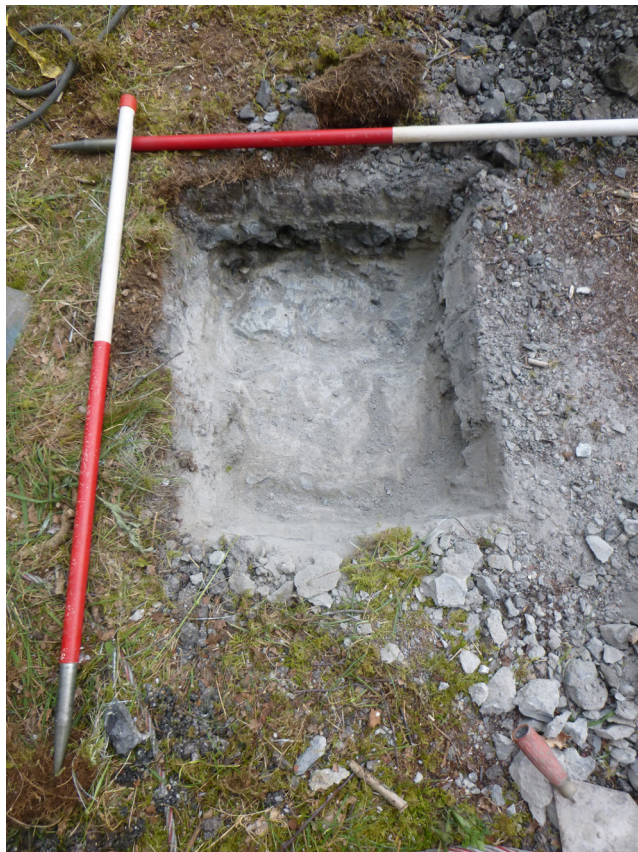
Fig. 13: Trial Pit 5

| Test Pit No. | Size (m) | Depth of Pit (m) | Description |
|---|---|---|---|
| 5 (Fig 13) | 0.65 x 0.6 | 0.4 | Located over arch 1. 0.15m of tarmac (001) over 0.15m of hardcore (002), over 0.1m of concrete (011). |

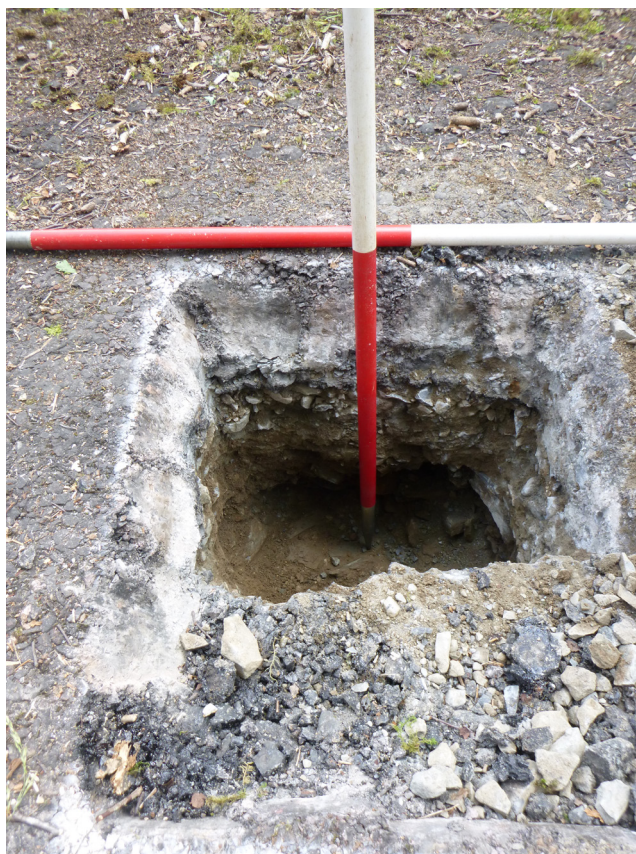
Fig. 14: Trial Pit 6

| Test Pit No. | Size (m) | Depth of Pit (m) | Description |
|---|---|---|---|
| 6 (Fig 14) | 0.6 x 0.55 | 0.6 | Located over abutment. 0.15m of tarmac (001) over 0.15m of hardcore (002), over 0.3m of coarse sand and stones (012), over boulders (013). Total depth of deposits over the top of the stone is 0.6m. |
