## Glenboig Masterplan Area Phase 1, Croftfoot Farm, Glenboig, North Lanarkshire

Archaeological Evaluation  
Report No. 3902

**Archaeological Evaluation**

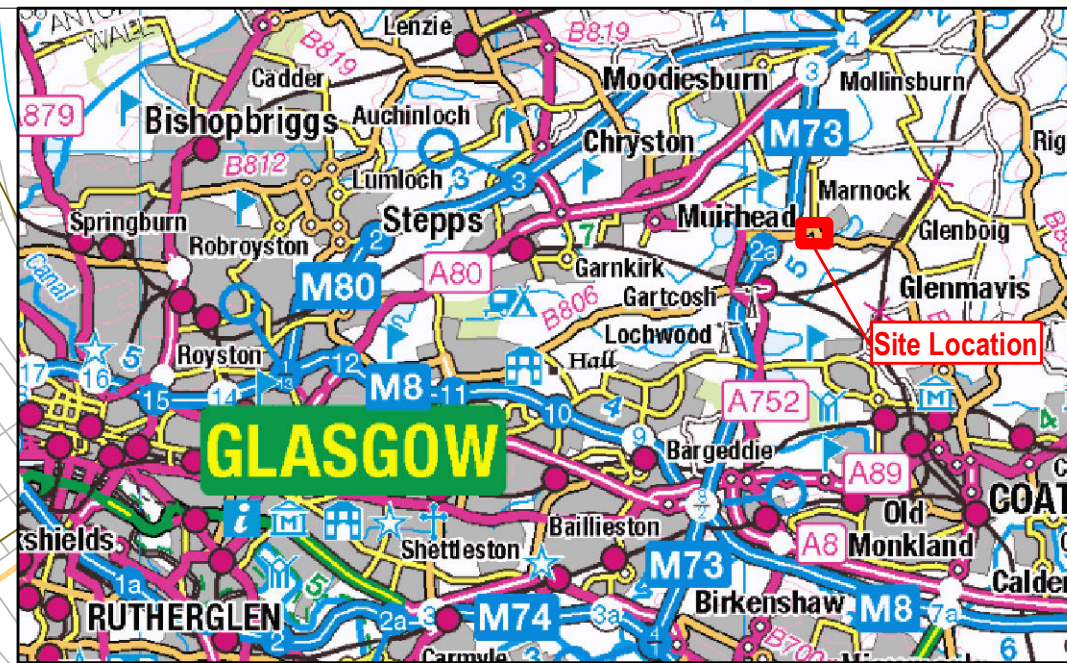
Title:  
Location map and site plan

Twenty-four trenches (Tr. 1-24, Fig. 1) were excavated with a total combined area of c.1918.5m<sup>2</sup> (c.6.75% of the 28400m<sup>2</sup> site). This was less than the 8% (2272m<sup>2</sup>) required because a significant part of the site was unavailable for trial trenching (see Section 1.2, paragraph 3).

Trench positions were surveyed using industry standard electronic surveying equipment and all trenches were backfilled at the end of each working day.

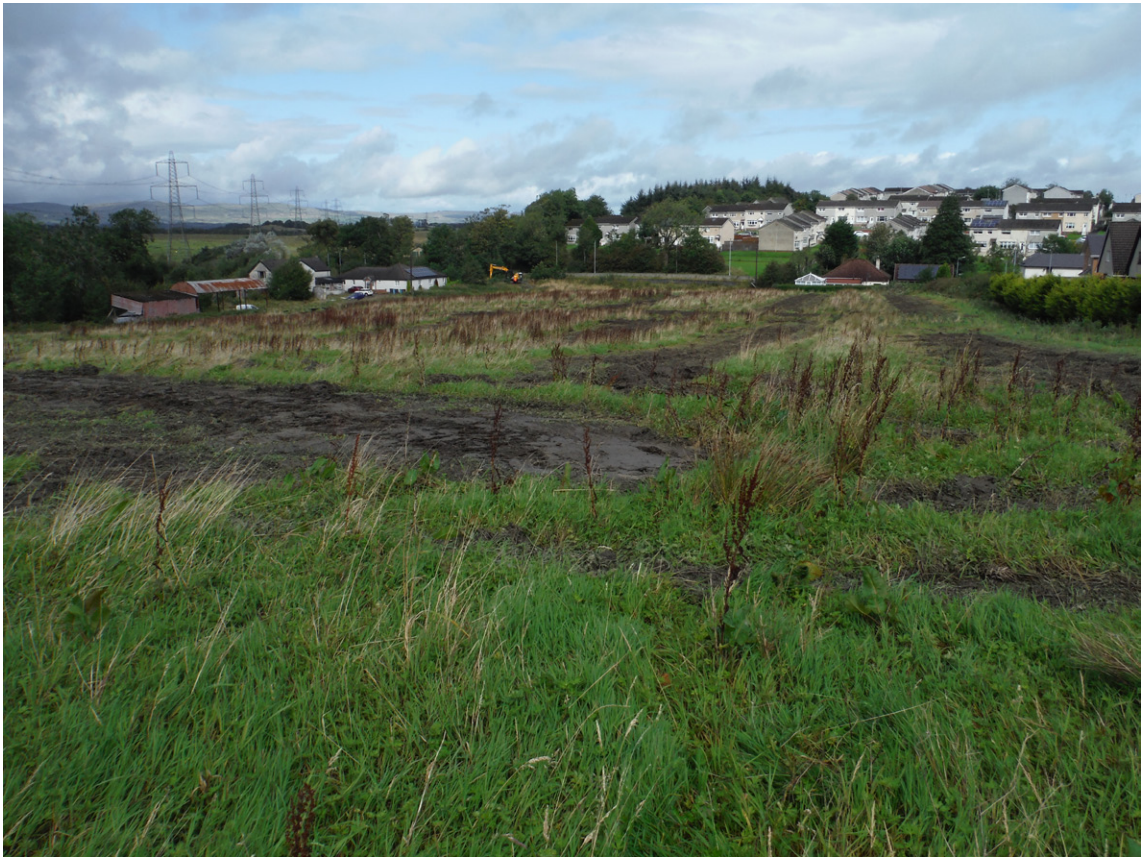
Fig. 2: General shot of development area looking NE

When this trial trenching evaluation was undertaken in September 2019, the site largely consisted of former improved land which had not been cultivated in recent years and was largely overgrown with rough grass and vegetation (Fig. 2-3). There was a complex of buildings (Croftfoot Farm) towards the northern end of the area along with an access track and areas of hard-standing. Piles of demolition debris within close proximity to the standing buildings probably relate to the demolished remains of farm buildings depicted on the early OS map editions. A watercourse along the eastern edge of the area follows the line of a mill-lade depicted on the First Edition OS map, but there was no surviving evidence of the mill building. Modern service maps depict a ruin relating to part of a line of buildings depicted on the Second Edition OS map, but this was now completely overgrown and the location was unavailable for trial trenching due to ecological constraints and the location of a water main. Early map editions suggest that the area to the north of Croftfoot Farm had been enclosed cultivated land, but this was now completely overgrown with dense tree cover. This

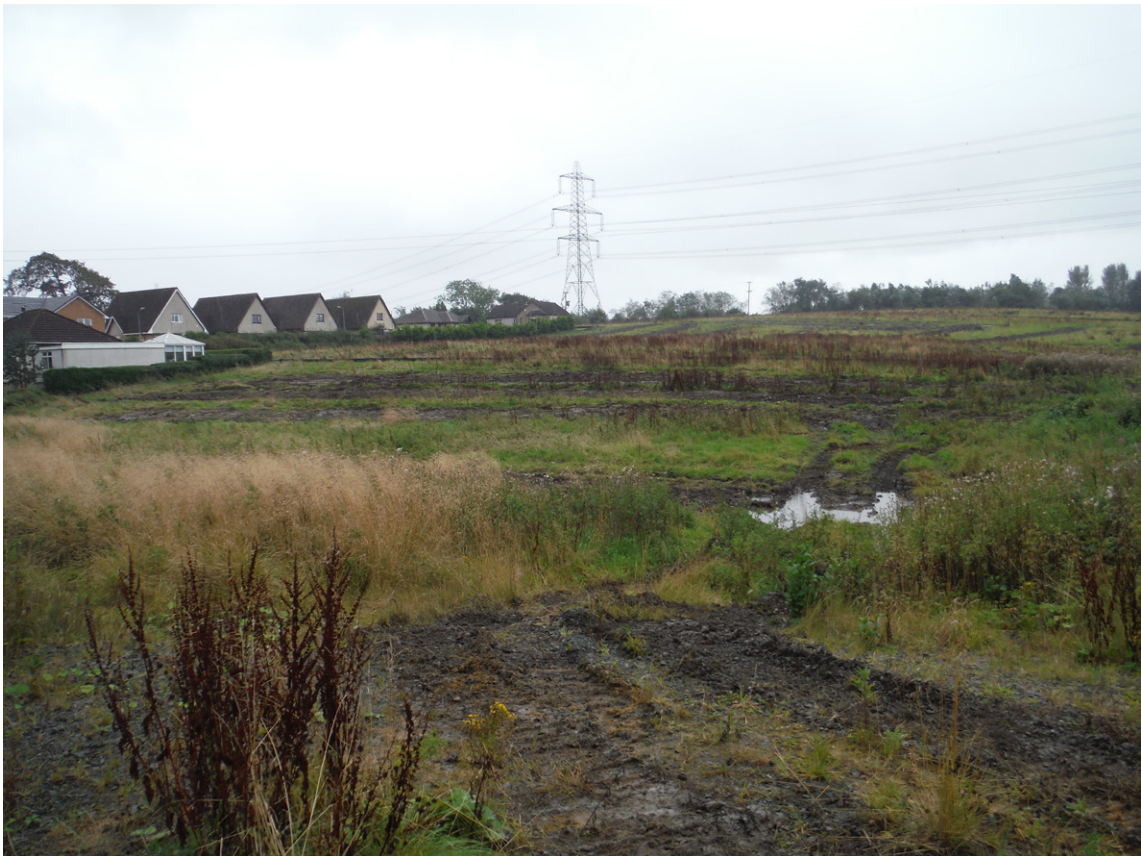
Fig. 3: General shot of development area looking SW

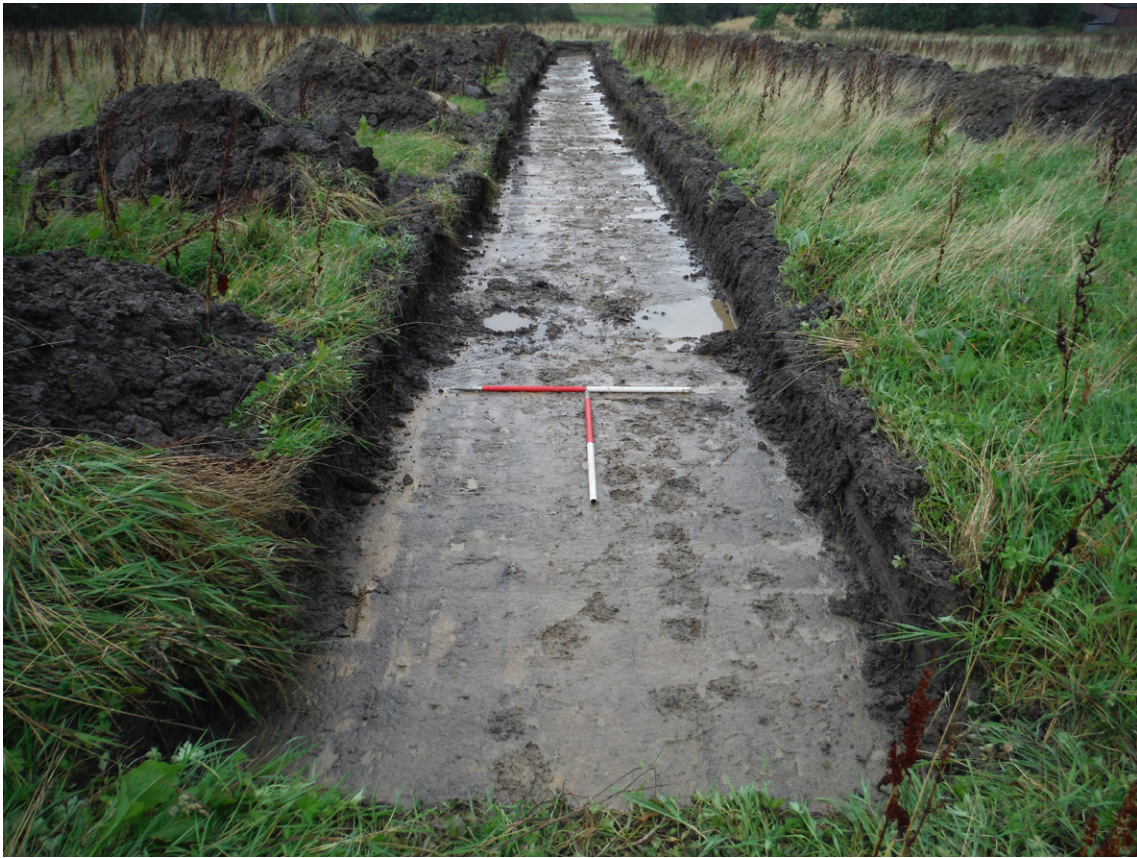
The deposits across the area had depths varying between 0.25m and 0.6m and predominantly consisted of grey-brown clayey-silt topsoil (**001**) and orange-brown silty sandy-clay subsoil (**002**) overlying mottled orange-brown and orangey-cream sandy-clay natural (**003**) (Fig. 4-7). Weather conditions during this trial trenching evaluation were predominantly wet and although the topsoil felt heavily waterlogged, flooding only occurred in Tr.1 within the lowest part of the site. The natural within this trench consisted of heavy grey clay whereas elsewhere it consisted of sandy-clay.

Fig. 4: Trench 5, general shot looking NNW

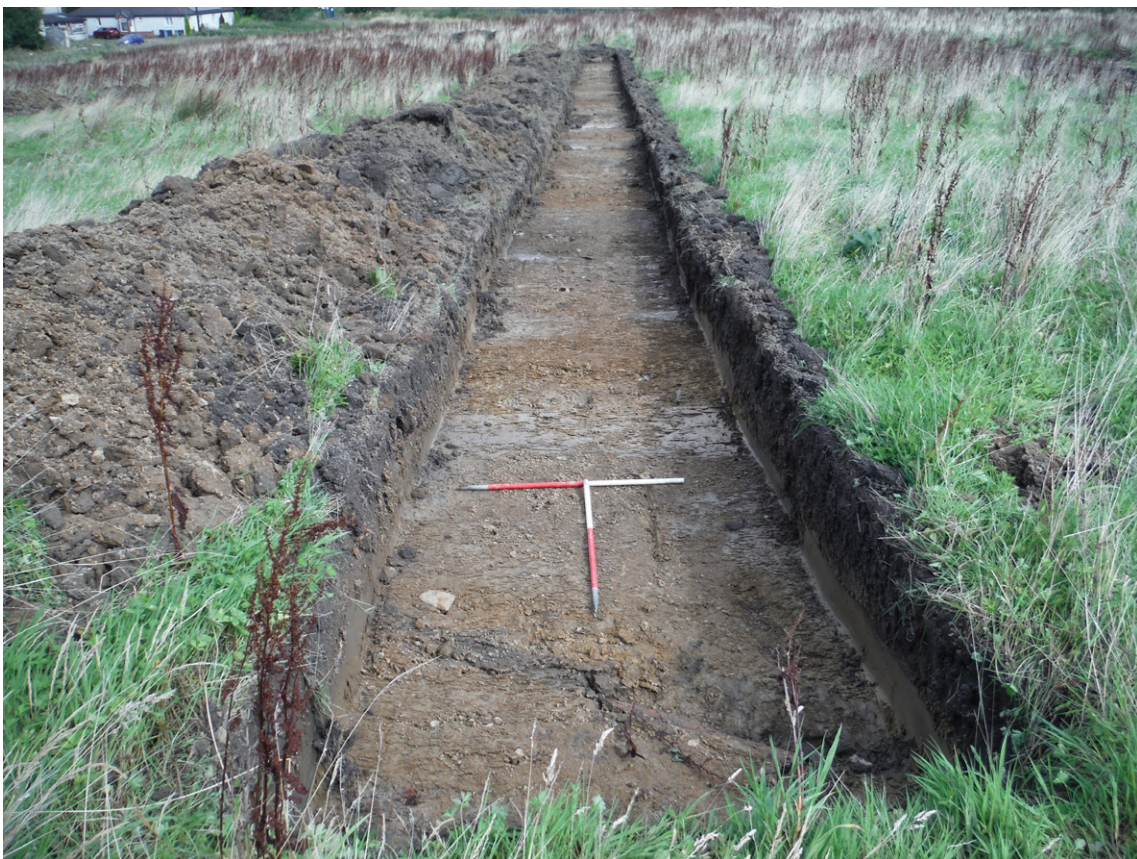
Fig. 5: Trench 11, general shot looking NE

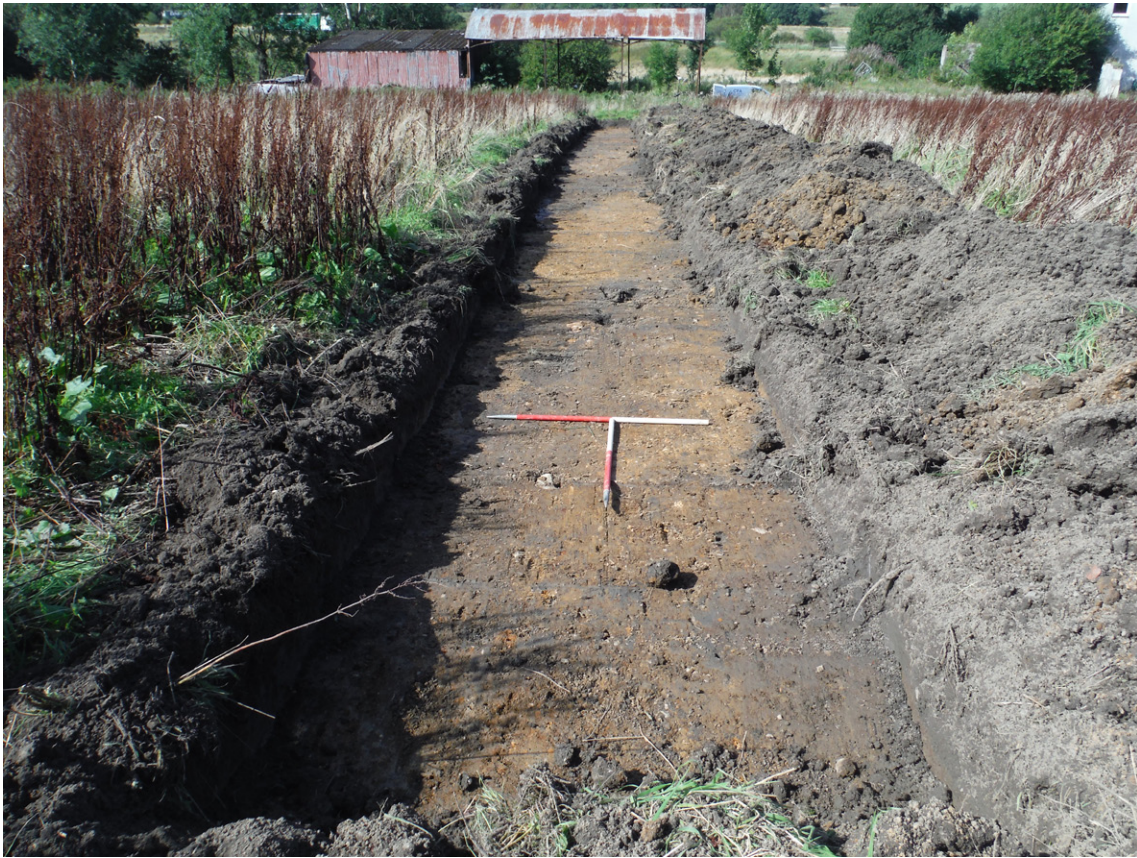
Fig. 6: Trench 17, general shot looking NW

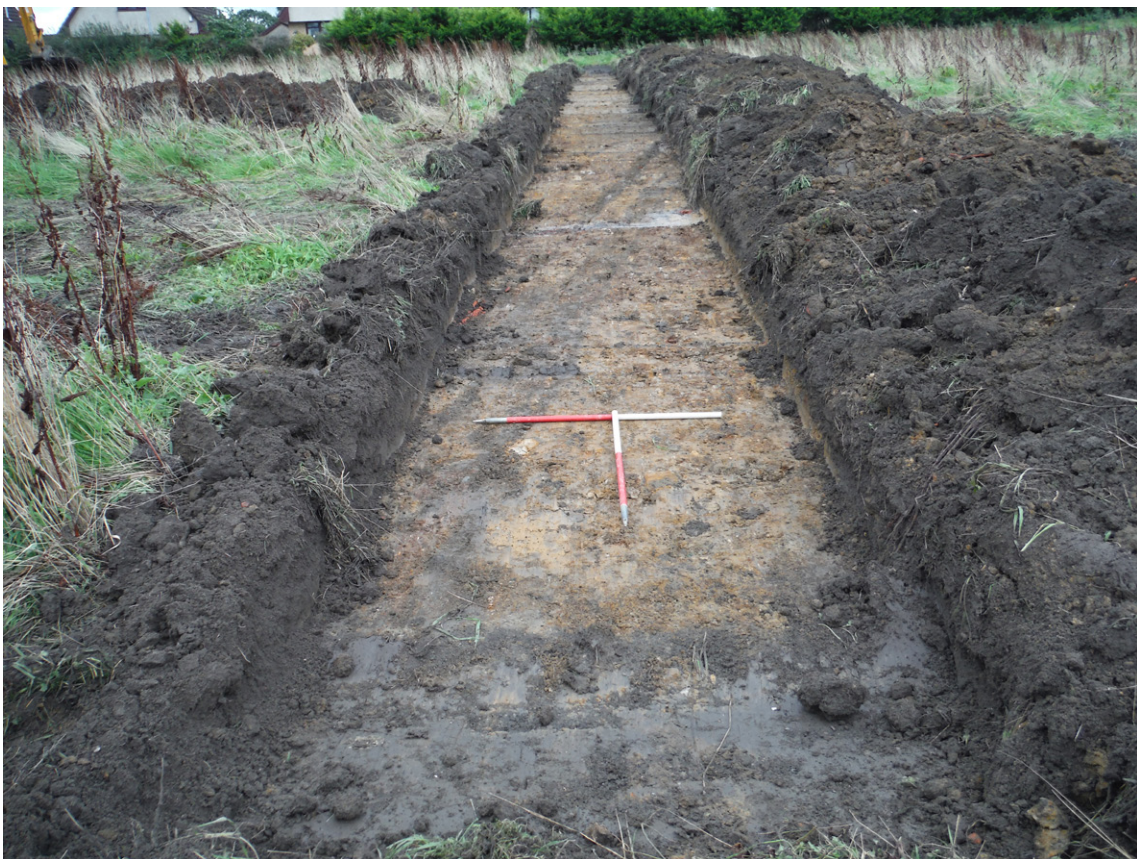
Fig. 7: Trench 23, general shot looking SE

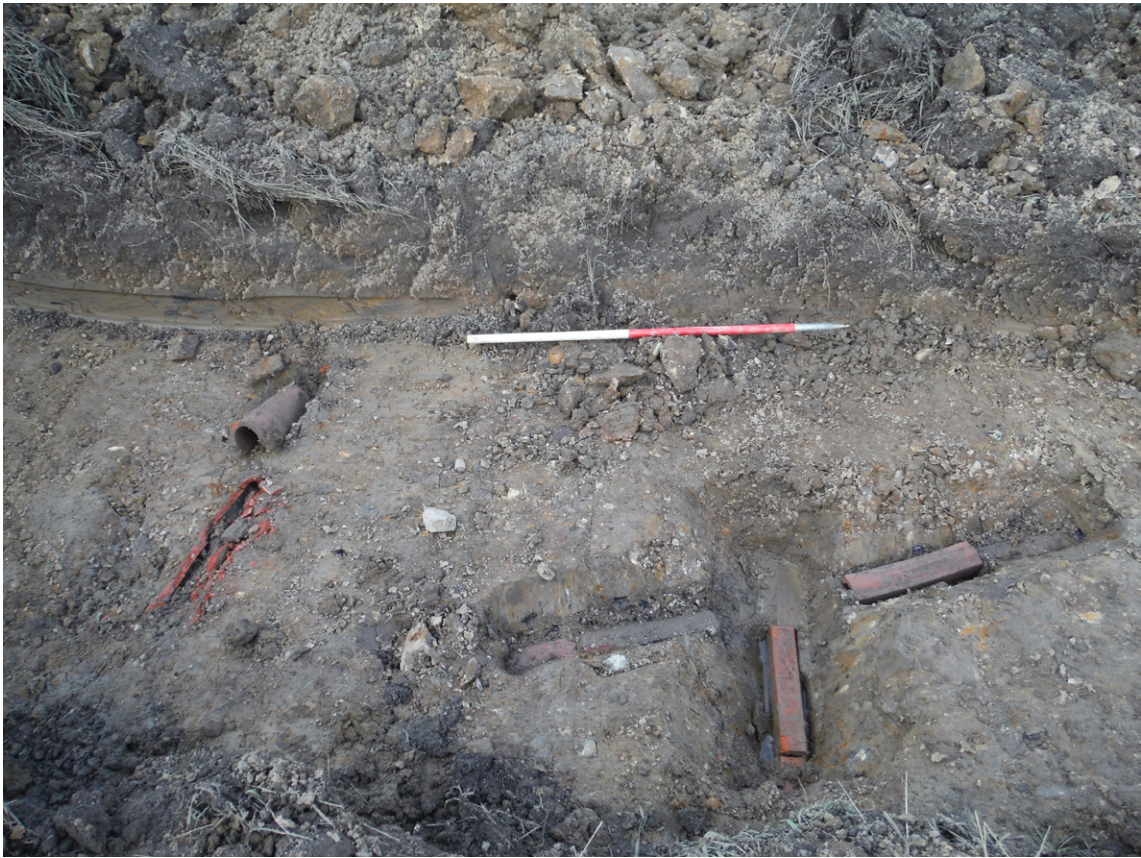
Evidence of more recent agricultural improvements was identified in the form of field drains. These consisted of early ceramic horseshoe drains as well as later ceramic cylinder drains (Fig. 8). There were also a number of drains containing industrial ash and cinders. The majority of these drains, particularly the earlier ones, tended to follow the alignment of the cultivation furrows.

Fig. 8: Horseshoe and cylinder drains in Trench 12

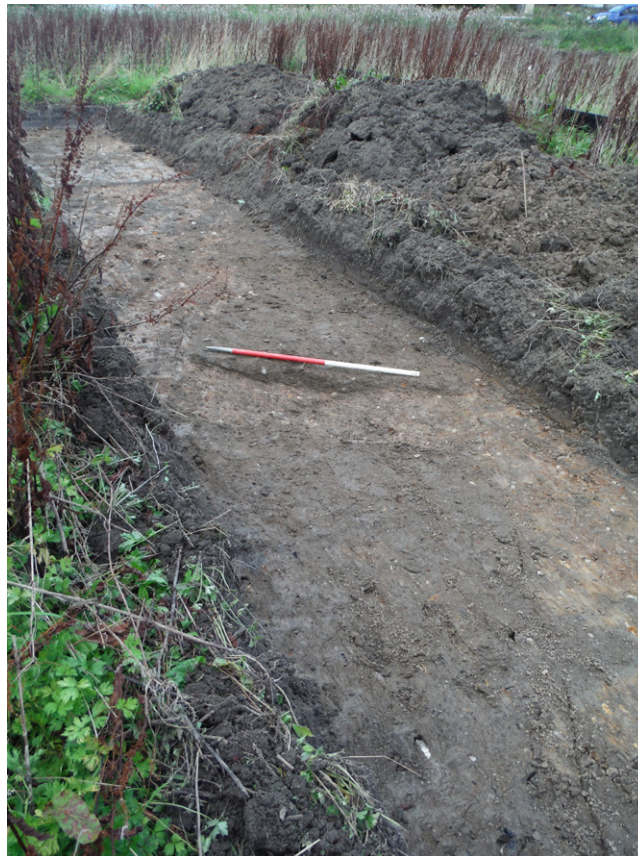
Cultivation furrows were identified across the entire area to the south of Croftfoot Farm (Fig. 9-10). These were all on the NNW to SSE alignment indicated on General Roy's map of c.1750. They predominantly measured between 1 and 2m in width and had a depth of <0.05m. The furrows generally tended to be c.4m apart, but spacing of as little as 2m in some places may indicate a possible second phase of cultivation.

Fig. 9: Cultivation furrow in Trench 18

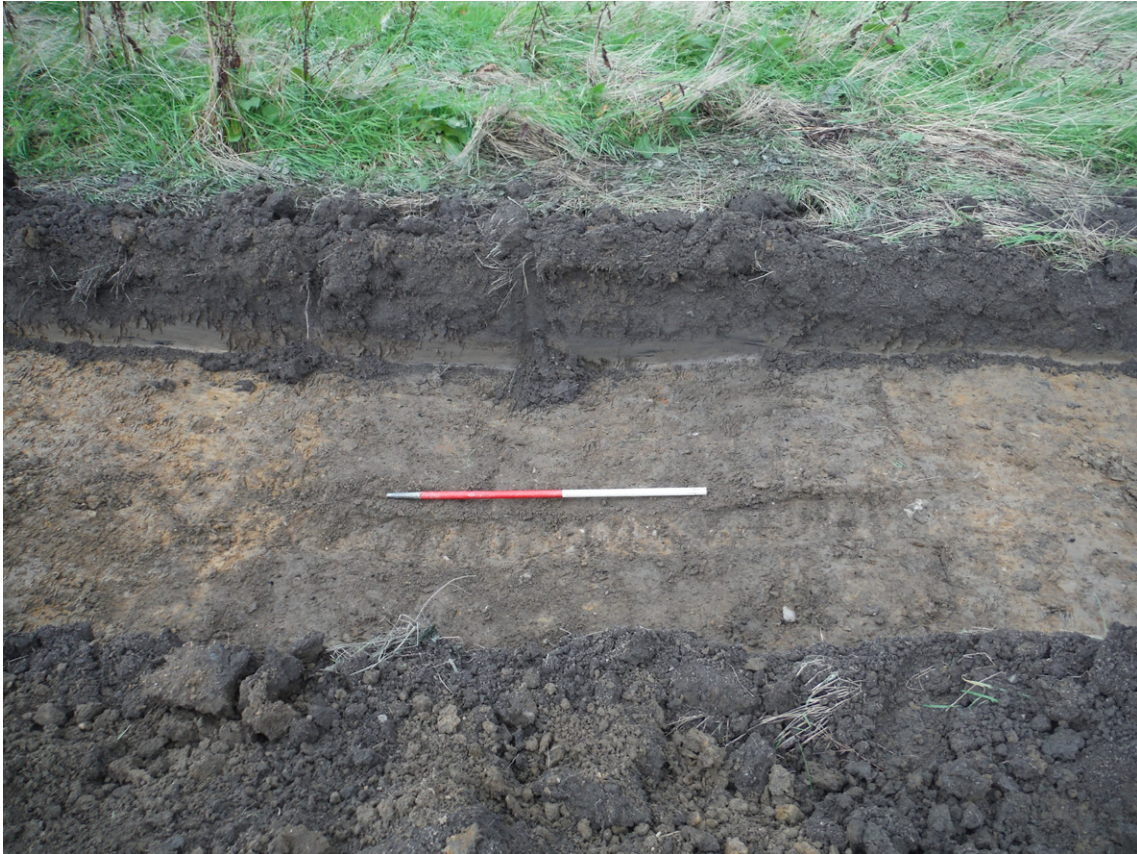
Fig. 10: Cultivation furrow in Trench 22
