Archaeological Watching Brief & Evaluation  
Report No. 3870

**Bonnington Mill,  
70-72 Newhaven Road,  
Archaeological Watching Brief & Evaluation**

**Report No.3870**

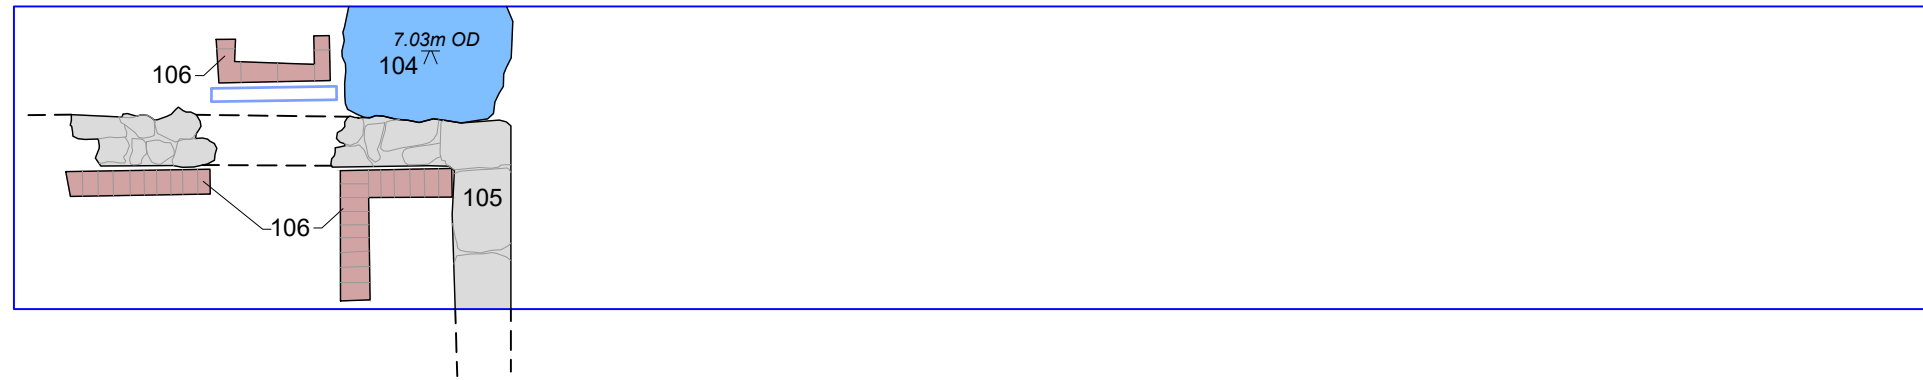
Fig. 3: Trench 1 Plan

Trench 1 measured 25m by 2m and was excavated to natural sand at a depth of 1.2m (Fig. 11).

A modern monoblock (**101**) surface overlay loose sand and clay with random lenses of rubble and ash (**102**) to a maximum depth of 1m. A sondage was excavated to verify natural which was clean sand (**100**) at a depth of 1.2m below the site surface.

The made ground lay over part of a sandstone structure (**105**) (Fig 12) whose upper surface was only just below the level of the monoblock surface. The wall was substantial and aligned north-south with a return to the west. It survived to 0.7m high. A concrete foundation block (**104**) lay to the immediate north of the wall. Short lengths of brick walls (**106**) were also identified, possibly lying in the inside and outside of the stone wall. No surfaces were identified.

It is probable that the stone wall had formed part of the Tannery shown on the 1852 map which was then appears to be incorporated into the later paper mill.

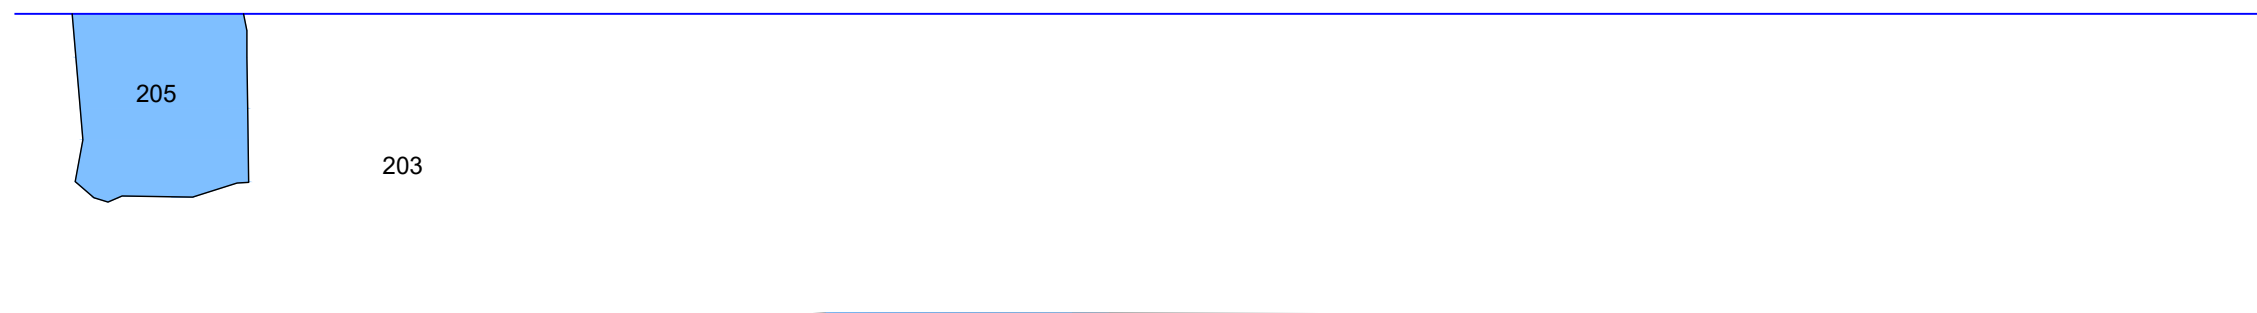
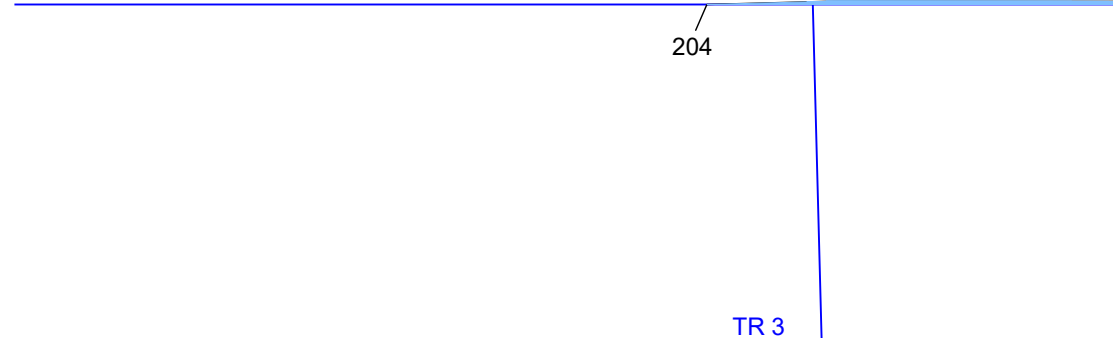
Fig. 4: Trench 2 Plan

Trench 2 measured 25m by 2m and where possible was excavated to natural (**200**) at a depth of 1.9m below the site surface. The trench was surfaced with recent demolition crush (**201**) between 0.4m and 1m deep. The crush overlay loose demolition rubble and made ground (**202**) comprising soil, clay, brick and stone rubble, and ash. This sealed all of the identified features.

The remains of an east-west aligned sandstone wall (**206**) were identified crossing the trench (Fig 13). It was 0.4m wide and survived to c.1m high. Due to the instability of the trench sides the foundations of it were not reached, however it was set into the surface of the black sandy clay deposit (**203**). A small surviving fragment of a flagstone surface (**209**) was exposed for an extent of 2m x 2.2m. It has been truncated on its northern and southern sides. It was laid on the surface of **203**. An fragmentary brick wall (**207**) situated between the flagstone surface (**209**) and the stone wall (**206**) (Fig 13) was also set onto the surface of **203**. A spread of ash (**208**) abutted one side of the brick wall.

More recent remains included the stub of an east-west aligned modern brick and concrete wall footing (**205**) measuring 0.8m wide and 0.6m; a north south aligned concrete wall (**204**) which was revealed in the trench section measuring 4.4m long and 1.3m high which was revealed in the trench section; and stub of a red brick wall (**210**).

The sandstone wall (**206**) and surface (**209**) may be fragmentary remains of the Paper Mill that occupied the site from at least 1876 but could have originated from the earlier Tannery.

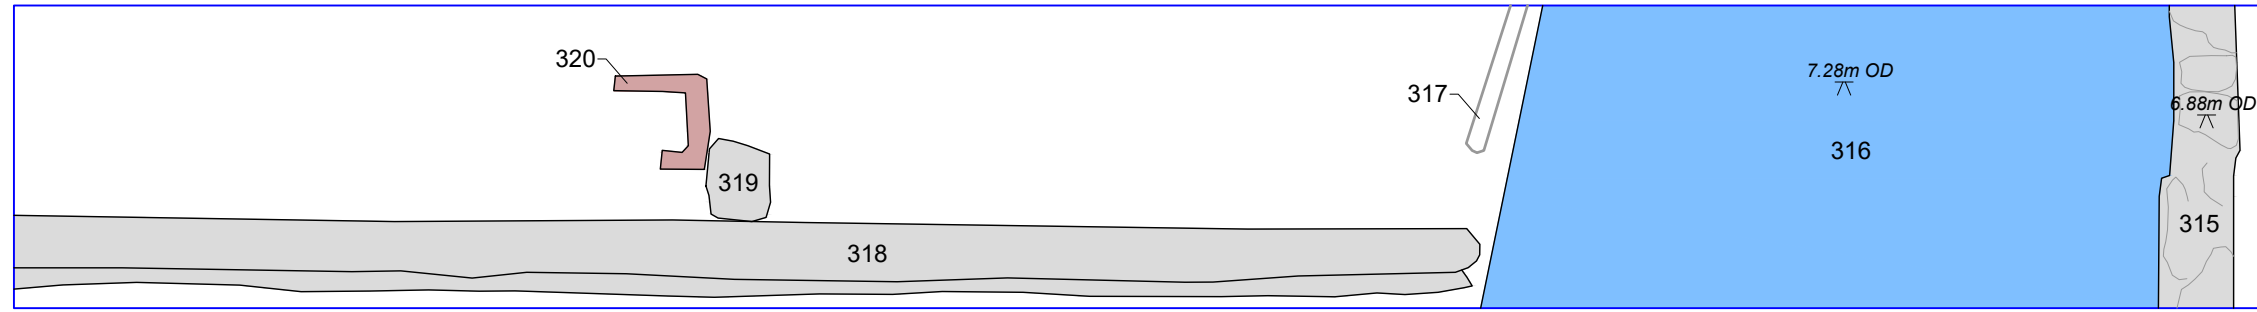
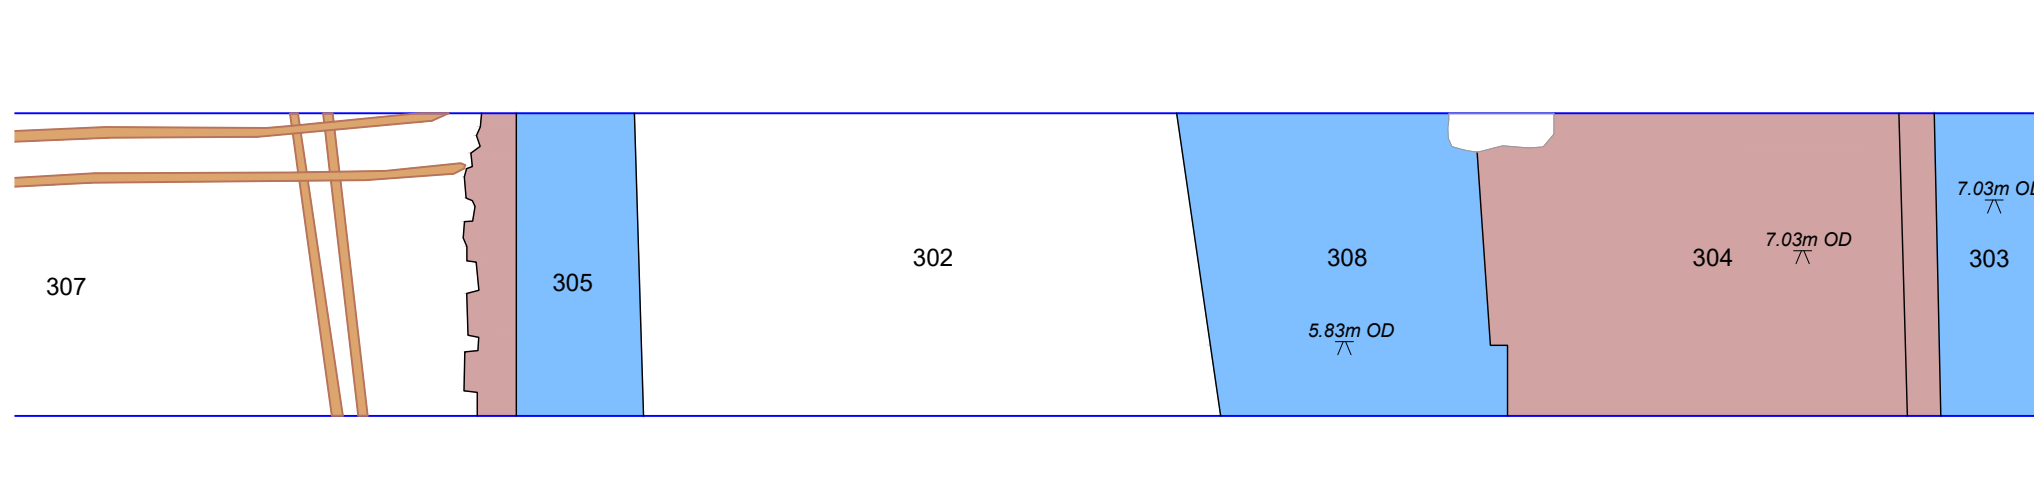
TR 3

Trench 3 measured 40m by 2m and was excavated to natural sand (**300**) where possible at a depth of 1.5m. It was placed abutting the edge of Trench 2 to better understand the nature of the wall (**204**) seen in section, and to investigate the remains of the tannery tanks depicted on the 1852 Ordnance Survey map and discovered during the monitoring of site investigation trial pits. The surface of the trench comprised recent demolition crush (**301**) to depths between 0.5m and 1m. It overlay made ground deposits (**302**) comprising earlier demolition including clay, ash, and stone and brick rubble to a thickness up to 1m.

Wall 204 extended in to this trench and was given the context number (**303**) it was brick lined on its western face. c.8.3m To the west of this wall and running parallel to it was another 0.8m wide concrete wall with brick facing (**305**). Between these walls a rough brick surface with no mortar jointing was exposed (**304**). The bricks used were predominantly curved flue bricks (Fig 15). They overlay a black ash bedding layer which in turn overlay loose brick rubble. At a depth of 1.5m below the top of Wall **204** the loose brick rubble overlay a smooth surfaced concrete floor (**308**). A very compact deposit of hard rubble (**302**) composed of clay, stone, concrete and ash was also identified below the brick rubble but it could not be excavated, however, it is likely that the concrete surface continued under this and adjoined Wall **305**. This is interpreted as a concrete machine pit or similar.

To the west of this the remains of what are interpreted tanning tanks (**307**) were exposed (Figs 14 & 25). From the observed remains, both in the evaluation and the SI watching brief the tanks measured c. 3m internally. They were built from timber shutters with a puddle clay lining. The interior of the tanks were filled with

To the west of the tanks a north-south alignment of potential flagstones with an abutting sandstone kerb (312) was exposed. It underlay a discrete hard deposit of black tar and ash (321) which had been cut by an electrical service trench (314). A north-south aligned sandstone wall (315) was also revealed measuring 0.5m wide (Fig 16).

The western end of the trench contained an east-west aligned sandstone wall footing (318) which was exposed for 10.5m. It was 0.4m wide and likely was a non-structural internal dividing wall. A single sandstone flag (319) abutted the wall. A partially surviving 0.6m square brick and mortar feature (320) was set against the flagstone.

The wooden tanks are probably part of the Tannery shown on 1852 OS map and the surfaces and walls etc probably belong to the later Paper Mill that occupied the site from at least 1876.

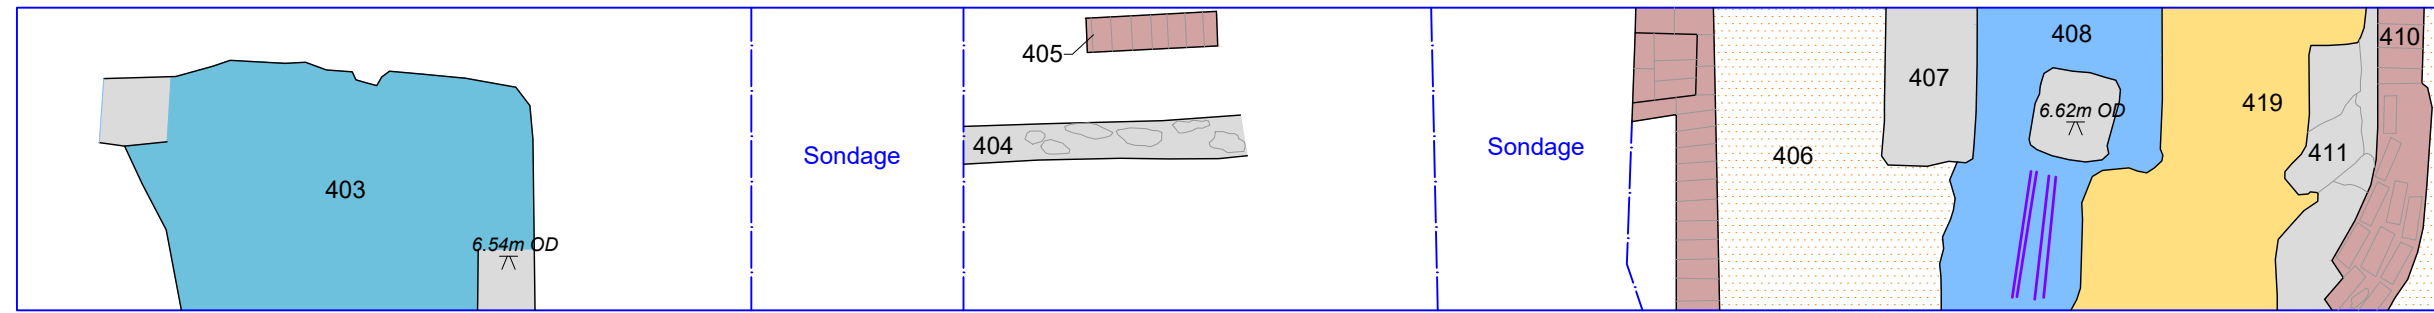
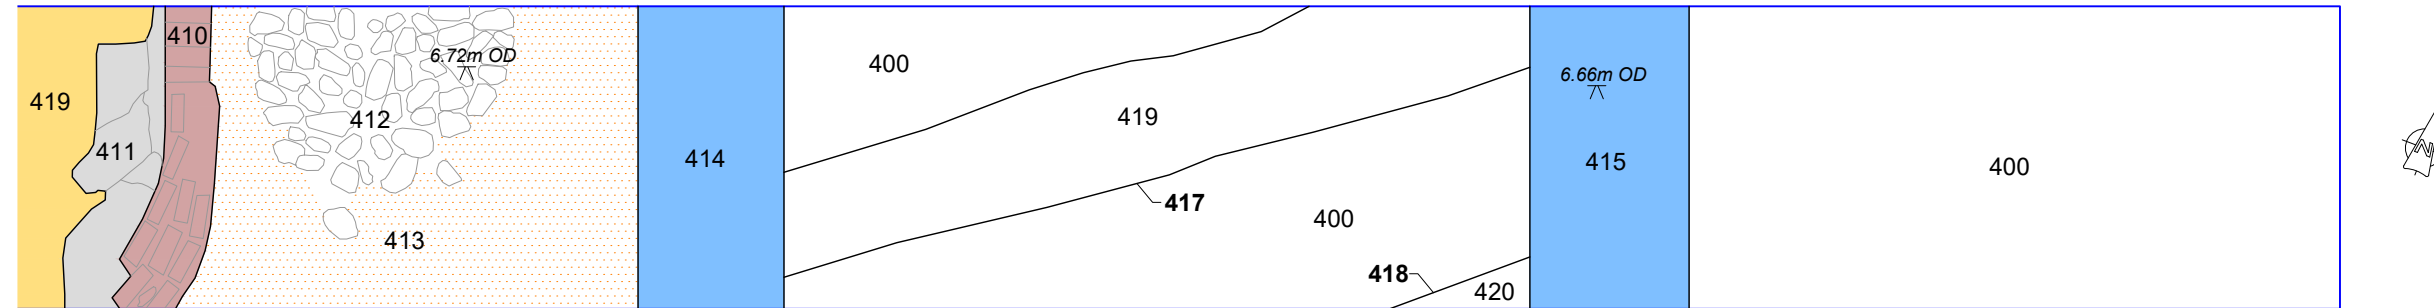
Fig. 6: Trench 4 Plan

Trench 4 measured 30m by 2m. The surface comprised recent demolition crush (401) to depths between 0.5m and 0.7m. The crush overlay earlier demolition deposits (402) of rubble, clay, stone and brick which lay to a thickness of 1.3m. Two sondages were excavated to verify natural subsoil (400) which was coarse sand with significant oil/tar contamination lay at 2m below the site surface.

This trench contained a number of features. A flagstone surface and associated sandstone wall remains (403) were exposed at the western end of the trench. The floor covered an area of c.3m x 1.5m and the wall survived to a height of 0.6m.

To the east of this a fragmentary stone wall (404) was revealed for an extent of 1.8m. It was 0.3m wide and in very poor condition. An alignment of modern red bricks (405) ran parallel to wall 404 for an extent of 1m. The surrounding ground had been heavily disturbed by demolition.

A series of abutting features occupied the centre of the trench. These were all aligned north to south. They all abutted an east-west aligned red brick wall (409) which ran down the south section of the trench. The features comprised an oil/tar contaminated brick structure with and surface (406) (Fig 17) which abutted a single large sandstone block (407) and a fragmented concrete surface (408) measuring 1.4m wide with inset iron pipes. A sandstone and mortar surface lay to the east of this and abutted a 0.9m wide sandstone wall (411) incorporating a brick structure (410) (Fig 18). A small

The remains in this trench were very fragmentary and it is most likely that these relate to the later Paper Mill that occupied the site from at least 1876.

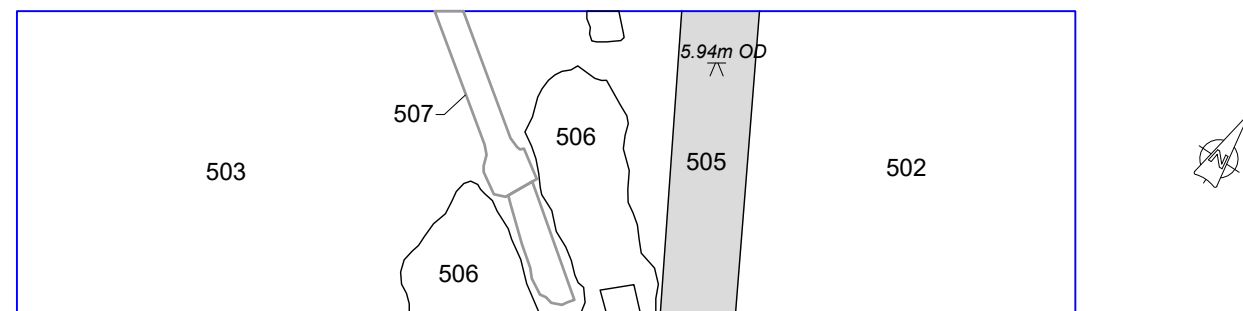
Fig. 7: Trench 5 Plan

This trench measured 7m by 2m and was excavated to a maximum depth of 0.8m. A substantial sandstone and brick wall (505) (Fig 19) aligned north to south crossed the trench. It measured 0.5m wide and was exposed to a depth of 0.8m. On the west side of the wall was a deposit of modern rubble (502) including voided stones, metal, brick and occasional fragments of corrugated asbestos tiles. Underlying this was a deposit of lime-rich rubble (503) and a modern piped service (507) surrounded by less lime rich rubble (506) was also identified. This end of the trench rapidly became flooded. Because of the presence of asbestos and the flooding, the trench was then abandoned.

The exposed wall was probably not associated with the Lade but was probably a part of the structure shown in this area from the 1876 map forwards. No surfaces were identified.

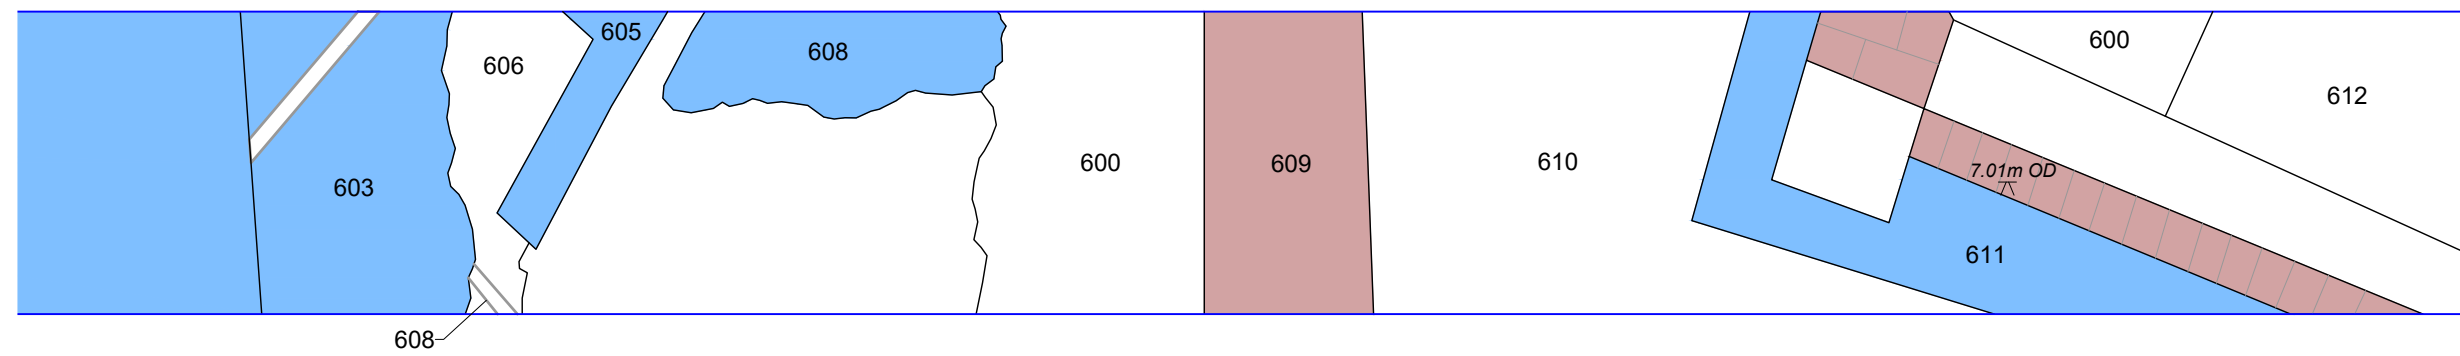
Fig. 8: Trench 6 Plan

Trench 6 measured 26m by 2m and was excavated to a max depth of c.2m. What is presumed to be natural sand (600) was exposed at a depth of 2m.

The surface of the trench was covered in recent demolition crush (601) which was 0.4m deep at the western end of the trench and up to 1m deep at the eastern end. Beneath the crush at the eastern end was a modern tiled floor surface overlying concrete (602) and concrete floor, possibly missing the tiles seen elsewhere (603) (Fig 20). The concrete was so thick it could not be removed. The concrete floor surface had a sandstone wall footing (604) aligned east-west running through it. It was 0.2m wide and was likely the stub of an interior dividing wall. A flat iron plate was fixed to the edge of the concrete. Beyond the concrete, the trench contained deep and mixed deposits of modern demolition rubble (606) which contained brick, soil, stone and ash. Numerous modern drainage services were set within the rubble. A yellow plastic pipe (608) was also identified and was avoided due to the risk of gas.

A number of modern structures were identified within the trench including two concrete manhole bases (605 & 611) set onto the natural sand surface, and a north-south aligned brick and concrete wall (609) measuring 1.1m wide and 0.6m high.

All of the features in this trench appeared very recent in date and may have formed part of the later phases on the Paper Mill.

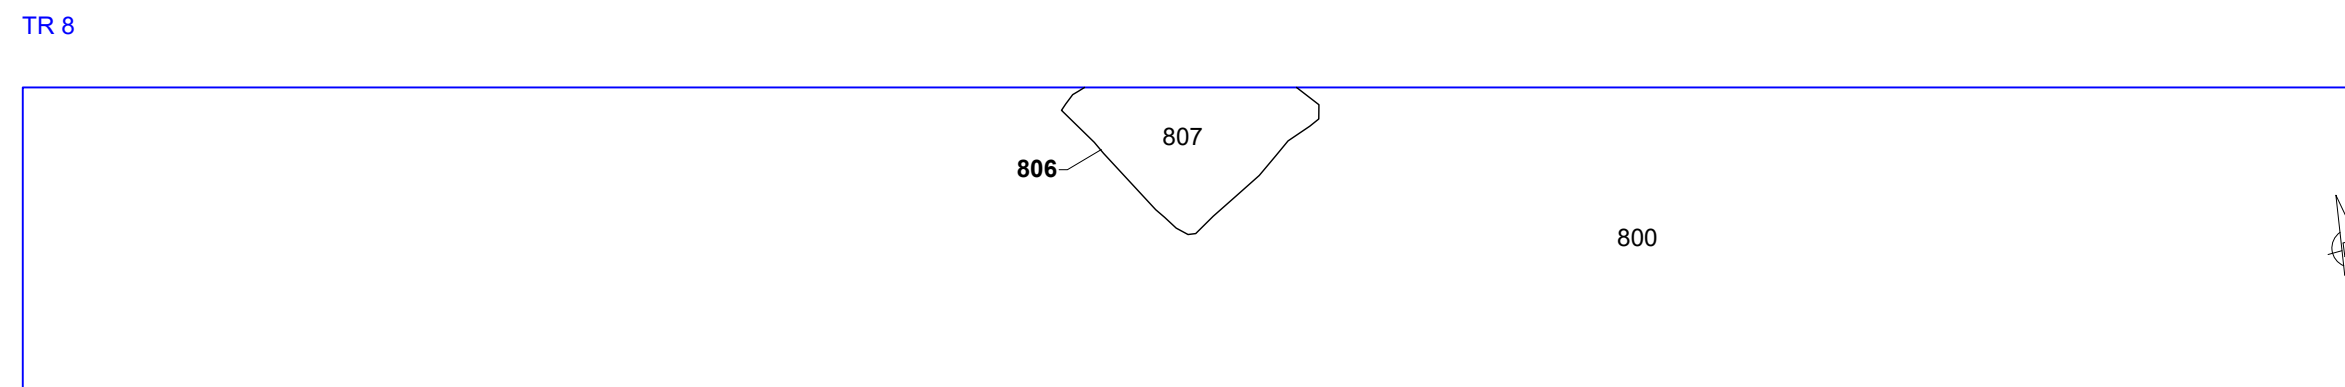
Fig. 10: Trench 8 Plan

Trench 8 measured 20m by 2m and was excavated to a maximum depth of 2m. This trench was excavated across an area occupied by yards or garden plots on the 1876 Ordnance Survey map.

The area of the trench was surfaced with modern monoblock (**801**) which was laid onto a concrete surface (**802**) which in turn overlay cobbles (**803**). A 0.8m deep deposit of mixed brick, stone and soil rubble (**804**) underlay the cobbles for the entirety of the trench. This overlay a 0.7m thick layer of made ground (**805**) which comprised brown and grey soils, with occasional lenses of mortar, brick and stone.

Natural sand (800) was exposed at the base of the trench and was coarse clean sand. A rectangular cut (806) was identified in the sand measuring 1.2m x 1.0m. It had straight sides and was filled with brick rubble and ash (807).

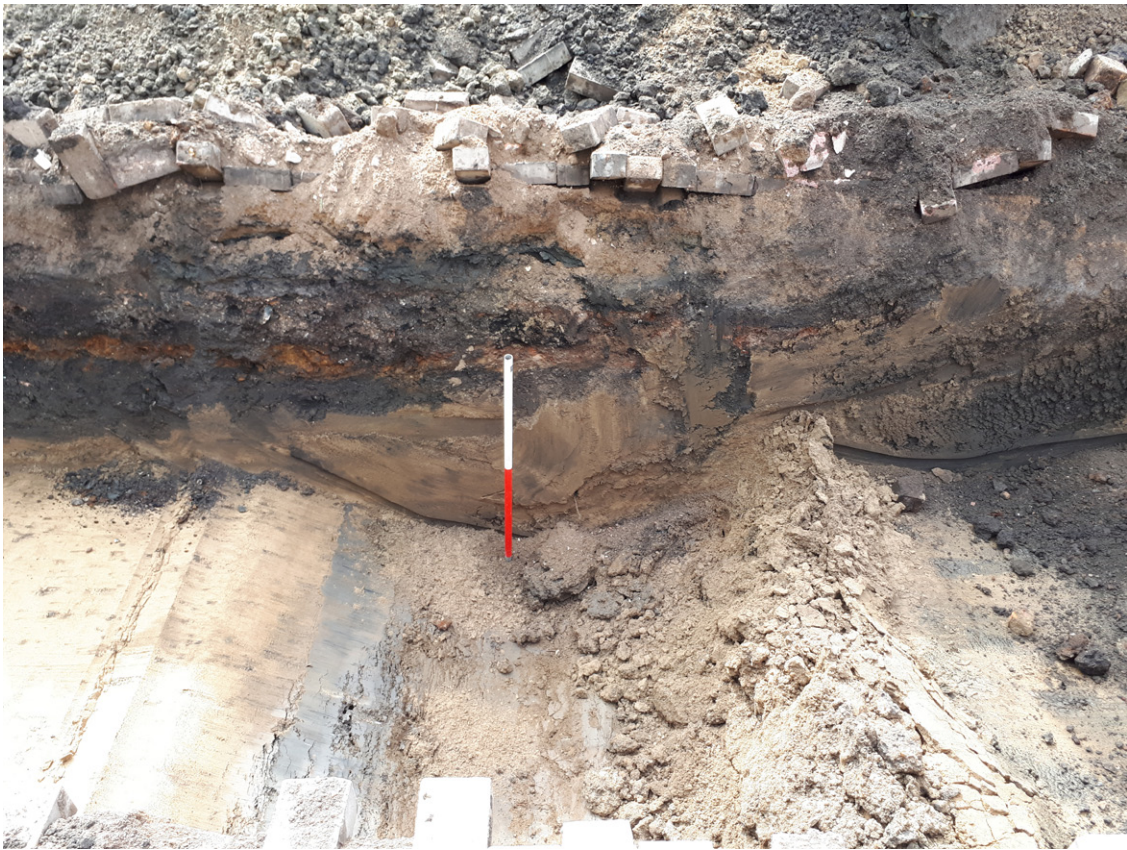
Fig. 11: Trench 1 Sondage

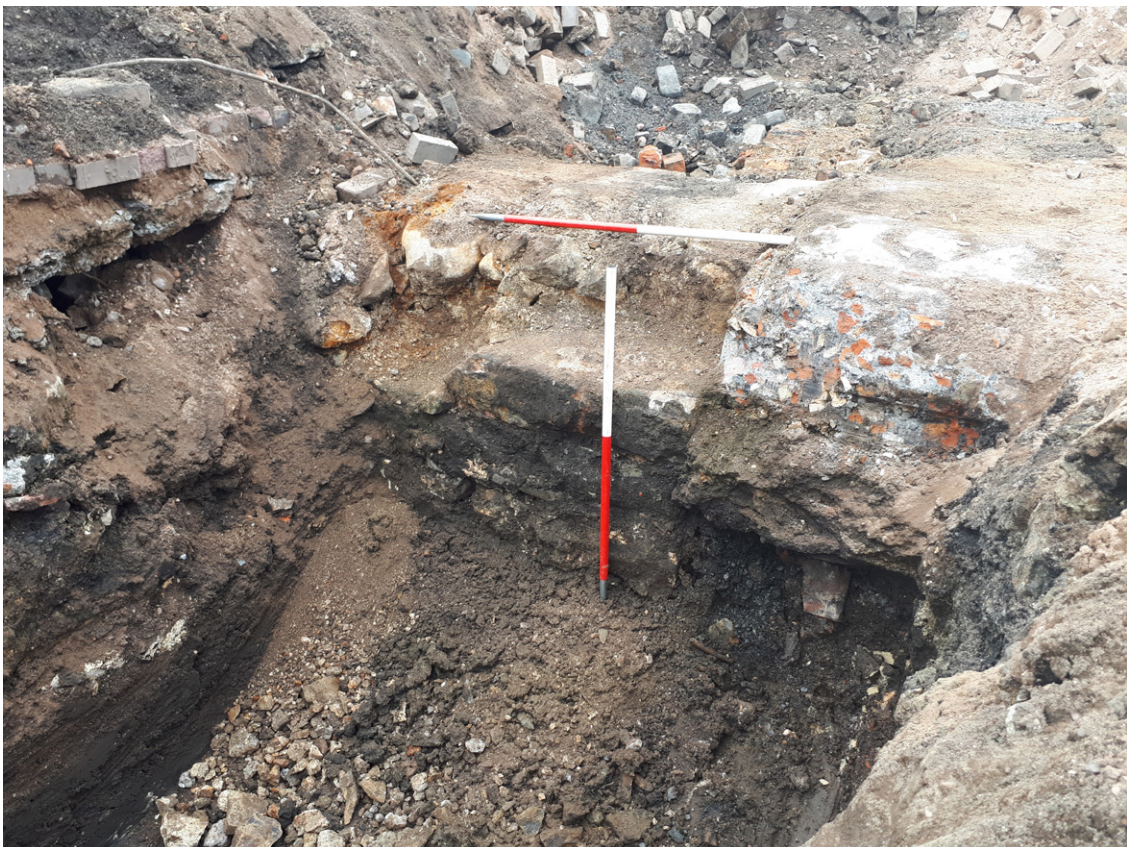
Fig. 12: Trench 1 Wall remains (105)

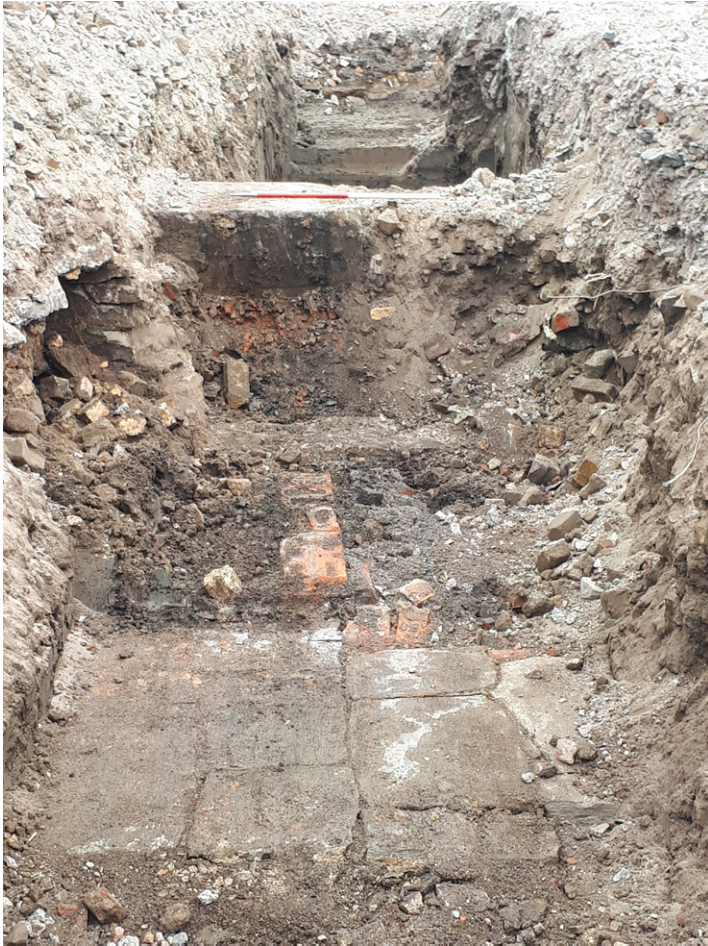
Fig. 13: Trench 2 stone surface (209) and wall (206) and wall (207)

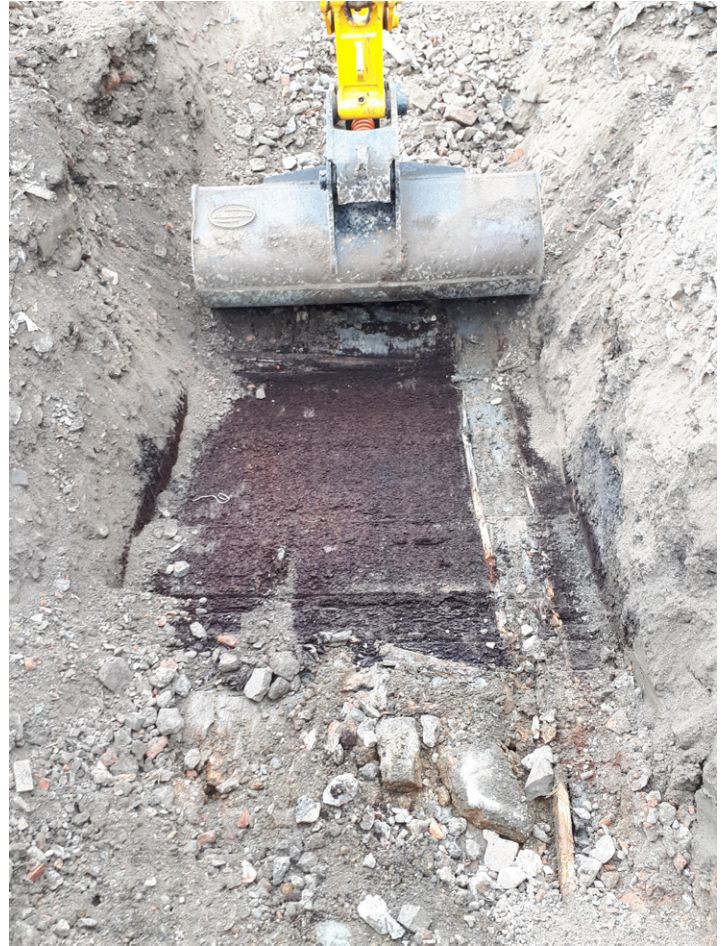
homogenous dark brown composted material. This was excavated during the SI watching brief and the tanks were shown to have a wooden base. These tanks appeared to have been truncated by the concrete lined tank to the east and by a service pipe (309) and a later brick wall (310) to the east.

Fig. 14: Trench 3, working shot showing tanning tank remains (307)

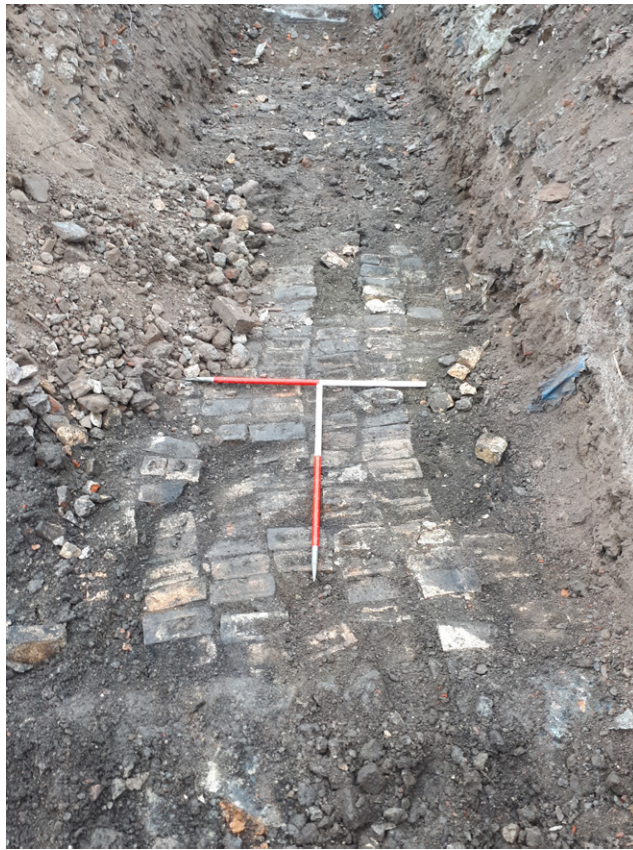
Fig. 15: Trench 3, Reused flue-brick surface (304)

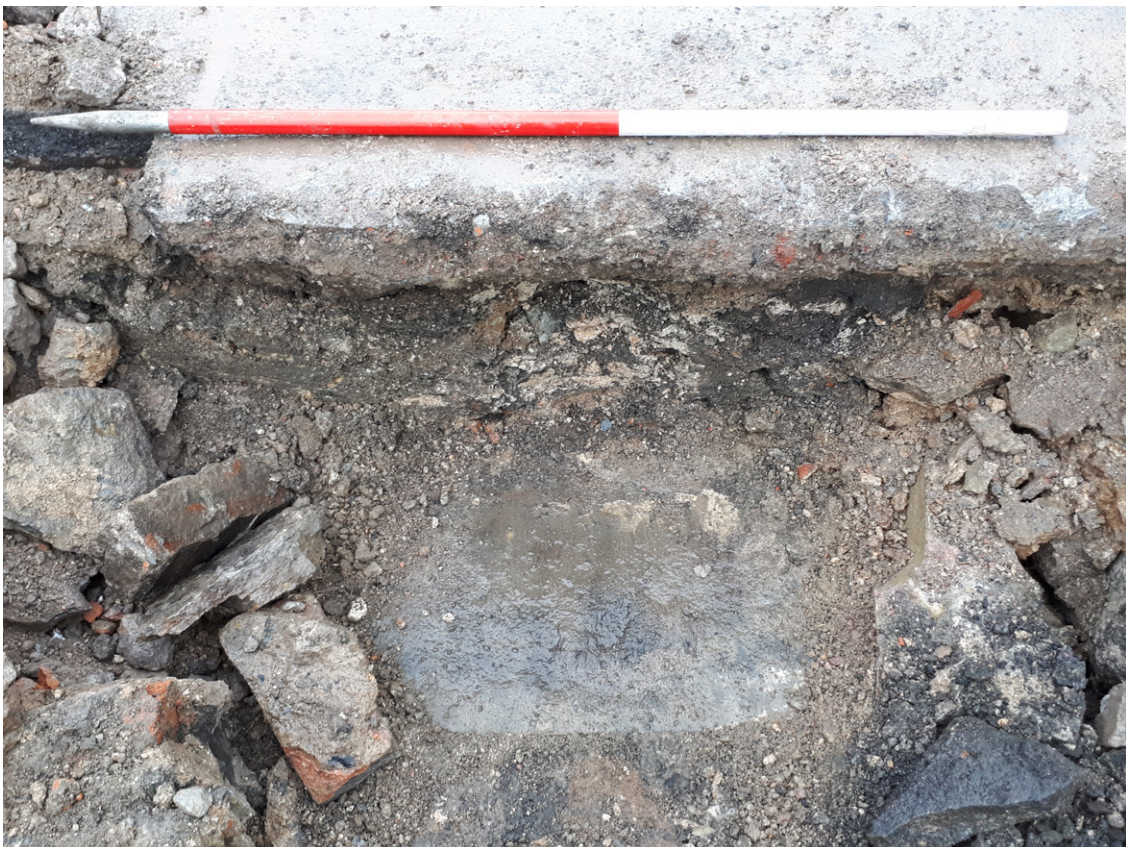
Fig. 16: Trench 3, Sandstone wall (315) under concrete surface (316)

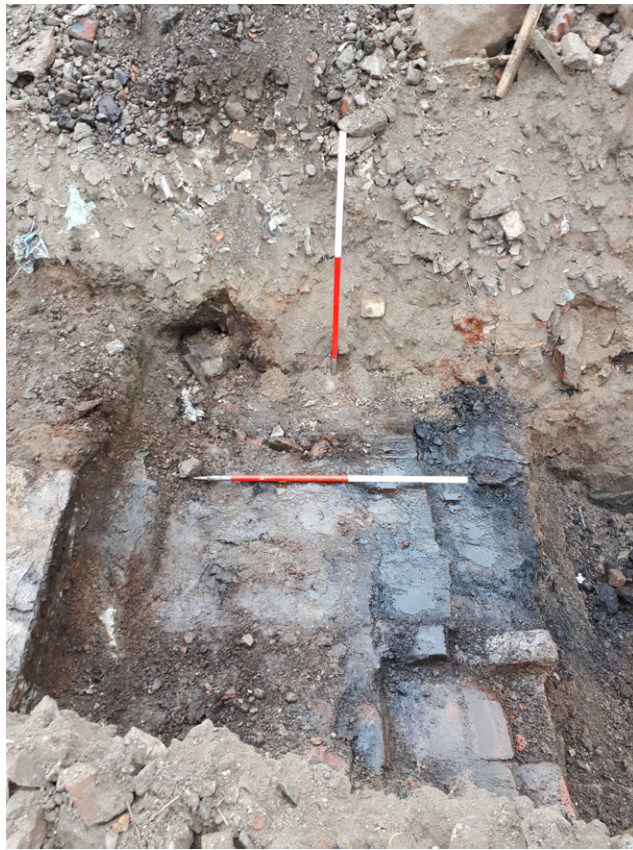
Fig. 17: Trench 4 Black stained brick structure (406)

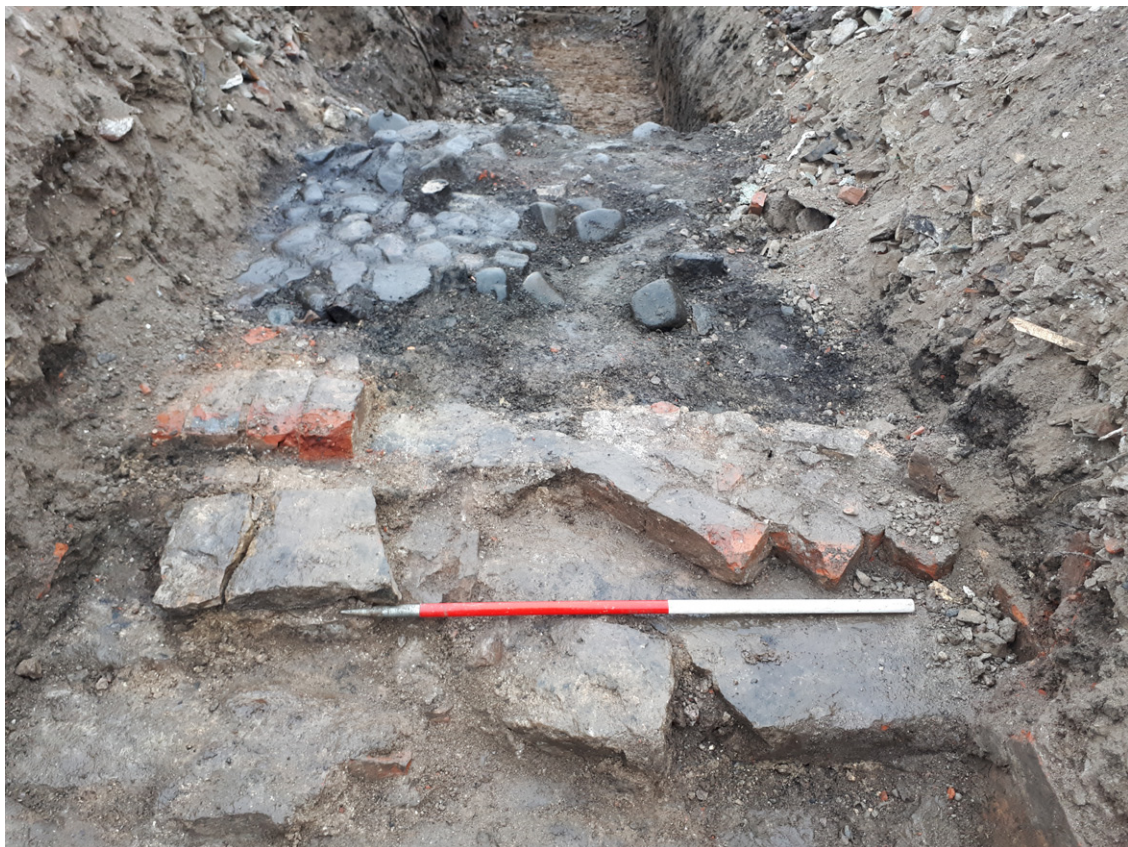
patch of rough cobbles (412) lay to the east of this which covered an area of 1.7m by 1.1m. They were set onto a hard deposit of tar, ash and brick rubble (413).

Fig. 18: Trench 4 Brick (410) & sandstone (411) structure and cobbles (412)

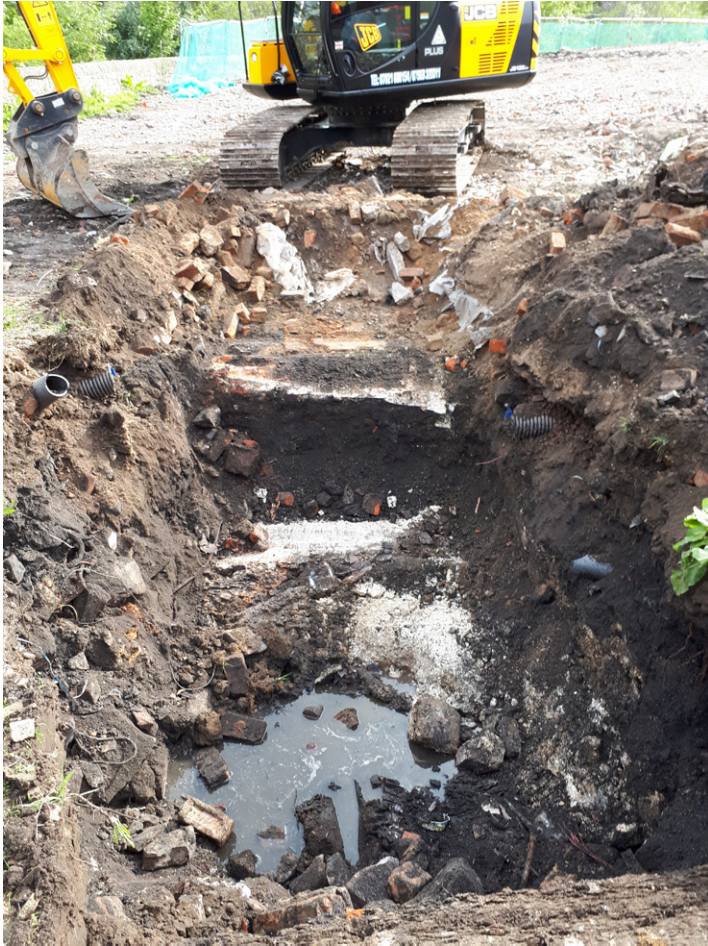
Fig. 19: Trench 5 showing wall (505)

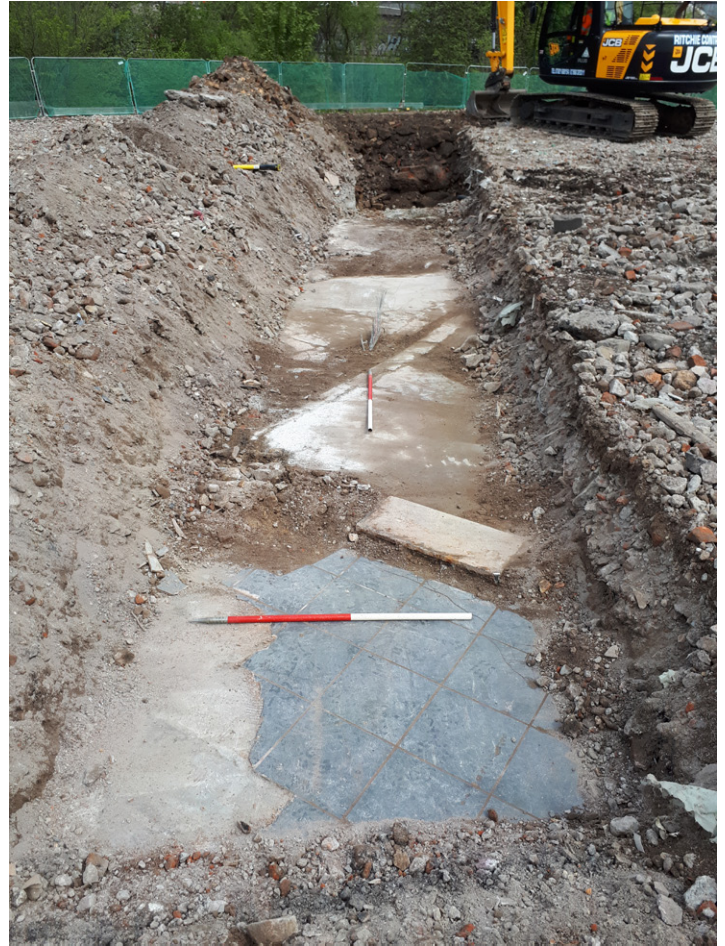
Fig. 20: Trench 6 showing tiles (602), Concrete (603) and stone wall or kerb (604)

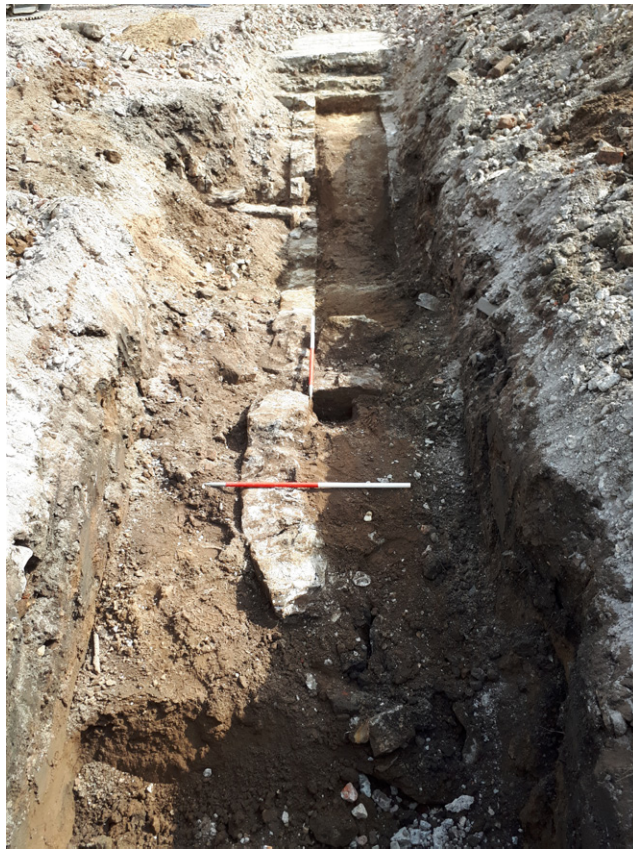
Trench 7A was covered with a thin layer of overburden (**704**) and modern demolition rubble (**705**) overlying made ground (**711**) comprising a brown silt/rubble/mortar mix measuring up to a maximum depth of 1m. The southern end of the trench was excavated down to a cobbled surface and stone kerb (**701**) and a later concrete surface (**702**) which the machine was unable to break through. The concrete abutted a mortar bonded sandstone wall (**703**) which ran east to west and was 0.6m wide. Two truncated parallel walls (**706** & **707**) abutted Wall **703** (Fig 21) and extended north towards the river for 9m. Both walls were built of mortar bonded sandstone and measured 0.6m wide. A sondage excavated down the side of wall **707** identified what is assumed to be the base of the foundation c.2.2m below the site surface. Wall **707** curved to the west at its northern end and Wall **706** ran under the section of the trench. The two walls were set 0.9m apart and the gap between was filled with very fine well sorted homogenous mid brown silt (**708**) up to 0.8m thick.

Fig. 21: 7A, Walls 703, 706, 707 and 709

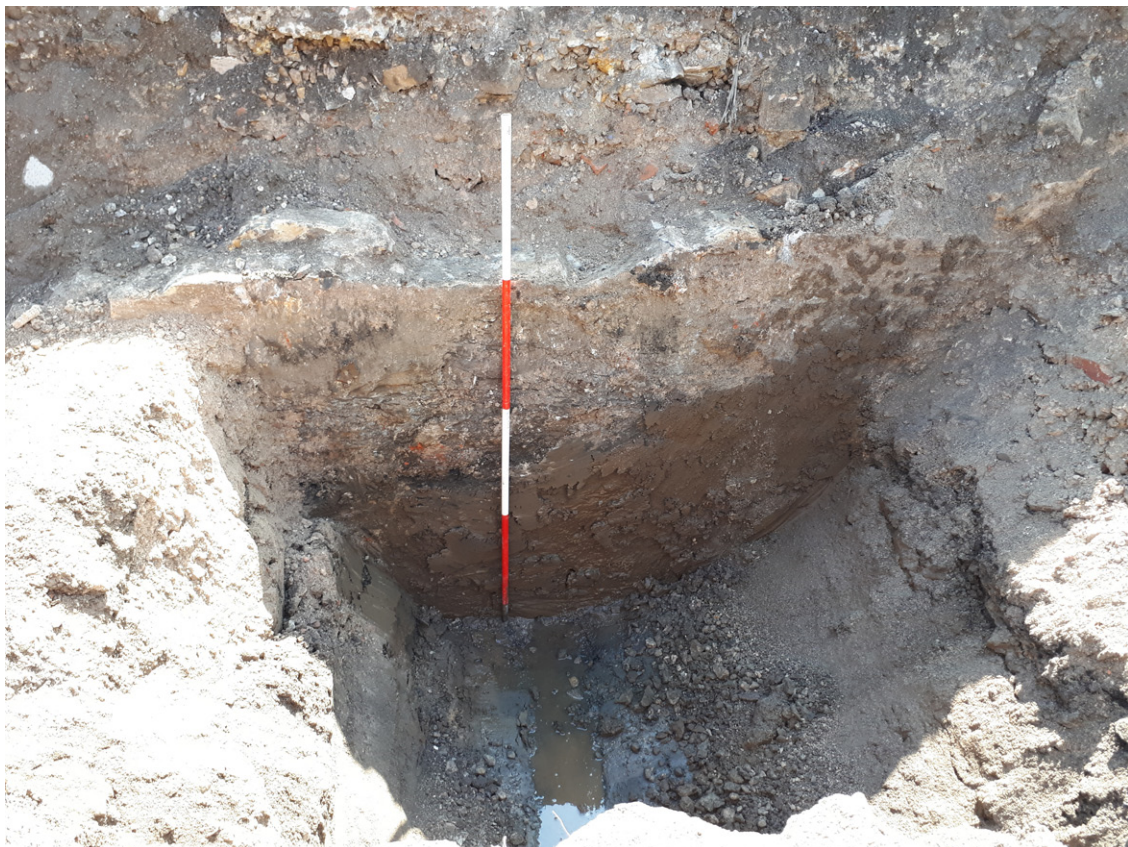
Trench 7B was excavated to examine two east-west aligned walls (**709** & **710**) which extended from Walls **706** & **707** respectively. Wall **709** ran east from wall **707** and was exposed for an extent of 2.6m. Wall **710** ran west from wall **706** and was exposed for an extent of 4m. Both walls were 0.6m wide and a sondage excavated against wall **710** identified what is assumed to be the base of the foundation at c.2.2m beneath the site surface (Fig 22). Natural sandy clay (**700**) was present c.2m beneath the site surface.

Fig. 22: Trench 7B Elevation of wall 710 to foundation

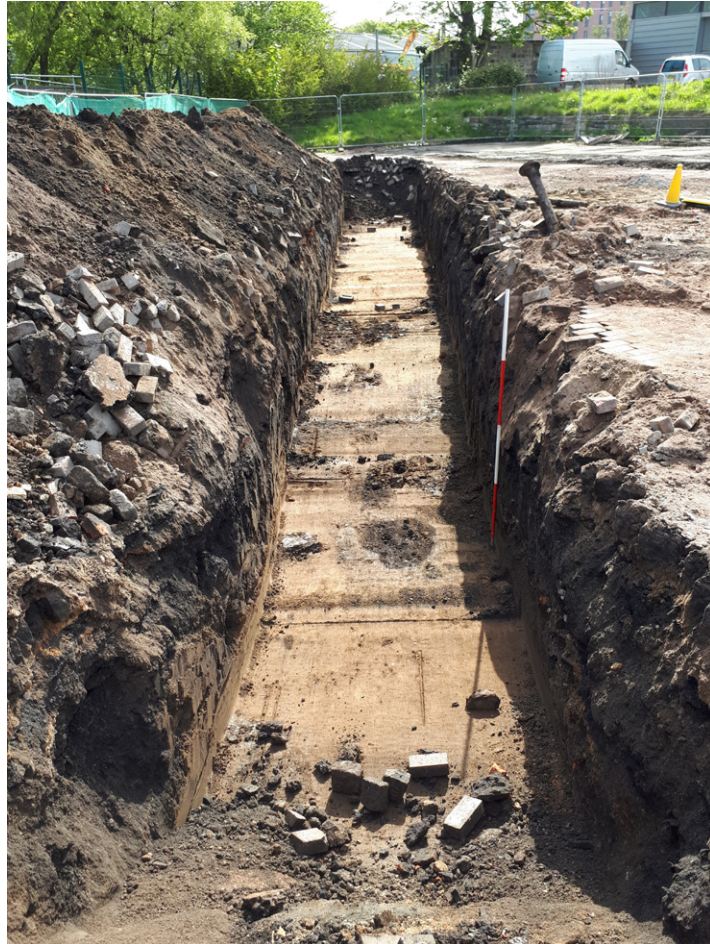
Fig. 23: Trench 8 post ex

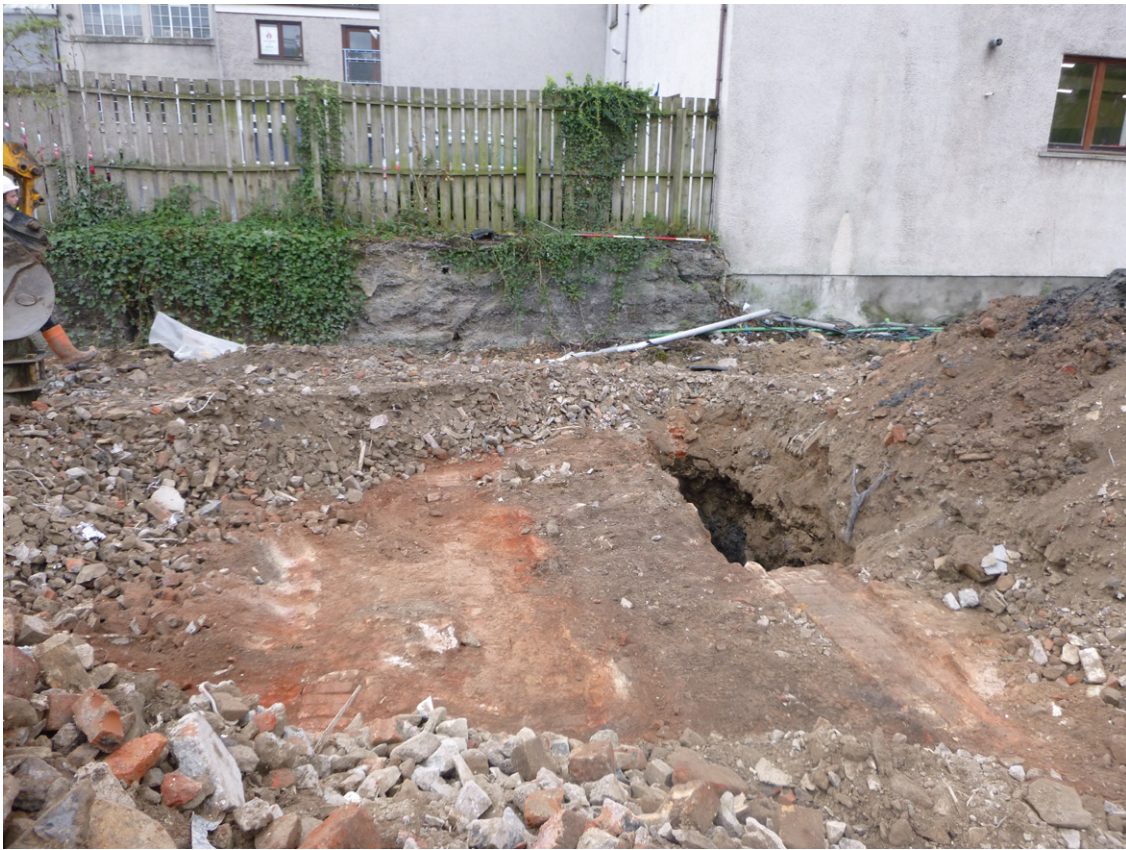
Watching briefs were carried out during site investigation works and demolition works to remove the foundations of the recent buildings on the site. The remains of a flue structure or Chimney base for Paper Mill as shown on the 1896 OS mapping was identified in Test-pit 4 (Fig 24) and wooden built tanning tanks (Fig 25) were identified in Test-pit 12, these presumably relating to the tannery shown on the 1852 OS mapping. No significant remains were identified during the demolition works although these were carried out to a limited depth and specifically targeted the foundations of know recent buildings.

Fig. 24: Site Investigation pit showing surviving brick flue structure

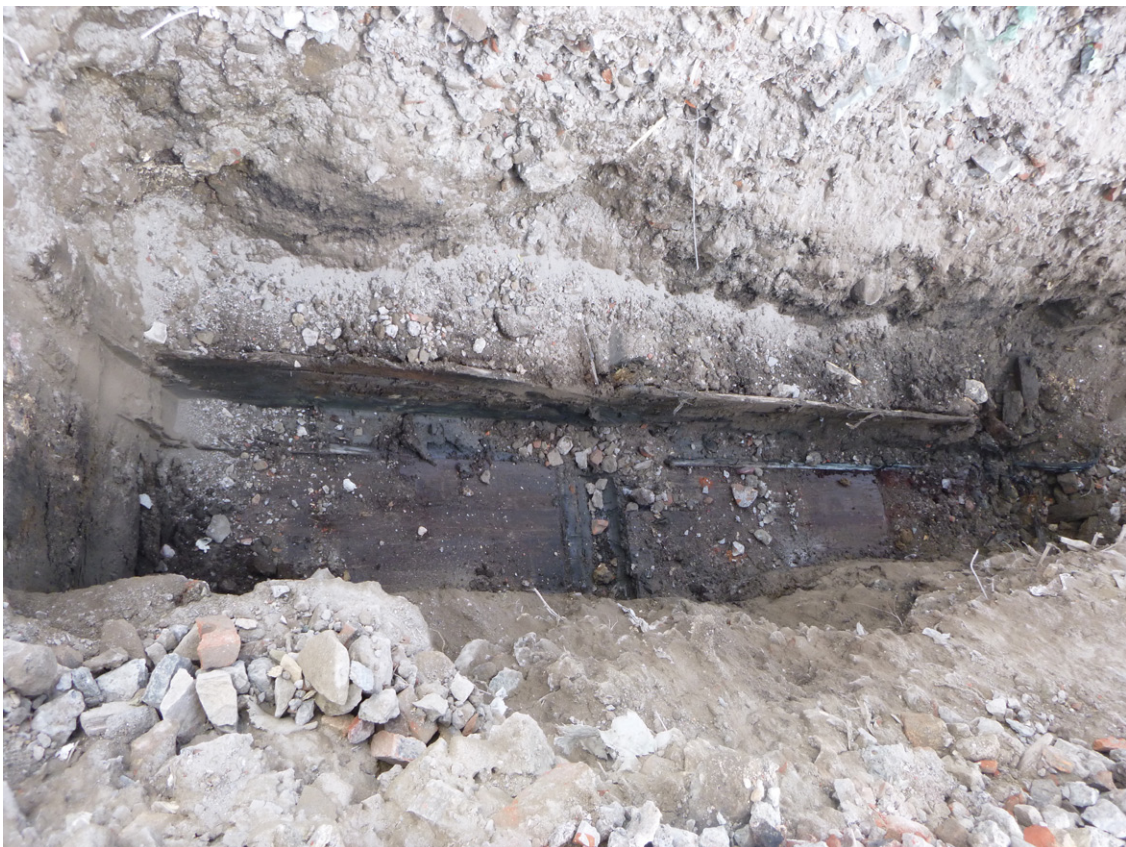
Fig. 25: Site Investigation pit showing tannery tanks
