Bonnington Mills, 70-72
Newhaven Road, Edinburgh

Archaeological Mitigation
Report No. 3888

Authors	Gary Savory MA ACIfA
Illustrators	Rachael Kershaw MA PCIfA
Approver	Bruce Glendinning Bsc PgDip MCIfA
Commissioned by	Queensbury Properties (Bonnington) Ltd
Date issued	January 2020
Version	2
Oasis No.	cfaarcha1-377085
Planning Application No	17/01183/FUL
Grid Ref	NT 26026 76022 (centred)

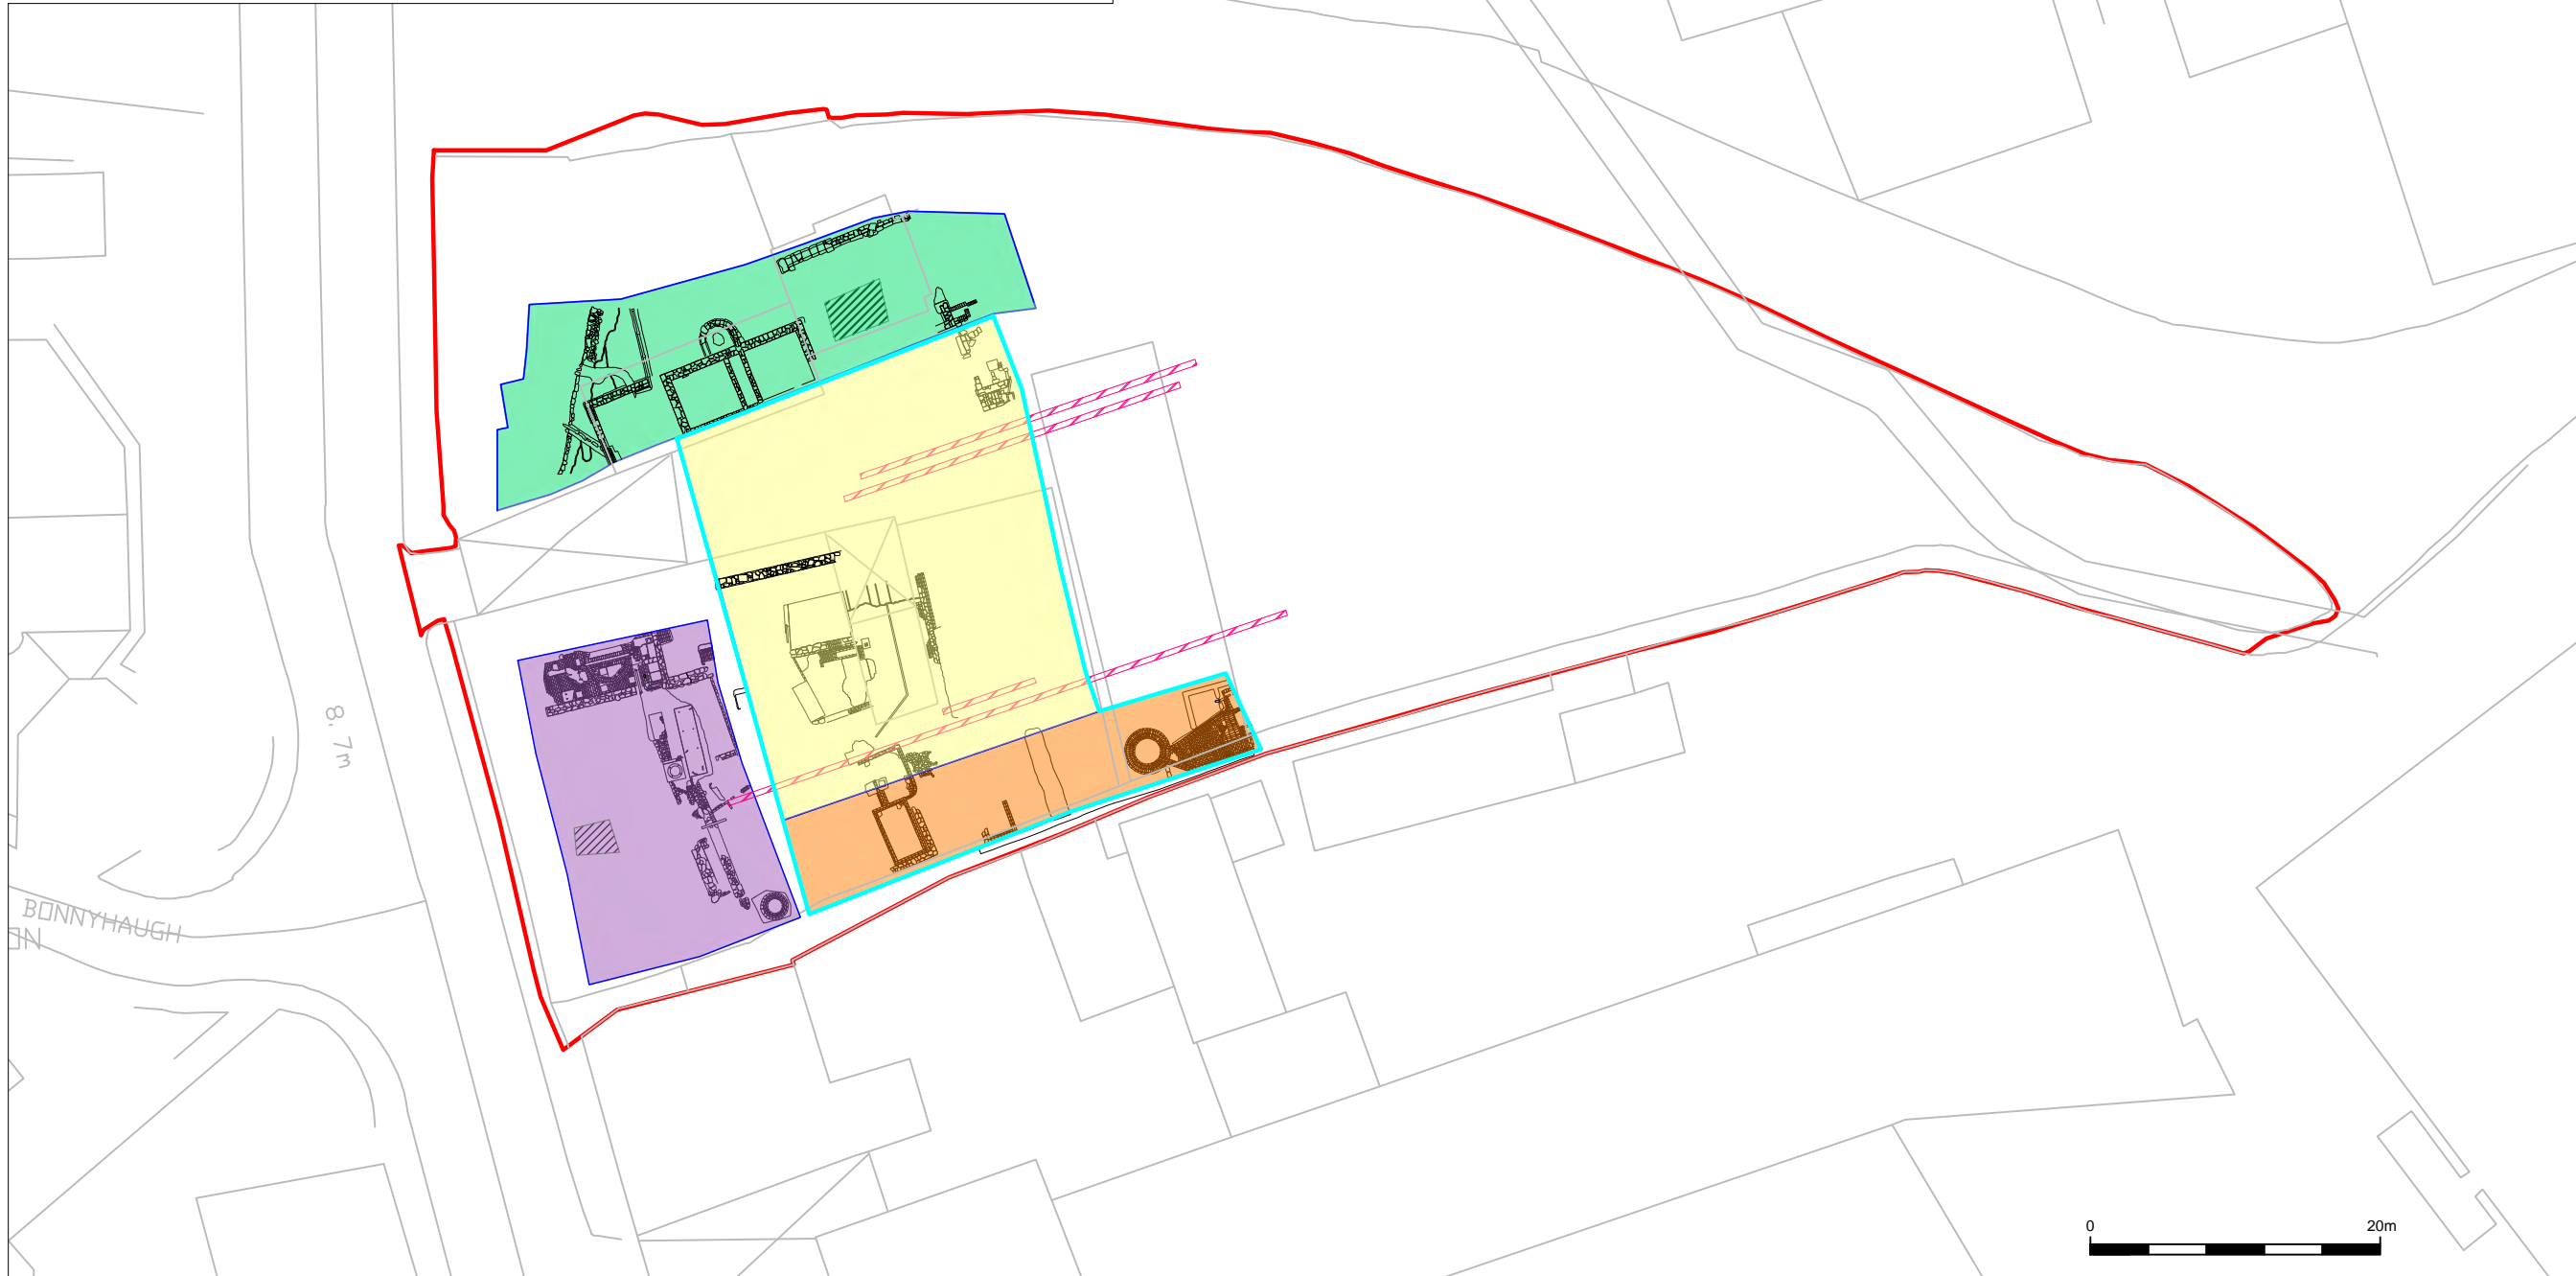
Report No: 3888	Fig. No: 1
---------------------------	----------------------

The development site, which encompassed an area of 0.35ha, was divided into a number of distinct areas where different mitigation measures were required (Fig. 1). Based on the results of the evaluation a broad model of where archaeological deposits survived was created and a mitigation strategy was agreed in consultation with CECAS. In the east of the site no further work was required.

The formation levels for construction across Blocks D & E were not very deep due to the nature of the development features that were to be constructed in those areas. These were in the main carparking and roads. The formation level across these areas ranged between 7.05m OD to 6.52m OD. The only development below this depth were service runs which were monitored under a watching brief. This meant that any features below the formation depths, that were not in the service runs, were preserved *in situ* (Fig. 1).

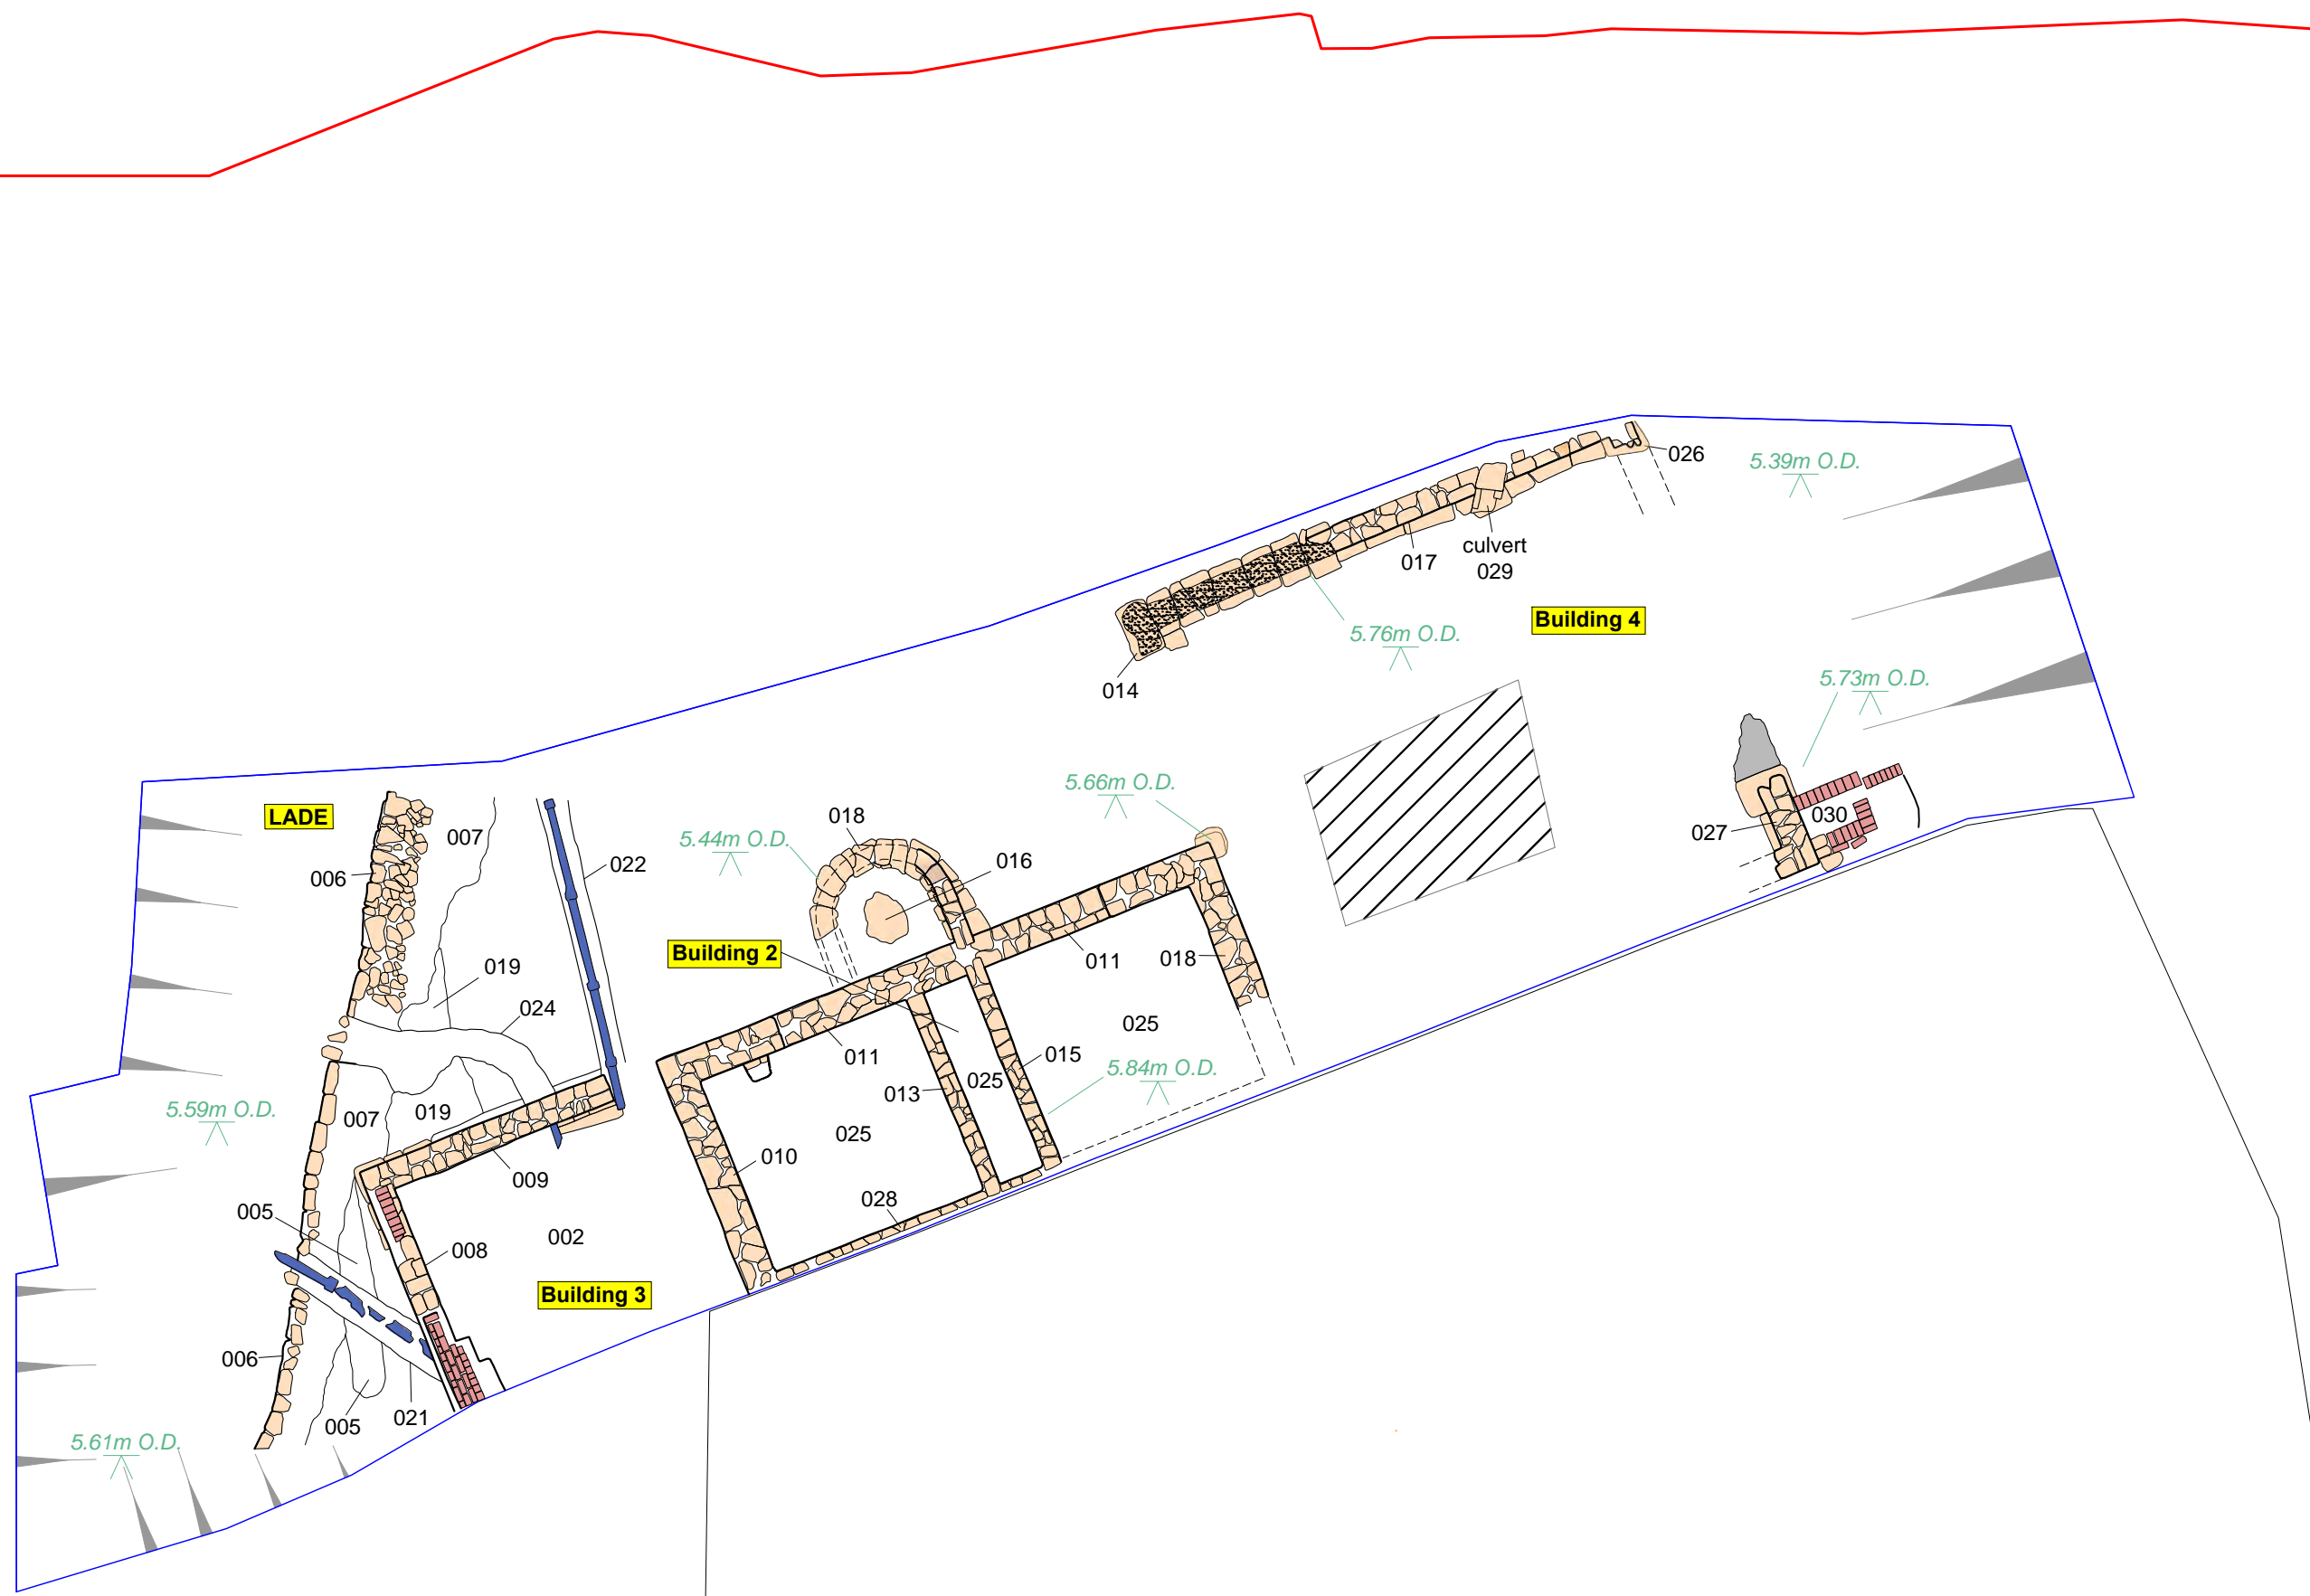
Title:
Detailed plan of Block B/C

Block B/C - Building 2 (Fig. 3b)

Building 2 had only recently been demolished, the foundations of which were identified during the excavation (Fig. 7). It measured 10.6m by >4.3m externally, and was aligned east-north-east by west-south-west. The walls (**010**, **011**, **018**, **028**) were sandstone and mortar-bonded, ranged in width 0.44m to 0.6m wide and survived to a height of 1.75m in some places.

The building was divided into two rooms by a central corridor (**013** & **015**) leading to a circular staircase (**016**) within a semi-circular outshot on the northern side. This staircase had not been visible in the most recent modelling of the building. Either side of the stairwell were two blocked openings which were doorways through wall (**011**).

Block B/C - The Lade (Fig. 3b)

To the west of Building 2 were the vestigial remains of the mill lade, aligned NE-SW, with a sandstone and mortar-bonded side wall (**006**), which formed the south-eastern side of the channel (Fig. 6). The north-western facing stonework had been dressed and to the south-east was a banking deposit of yellow lime mortar (**007**). The opposite side of the lade presumably survived to the west but was not identified as it lay beyond the limits of the excavation. Similarly, the base of the lade channel was not identified due to the water table and the presence of contaminants.

Block B/C - Building 3 (Fig. 3b)

The 1876 map depicts an extension to the west side of Building 2 (Building 3) and as with Building 2 it had only recently been demolished.

The surviving foundations measured 5.5m by 4.5m externally and were aligned east-north-east by west-south-west and abutted the western wall of Building 2. The walls (**008 & 009**) were constructed in a similar sandstone and mortar method and survived to a height of 0.65m. Along the top of the western wall (**008**) was a single course of red bricks. Drains (**021, 022, 024**) to the north and west may relate to this extension.

Block B/C - Building 4 (Fig. 3b)

The 1876 map depicts an extension to the east side of Building 2 (Building 4).

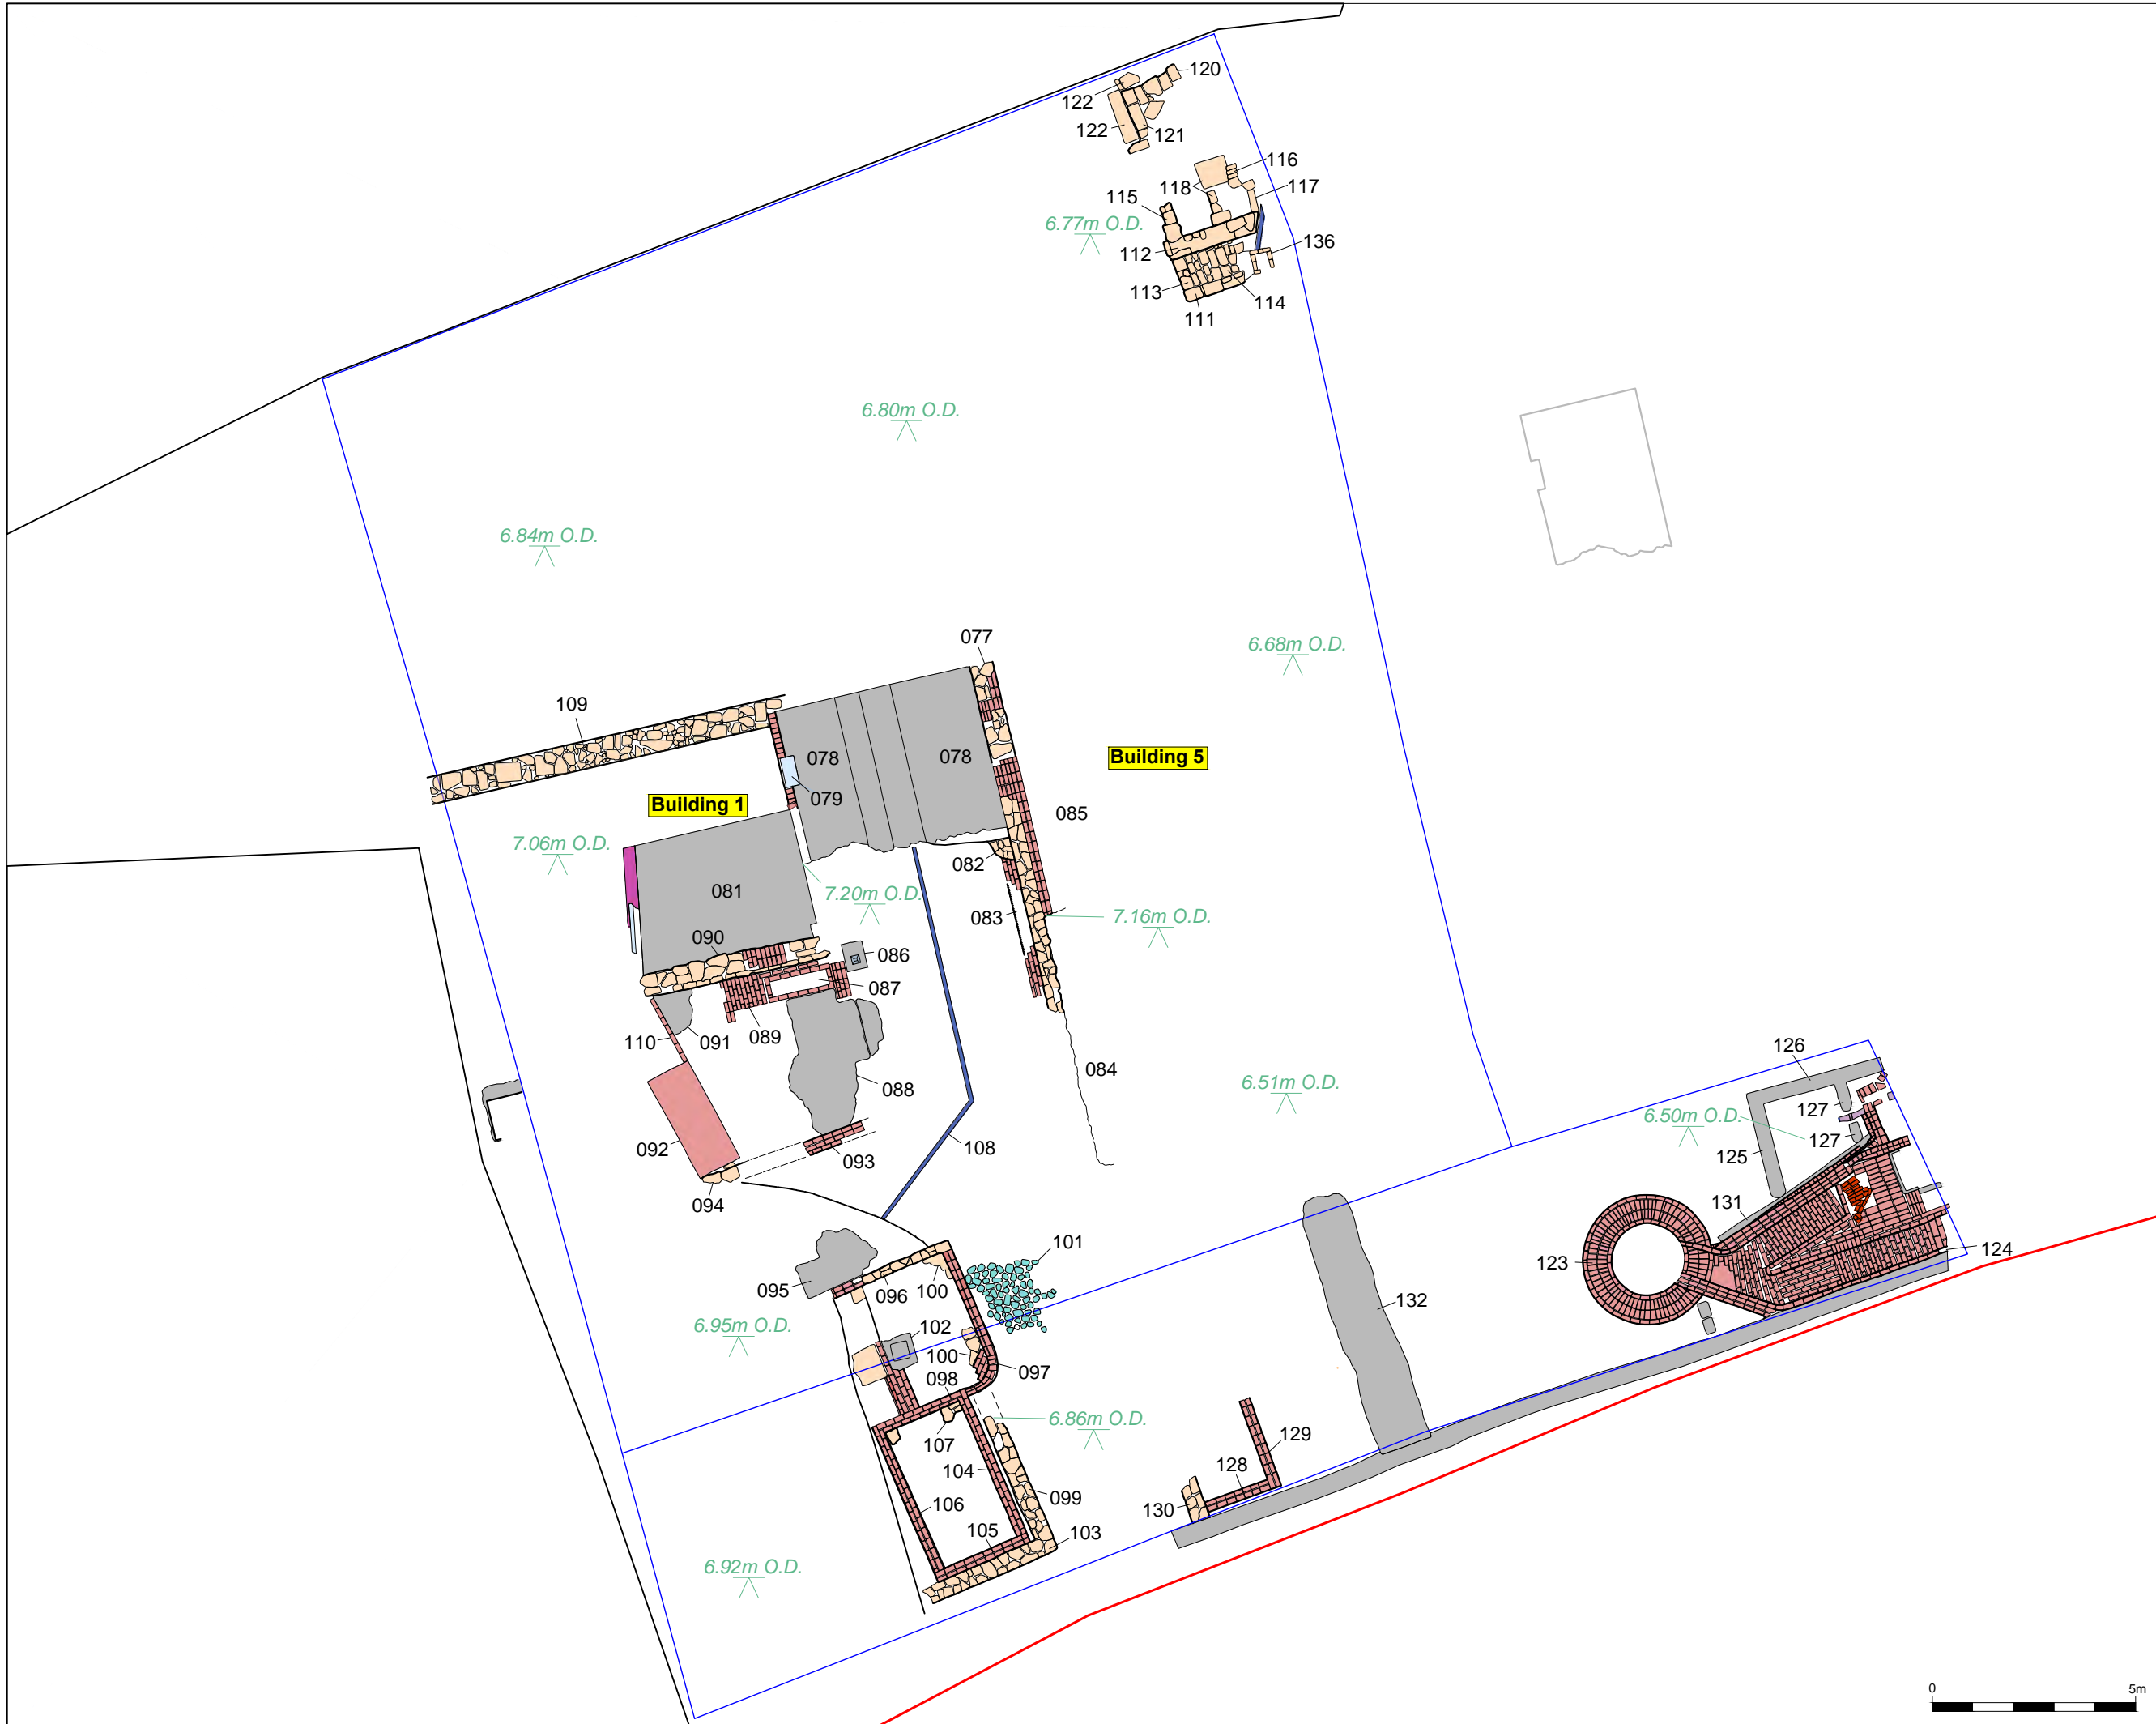
Report No: 3888	Fig. No: 3c
---------------------------	-----------------------

Block D - Building 1 and 5 (Fig. 3c)

Additional components of Building 1 were recorded. Wall (**090**) was a continuation of wall (**032/070**) on the same east-north-east to west-south-west alignment, forming the southern elevation of this part of the building. Wall (**109**) represented the northern elevation of Building 1. No further internal details belonging to this phase were identified.

Wall **077** corresponded with the western elevation of Building 5 (the wall of the building containing tanning tanks as depicted on the 1853 OS Town Plan). Wall **077** was sandstone and lime mortar-bonded, measured 14.6m long, 0.65m wide, and survived to a height of 0.5m. A brick-built drainage channel (**083**) ran alongside the wall. A fragment of sandstone surface (**082**) may well belong to this phase of building.

A short length of L-shaped brick wall (**128 & 129**), which measured 2m and 2.5m long respectively, was recorded to the south of Building 5. Wall **128** abutted what was probably an earlier sandstone wall **130**. This may be part of a tanning tank depicted on the 1853 OS map.

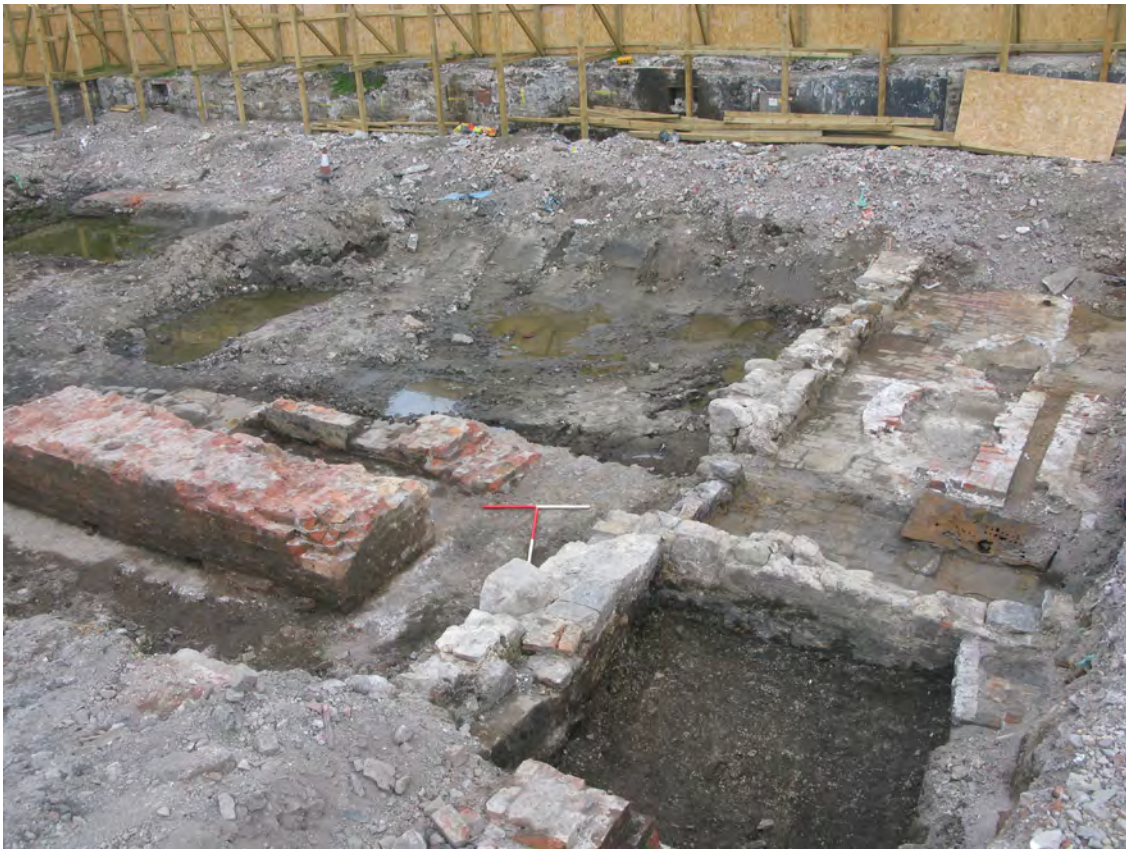
Fig. 4: General shot of Block A, looking east

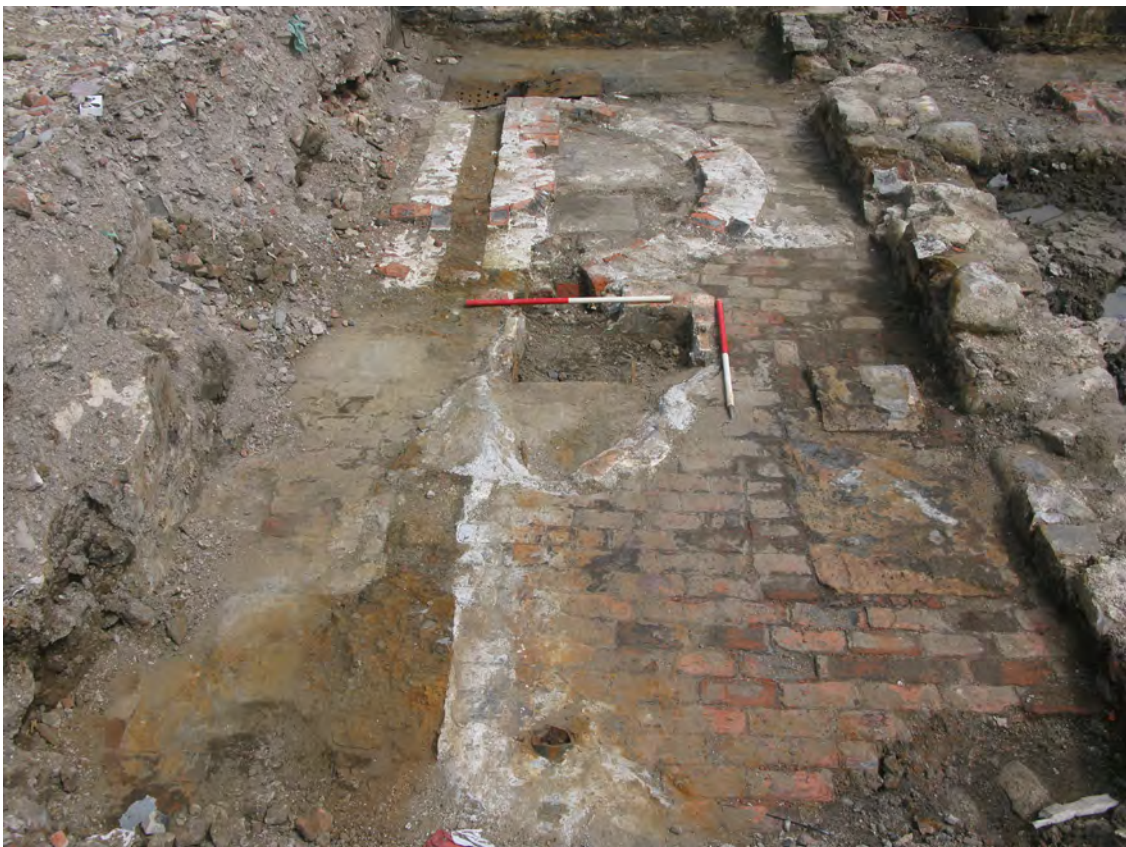
Fig. 5: General shot of Room A1, looking east

Room A1 measured 8.6m by 3.4m, internally, with the long axis following the alignment noted above. Room A2 measured 3.5m by 3.2m. The walls (**032**) were sandstone and lime mortar construction with a width of 0.6-0.8m and which survived to a maximum height of 0.7m. The wall dividing the two rooms (**031**) was slightly narrower, at 0.45m wide. A break in the build was visible to the east, with the wall continuing in the same construction (**070**) but wider, at 0.8m. At the south-eastern corner of Room A1 there was a bricked up doorway (**033**).

Internally, Room A1 had a brick and stone floor (**034**) and the base of a circular brick structure (**040**) with a channel (**044**) running through the middle, leading to a drain (**038**) (Fig. 5). The circular structure measured 3.3m in diameter and survived to a height of 0.15m. Two machine-fittings (**042**) and (**043**) and two parallel rows of east-west aligned stone column bases (**041**) were also identified in Building 1. A brick and concrete wall (**036**, **037**, **046**), possibly forming an L-shape, was present in the north-east corner.

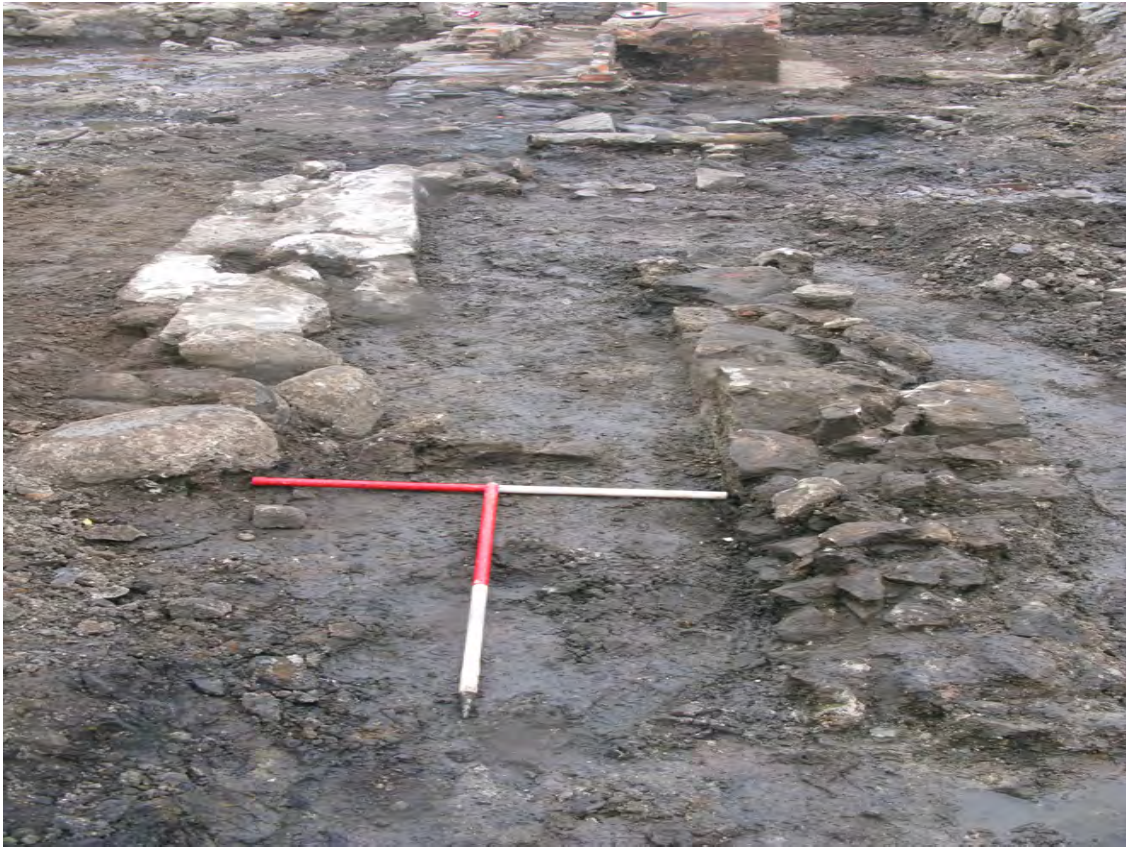
Fig. 6: Wall 065 in foreground, 063 in background

The NNW-SSE aligned part of Building 1 was far more fragmentary and only short lengths of wall remained. Only two incomplete lengths of the western elevation survived (**063** & **065**) (Fig. 6). The wall was of sandstone and lime mortar construction and was 0.7m wide and survived to a height of 0.1m. Wall **056** was on the same alignment and may represent an internal wall, along with wall **069**. The internal divisions of this part of Building 1 are not shown on the 1853 OS plan.

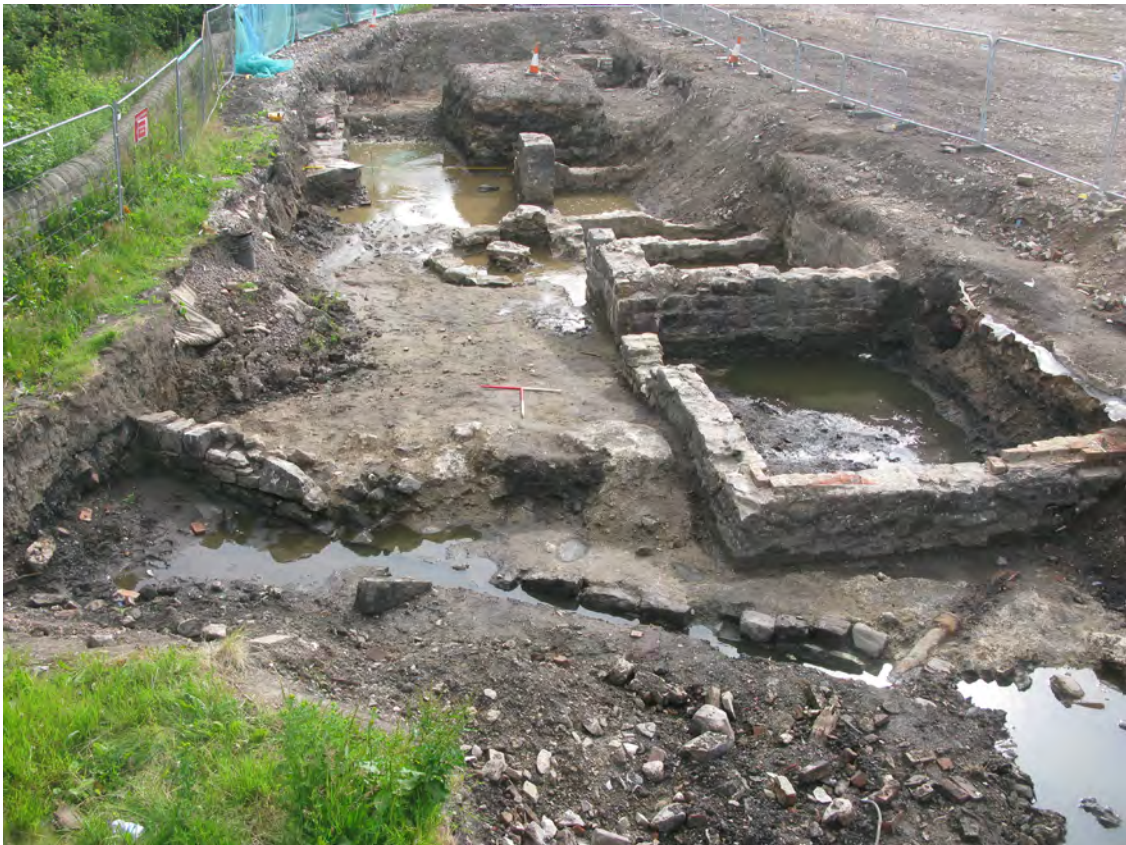
Fig. 7: Block B/C, general shot, looking east

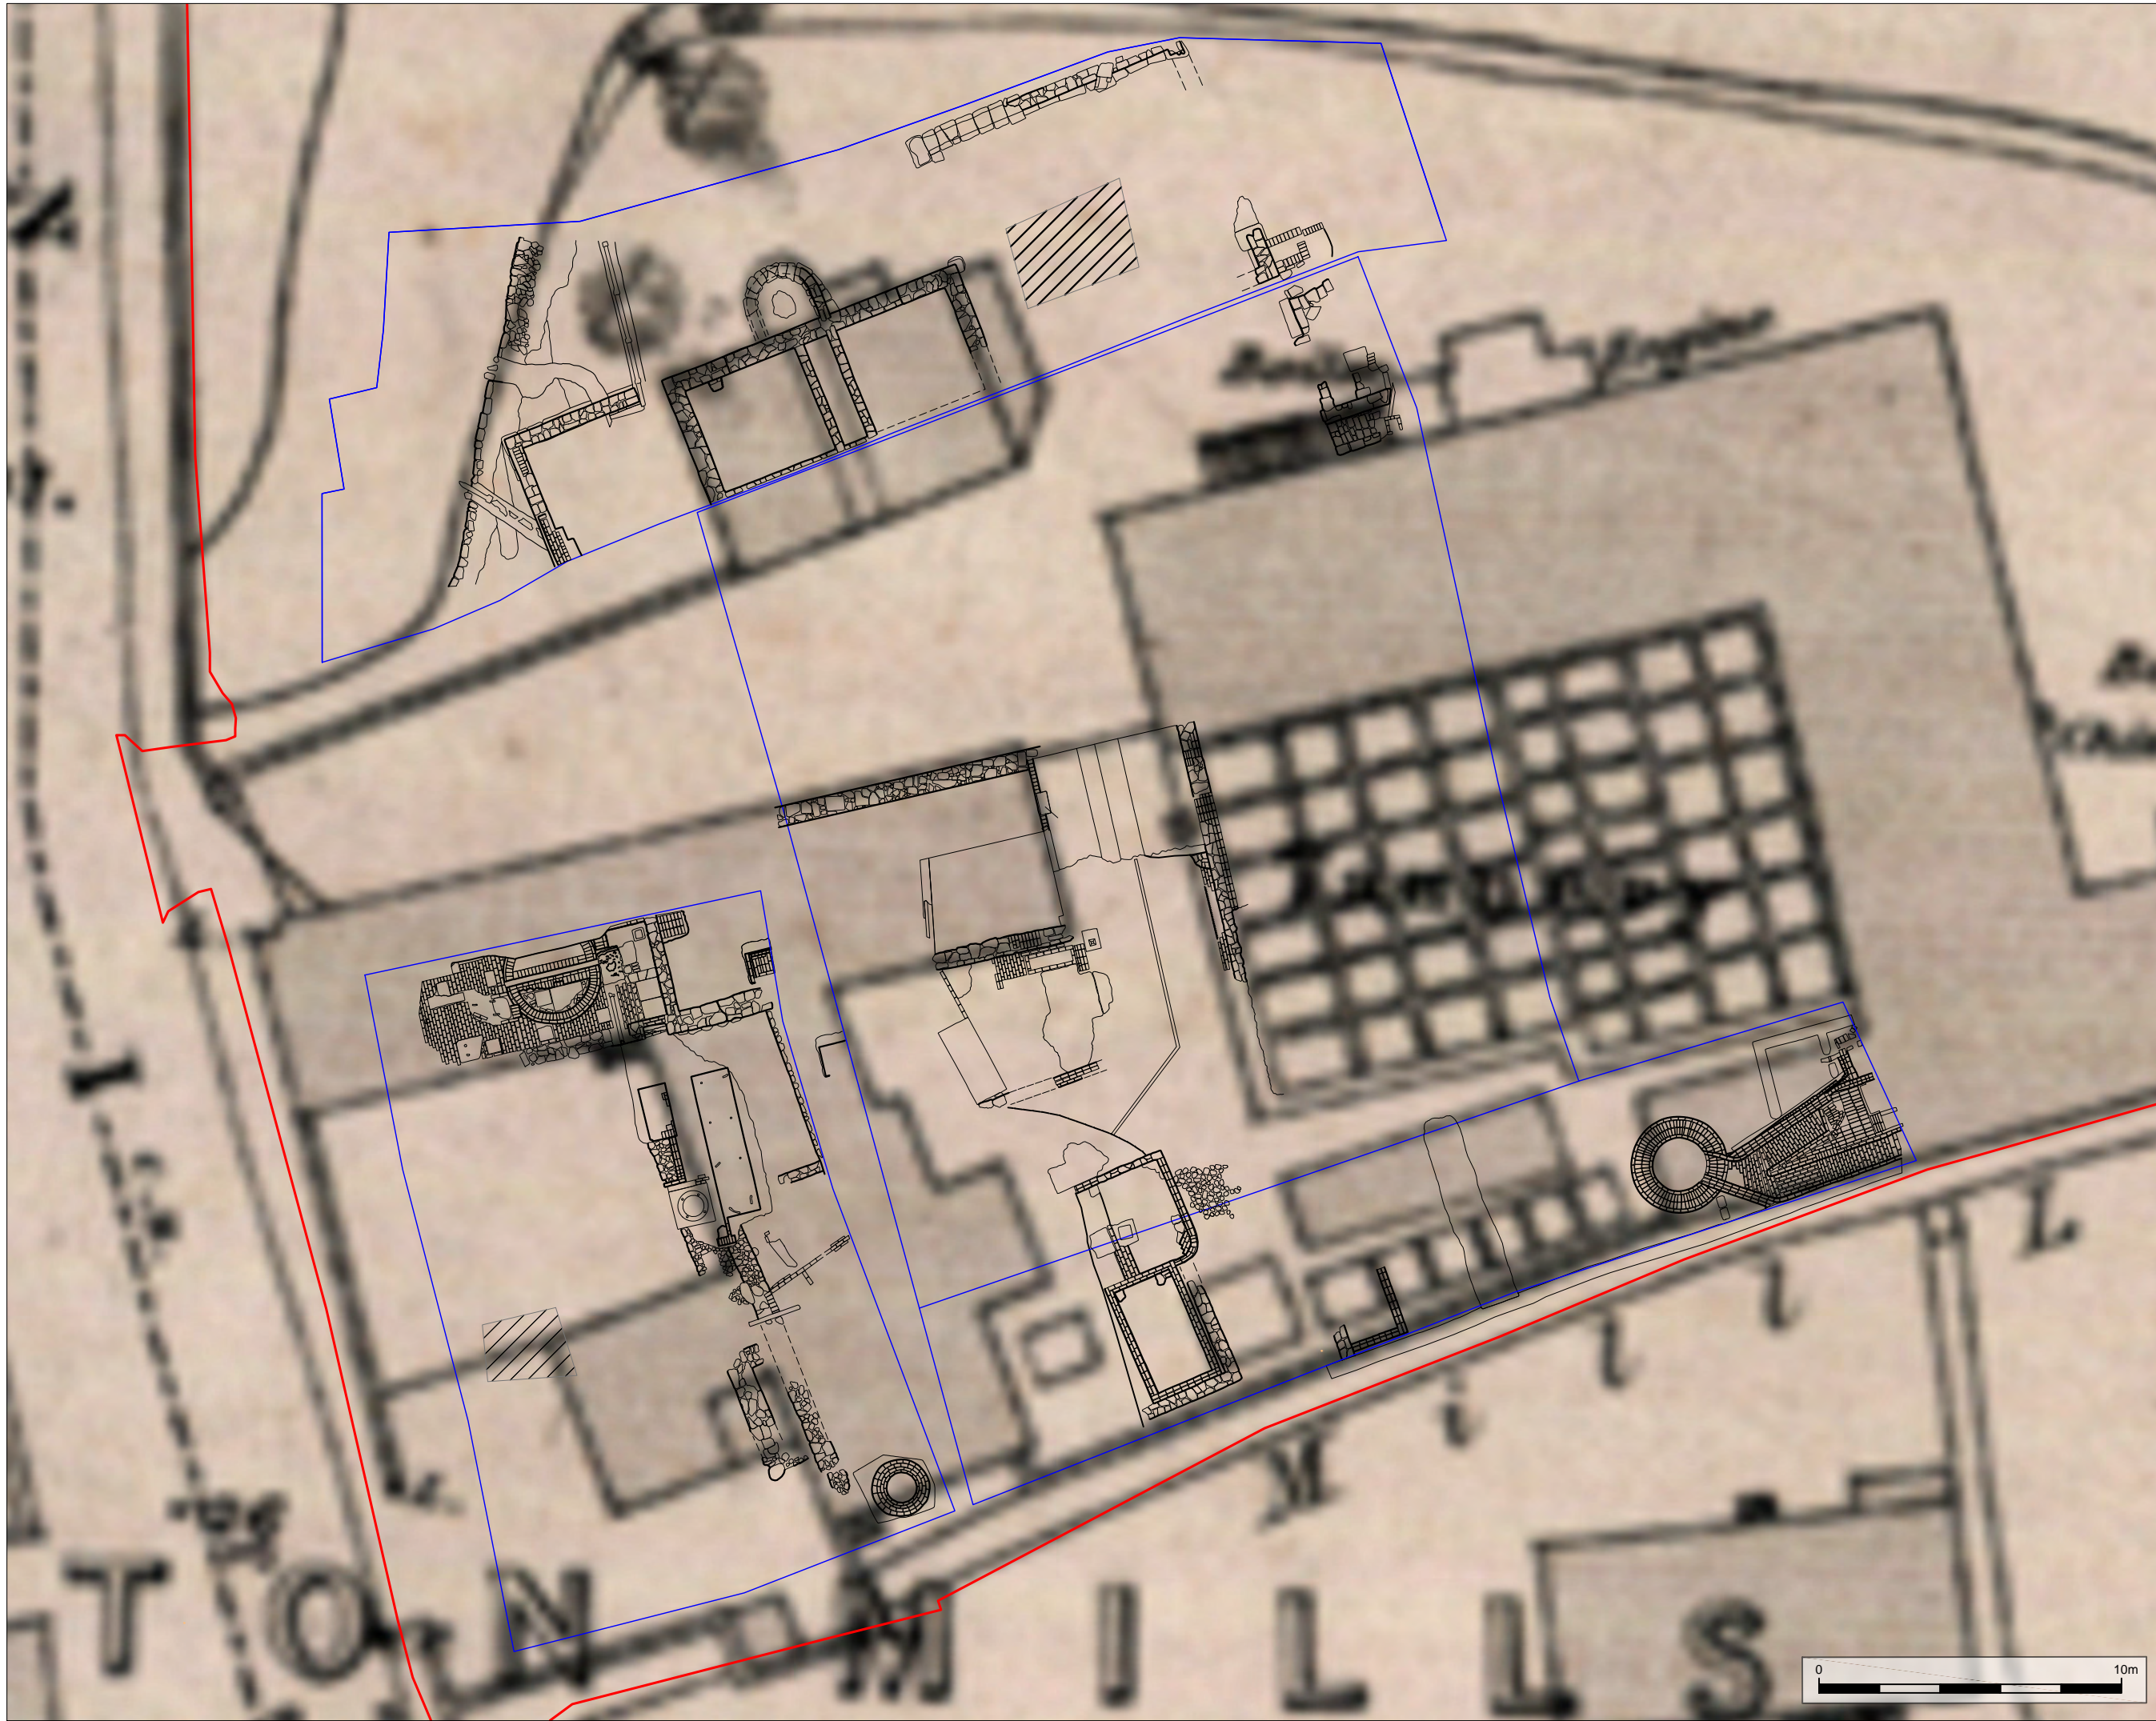
Report No: 3888	Fig. No: 8a
---------------------------	-----------------------

3.2 Structures depicted on the 1853 OS Town Plan (Fig. 8a for map overlay)

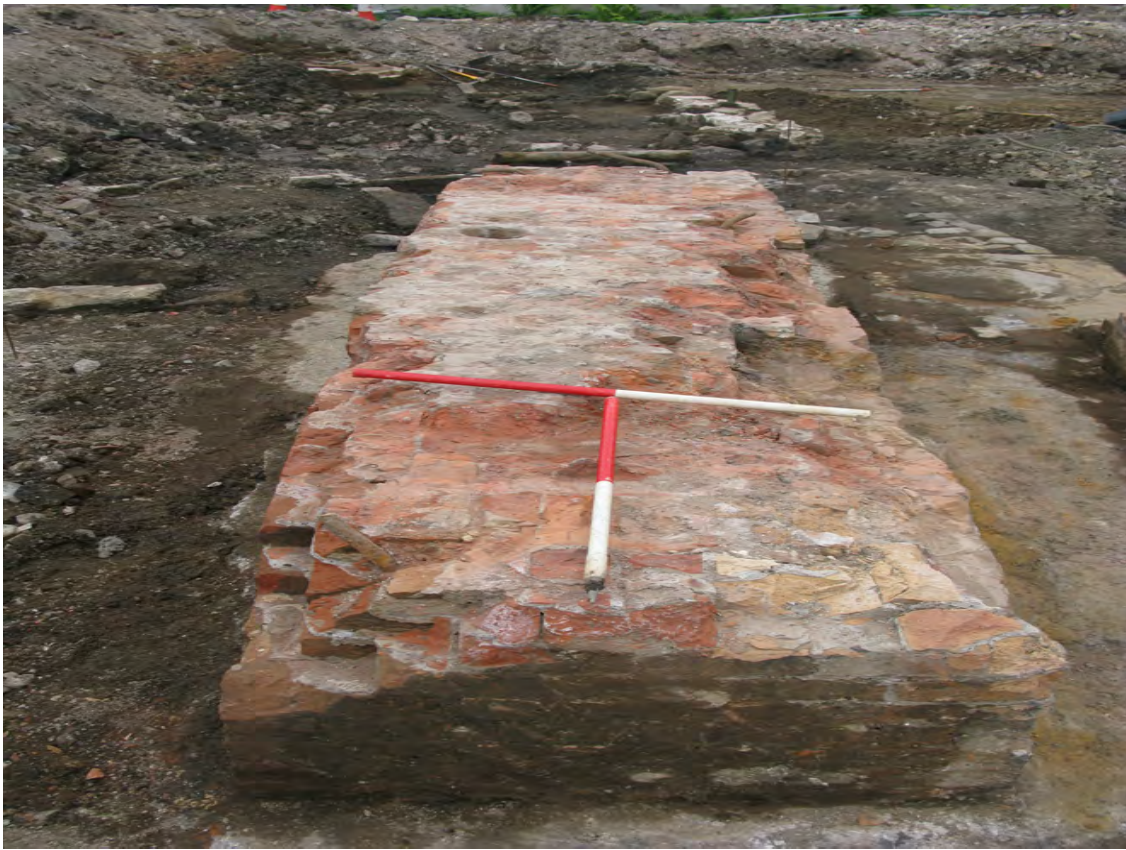
Fig. 9: Brick machine mount 052

Two large brick machine mounts (**048 & 052**) were built into the concrete surface and, given their alignment and location, must be related to this later phase, along with brick wall **049** and stone setting **050**, which cut across the earlier wall **063** and courtyard cobbling. Brick partition wall **062** may also be an internal feature from this phase.

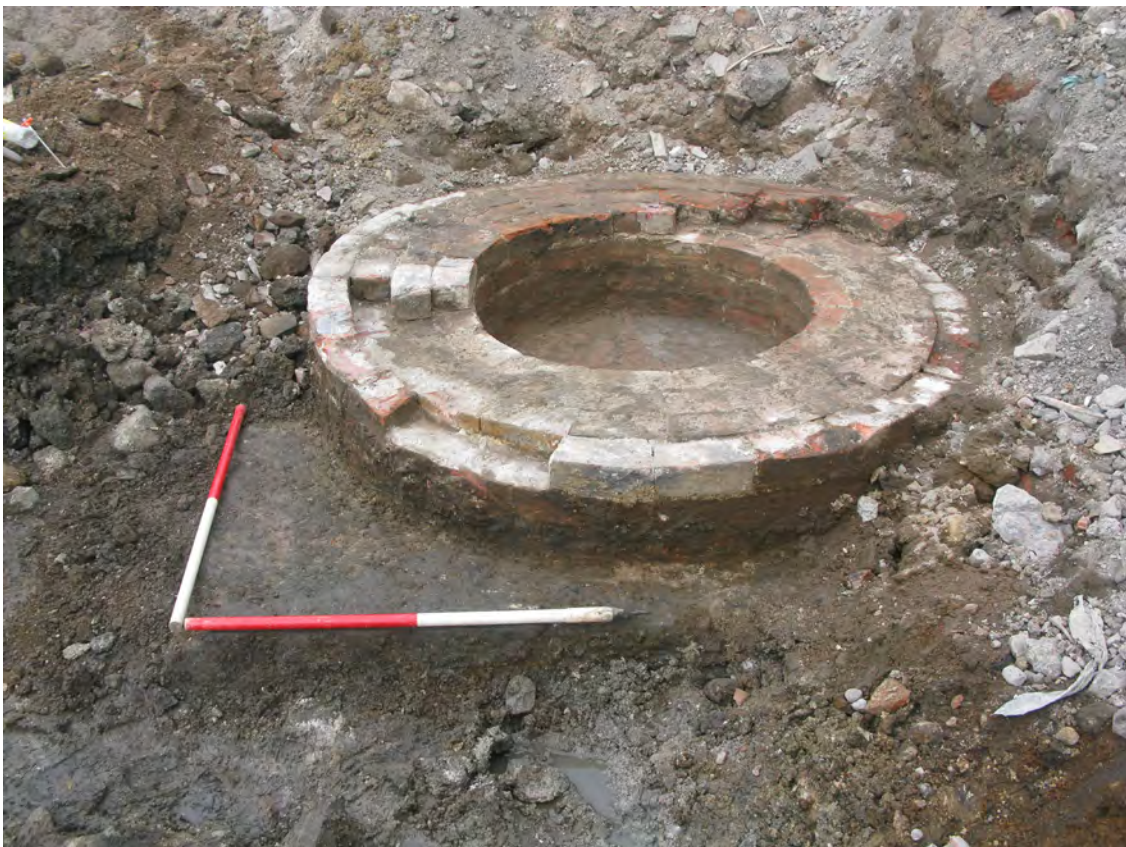
Fig. 10: Brick chimney (068) and concrete base (067)
