Bonnington Mills, 70-72
Newhaven Road, Edinburgh

Archaeological Mitigation
Report No. 3888

Authors	Gary Savory MA ACIfA
Illustrators	Rachael Kershaw MA PCIfA
Approver	Bruce Glendinning Bsc PgDip MCIfA
Commissioned by	Queensbury Properties (Bonnington) Ltd
Date issued	January 2020
Version	2
Oasis No.	cfaarcha1-377085
Planning Application No	17/01183/FUL
Grid Ref	NT 26026 76022 (centred)

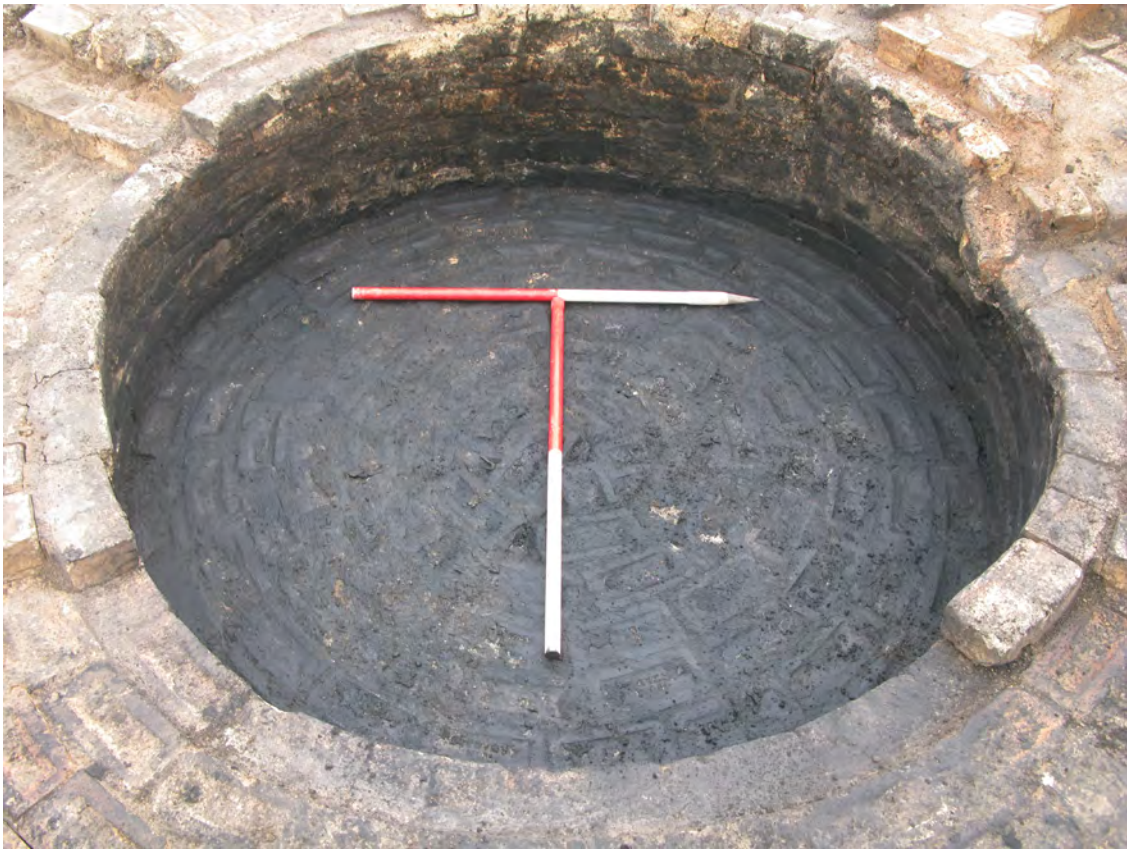
Fig. 11: Brick chimney base (123)

The chimney measured 3.5m in diameter and had an internal aperture 1.8m in diameter; it was 0.4m deep (7 courses) with a brick-lined base (Fig. 11, 12 & 13). The flue system had a large ramp, aligned east-north-east by west-south-west, which led up to the chimney and was 5.5m long and 0.85m wide, with another flue leading away from the chimney, aligned north-east by south-west, which measured 3m long and 1.25m wide. Where the two flues joined, the chimney had been bricked up. Both of the elements of the flue system were heavily stained with soot. The flue system appeared to have been rebuilt as it was overlying a concrete and brick base (**131**) on a slightly different alignment (Fig. 14).

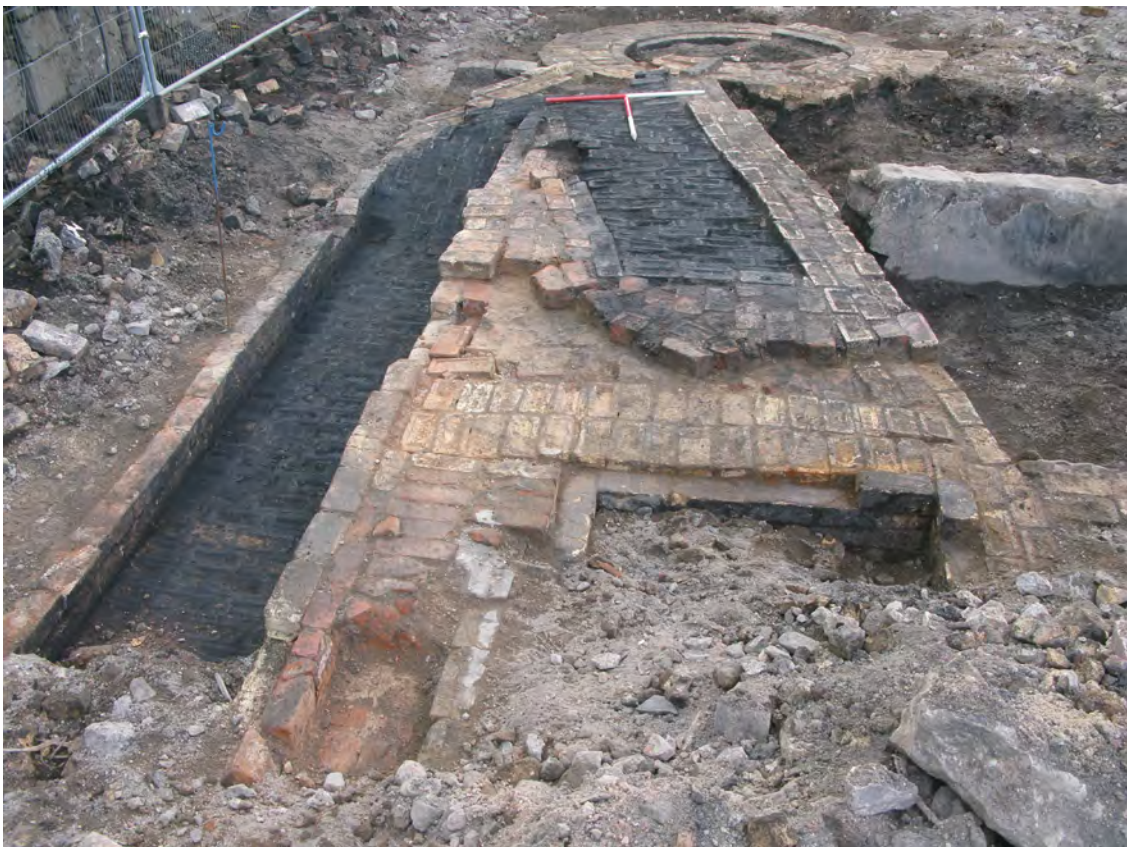
Fig. 12: Brick flue system (124)

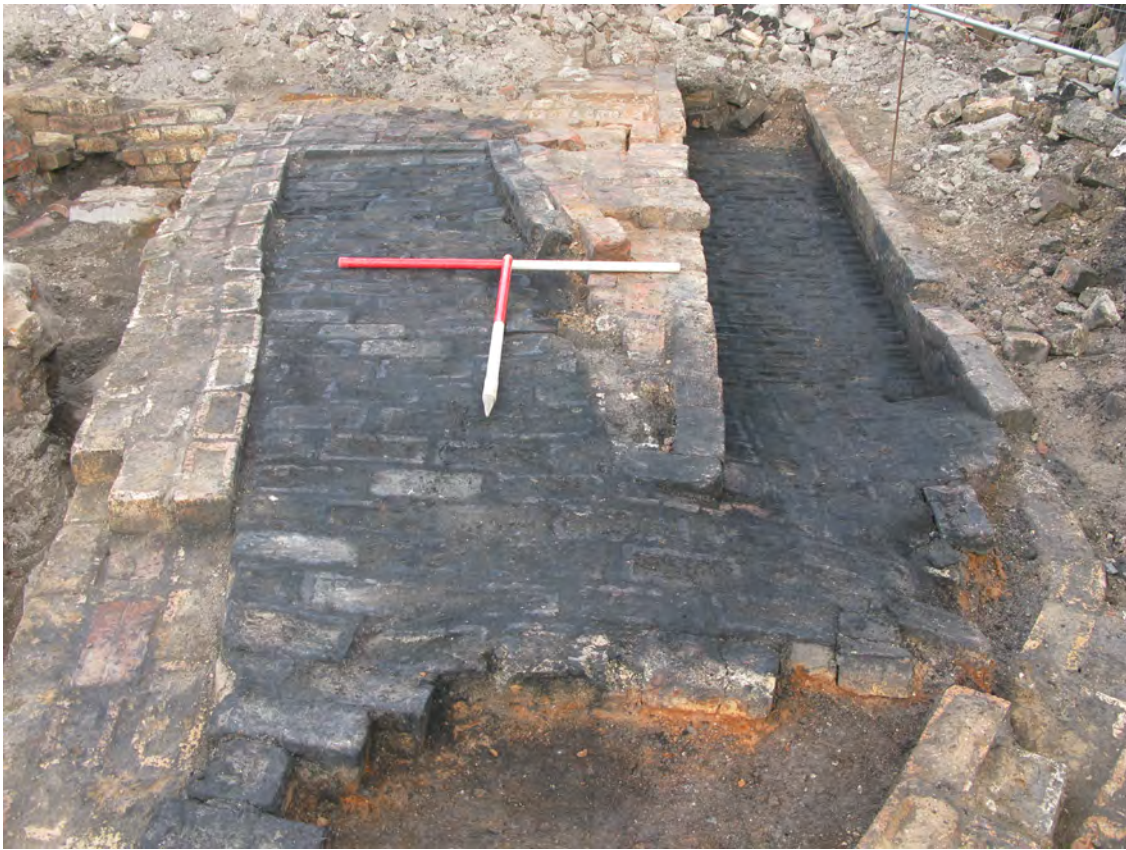
Fig. 13: Brick flue system (124)

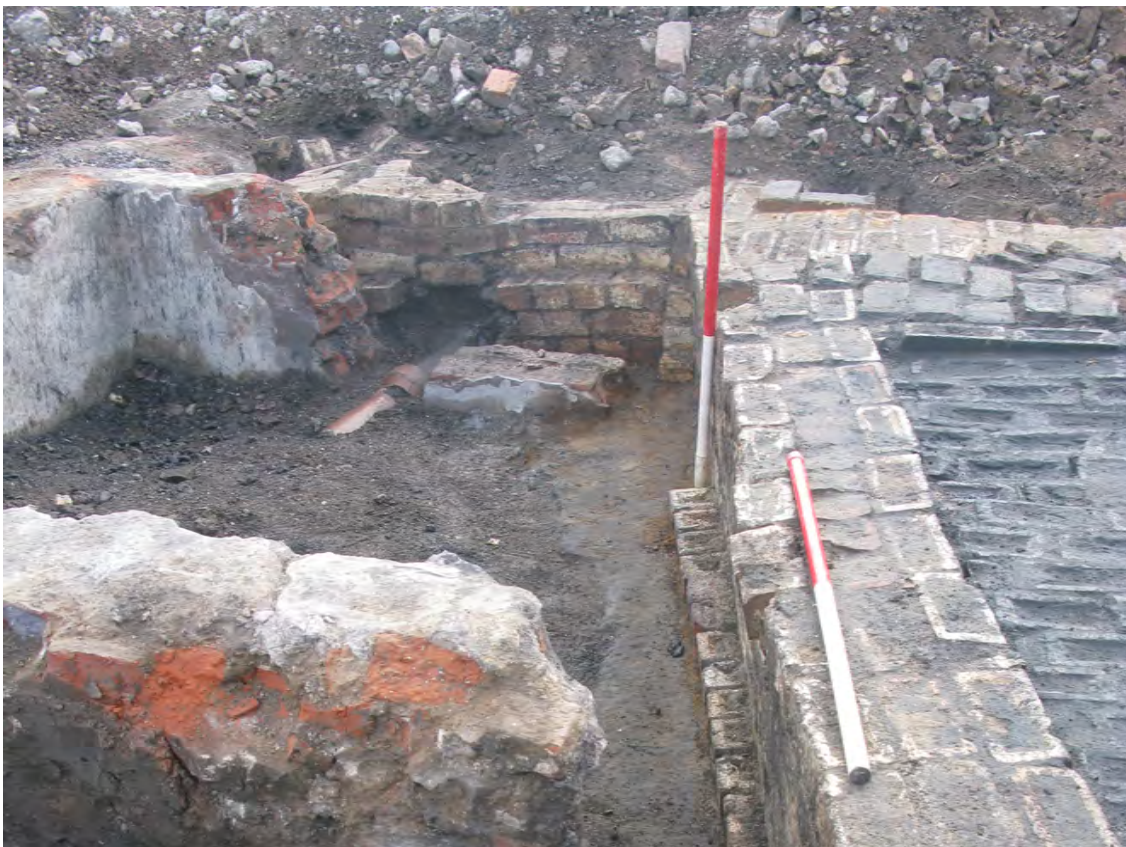
Fig. 14: Earlier flue system (131)
