Land East of Carriden Brae, Muirhouses, Falkirk

Archaeological Evaluation
Report No. 3926

Archaeological Evaluation

Report No. 3926

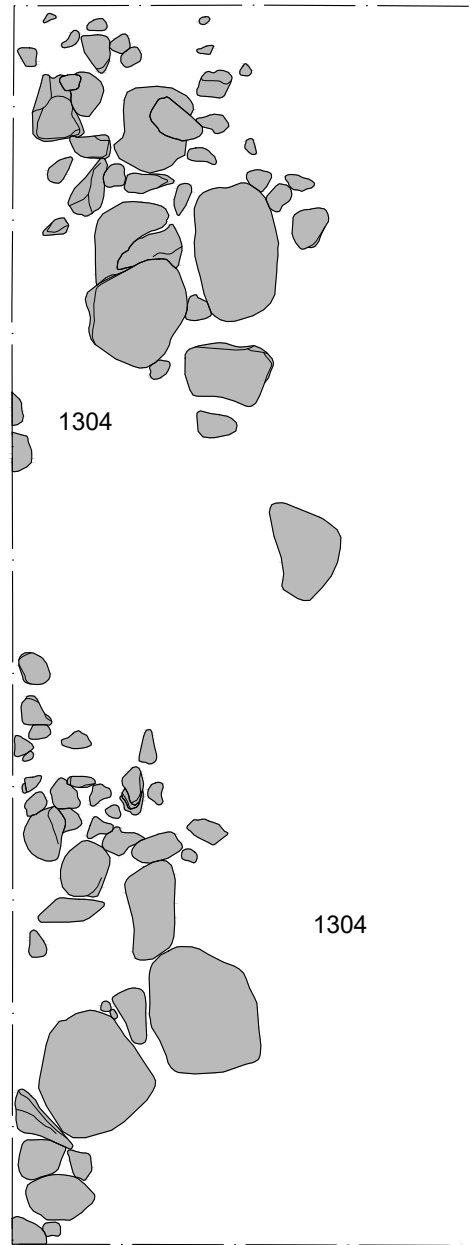
Fig. 2 - Trench 13, plan of possible Stone Surface 1303

Trench 13 measured 50m long by 1.8m wide. At the southern end of this trench on the probable alignment of the Coffin Road a rough stone surface (**1303**) (Fig. 2) was identified at a depth of c.0.8m below the current ground surface. This was sealed by 0.3m of subsoil (**002**) and 0.5m of topsoil (**001**), this surface measured >5m wide north to south by c.0.2m thick, and consisted of rough, unevenly sized, flattish stones (one of which possibly had a small circular hole drilled into it) (Fig. 9). These stones were set within a matrix of dark grey-brown silty-clay (**1304**). The survival of this feature was rather intermittent, with it appearing to peter out towards the eastern edge of the trench, and there were a number of large gaps between the stones where natural (**003**) was visible directly below the surface.

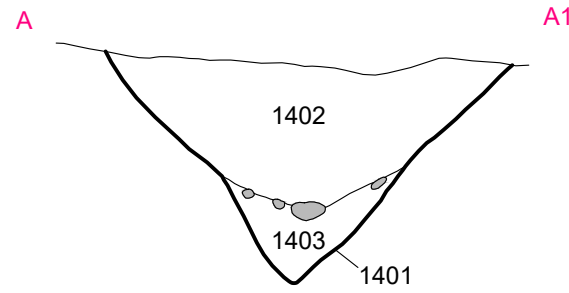
Fig. 3 - Trench 14, SW-facing section through Ditch 1401

Trench 14 measured 50m by 1.8m. Towards the southern end of the trench a NE to SW aligned ditch (**1401**) was identified (Figs 3 and 10). The ditch had a V-shaped profile with steeply sloping sides, and measured 1.64m wide by 0.89m deep. It contained two fills, with an upper fill (**1402**) consisting of greyish-brown silty clay and a lower fill (**1403**) consisting of bluish-grey clay. Given the alignment and position this ditch may have been a roadside ditch associated with the Coffin Road. If this was the case then it would have been located on its northern side, given its position in relation to the mapped alignment of the road (Figs 1 & 15). Evidence of the Coffin Road was not identified within this trench and there was no evidence of an extension of the ditch into Trenches 13 15, or 27, where it might have been expected to be intercepted if it was present.

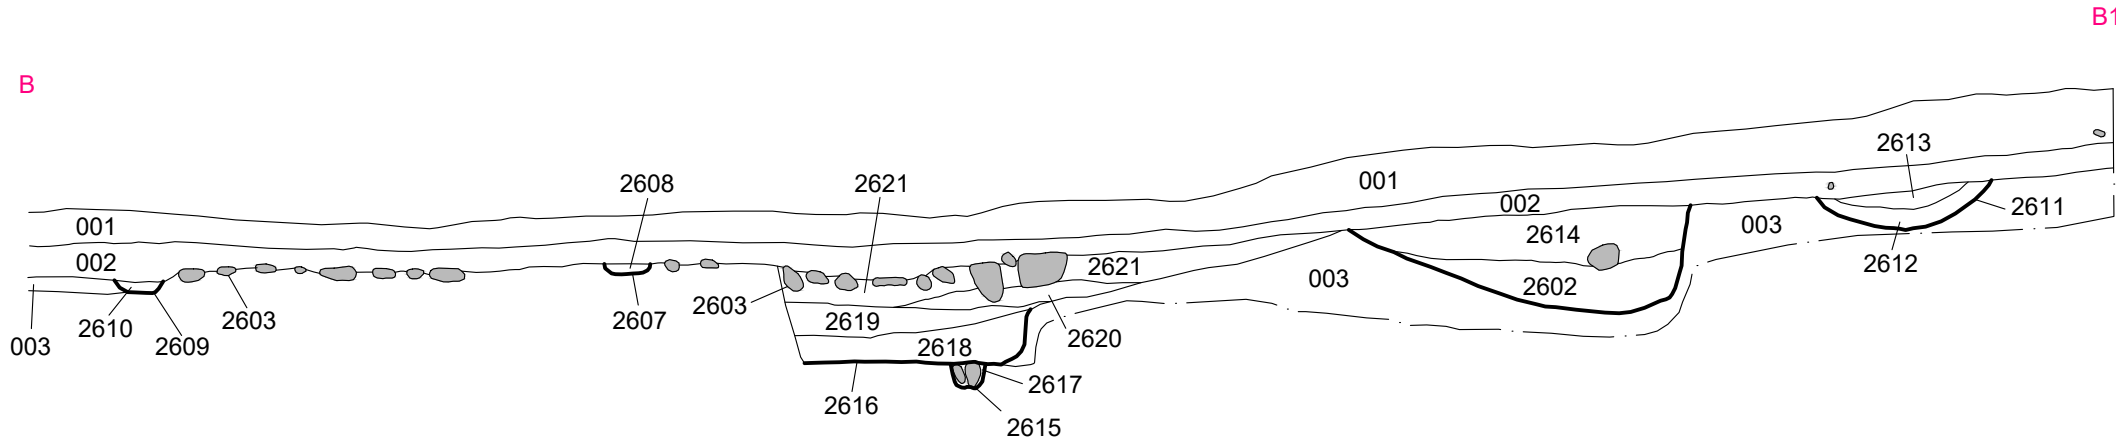
Fig.4 - Trench 26, W-facing section through track and ditch

Within the southern part of the trench (Fig. 11), on the alignment of the hollow way, a rough cobbled surface (**2603**) within a matrix of orangey-brown gritty clay-silt (**2621**) was identified (Fig. 4) at a depth of 0.2m below the current ground surface. Sealed by 0.1m of subsoil (**002**) and 0.1m of topsoil (**001**). This surface measured 3.9m north to south by 0.1 to 0.2m thick and consisted of numerous fairly small rounded cobble stones. Two parallel shallow grooves (**2607** and **2609**) were identified within the surface of the cobbling. These were situated c.1.8m apart and are thought to represent wheel ruts. They measured c.0.2m – 0.3m wide by 0.05m – 0.1m deep.

Immediately below cobbled surface **2603** there was a layer of grey silty sand and clay (**2619**), which overlay compacted mixed clay, coal fragments and cinders, which appeared to contain burn oil shale (**2618**). This directly overlay the natural (**003**). This material sat within a slight hollow (the hollow way) (**2616**). It is unclear if this hollow

A ditch (**2601**) was identified running apparently parallel with the southern edge of the track. It measured 1.4m wide by 0.4m deep and had a steeply sloping profile on the southern side and a gently sloping profile on the northern side. It contained two fills, with the lower fill (**2602**) consisting of grey-brown gritty clay-silt and the upper fill (**2614**) consisting of light grey-brown silt.

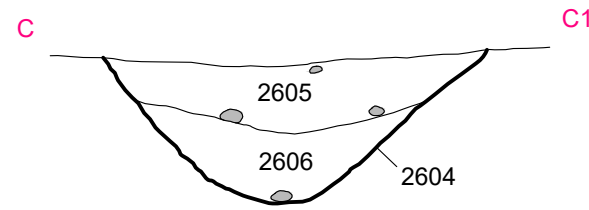
Fig. 5 - Trench 26, Ditch 2604, SW-facing section

On the northern side of the track another ditch (**2604**) was identified this measured 1.56m wide by 0.55m deep and had sloping sides and a concave base (Figs.5 and 13). The lower fill (**2606**) of this ditch consisted of dark-brown silty-clay and the upper fill (**2605**) consisted of mottled orange-brown sandy-clay. Fragments of a c.19th century bottle and a similarly dated ceramic sherd were recovered from the lower fill of this feature. The position of this section of ditch appears to align with a field boundary depicted on the 1856 Ordnance Survey map (Fig. 15), which ran roughly east-west across the site before turning through 90° and extending northwards as far as the current field boundary which marks the northern edge of the proposed development area.

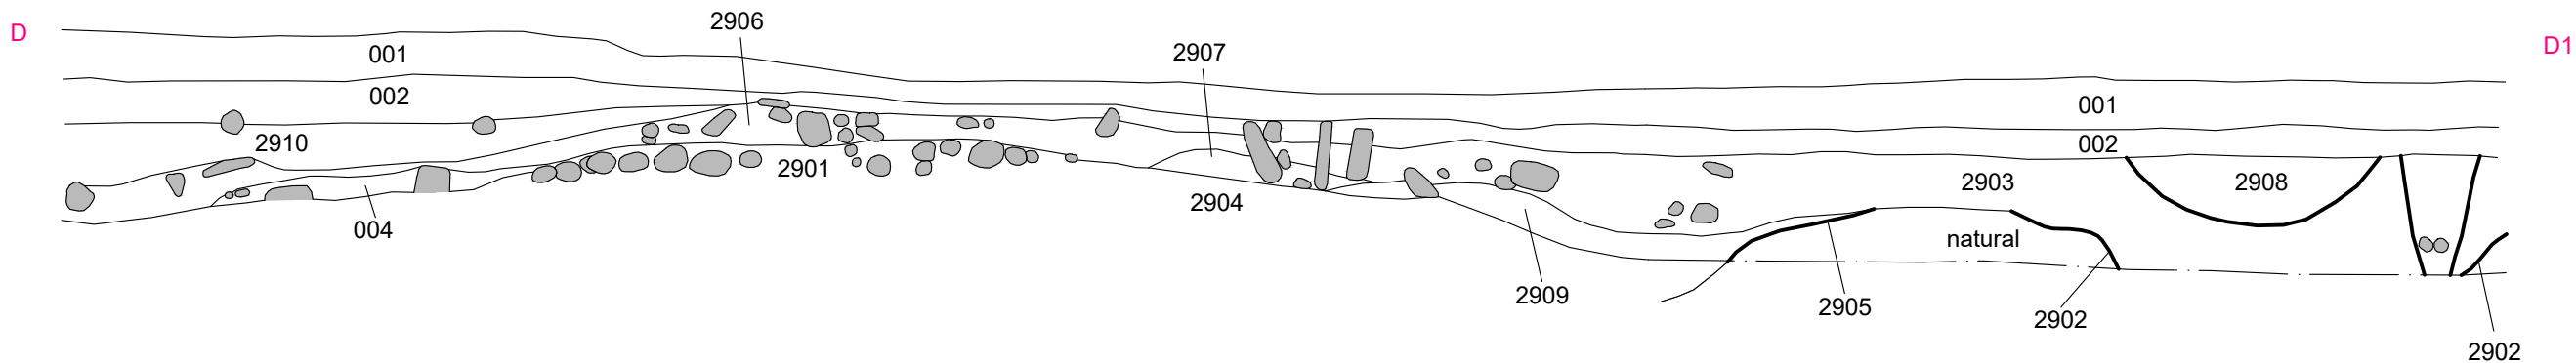
Fig. 6 - Trench 29, E-facing section through track and ditches

Trench 29 measured 50m by 1.8m. Towards the northern end of this trench on the alignment of the hollow way a rough stone surface (**2901**), which was presumed to be the surface of the Coffin Road, was identified at a depth of 0.26m below the current ground surface (Fig. 6 and 14). This surface measured 2.9m wide by c.0.2m thick and consisted of rounded cobbles. It was overlain by a 0.1m thick deposit of greyish-brown gritty clay-sand (**2906**), 0.06m of subsoil and 0.1m of topsoil.

The cobbled surface, **2901**, overlay a 7m wide deposit of compacted mixed clay, coal fragments and cinders which appeared to contain burn oil shale (**2904**), which sat within the hollow way (**2905**). This was the same as identified in Tr26. The hollow-way was only really pronounced on the northern side. As in Trench 26, it was unclear if this was a deliberate cut or simply worn to this depth through usage. A few sherds of c.19th century pottery and other late finds were recovered from between the cobbles forming surface (**2901**). This would certainly indicate that the surface was exposed at around that date.

To the north of the Coffin Road, a ditch (**2902**) with a width of 1.8m was identified. This ditch was not fully excavated as this part of the trench rapidly filled with water, but the recorded section identified that it was filled with dark-brown sandy-clay (**2903**) which was almost indistinguishable from the subsoil (**002**). This material extended beyond the confines of the ditch towards the edge of the road indicating that the ditch was probably open at around the same time as the exposed road surface. Several sherds

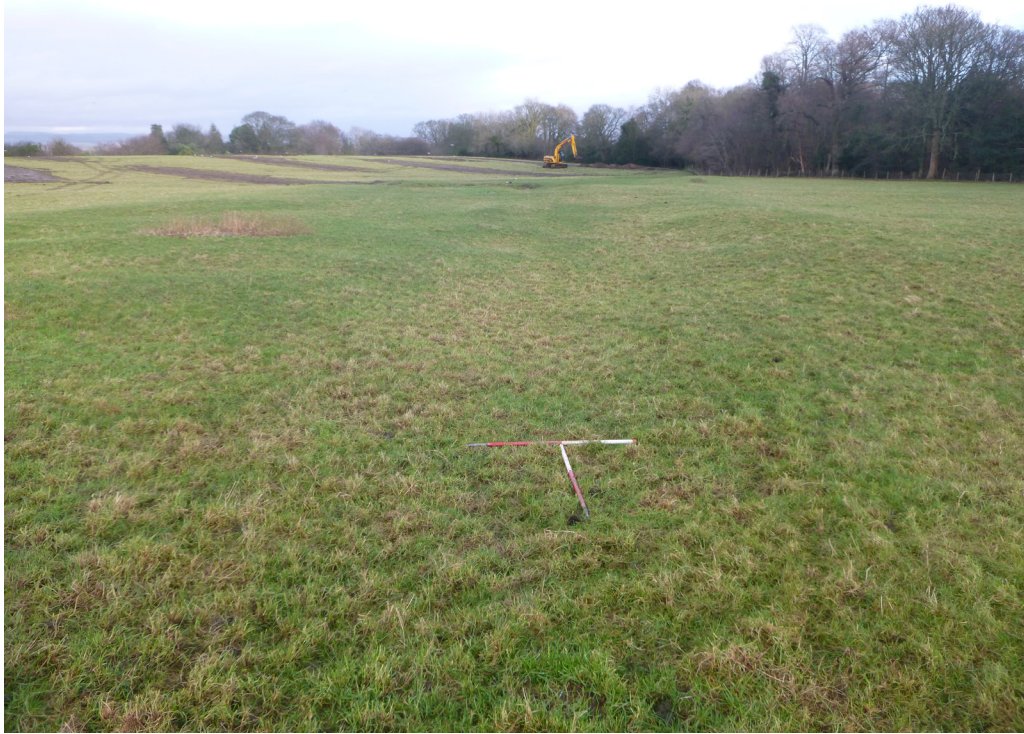
Fig. 7 - Hollow way marking probable course of Coffin Road

Traces of the Coffin Road were found in Trenches 29 and 26b these survived in a hollow way that was partially visible on the surface. This hollow way seemed to broadly follow the route of the Coffin Road as it was shown on the early OS mapping (Fig. 15). A possible cobbled surface in Tr. 13 could also have been associated with the Coffin Road and a ditch which may have been associated with the Coffin Road was identified within Trench 14, possible road side ditches were also identified in Trenches 29 and 26b.
