## The Stable Block, Sewell Manor, Central Bedfordshire

Historic Building Recording and Watching Brief

Report No. MK 184/19

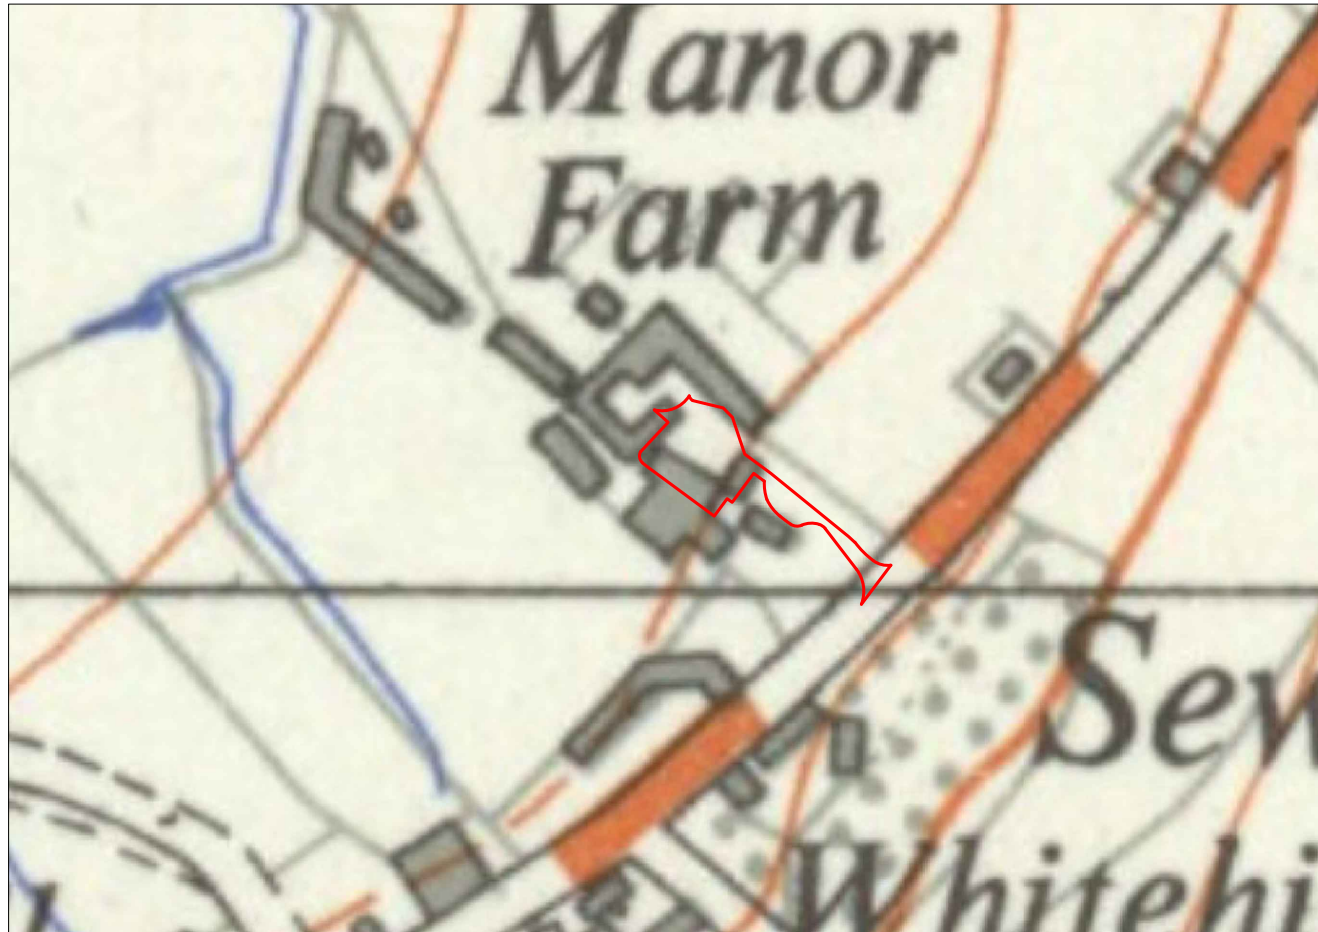
Fig. 2d - Extract from the Ordnance Survey map Sheet No SP9) Published: 1955

The final map used to plot changes in the buildings is published in by the Ordnance Survey in 1955 (Fig. 2d). This map shows new buildings erected in the fields to the north west of the farm and a large structure has been added to the building occupying the footprint of the stables. This large structure is a shed and the partially remains of this was noted on site.

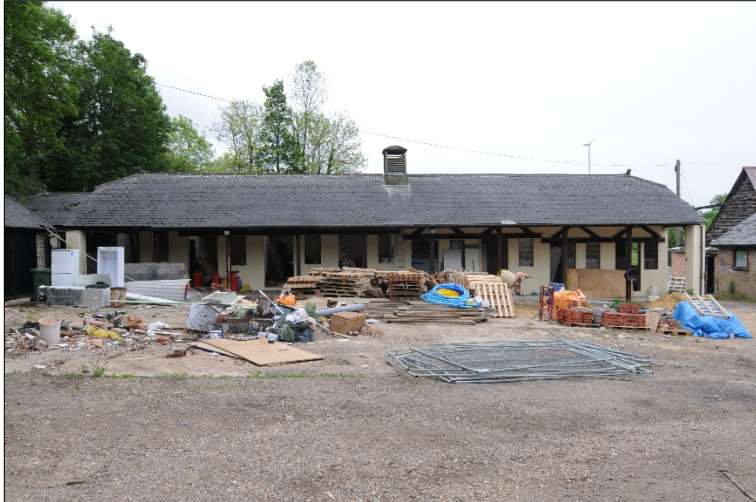
Photograph 1: North-east elevation of stable block

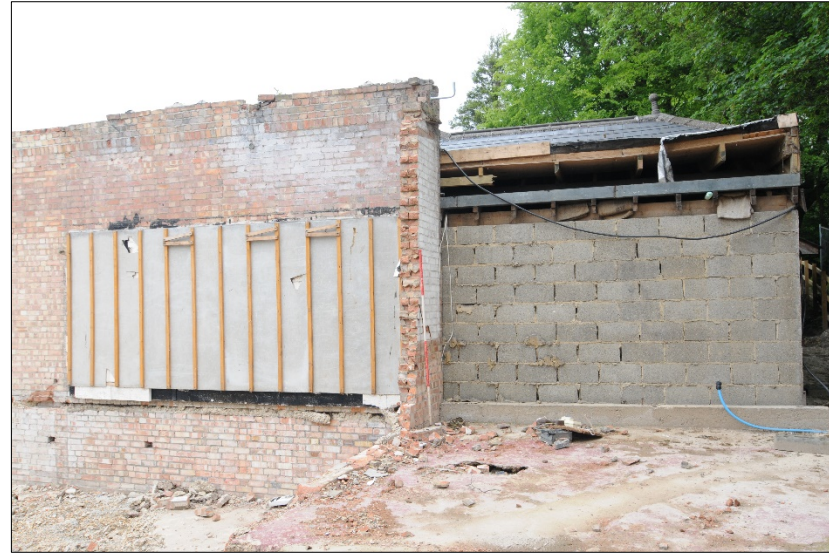
The north west gable end of the stables is rendered externally and there is a single four-light casement window with diamond patterned leaded lights (Photograph 5). The south west elevation of the stables is constructed against the brick wall of a now demolished shed (Photograph 7) the footprint of which can be seen on the Ordnance Survey map published in 1955 (Fig. 2d). At the south east end of the south west elevation the breezeblock construction of the stables is exposed along with the underside of the roof structure (Photograph 6).

Photograph 6: South-west elevation of stable block showing brick wall of demolished shed and south-east end of stable block

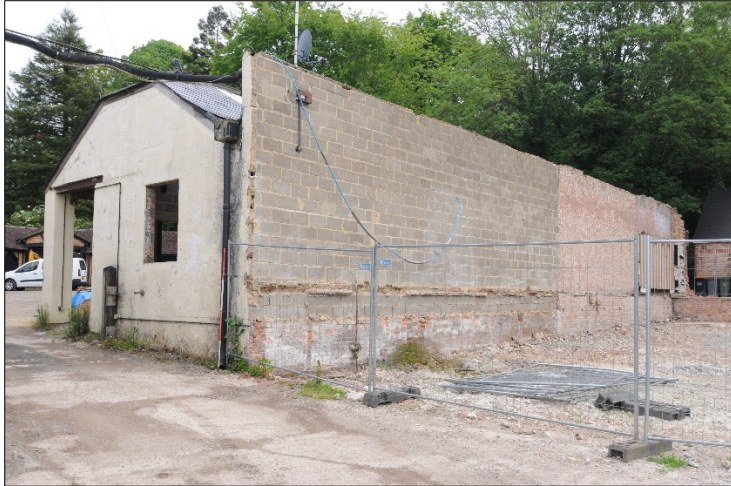
The wall of the former shed on the south west side of the stables (Photograph 9) is 23.5m in length and constructed in two separate phases: The north-west half of the wall is constructed from breezeblock but sits on earlier courses of brick, while at the south-east end of the wall is constructed entirely with modern engineering brick. Approximately 0.7m above the external ground level, on the south west side of the building, a levelling layer of cast-concrete is exposed in the former shed wall. The height of this levelling layer corresponds to the internal floor level of the stable block. The north east elevation of the stables (Photograph 9) has a single window opening but the wooden window frame has been removed.

Photograph 9: West corner of stables showing block built up against demolished shed wall

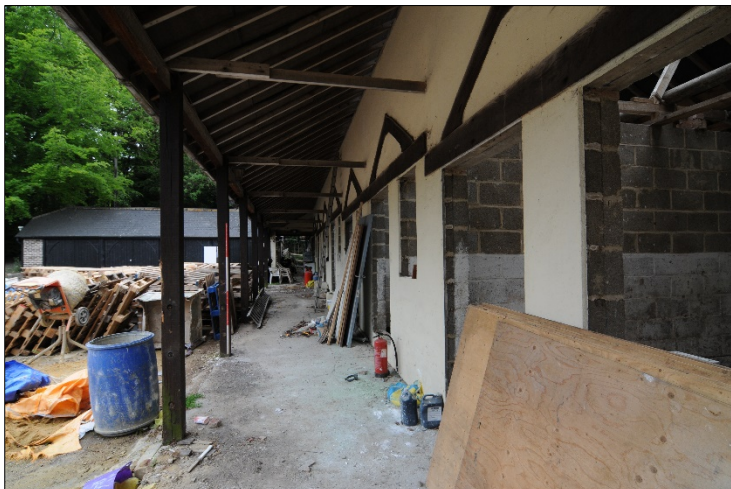
The stables are constructed from breezeblock, externally rendered, and orientated on a north-west to south-east axis with regularly spaced stable doors on the north-east side overlooking a yard (Photograph 1). The stable block is rectilinear in plan, measuring 28.1m in length by 5.27m wide. The width of the building is extended on the north east side by over sailing roof eaves that form a covered walkway 2.24m wide running the full length of the building (Photographs 11 and 12).

Photograph 11: Covered walkway at north-east side of stable block (looking south-east)

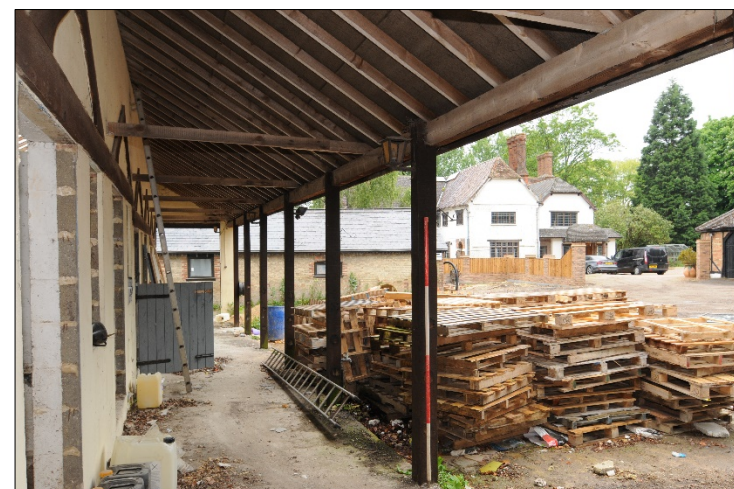
Photograph 12: Covered walkway at north-east side of stable block (looking north-west)

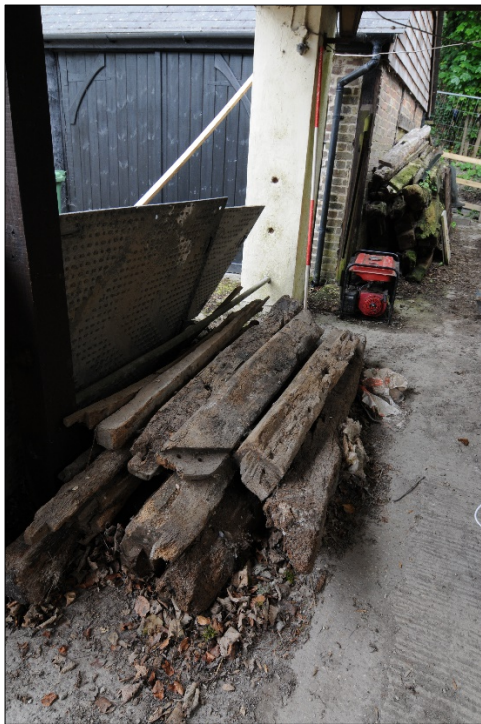
The half-hipped roof structure over the stables is slate covered and supported on the outer block walls and by regular spaced wooden posts along the length of the walkway. Under the covered walkway at the south-east end of the building there are two stacks of worked timber (Photograph 15 and 18). A limited inspection of these was possible, revealing the presence of angled pegged tenon joints identifying their former use as principal rafters from an early roof structure.

Photograph 15: Old roof timbers, some of which have pegged tenon joints

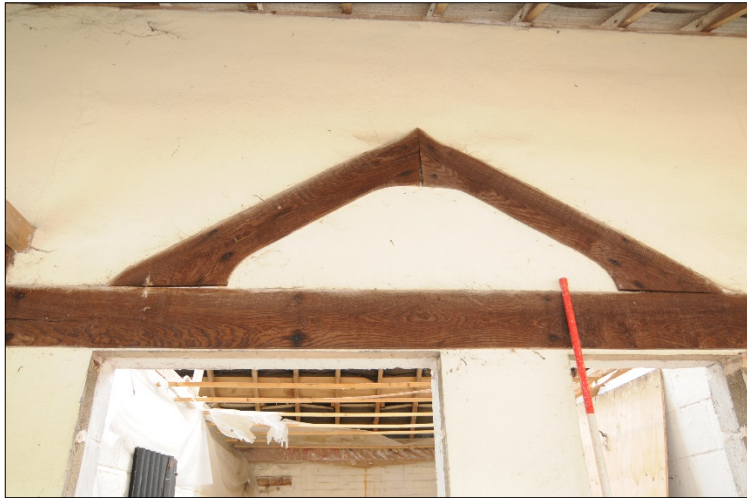
There are 8 equally spaced stable doors along the north east elevation of the building and to the south-east side of each door there is a window opening fitted with a wooden single glazed casement window frame with diamond pattern leaded lights (Photograph 14). Each of the stable doors are fitted with metal strap hinges (Photograph 13) and above each door and window combination there is an inserted timber feature formed from machine-cut softwood (Photograph 17).

Photograph 17: Inset timber feature above stable doorway

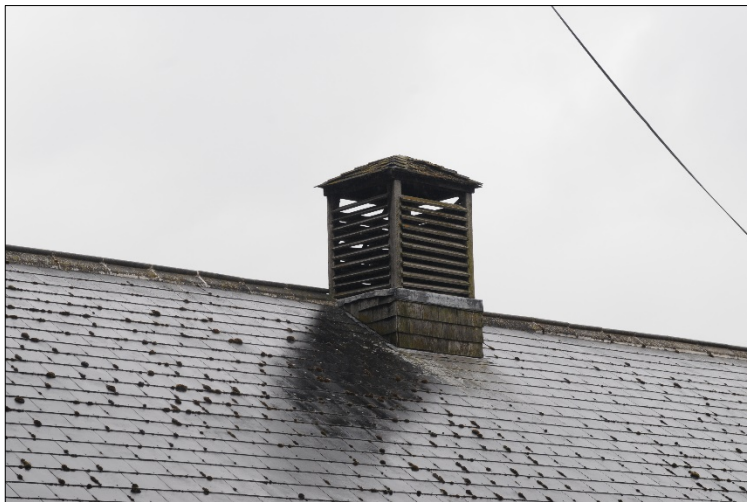
The slate covered roof over the stables has a centrally placed raised ventilator (Photographs 19 and 27), and the roof ridge is capped with stone. To either gable, there is a stone volute moulded finial with floral embellishment (Photograph 21).

Photograph 19: Wooden ventilator hood on the north east pitch of the stable roof

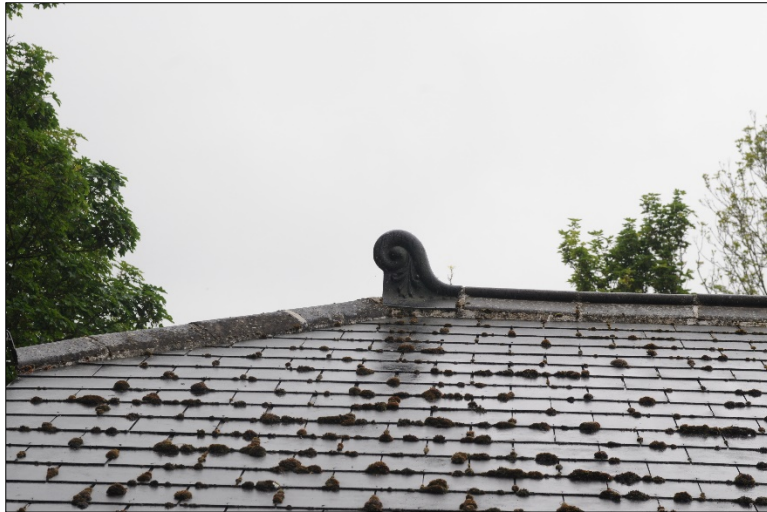
Photograph 21: Spiral finial on the hipped south-east end of stables

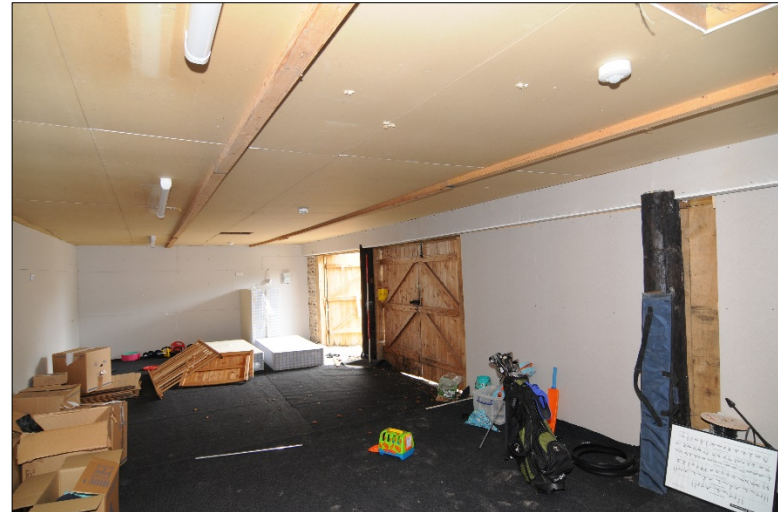
Internally, the garage on the south east side of the yard is open plan and currently used as a play area and storage. There is a modern raised modern wooden floor surface and there is plasterboard to the walls and the ceiling (Photograph 22).

Photograph 22: Interior of the garage showing a suspended ceiling and wall cladding

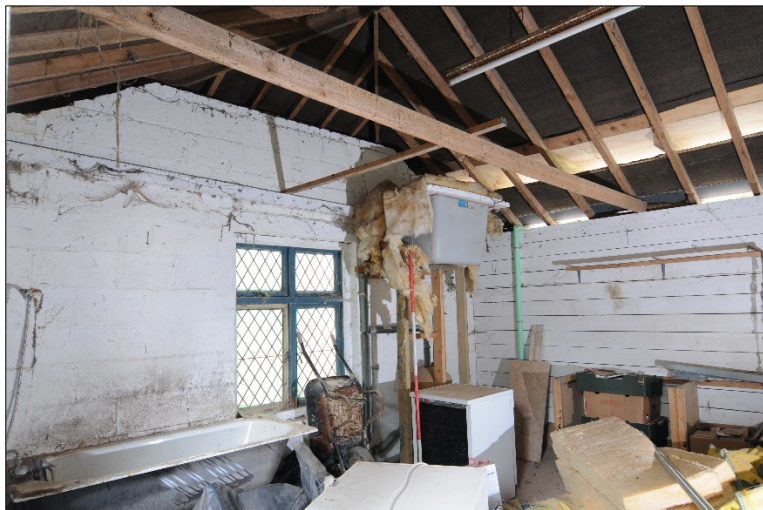
Internally the stable block is divided into eight equally sized cells (2.6m x 4.8m), with each cell separated by a full height breezeblock partition. As noted earlier there is a large storage room at the south-east end of the stables measuring 4.3m by 4.8m but this only contains a raised water tank (Photograph 23) and has a cast concrete floor with a drainage channel to one side (Fig. 3a).

Photograph 23: Interior view of Room 9 at south-east end of stables showing a water tank

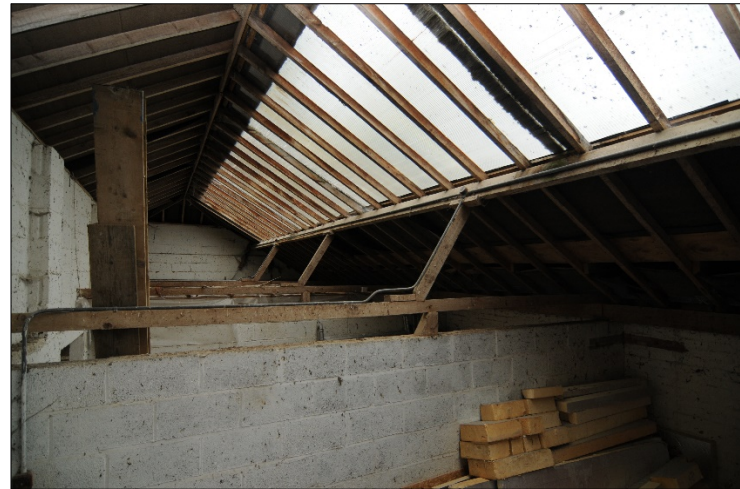
The roof over the stables is supported by softwood purlins and rafters (Photograph 29) and along the south-west pitch of the roof there is a continuous skylight running the full length of the building (Photograph 26).

Photograph 26: Roof structure over the stables showing continuous skylight

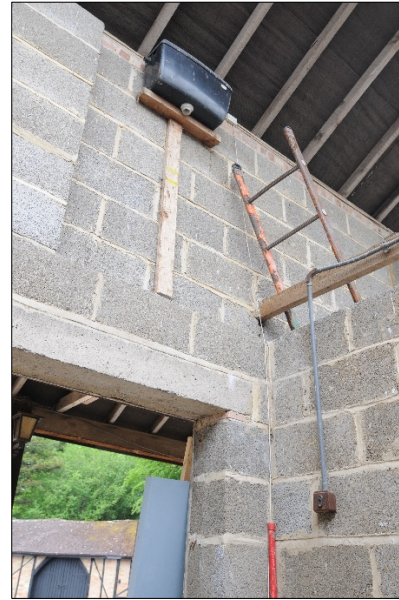
Each stable has a cast concrete floor with a regular square shaped pattern stamped into it for extra grip. In stables 1, 3, 5, 6, and 8 (Fig. 3a) there is a brick-built corner trough with a tethering ring set against the south-west wall. Along the north east wall of each stable there is a continuous drainage channel that passes through the breezeblock partitions to drain hole at the south-east end of the building (Photograph 24). Each of the stable blocks contains a water tap (Fig. 3a) and in stables 4, 5, 6, 7 and 8 there is a water drinker with an internal ball valve (Photograph 25) controlling the water supply from an overhead cistern in stable 6 (Photograph 28).

Photograph 28: Cistern to control water flow to the drinkers in each stable

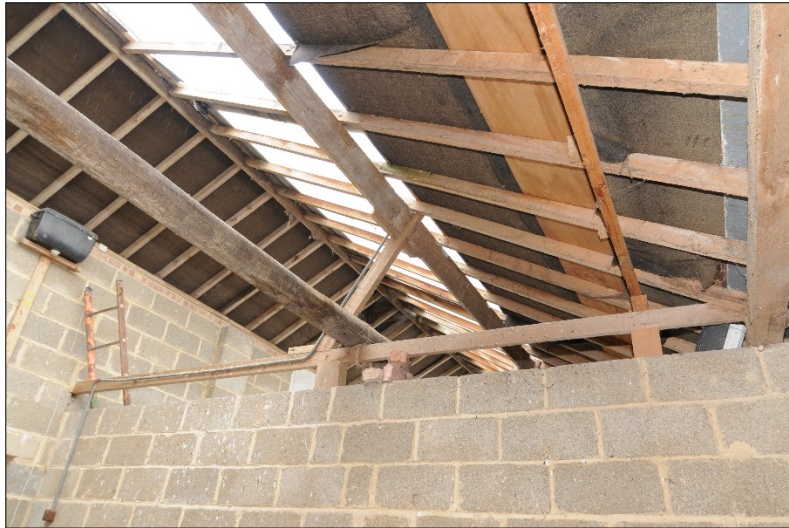
Photograph 29: Softwood purlins and rafters over the stables

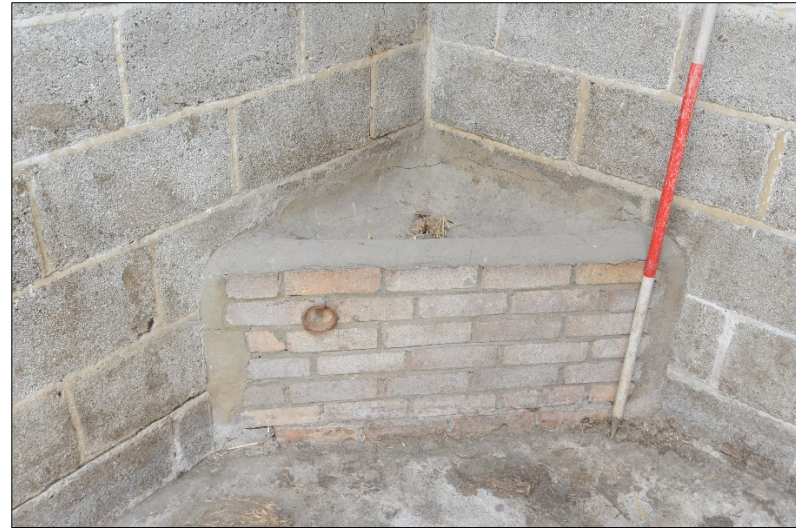
Photograph 30: Detail of the corner trough in Stable No. 3 showing tethering ring
