Halls Farm Cottages, Nr Dunbar, East Lothian

Basic Historic Building Survey
Report No. 3990

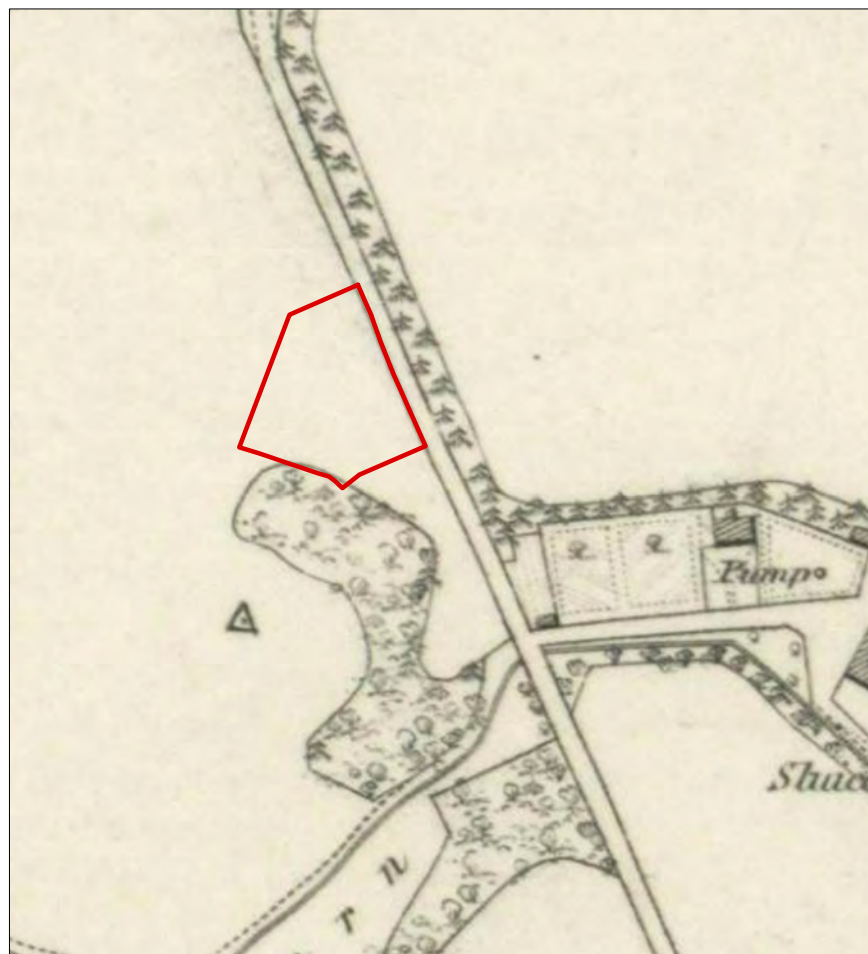
Fig. 2a - 1855 First Edition Ordnance Survey

The 1855 First Edition Ordnance Survey map shows Halls Farm, but the cottages had yet to be built (Fig 2a). The cottages are depicted on the 1894 Second Edition Ordnance Survey map (Fig 2b) and are shown with their property boundary adjacent to the road that passes the farm. Two outhouses are shown on their west side. The 1907 Ordnance Survey map shows no changes occurred since 1894 (Fig 2c). The cottages are depicted on subsequent maps sheets (Fig 2d-e). A brick-built extension to the western side of Building 3 was added between the 1957 Ordnance Survey map and the 1969 Ordnance Survey Map (Fig 2d-e). The 1969 Ordnance Survey map depicts the cottages with the same footprint as shown in Fig 1.

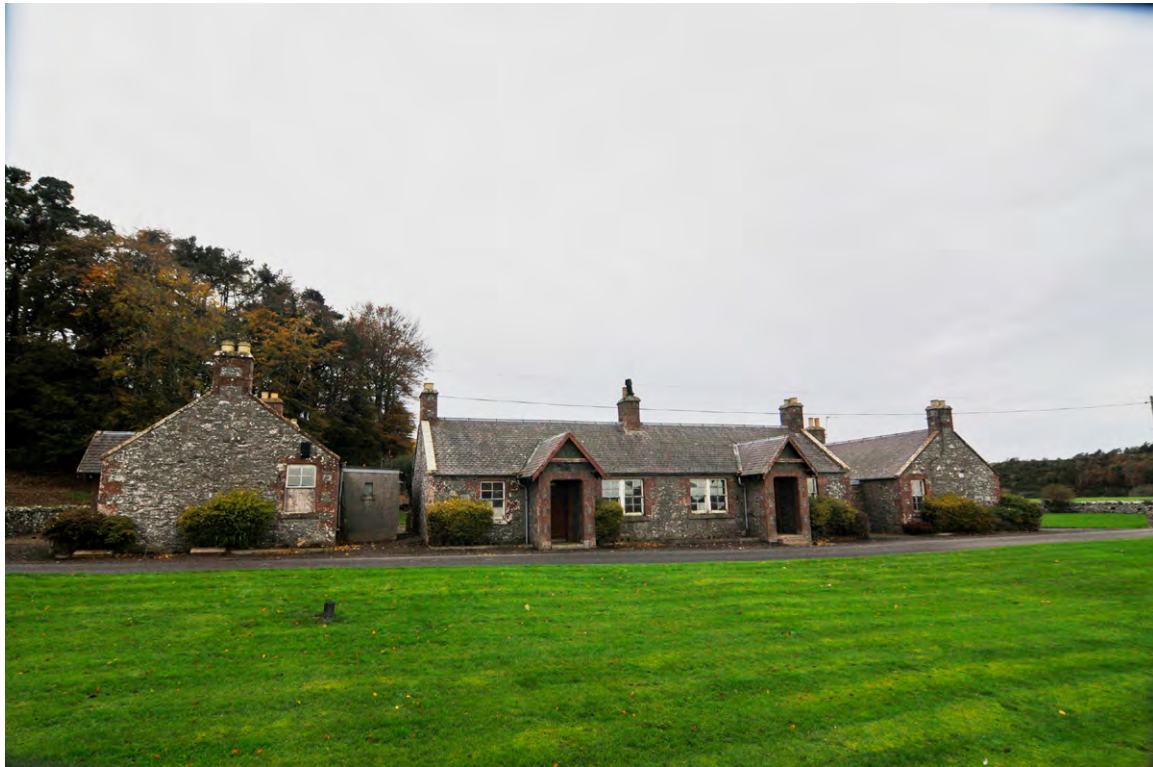
The east elevation faced onto the main road leading to Halls Farm. The elevation comprised a pitched gable constructed with grey whinstone with stugged ORS dressings. The window on the north side was a part boarded sash-and-case with the top panes surviving. The stack and ridge copings were ORS with the former incorporating two courses of whinstone.

Fig. 5 - East elevations of Buildings 1-3

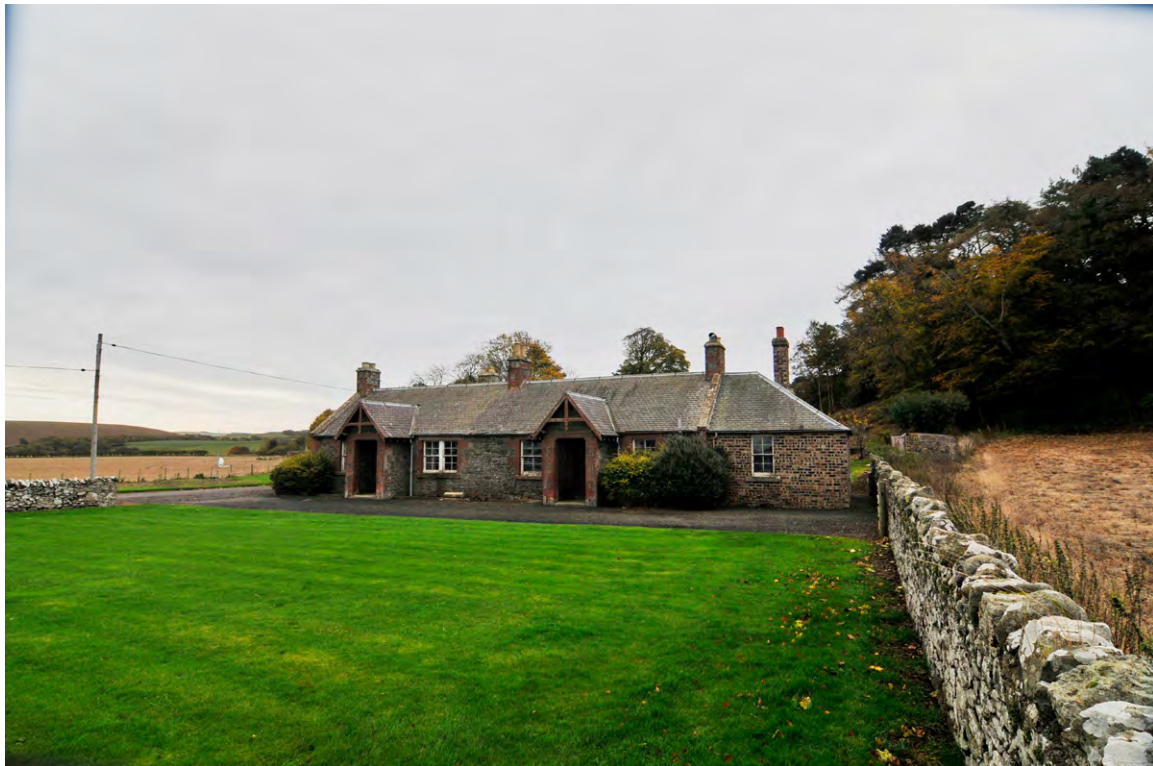
The north elevation of Building 3 had seven bays two of which were the porches for the two individual cottages. The fabric was the same as seen on Building 1. However, the fenestration differed slightly as it had only one mullioned sash window. The rest were uniform single sash windows. The cottages had a brick-built extension added to its west end with a hipped slate roof and an-off centre sash window and brick chimney stack. The highly fired factory brickwork had been laid in stretcher bond.

Fig. 6 - North elevation of Building 3

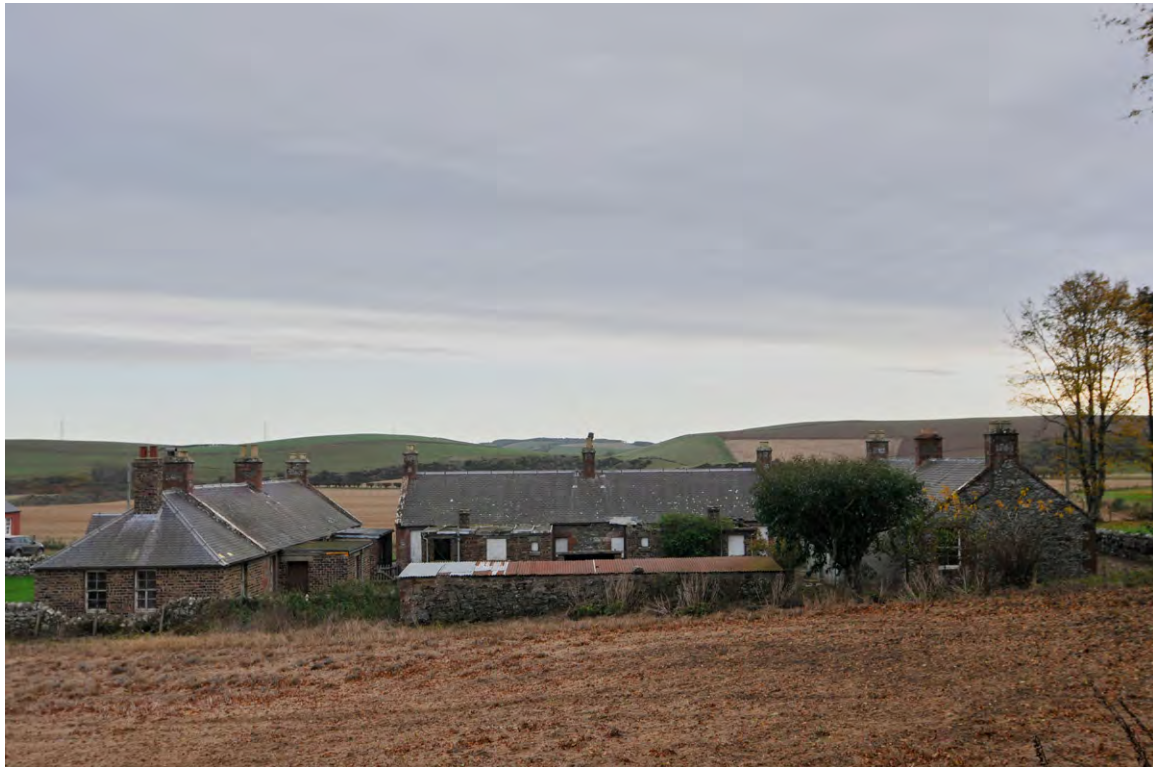
Fig. 7 - West elevations of Building 1-3 from a distance

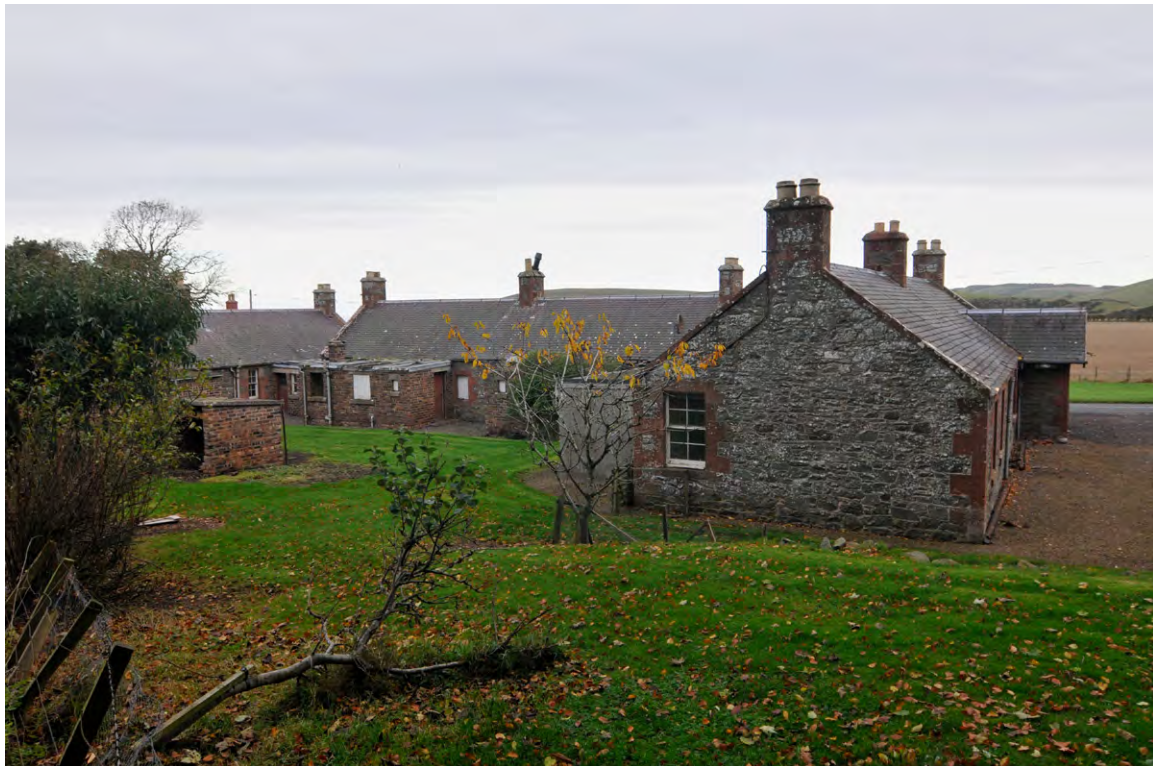
The west elevation was a gable wall that mirrored the east gable and contained no additional features. Its window also on the north side was complete. The wall appeared to have been re-pointed as the joints were very sharp.

Fig. 8 - West elevation (gable) of building 1

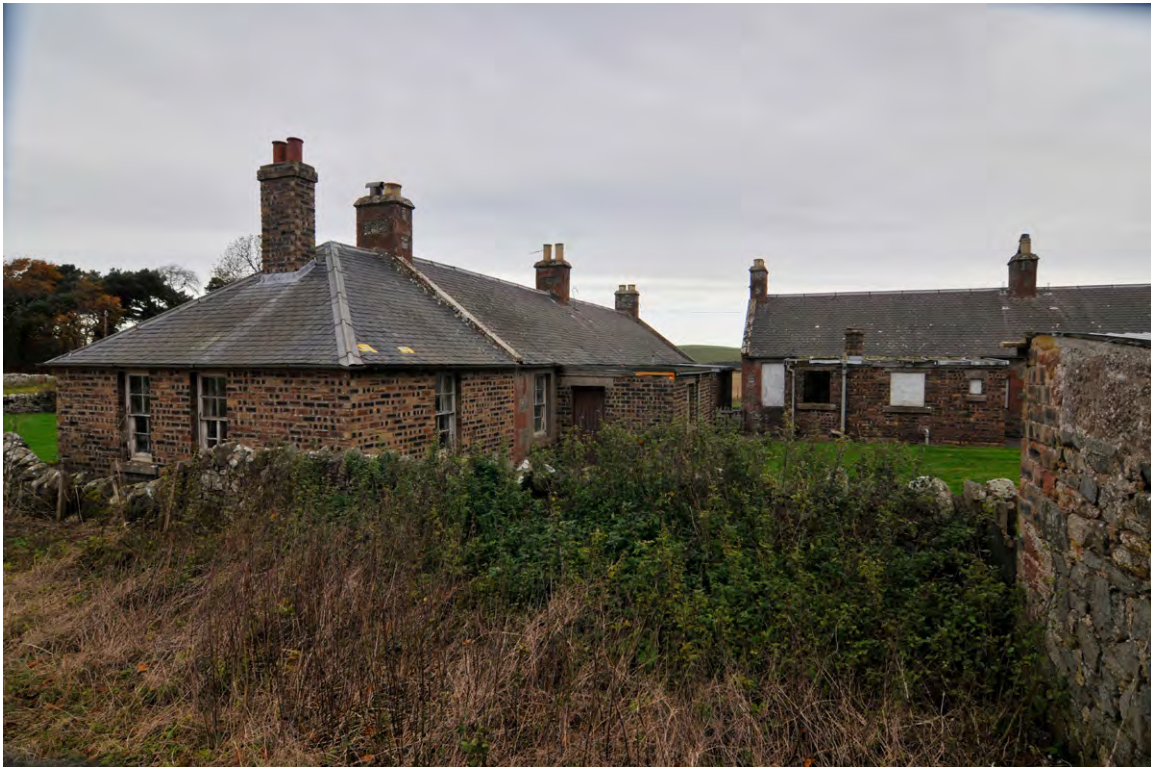
The west elevation was a brick-built gable for the extension with the aforementioned hipped slate roof. A tall brick-built chimney stack had been built on its north side.

Fig. 9 - West elevation of Building 3 (gable), brick extension

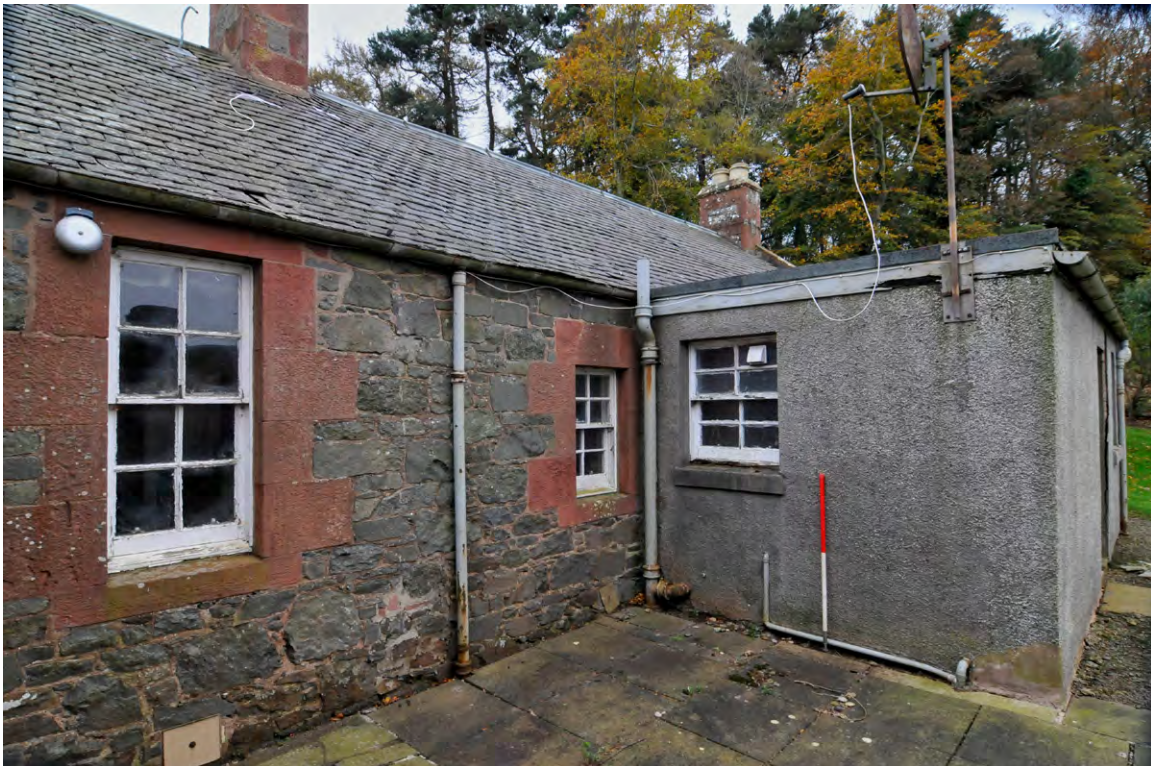
The north elevation was at the rear of the building facing the garden and Building 2. It contained two brick extensions that had been harled. The roofs were felted. The main elevation was built of coursed sub-angular whinstone (basalt) and the margins around the fenestration comprised stugged ashlar dressings using local Old Red Sandstone (ORS). The windows were all sash-and-case (4-over-4). The extensions had plain plank-built doors with both sash-and-case and single paned windows. The pitched roof was slated, had sandstone ridge skews and the three chimney stacks were a combination of ORS and whinstone.

Fig. 10 - Building 1 north elevation, with rear extension

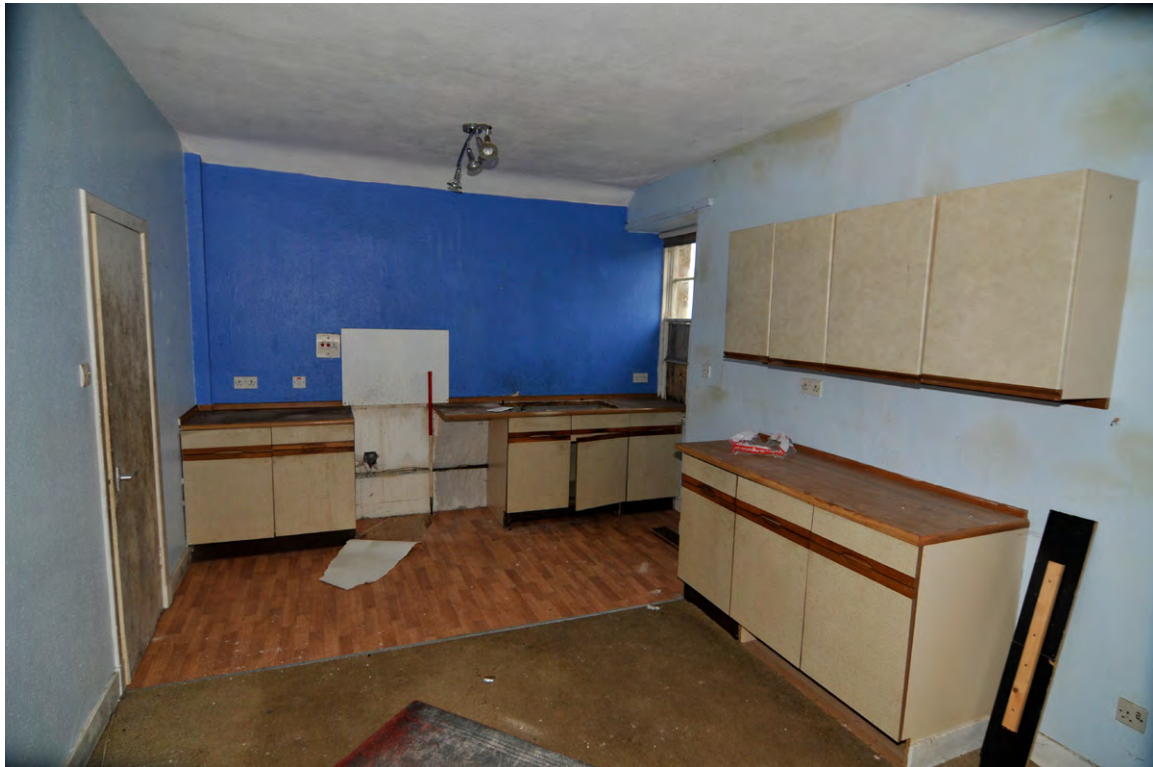
Fig. 11 - Building 1, Unit 3, kitchen interior

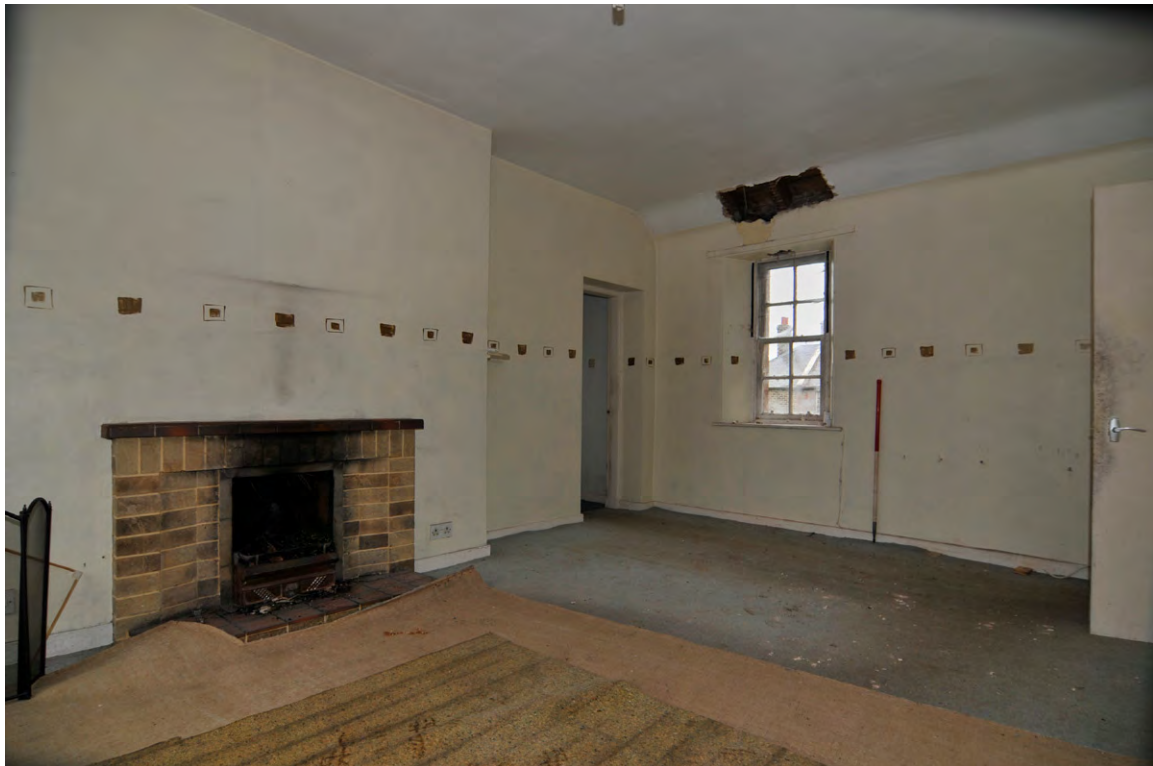
Fig. 12 - Building 1, Unit 6, living room

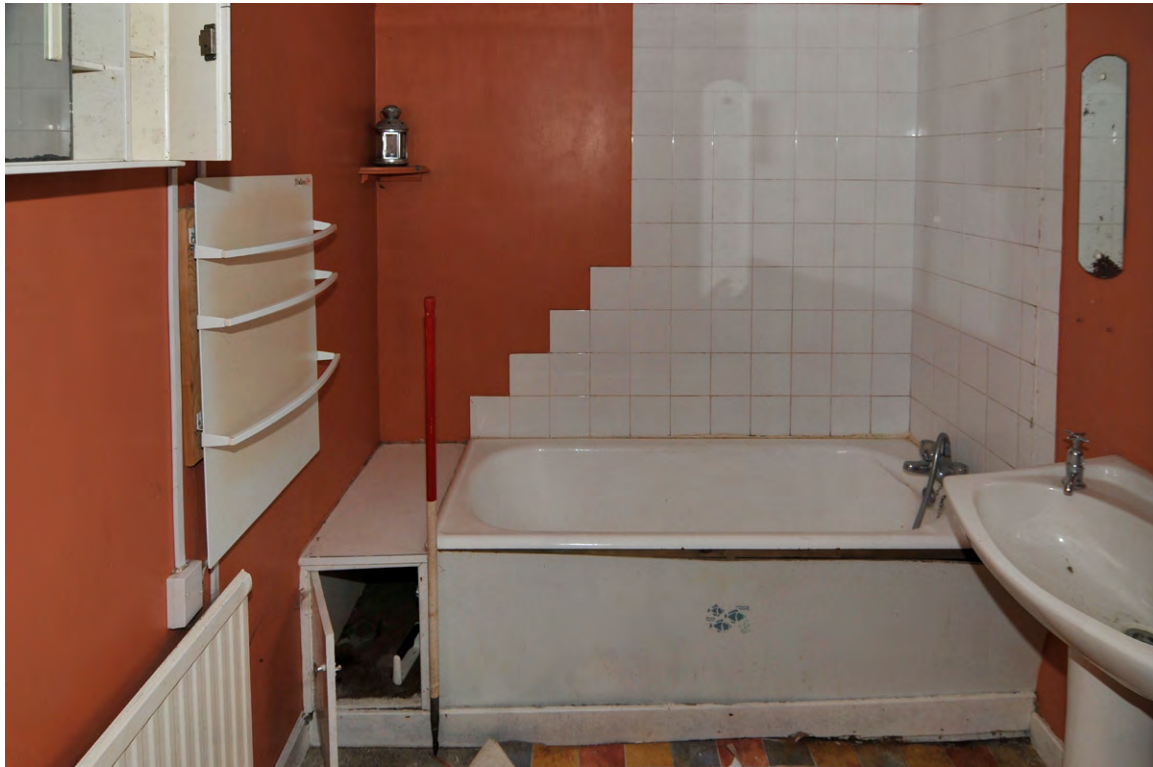
11	Bathroom withing an extension with modern sanitary goods, enamel bath and pedestal sink. Frosted paned sash window on N wall. (Fig 13)	None
12	External Storeroom fitted out with shelving. Painted plaster walls	None

Fig. 13 - Building 1, Unit 11, bathroom

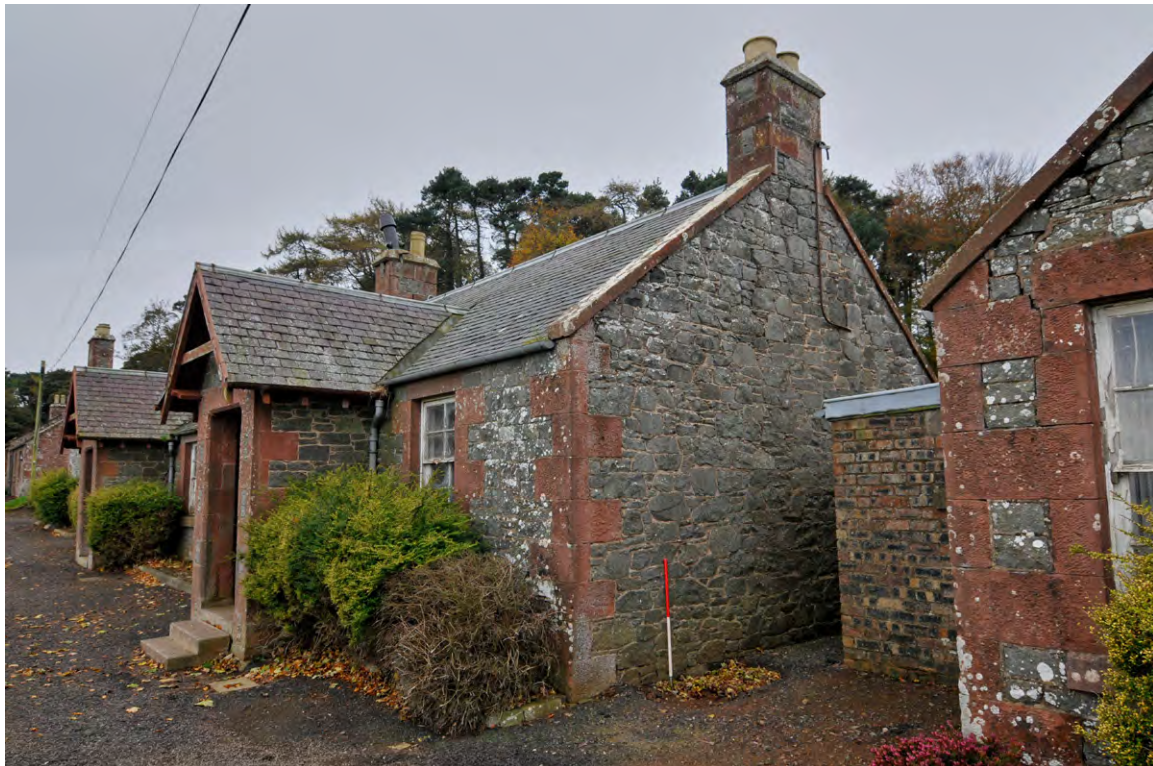
The north elevation was a windowless gable wall built using coursed sub-rectangular blocks with ORS dressings. The pitched roof had sandstone copings and the chimney stack was haunched with two chimney pots.

The east elevation faced the main road and it had six bays, at the middle were two mullioned windows, flanked by two porches and two outer windows towards the gables. The main build was the same as Building 1. The central chimney had had a modern chimney pot added with a cowling. Both the doors were plank built.

Fig. 14 - Building 2, Exterior east and north gable

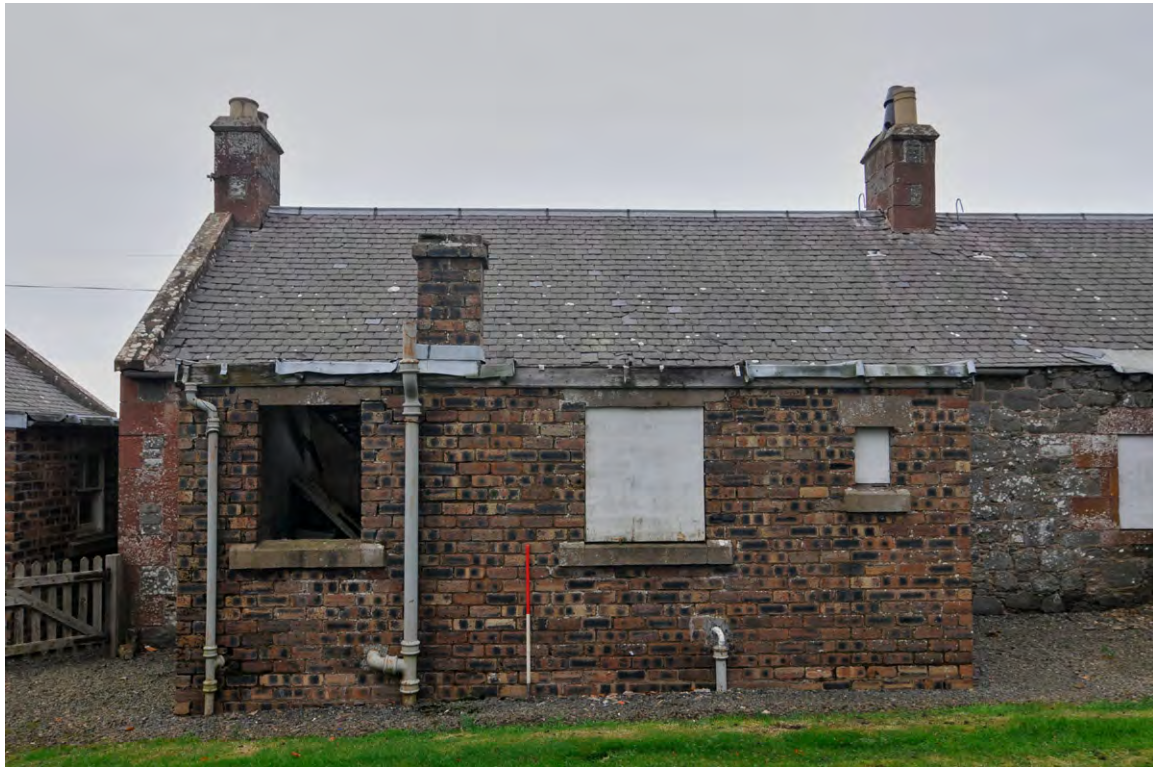
The west elevation was the same as Building 1, but its windows were all boarded. Both outshot extensions had bare brick walls. Both had small brick-built chimneys typical of domestic washhouses which had a coal fired copper or boiler.

Fig. 15 - Building 2 Exterior west elevation with surviving washhouse chimney

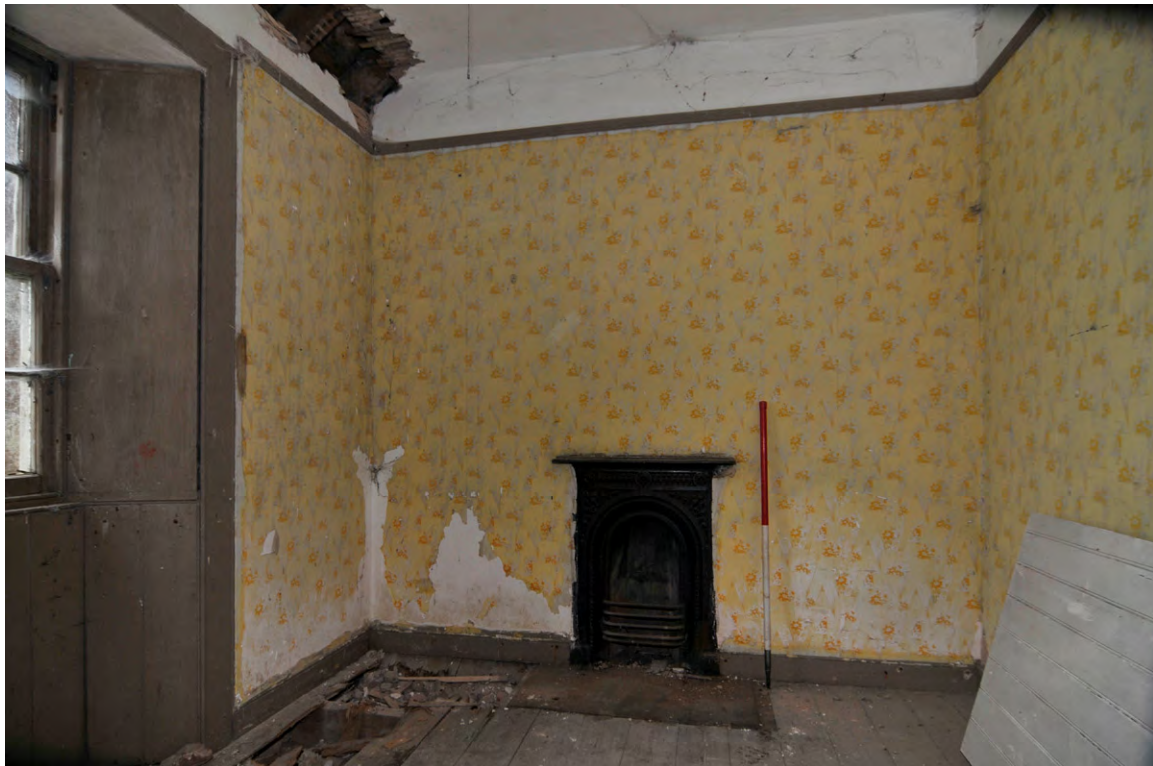
Fig. 16 - Building 2, Unit 14, bedroom with cast-iron fireplace and window shutter

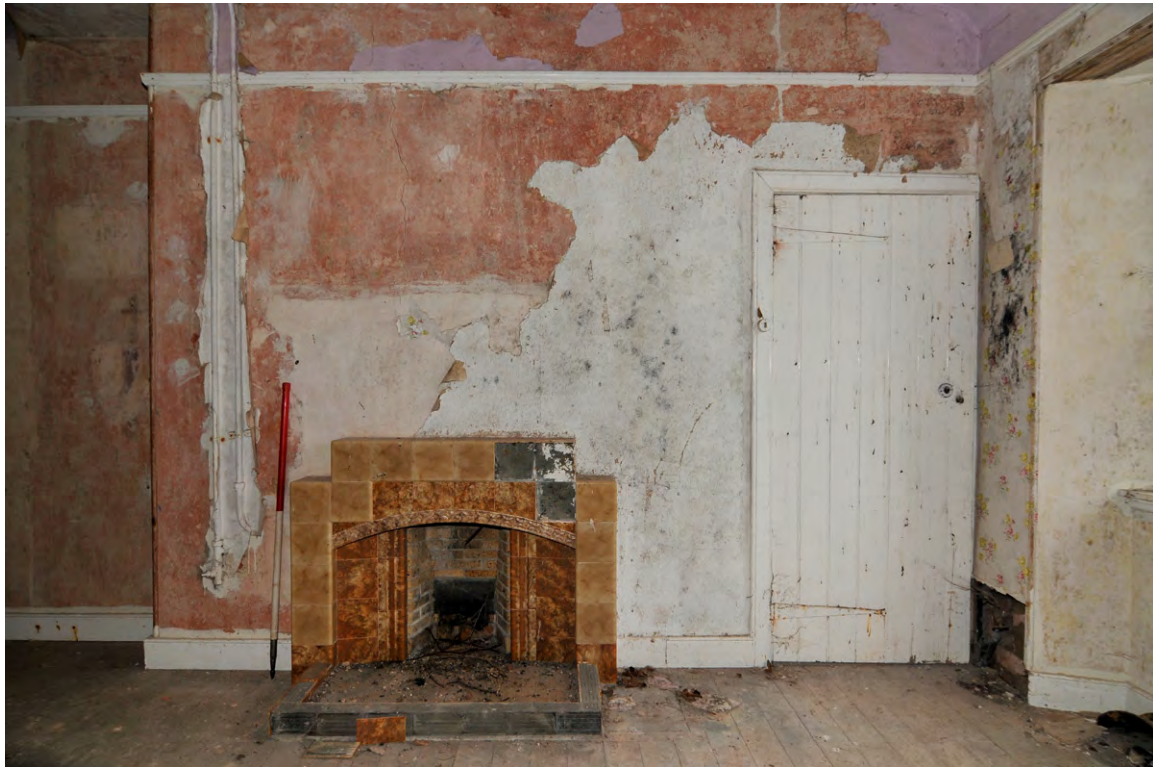
Fig. 17 - Building 2, Unit 16, living room with tiled fireplace

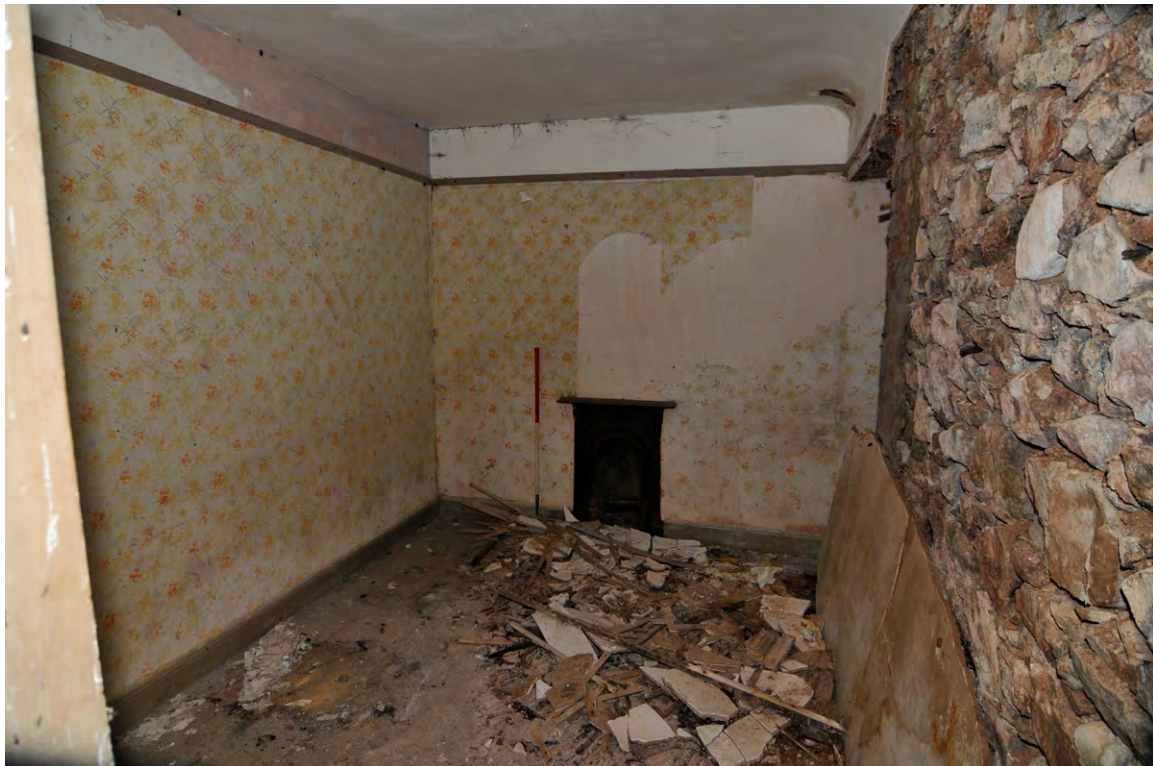
Fig. 18 - Building 2, Unit 18, bedroom with cast-iron fireplace and rubble gable wall

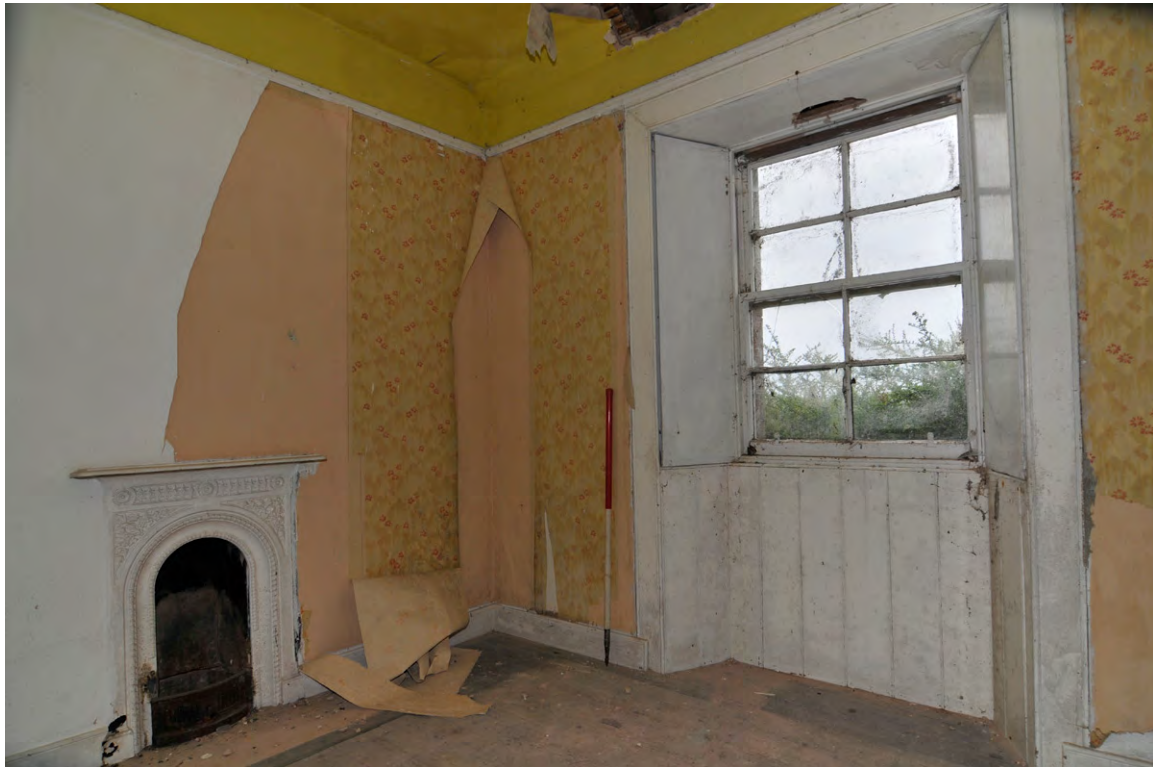
23	Entrance hall and cupboard	None
24	Hallway	None
25	Bedroom with ornate horse-shoe shaped fireplace. Shuttered sash window (Fig 19)	19 th C fireplace
26	Kitchen within the rear extension with a stainless-steel sink. Interior derelict.	None
27	Bathroom with collapsed ceiling. Modern sanitary goods.	None

Fig. 19 - Building 2, Unit 25, bedroom fireplace and shuttered window

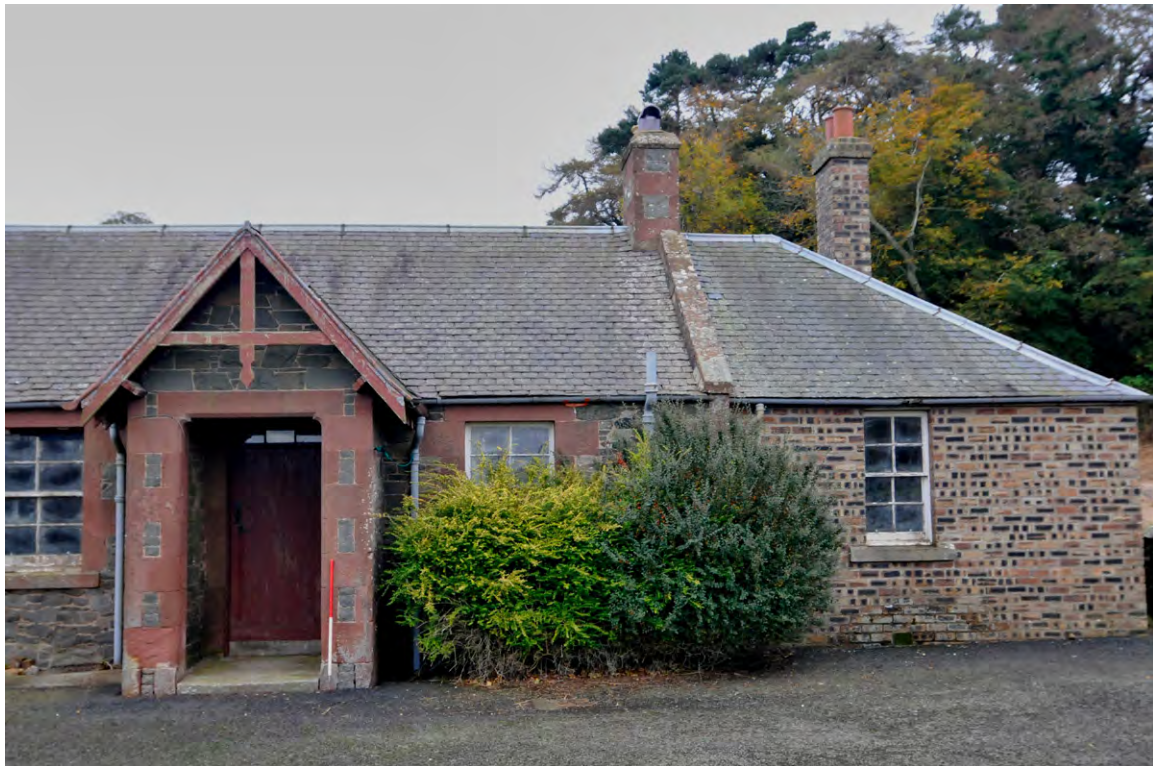
Fig. 20 - Building 3, Exterior north elevation with porch and brick-built extension

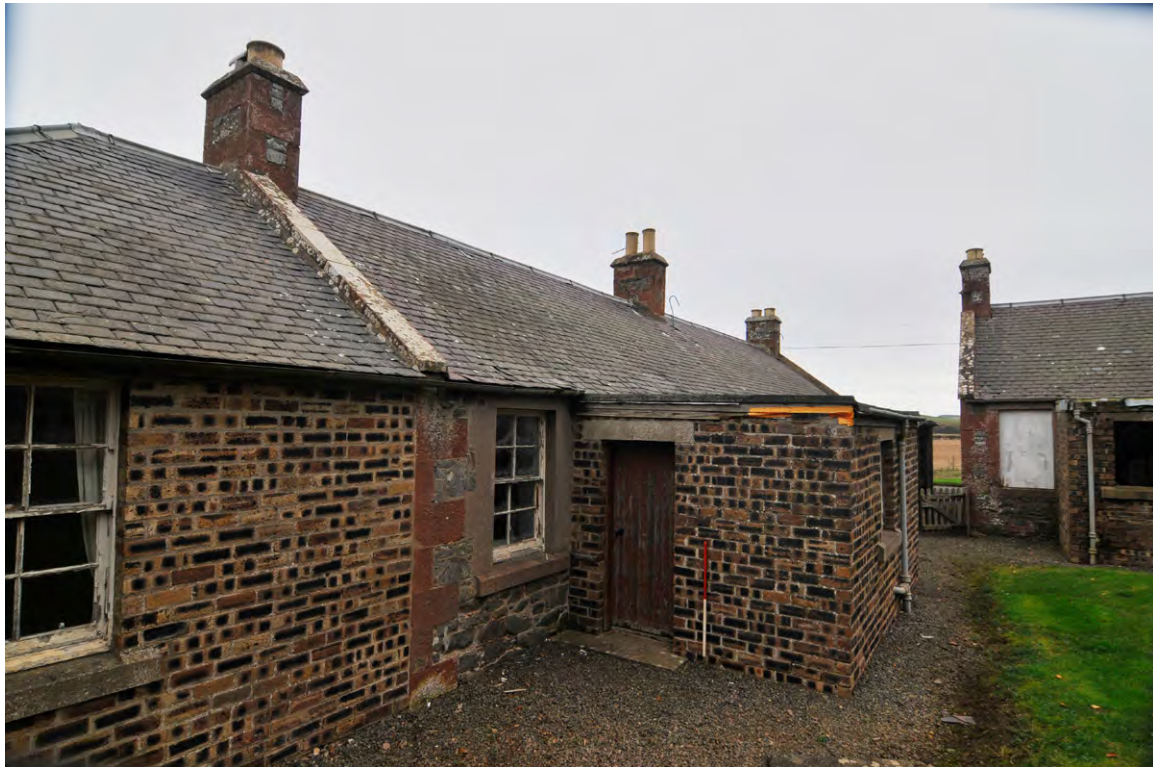
South elevation faced onto the drying green and it had the brick-built extension at its west end with a hipped slate roof and brick chimney stack. It had a central sash-and-case window. Two brick-built outhouses were outshot off the main elevation. Their chimneys had been removed and the flat roofs appeared to be modern replacements. The fenestration on the main elevation was the same as that previously described with stugged ORS and with occasional replaced stonework.

Fig. 21 - Building 3, Exterior south elevation with brick-built extensions

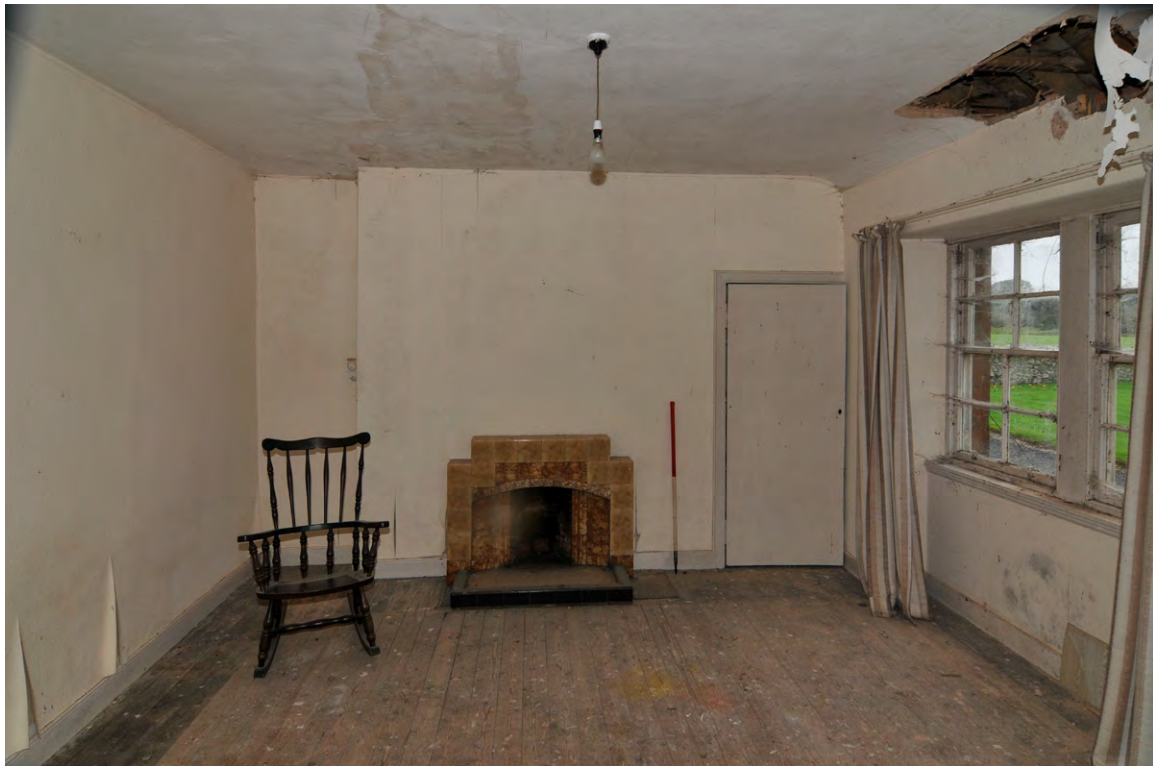
Unit No.	Summary description	Period Feature
	<i>Cottage 4</i>	
28	Front porch with main entrance door to cottage 3	Porch
29	Small box room with a sash window.	None
30	Living room with a central mullioned window. Tiled fireplace (Fig 22)	Pre-modern fireplace
31	Bedroom with single sash window, combed ceiling	None
32	Kitchen with Belfast sink with sash window over. Plank-built doors with a bathroom leading off (Fig 23)	Modern sink and taps
33	Bathroom lit by frosted sash window. High level toilet cistern with chain pull. Boxed in bath and pedestal sink. Ceiling combed.	Pre-mod cistern
34	Pantry off the kitchen	None
	<i>Cottage 5</i>	
35	Porch interior and main door to cottage 4	None
36	Living room with a pre-modern fireplace. The room was lit by a sash window (Fig 24). All the doors were plank-built with latches.	Pre-mod doors and fireplace
37	Hallway with papered walls. Pre-mod light switches	Light switches

Fig. 22 - Building 3, Unit 30, living room and mullioned window

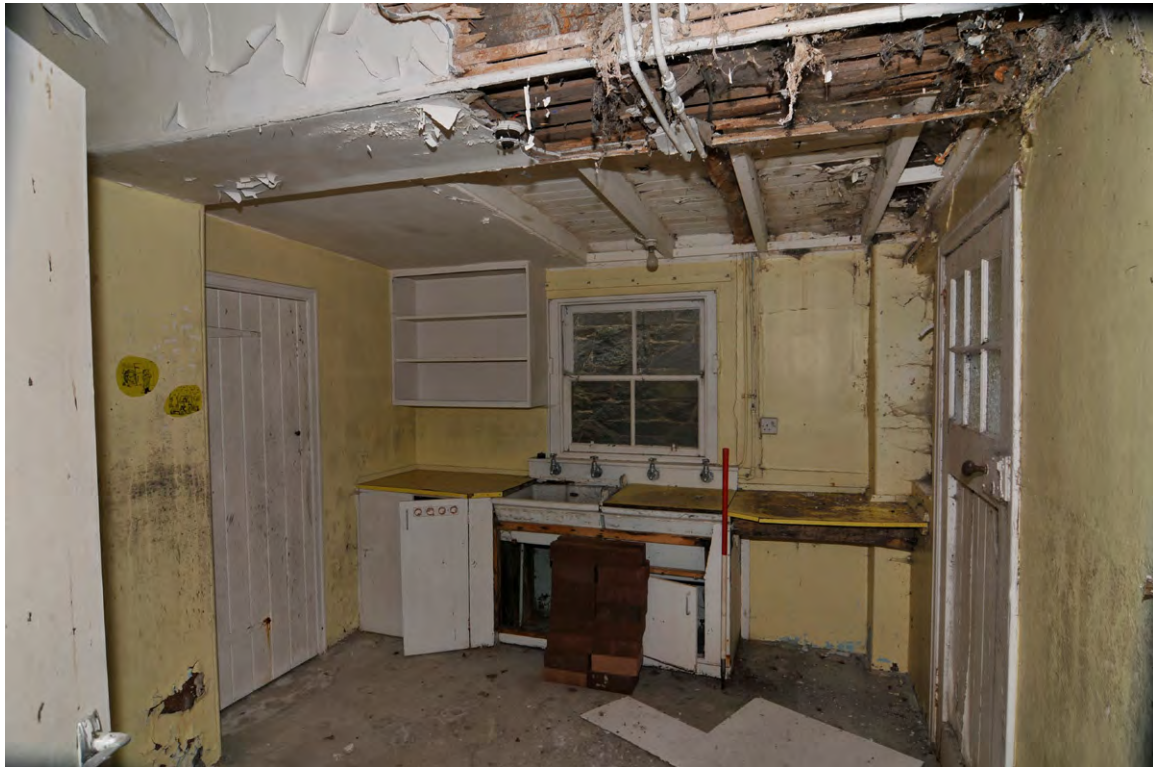
Fig. 23 - Building 3, Unit 32, kitchen and boarded window

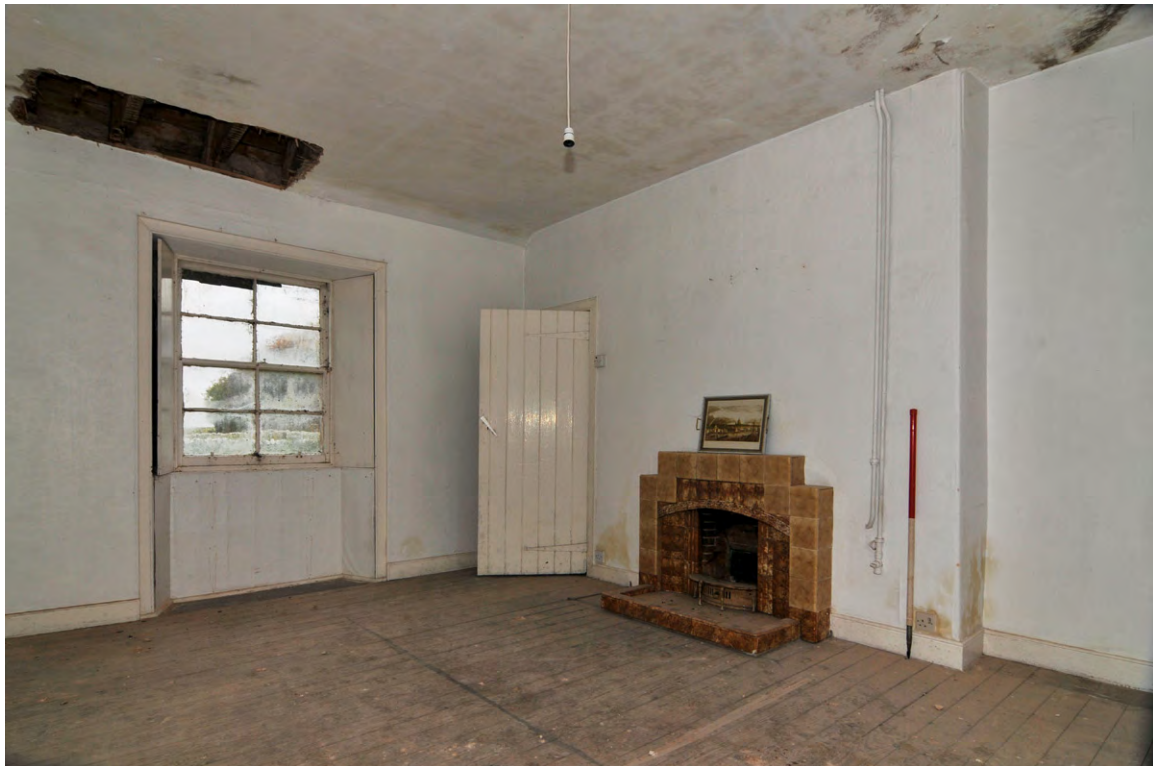
Fig. 24 - Building 3, Unit 36, living room with fireplace and single window

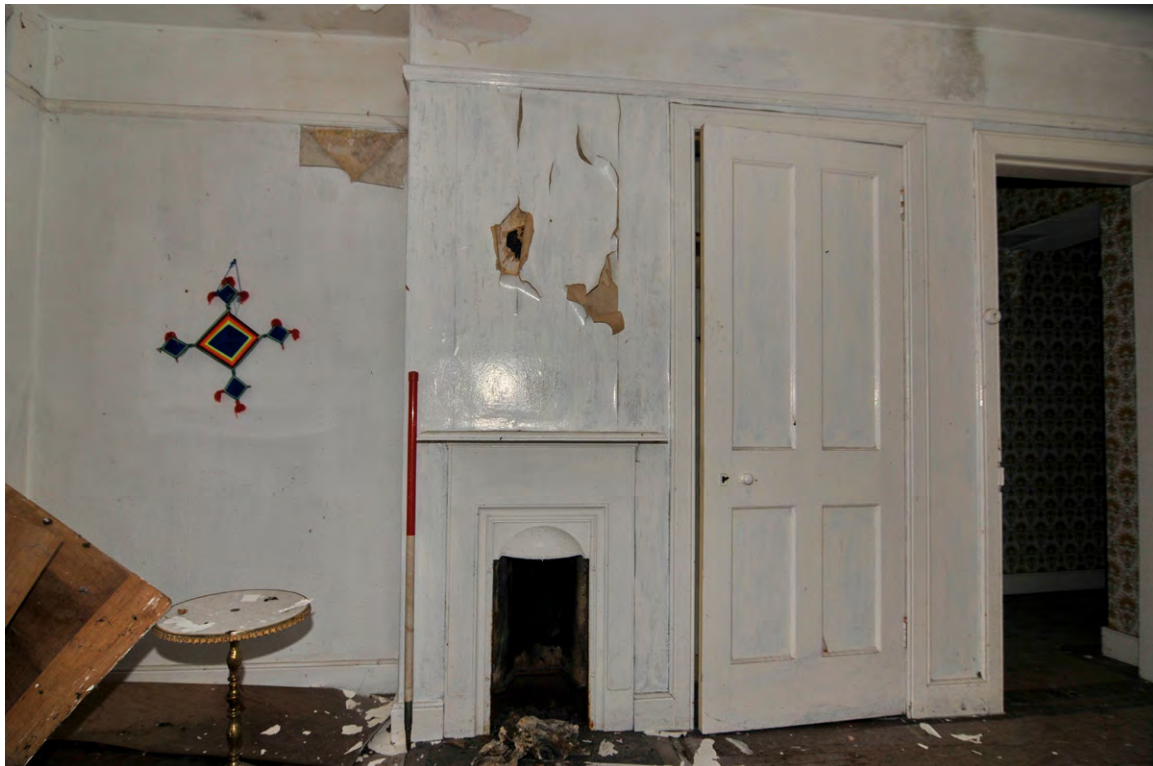
Fig. 26 - Building 3, Unit 41, bedroom with cast-iron fireplace

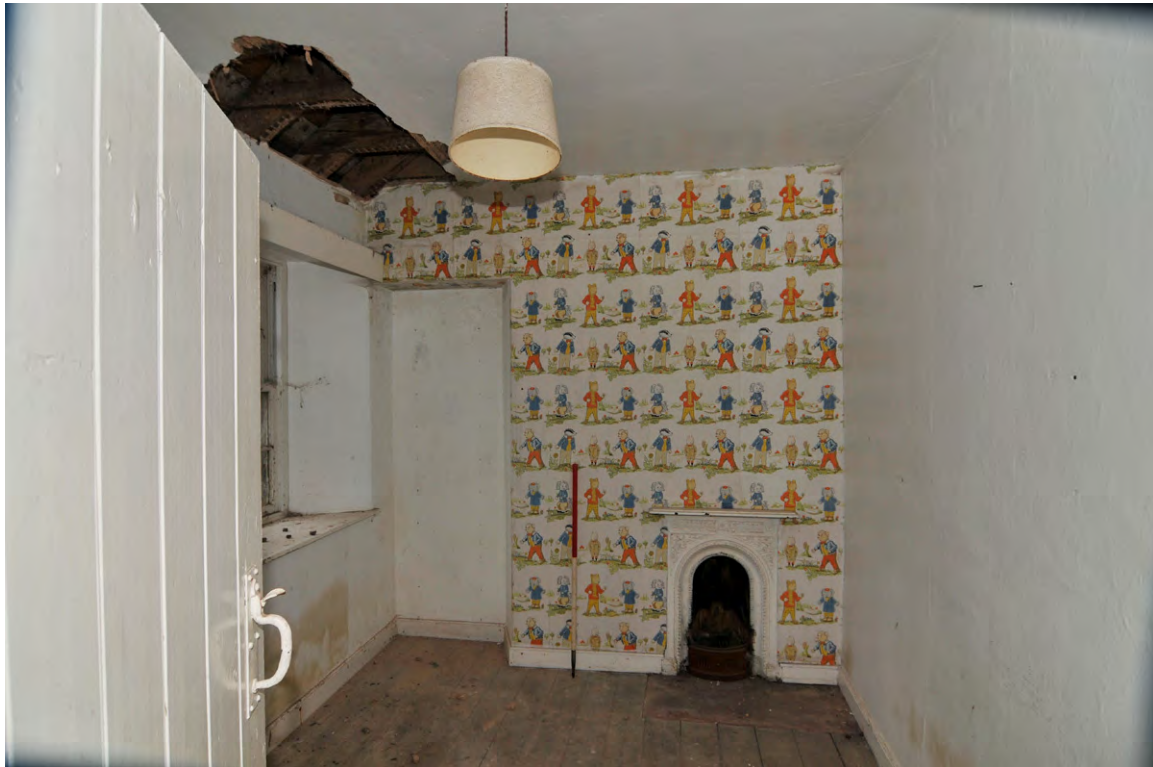
Fig. 27 - Building 3, Unit 42 bedroom with horse-shoe shaped fireplace
