Halls Farm Cottages, Nr Dunbar, East Lothian

Basic Historic Building Survey
Report No. 3990

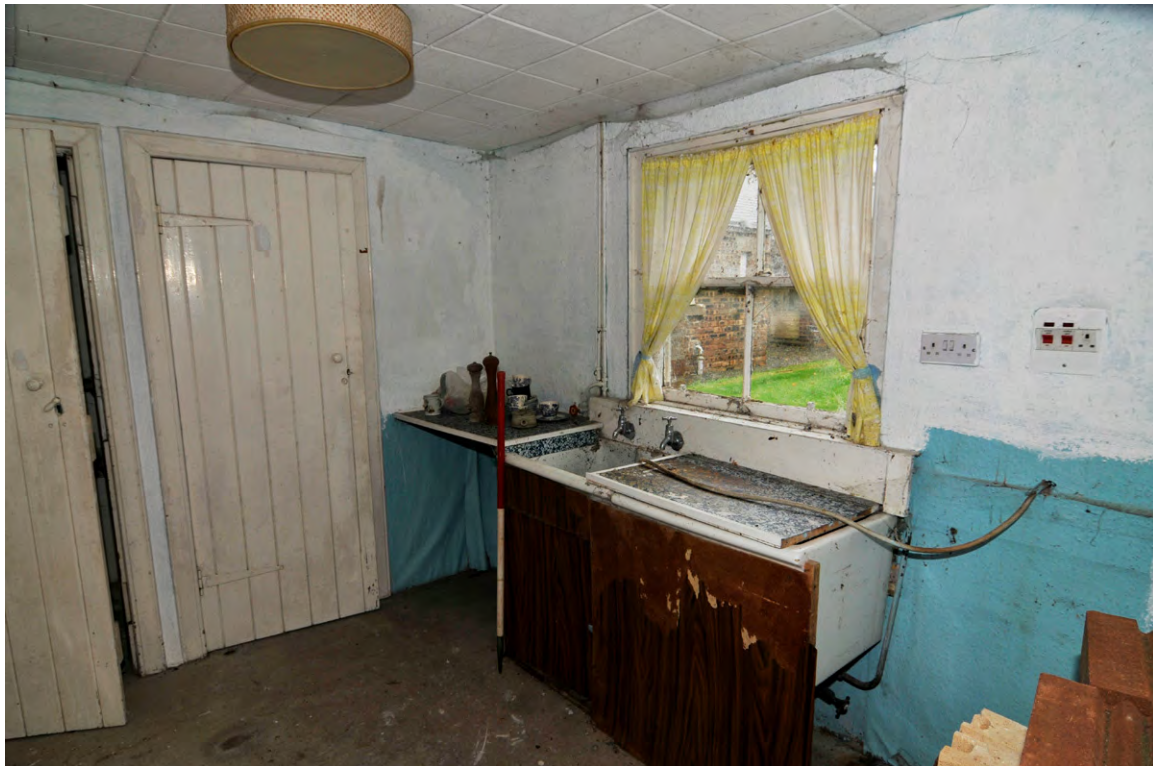
38	Narrow hallway with papered walls.	None
39	Bathroom with high level toilet cistern with chain pull. Cast-iron enameled bath. (Fig 25) Shuttered half frosted sash window. Recent lined pine reveals.	Toilet cistern
40	Small bedroom with a pre-modern fireplace with cast-iron surround and mantle. Two four-paneled doors. Sash window opposite the fireplace	Pre-mod fireplace
41	Bedroom with the same fireplace seen in Unit 40. Four paneled doors. Cupboard to the right of the fireplace. Picture rail round the walls. Bakelite light switch (Fig 26).	Pre-modern fireplace and light switch
42	Bedroom with narrow cast iron horse-shoe shaped fireplace with press cupboard to its left, sash window within a splayed reveal (Fig 27).	19C fireplace
43	Kitchen, largely bare with no fittings except large, Belfast sink. Concrete floor, single sash window, two cupboards each with a wooden board doors, (Fig 28).	Early to mid 20 th C Belfast sink

Fig. 28 - Building 3, Unit 43 kitchen with Belfast sink

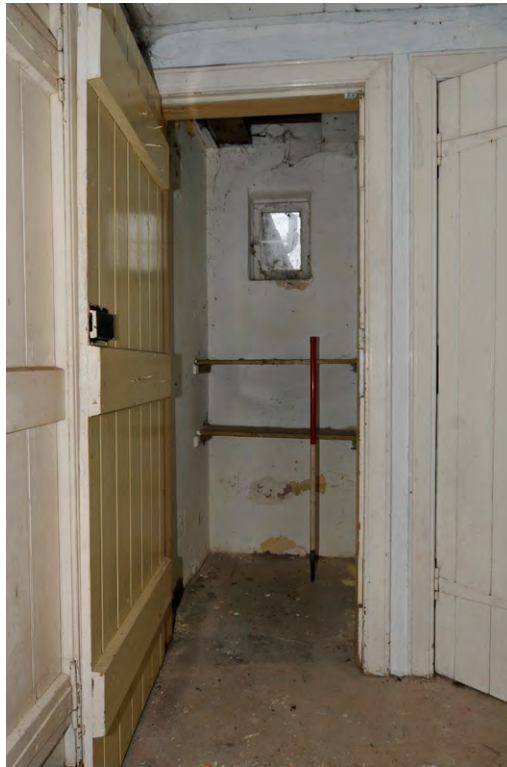
44	Cupboard with a wooden board door, simple wooden shelves and small, single paned windows set high on the outside wall, (Fig 29).	None
45	Cupboard with a wooden board door, simple wooden shelves and small, single paned windows set high on the outside wall, (Fig 30).	None

Fig. 29 - Building 3, Unit 44 cupboard

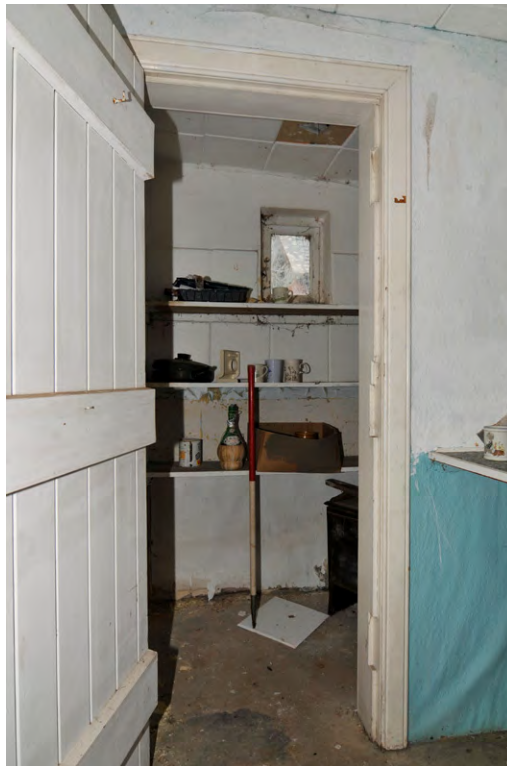
Fig. 30 - Building 3, Unit 45 cupboard

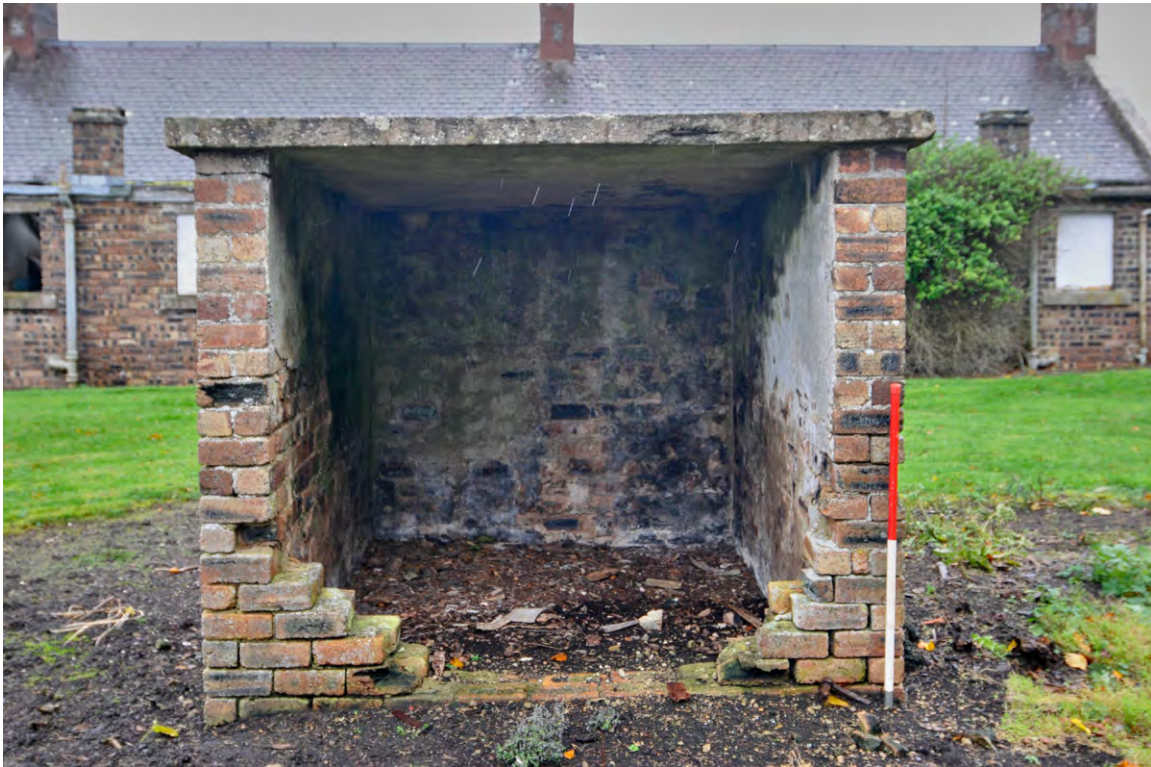
At the centre of what would have been a common drying green was a brick-built building (Unit 46) open to the south-west. It had a sloping concrete slab roof with a brick and stone floor. What the building was used for is not clear, but storage seems most likely.

Fig. 31 - Detached building (Unit 46) general view of its west side

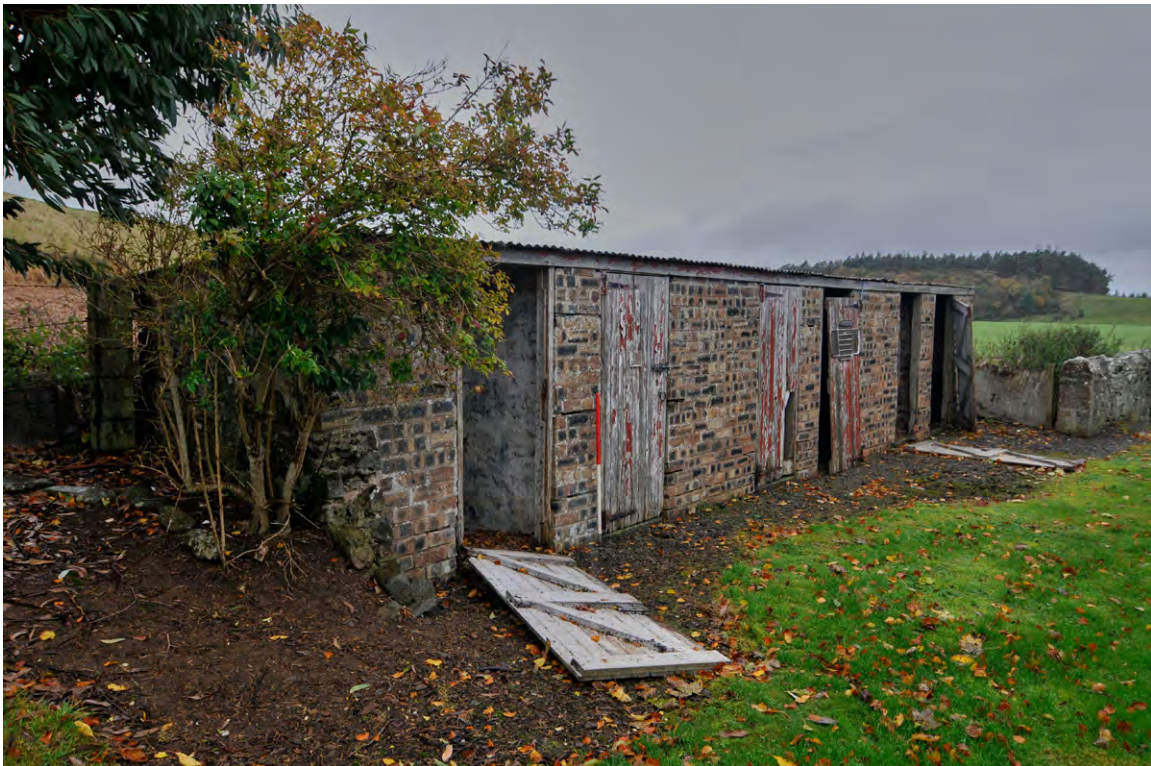
On the western boundary of the site was a long brick-built shed (Unit 47, Figs 4e & 28-29) with six individual compartments accessed by plank-built doors. The building was brick and rubble-built with extensive re-pointing. The front elevation is brick-built but its rear and side walls include random rubble suggesting an earlier building was remodelled. The individual spaces were probably coal houses. The earlier building may have been the original outside earth closets in use prior to the installation of bathrooms.

Fig. 32 - Row of sheds (Unit 47) on the west side of the cottages

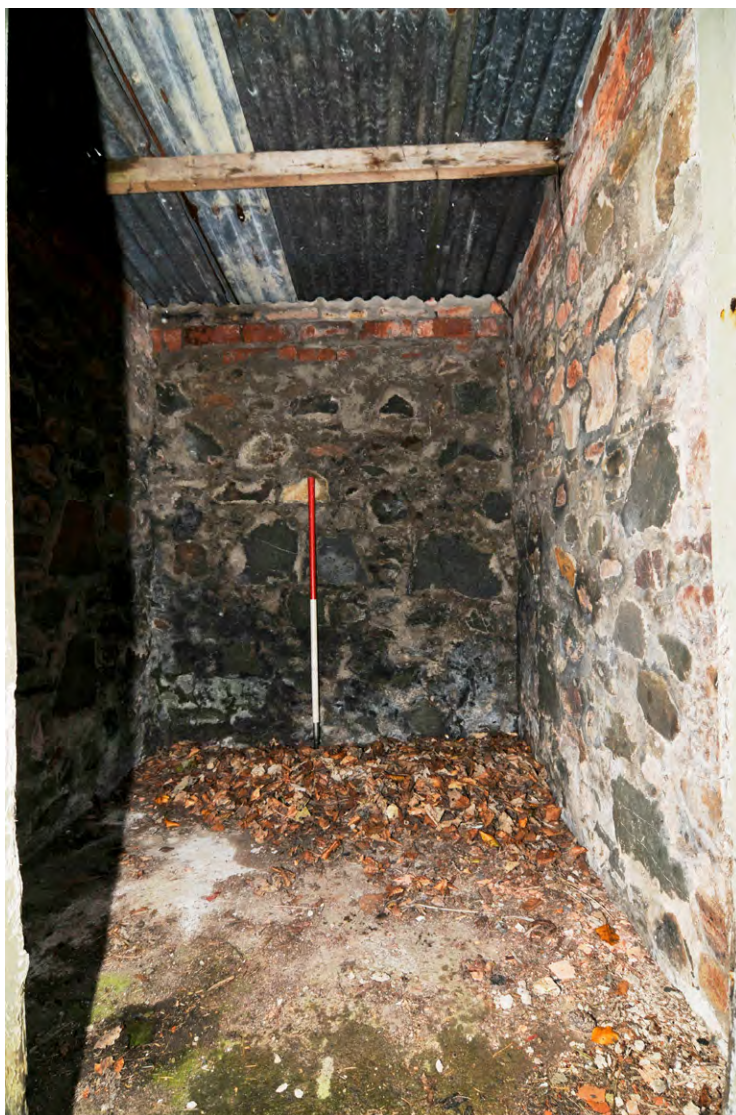
Fig. 33 - Interior of one of the sheds (Unit 27)
