CFA ARCHAEOLOGY LTD

October 2008

**Walled Garden, The Old Manse,
Morham, East Lothian:
Archaeological Desk-Based Research, Evaluation
& Standing Building Appraisal**

Report No. 1504

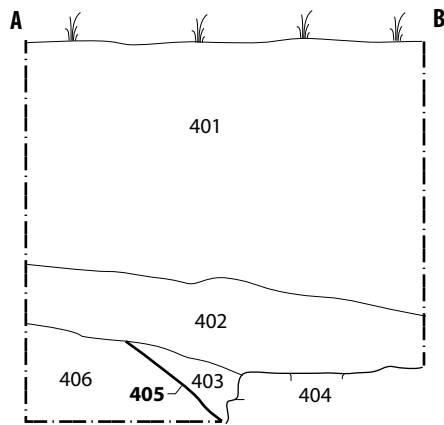
Fig 9 - Trench 4, south facing section

- 3.2.15 This trench (Figs. 2, 9-10, 14) lay at the edge of the proposed development and was placed to examine the survival of any wall remains springing from the edge of the manse gable end built into the garden wall. Below 0.7m of topsoil (401) was a 0.25m thick deposit of loose crushed stone, roofing slate and mortar demolition debris, oyster shell and bottle glass of 17th/18th century date (402). Below this was the footing of a wall (404) which appeared to have a foundation cut (405) filled with a light brown soft silt (403). The foundation cut (405) was cut through an orange-brown sandy deposit (406), which may represent bedding material. Excavation did not proceed beyond 1m in depth and natural subsoil was not reached.

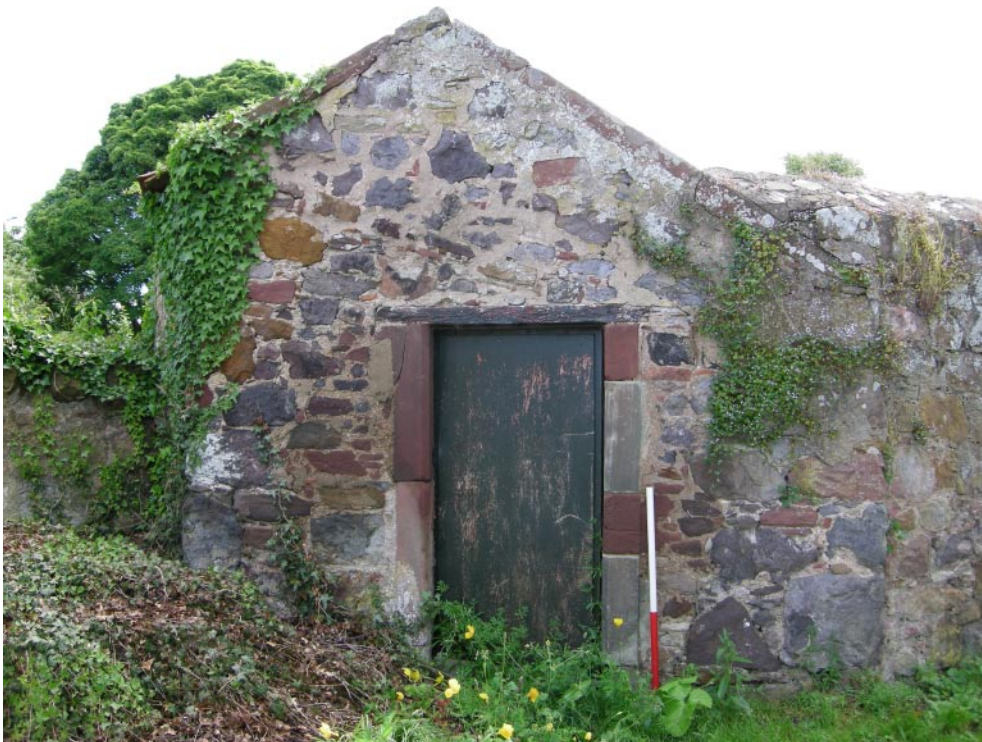
Fig. 17 - West facing elevation of Potting shed

4.2.5 The western elevation (Fig. 17) contains a doorway with an opening measuring 0.75m wide by 1.68m high. This is surrounded by chamfer moulded, ashlar sandstone blocks with a wooden lintel and filled by a boarded-up plank-built door. The doorway appears to be a more recent insert, suggested by the irregularity of its surrounds and the ephemeral nature of the lintel. Quoins are visible at both wall edges, comprising large basalt blocks at the base with smaller sandstone quoins above. The amount of repair work

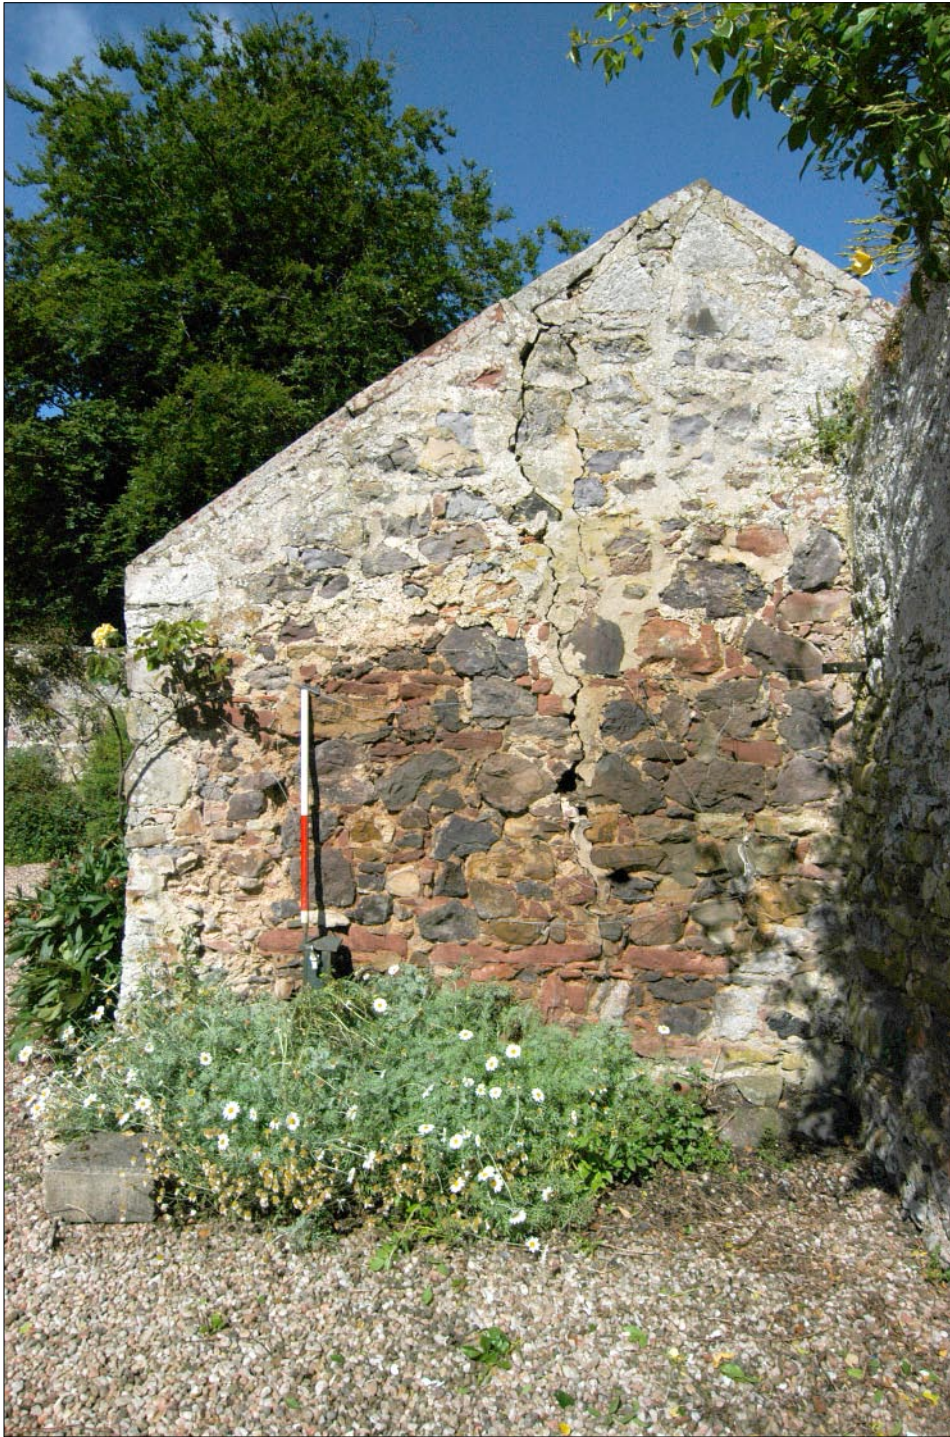
Fig. 18 - East facing elevation of Potting shed

4.2.3 The eastern elevation (Fig. 18), 2.5m wide by 3.7m high, has visible quoins on its southern extent immediately above a brick repair at the southern base of the wall. Three Bee Boles, which have been blocked by rubble sandstone, are present along the base of the wall (Fig. 19). They average 0.55m wide by 0.4m high. There is a vertical surface crack in the wall.

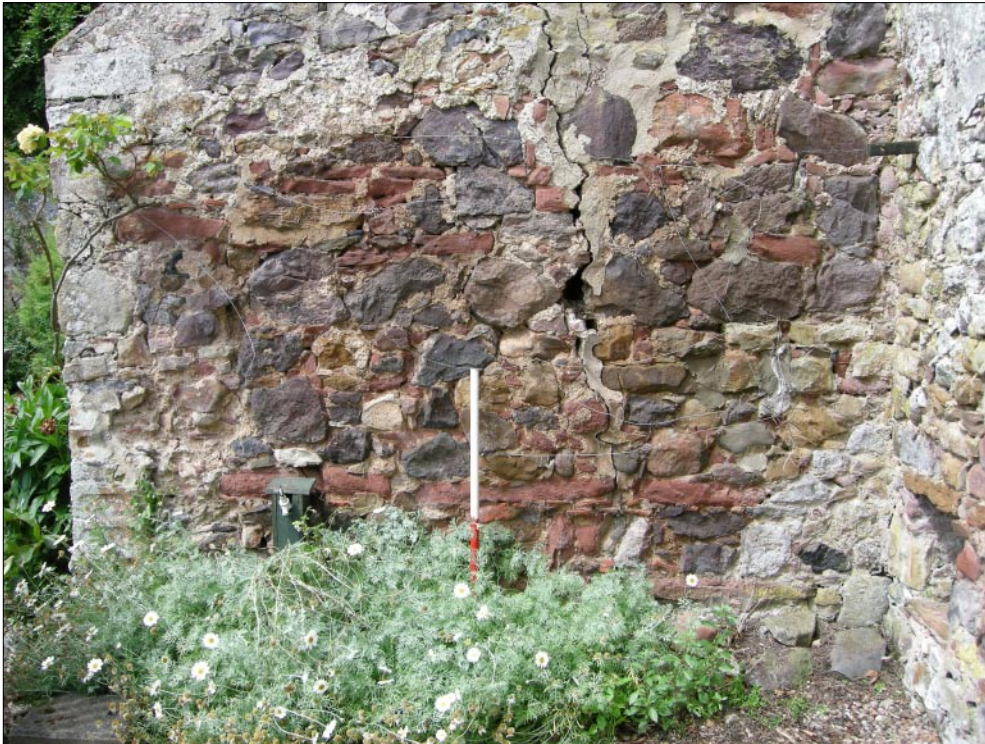
Fig. 19 - East facing elevation of Potting shed - close-up of Bee Boles

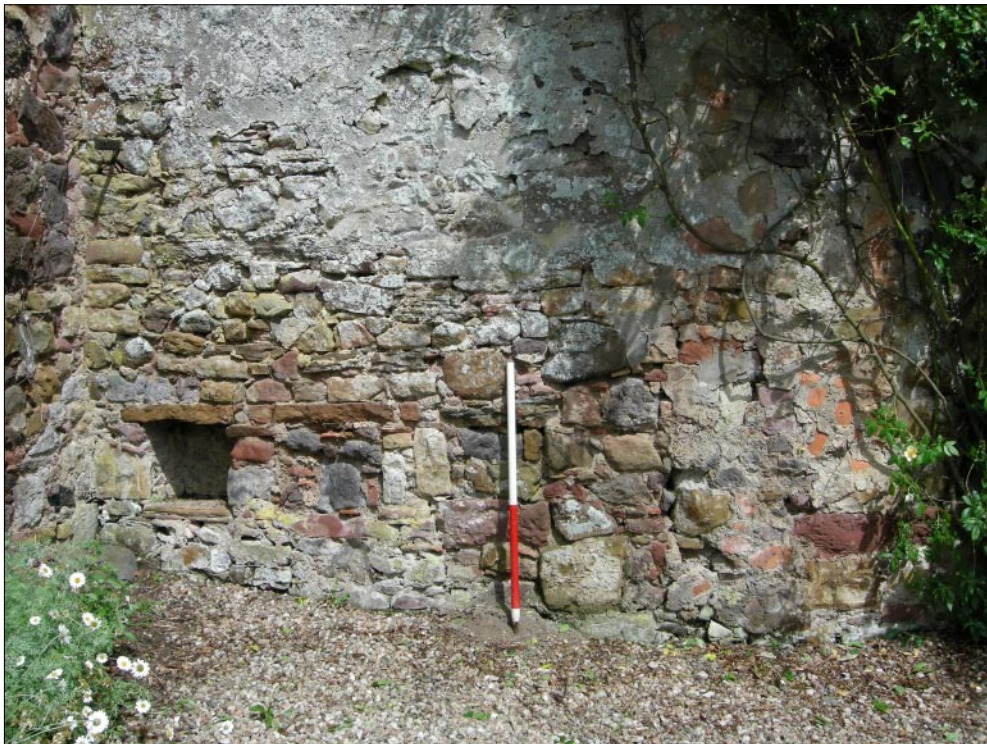
Fig. 27 - South facing elevation of stone wall between Potting shed and 'Manse' wall - close-up of Bee Boles

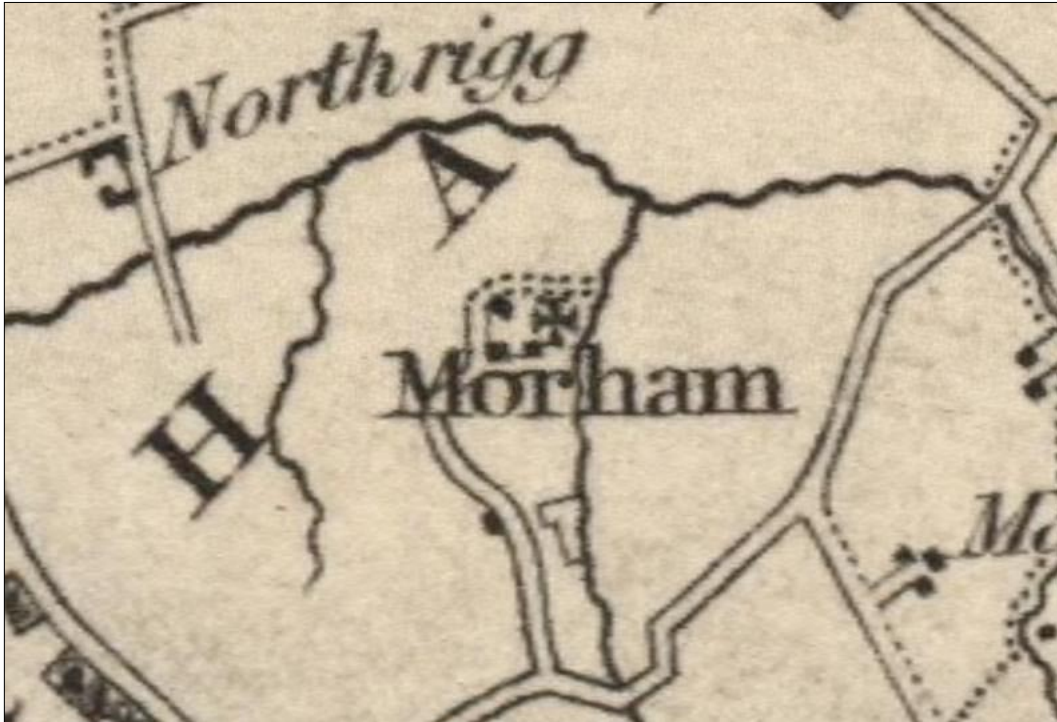
Fig. 37 - Extract from Greenwood's map of 1825

- 3.1.8 Earlier cartographic sources consulted show the church and grave yard at Morham, for example Greenwood (1825; Fig. 37), with a slightly different layout to that depicted on the First Edition OS map. Although none are named as the manse, there are three buildings to the west and south-west of the church, but the map lacks detail. Thomson's (1820) and Forest's (1802; Fig. 36) maps both depict and name the church and manse, the manse shown lying directly to the south of the church. Armstrong (1773; Fig. 35) shows the church and, while not naming it, does depict a small building to its south.
