*Commissioned by ERM on behalf of Scottish Water*

**Glencorse Water Treatment Works,  
Glencorse Mains, Penicuik, Midlothian.**

**Archaeological Evaluation of Soil Storage Areas.  
Data Structure Report  
No. 1529**

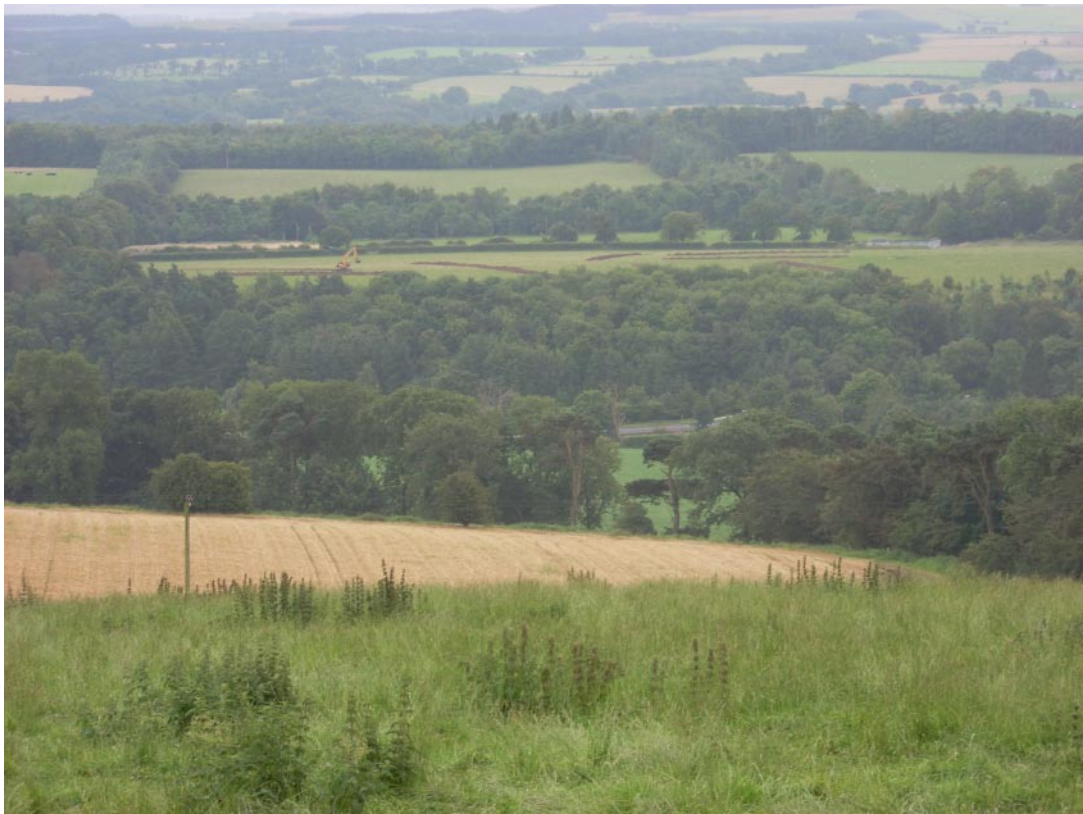
Fig 2 - General view of the site from Castlelaw showing the trenches within sheltering woodland

Fig. 2 General view of the site from Castlelaw showing the trenches within sheltering woodland

- 3.1.3 The overall site lies at around 190m OD and has a generally south-easterly aspect. Two fields, termed Fields 1 & 2 (Figs 1-2) were evaluated and these were separated by a trackway bounded by hedges and ditches. Both fields were in grass at the time of the evaluation. In general, 0.3m of compact brown clay-silt topsoil overlies a brownish-pink compact sandy and stony clay-silt natural subsoil. Localised patches of creamy yellow-grey and yellow-orange clay were recorded and overall, the natural subsoil is poorly drained. A notable exception to the clay-based natural subsoil was recorded in Trenches 38, 40 and 41 in Field 2 where more sandy material was recorded. Agricultural subsoil was identified in trenches along the low-lying south-east edges of Field 1, (Trenches 1-4, 6, 8, 10-12, 22 and 23) and in Field 2, (Trenches 38, 40, 41 and 43) where they would naturally accumulate through ploughing and slope wash.

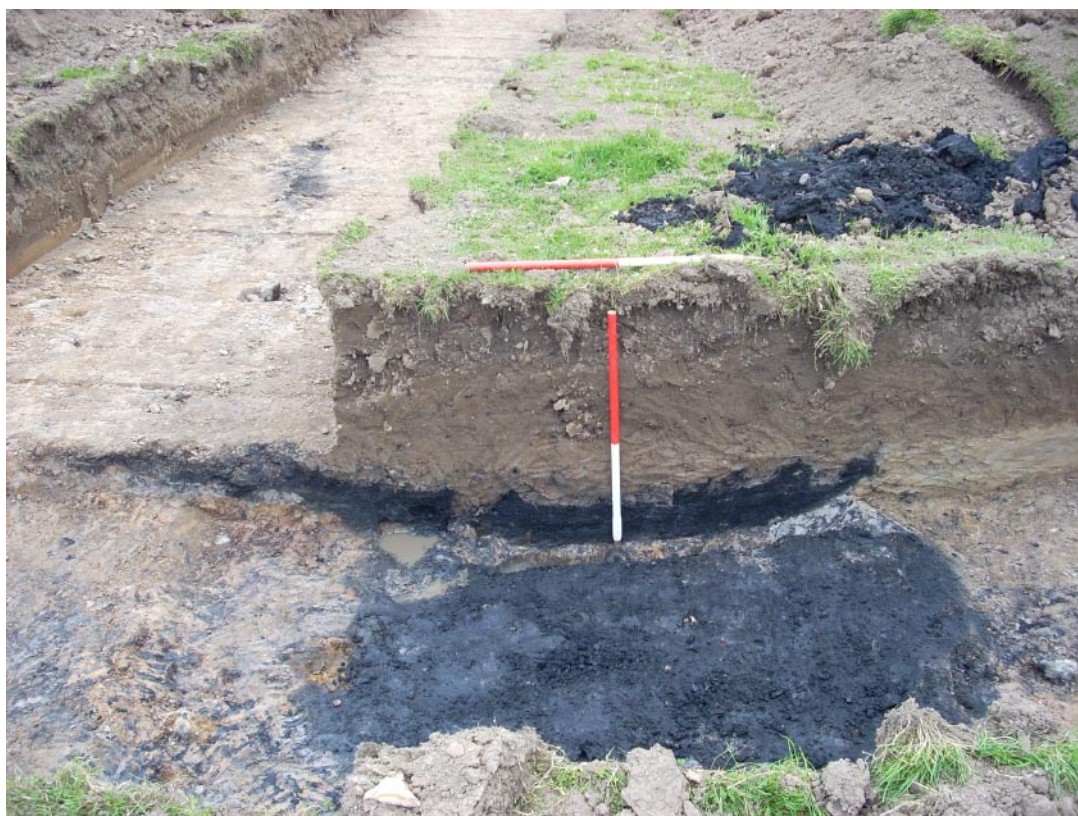
Fig 5 - Trench 11, ditch terminal 11006 and section

Fig. 5 Trench 11, plate showing ditch terminal and section

- 3.2.2 A broad irregular ditch filled with crop processing remains and aligned north-west to south-east was recorded in Trench 11 (**11006**). It is thought, based on alignment and fills, that the continuation of this ditch was also found in Trench 8 (**8004**) and Trench 10 (**10004**). However, in both Trench 8 and 10 the ditch was not as broad and was more regular.
- 3.2.3 In Trench 11 (Fig 3, 4 and 5) modern topsoil (**001**) overlay subsoil (**11003**) which also appeared to fill a linear furrow (**11012**) which was 1.5m wide by 0.15m deep. Field drains containing both locally quarried purple volcanic stone (**11014**) and a one-piece clay-pipe (**11016**) were cut from the base of the modern topsoil. The furrow (**11012**) appeared to cut the upper fill (**11004**) of an irregular ditch (**11006**). The upper fill of the ditch was a brownish grey

silty clay (**11004**) which contained quantities of stones (**11013**) along the south-western side. The primary fill of the ditch (**11011**) was a black carbonised deposit 0.3m deep. A sample was recovered for palaeobotanical analysis by Mhairi Hastie and the results are detailed in Section 3.5 below. A second section (Fig 6) was excavated to the south-east and the same fill sequence was identified but the ditch appeared shallower at this point and the lower fill (renumbered **11005**) was less rich in organic remains than the same fill (**11011**) in the section to the north-west. Again the upper fill of the ditch appeared to have been cut by a furrow (**11001**).

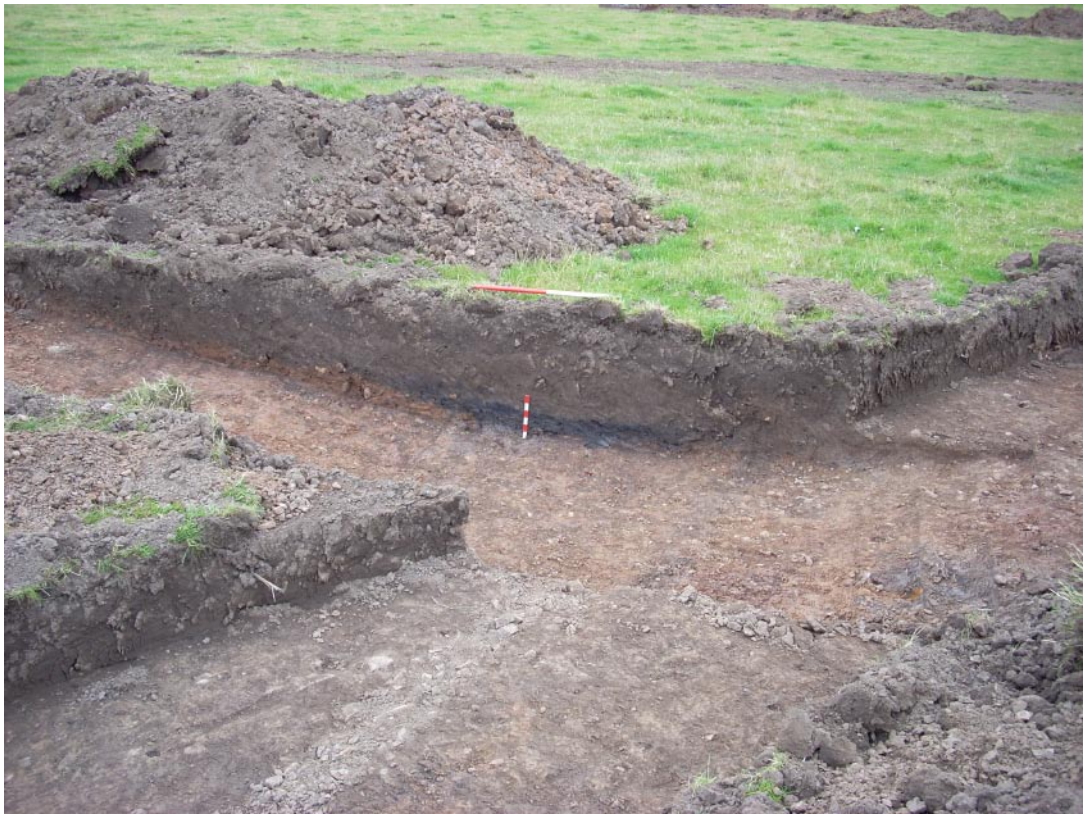
Fig 6 - Trench 11, plate showing broader and shallower ditch to south-east of terminal

Fig. 6 Trench 11, plate showing broader and shallower profile to south-east of terminal

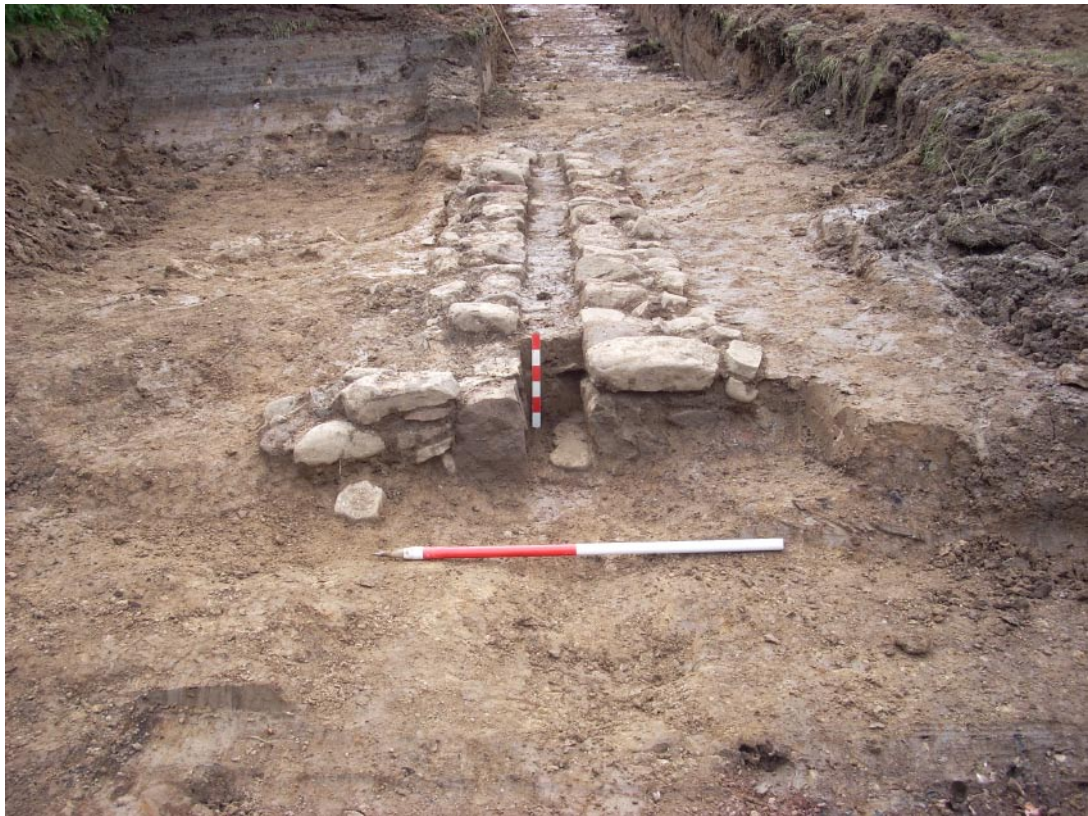
Fig 8 - View of stone culvert in Trench 40

Fig. 8 View of stone culvert in Trench 40 from the north-east

- 3.3.2 Trench 40 was excavated some 3m from the hedge and modern fence flanking the trackway between Fields 1 & 2 (Fig. 1). Under modern topsoil (**001**) with a depth of 0.5m was a very compact deposit (**40001**) of dark brown soil, 0.1m deep, which was flecked with coal and mortar and contained late 18th or 19th century finds. This sealed the remains of a probable culvert constructed from two parallel linear mortared walls (**40002**, **40003**) built within a cut into the natural undisturbed subsoil. The channel created by the culvert was 0.25m in

width. The side walls of the culvert were 5m long and 0.4m wide. The north-eastern (downslope) end of wall **40002** was clearly damaged but retained a depth of 0.35m. The culvert channel had a partially paved base (**40010**). The feature continues to the north-west and south-east as a linear gully (**40008**) which was filled by the same homogeneous yellow-brown clay-silt as the culvert. A section was cut across this gully and it was found to have a U-shaped profile with a depth of 0.2m and a width of 0.5m. This feature continued for the 85m length of Trench 40. Other features consisted of an irregular cut feature (**40006**) filled with dark brown stony clay (**40007**) and two small discrete areas of stone (**40011**) and (**40012**) lying in the natural subsoil. No function or date can be ascribed to these.
