Lodge Moor Prisoner of War Camp, Redmires Plantation Redmires Road, Sheffield South Yorkshire

Community-Led Archaeological Excavation
Report No. Y612/22

Community-Led Archaeological Excavation

Report No. Y612/22

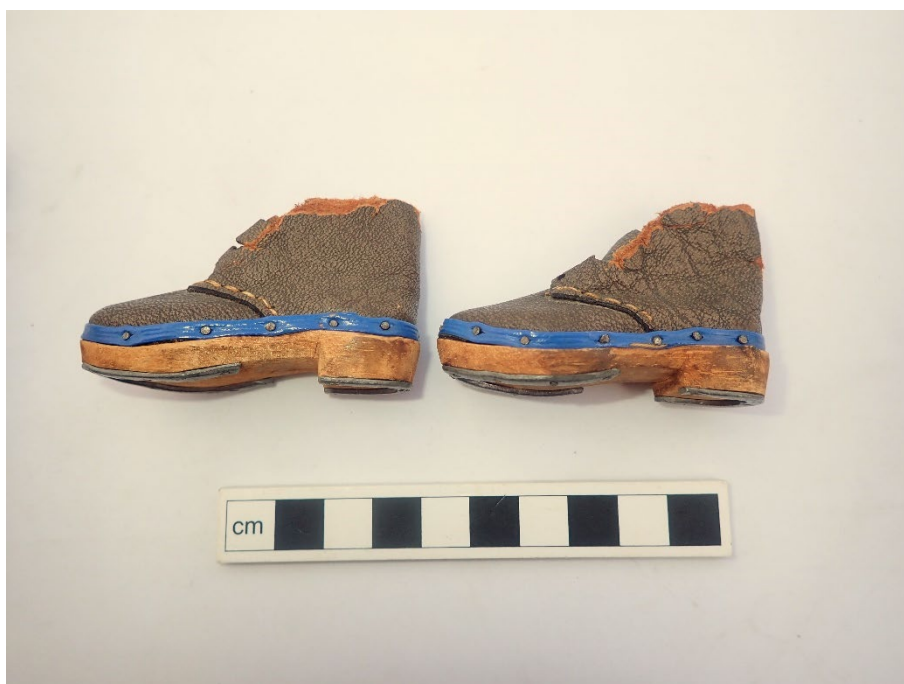
Plate 2: Small handmade shoes made by an Italian POW from Lodge Moor Materials: Leather, wood and metal.

An Italian POW from Lodge Moor made these small leather shoes (Plate 2) and traded them with a local for seeds.

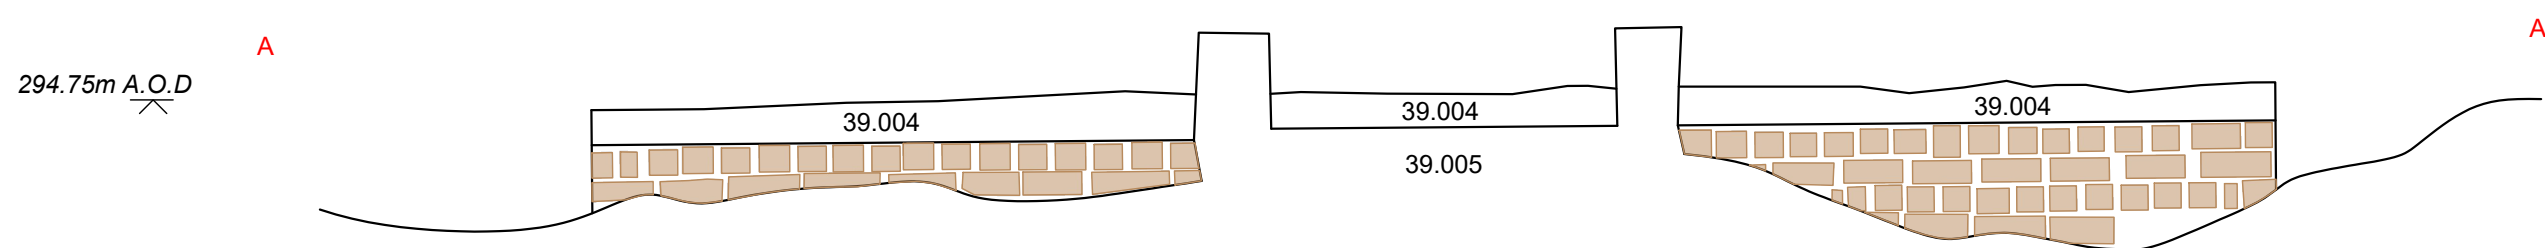
Fig. 3: North-facing elevation of Hut 39

Hut 39 was located at the north-eastern corner of the camp, within Row 1, Block D, and ran parallel to Hut 39, 3m to its west. The hut was rectangular in plan on a north-south alignment and had external measurements of 35.05m by 5.49m. Its brick foundation (39.004) comprised seven courses of brick in an English bond formation. Mortar stains at the northern and southern extents of the concrete hut base provided evidence of internal partitions and possible doorways. The stain to the south is the same as that of the north and extends to a central plinth made of brick encased concrete forming half a decagon shape, with the long edge facing the south towards the doorstep. To north, immediately internal from Doorstep (39.005) in an L-shaped mortar stain, of similar dimensions to the doorstep, indicating a porch-style division, corralling entrants to enter the hut from the north-west corner, passing another possible partition. This is indicated through another mortar stain orientated north to south, with two indentations set within the concrete, presumably to hold something (Fig. 2a).

The drainage channels (39.004) along each of the sides of Hut 39 led to downpipes at the northern end and along the central length (39.008). Each channel measured 34.30m. The downpipes were constructed with a ceramic pipe and was cemented into a purpose made gap in the brickwork of the foundations. The downpipes (39.008) flowed into the underground drainage network (39.009). The drainage network was identified 0.41m below ground level and comprised a series of interconnected ceramic pipes (Fig 6.22). Above the drain system was rubble deposit 39.011 within a matrix of grey-brown loose sandy silt with occasional small stone inclusions. This layer was likely used to aid drainage.

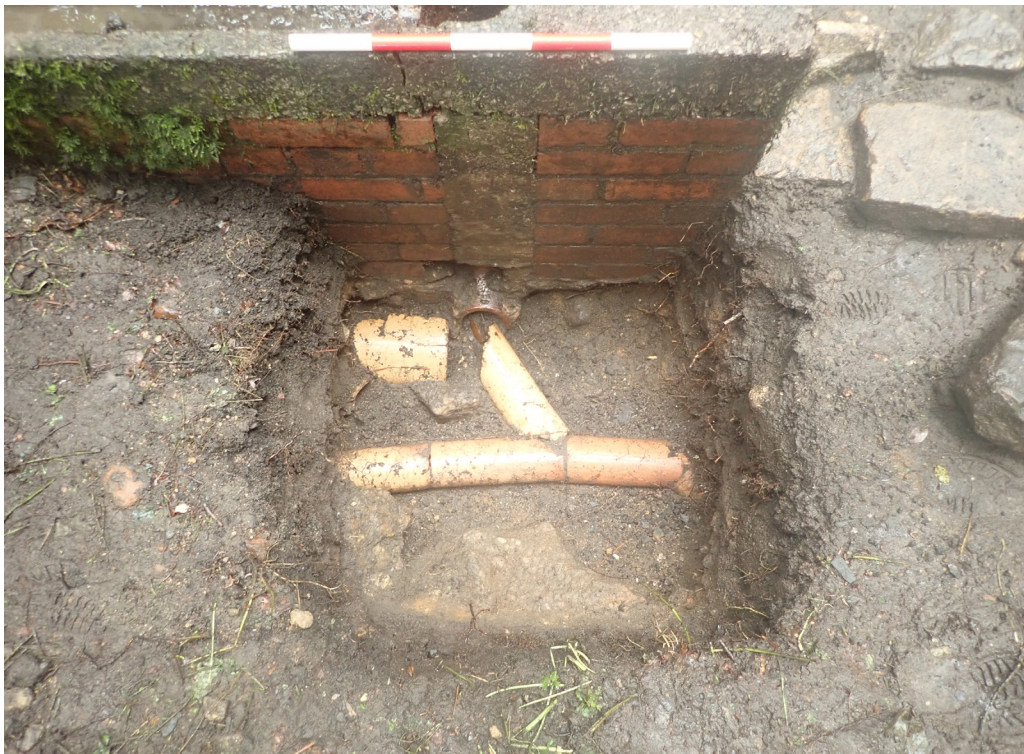
Fig: 6.22 Digital Ref: POWR_039
 Direction: W Date: 25/08/2022
 Description: Plan of Drain 39.009

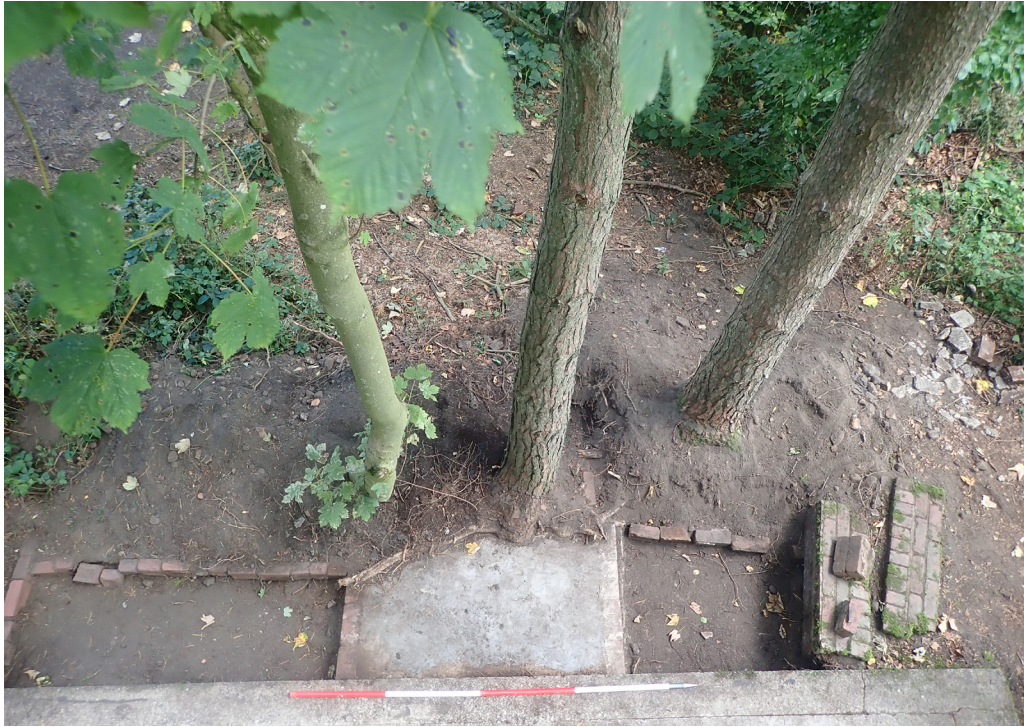
Fig: 6.23 Digital Ref: POWR_153
 Direction: N Date: 01/09/2022
 Description: Overhead shot of Doorstep 38.003

At the northern end of Hut 38 was a doorstep (38.004), providing access into it. The doorstep was 0.93m long, 1.61m width and 0.48m high. It was constructed of a concrete pad bordered by a brick wall on both the eastern and western sides. These brick sidewalls comprised five courses of brick in an English bond, though only two courses survived in situ, with the other two having been identified broken off nearby (Fig. 6.23). This whole construction was built up from another underlying concrete base. It was not fully exposed to the north due to the establishment of tree growth.

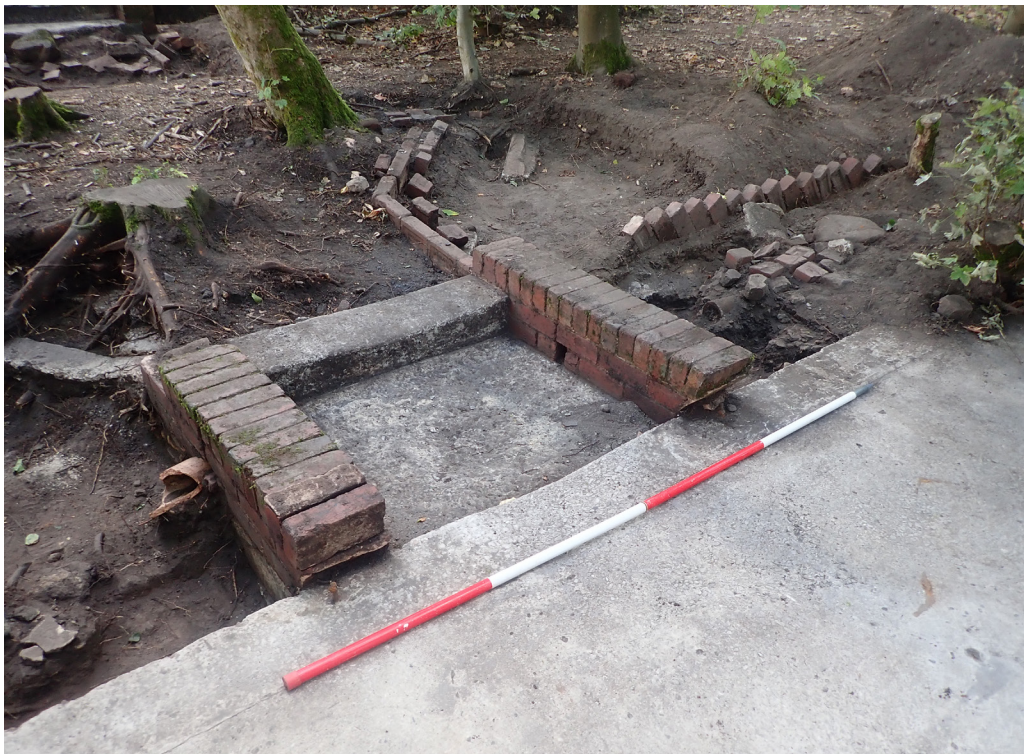
Fig: 6.24 Digital Ref: POWR_169
 Direction: SW Date: 01/09/2022
 Description: Oblique of Doorstep 38.005 and Garden Area 38.007

At the southern end of Hut 38 was Doorstep 38.005, providing access down into Hut 38 from the pathway. It measured 1.17m long, 1.52m wide and 0.33m high. The doorstep was constructed with a concrete pad, an elevated concrete step along its southern edge, both bordered by two small brick walls on the eastern and western sides. The concrete showed considerable wear, exposing some of the aggregate material and signs of water damage on the pad edge. The brick sidewalls comprised three courses of machine-made red brick in a stretcher bond with the top course in a header bond, surviving to completed height. A small drain hole was apparent at the bottom course for water to flow through between the ceramic drains on either side of the wall.

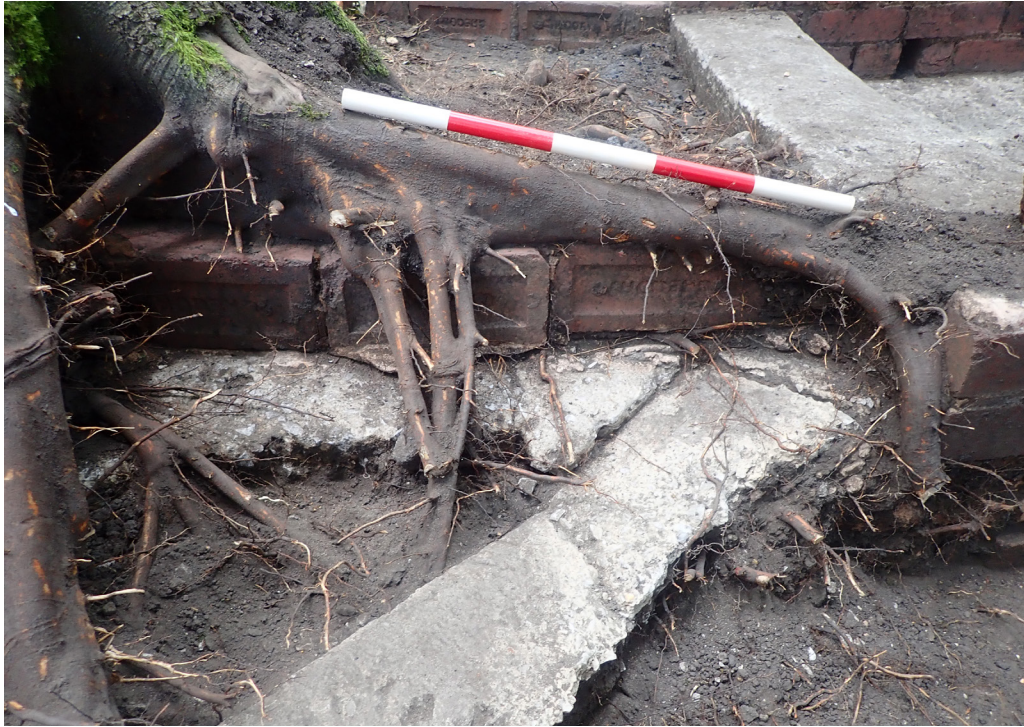
Fig: 6.25 Digital Ref: POWR_167
 Direction: W Date: 01/09/2022
 Description: Interaction between tree and Doorstep 38.005

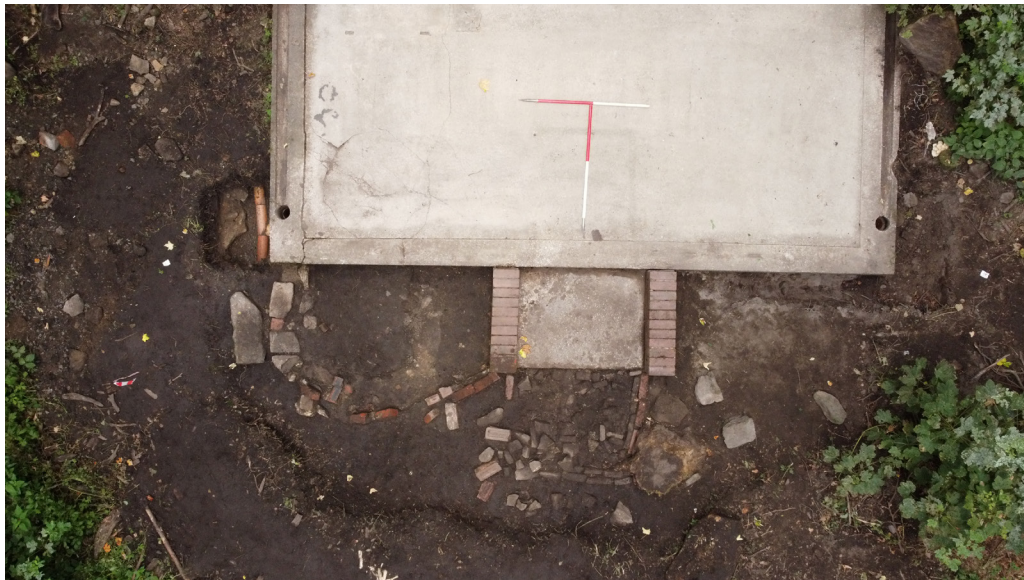
Fig: 6.26 Digital Ref: POWR_025
 Direction: S Date: 29/08/2022
 Description: Hut 39

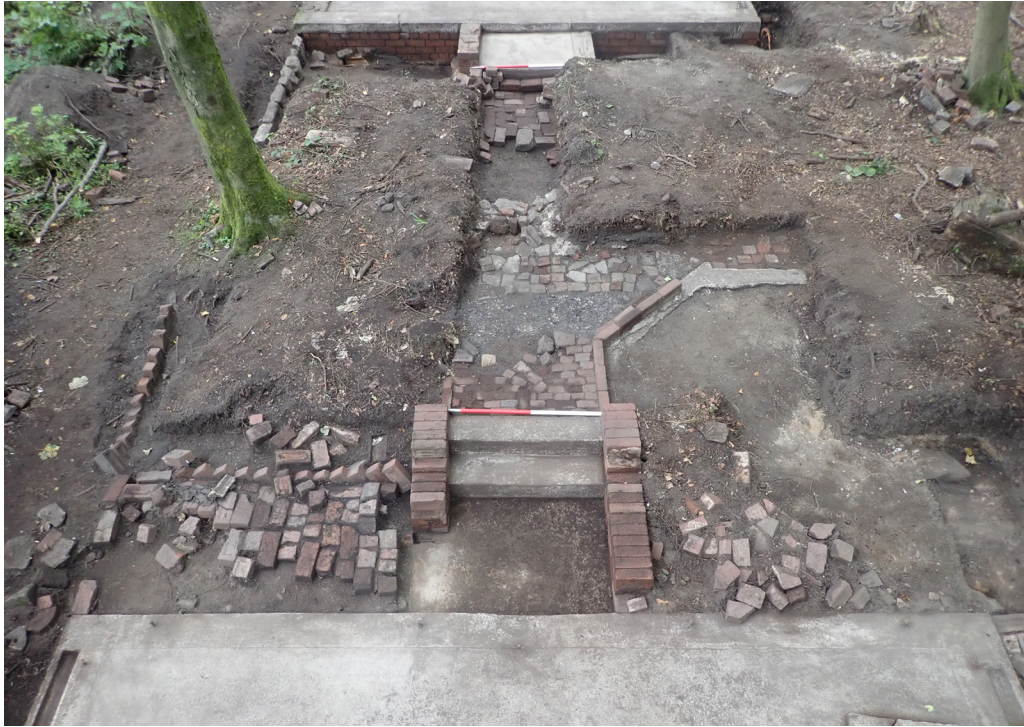
Fig: 6.27 Digital Ref: POWR_089
 Direction: S Date: 29/08/2022
 Description: Pathway between Huts 39 and 62

Leading away from Doorstep 39.014 was the Central Pathway 39.010. The pathway was constructed using a brick border set on a concrete foundation to define a brick laid surface. The concrete surface was orientated due south from Doorstep 39.014 for 0.7m before changing orientation to towards the south-west for 1.45m, then orientated due west, continuing beyond the limit of excavation (Fig. 6.28). It is likely that a mirrored construction was used on the eastern side of the doorstep though this was not excavated. The brickwork was mostly intact, forming a rough Flemish bond with some clinker type material where the bricks were absent. On the western side of Doorstep 39.014 was a sandy silt deposit (39.003). It measured 1.60m east to west and 1.40m north to south and comprised a loose grey-brown sandy silt with occasional stone inclusions. Deposit 39.003 contained several bricks which were not in-situ at the time of recording but could have been the remains of a brick laid surface as seen on the eastern side of Doorstep 39.014.

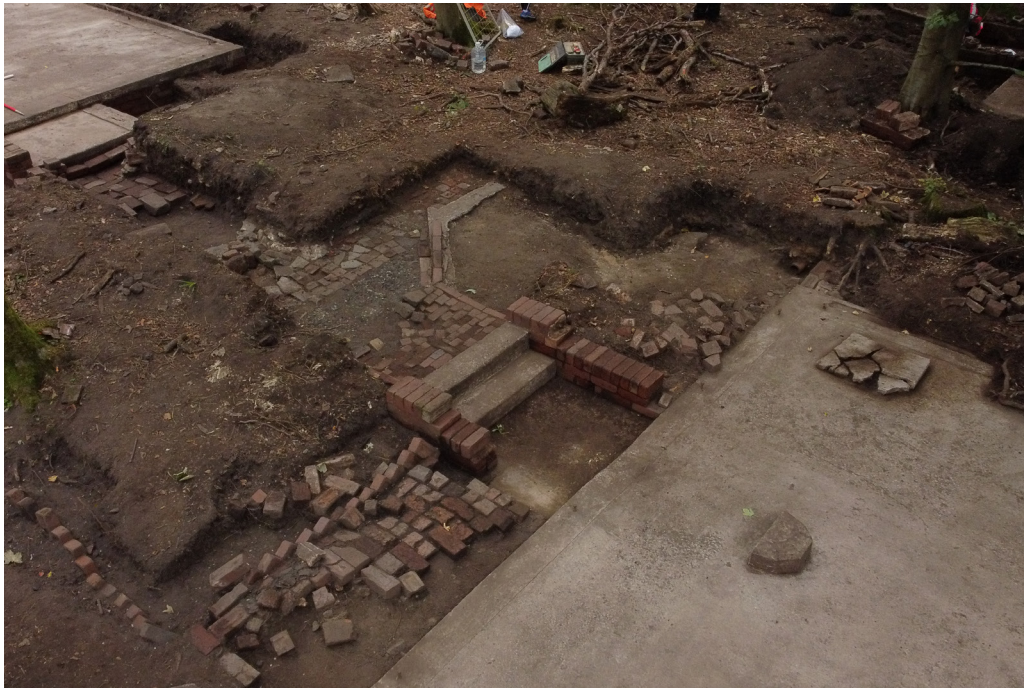
Fig: 6.28 Digital Ref: POWR_052
 Direction: SW Date: 29/08/2022
 Description: Pathway between Huts 62 and 39

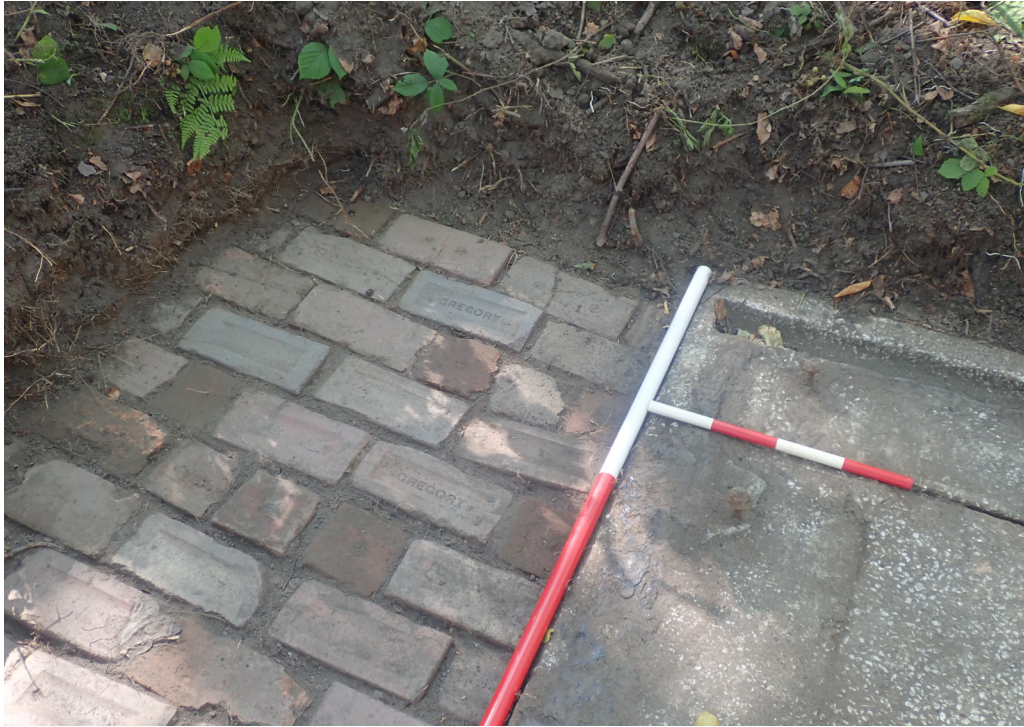
Fig: 6.29 Digital Ref: POWR_045
 Direction: SW Date: 31/08/2022
 Description: Oblique of Garden Area 61.005

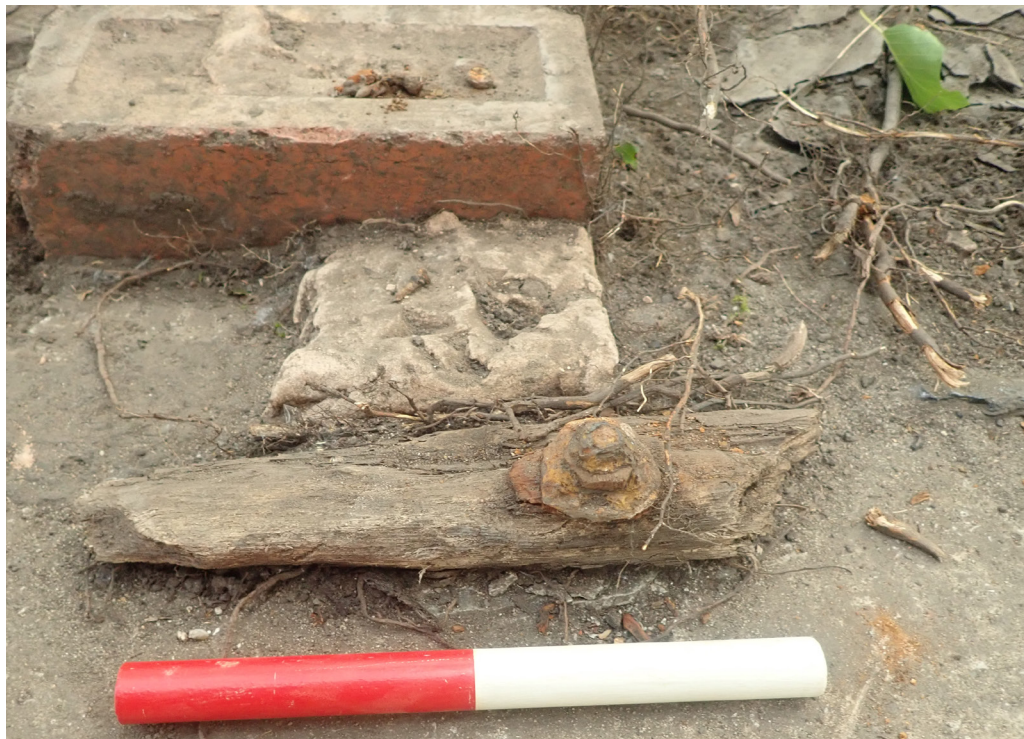
Fig: 6.30 Digital Ref: POWR_205
 Direction: S Date: 01/09/2022
 Description: Metal fitting with wood attached in Hut 61

Hut 61 was located at the north-eastern corner of the camp within Row 2, Block D, and ran parallel to Hut 62, 3m to its east. Its brick foundation comprised four courses of brick in an English bond formation (61.002). The western drainage channel of Hut 61 differed to the other three huts investigated, with the channel starting 0.06m from the southern end rather than 0.30m away as seen in the other huts (Fig. 6.29). Evidence of internal partitions and doorways was present as mortar stains at the southern and northern extent of the hut base, in a mirrored image of Hut 39, without the plinth. Hut 61 showed better preservation of features, with wooden door threshold still surviving, and a metal fitting for a possible door (Fig. 6.30)

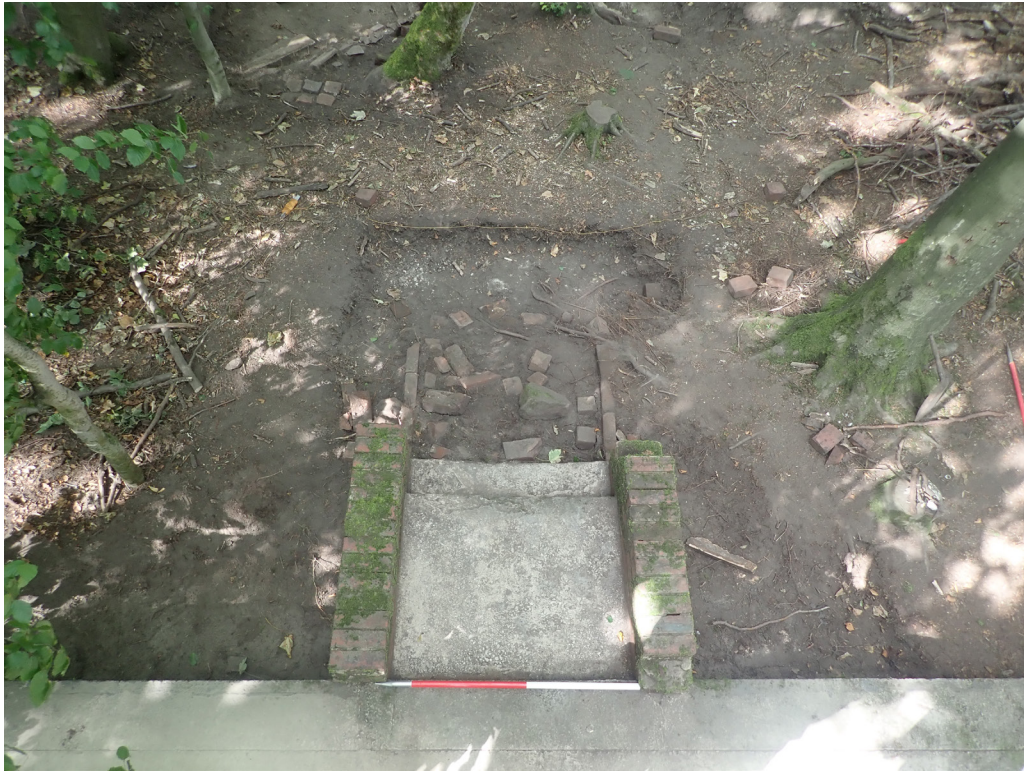
Fig: 6.31 Digital Ref: POWR_142
 Direction: N Date: 31/08/2022
 Description: Doorstep 61.004

were missing from the northern end of the eastern wall. No garden areas were exposed either side of Doorstep 61.004, but a layer of silty clay, likely the same as deposit 61.001, was observed which was not fully excavated due to time constraints (Fig. 6.31).

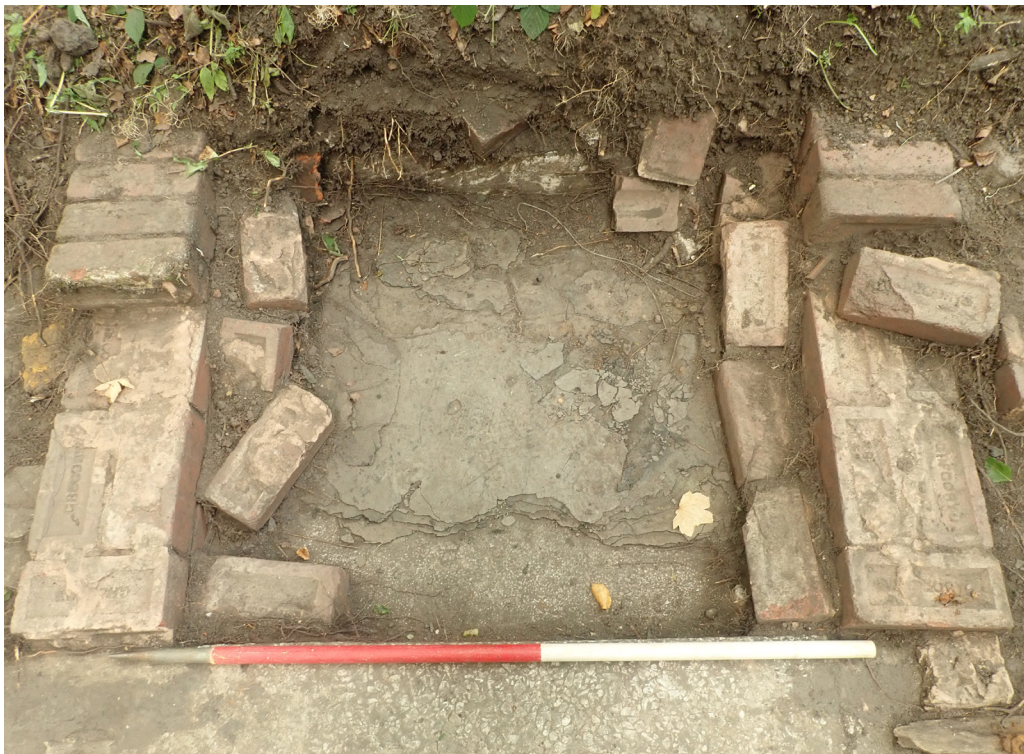
Fig: 6.32 Digital Ref: POWR_201
 Direction: S Date: 01/09/2022
 Description: Plan of Doorstep 61.006 with tar paper remains

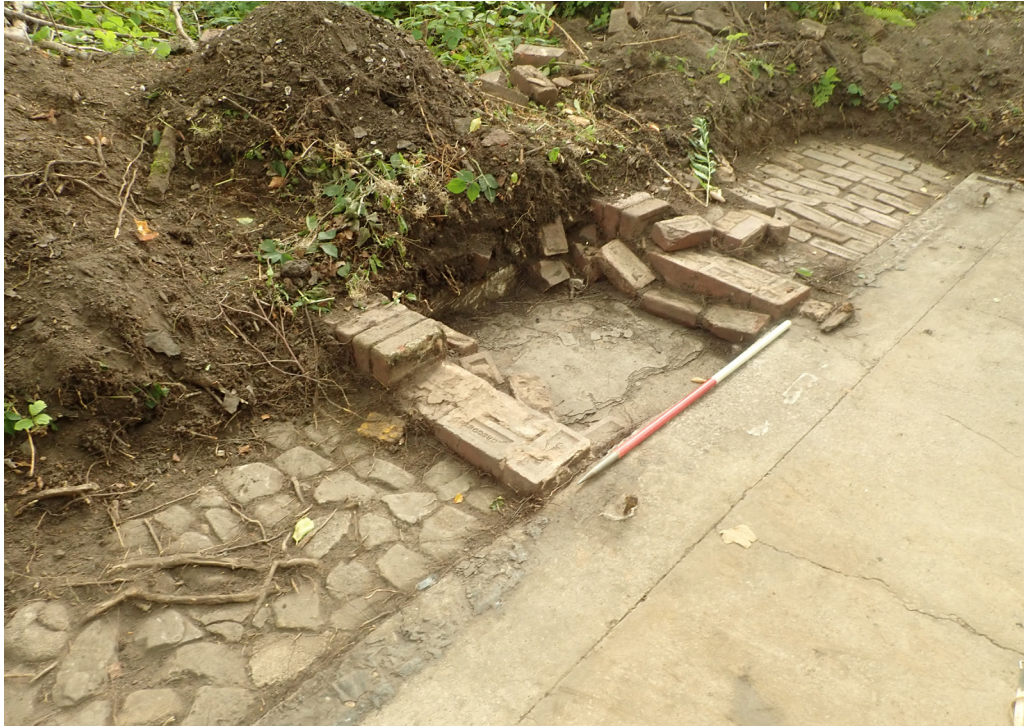
Fig: 6.33 Digital Ref: POWR_204
 Direction: SW Date: 01/09/2022

Description: Oblique of Crazy Paving 61.007, Doorstep 61.006 and Garden Area 61.005

On the western side of Doorstep 61.006 was a brick laid floor surface (61.005). It measured 0.85m north to south and 1.97m east to west. The floor surface was constructed with bricks laid in a stretcher bond formation with occasional broken bricks being used to infill areas. Remnants of tar paper were present in the north-eastern corner. On the eastern side of Doorstep 61.006 was an area of crazy paving. The exposed area measured 1.10m east to west and 0.62m north to south. The crazy paving area was constructed with stone paving slabs of irregular sizes and shapes to form an irregular pattern. Both areas have tentatively been interpreted as the 'garden areas' of Hut 61 (Fig. 6.33).

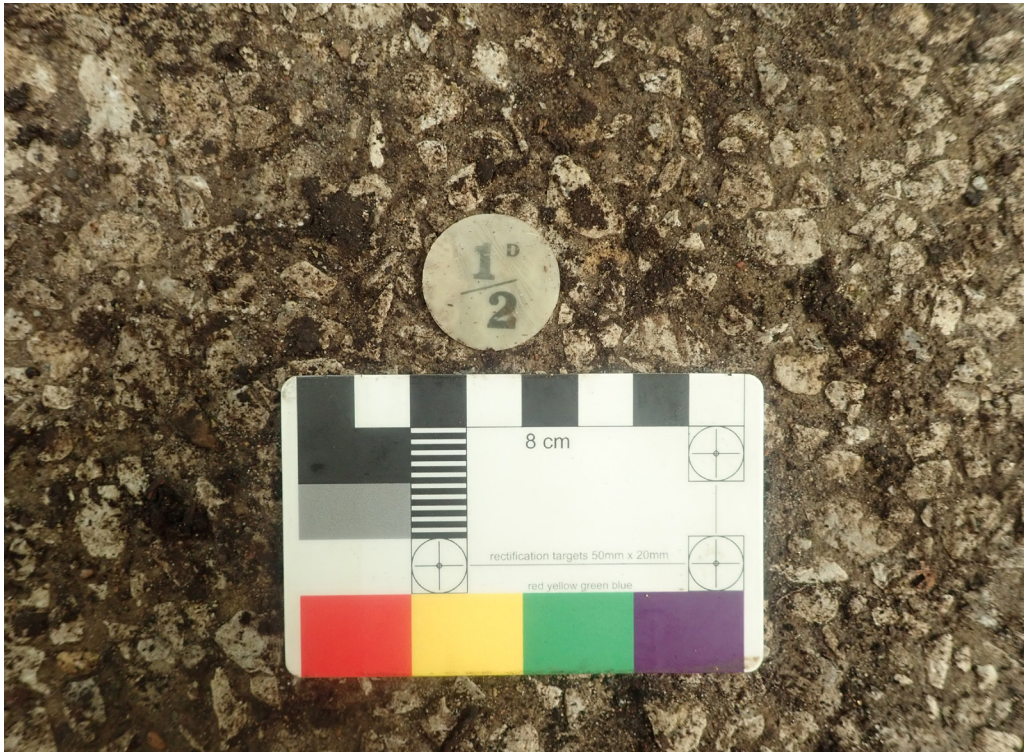
Fig: 6.34 Digital Ref: POWR_016
 Direction: E Date: 23/08/2022

Description: Plastic facsimiled money token from 62.002

A circular plastic money token, also from the hut base, is a rare survival (Fig. 6.33). With a ½ ^D denomination, it was issued in place of currency and was earned for undertaking labour within the camp. Other examples are known from British POW camps in Northern Ireland (Franklin 2017). Another unusual find, and one that tells a story of recreation within the camp, is an intact ceramic paint pan from a Winsor and Newton watercolour set. Indeed, a painting made by one camp inmate, Heinz Lutz, is now in the care of Sheffield City Archives.

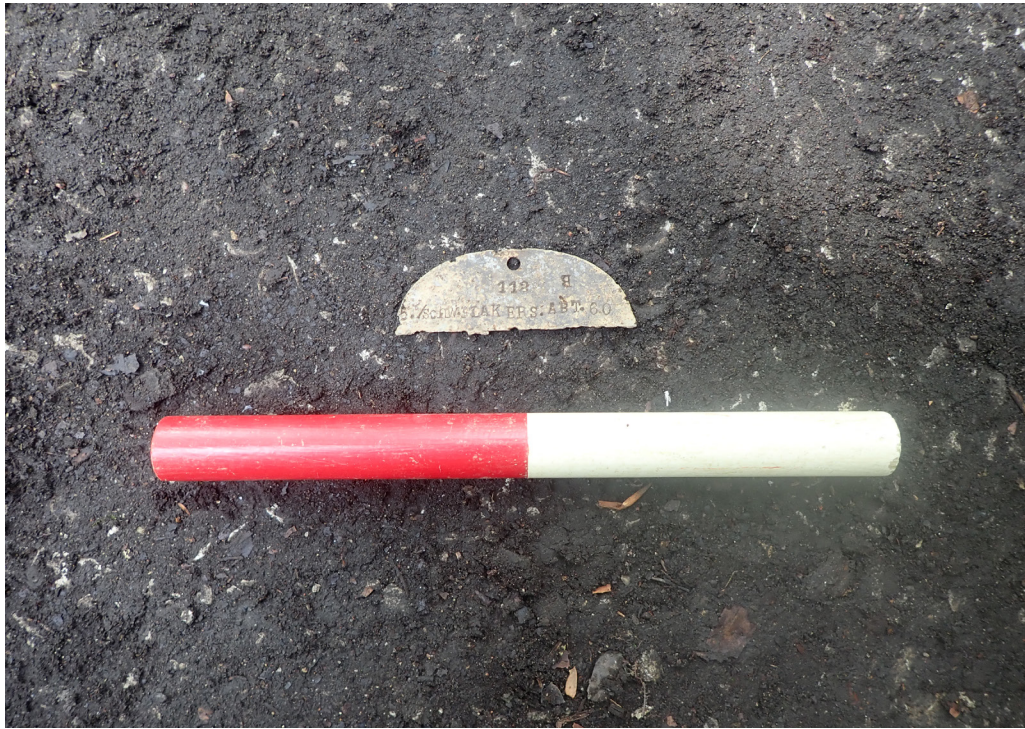
Fig: 6.35 Digital Ref: POWR_002
 Direction: W Date: 22/08/2022
 Description: German Dog Tag from Hut 62

A German soldier's identity tag was found in topsoil context 62.001 (FeldGrau 2022). This was the standard-issue German military identification tag or *Erkennungsmarke*, introduced and issued in August 1939 to all members of the German Wehrmacht (Figs 6.35 and 6.36). These tags were oval discs made from thin aluminium, zinc, steel, or tin. They were worn around the neck on a chain or lace, although another common practice was to wear the tag in a leather pouch, which had two holes in the back to accept the cord, and two snaps on the front to allow access to the tag. The tags had a row of central perforations and were stamped with identical information above and below the perforation line. The tag was designed to be broken in two when the soldier was killed. The lower half would be collected, if possible, and given to the unit HQ for grave registration and notification. The upper half would remain with the body. The example from Hut 62 is broken across the perforation but whether this was deliberate is difficult to ascertain. No accounts have so far been found to suggest that the lower portion of an

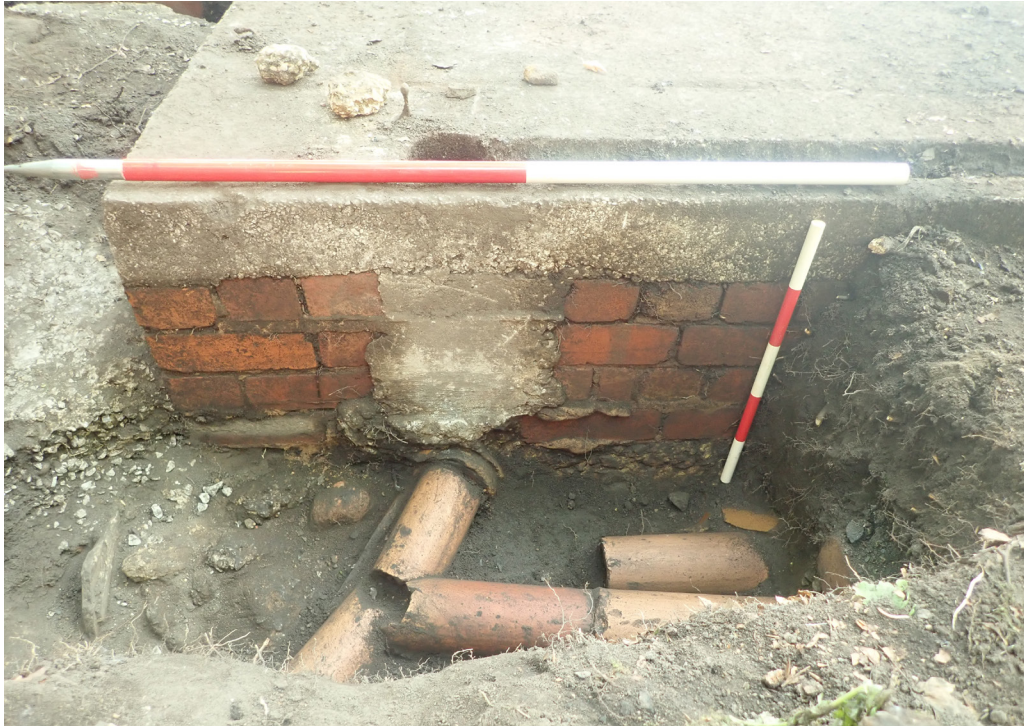
Fig. 6.37 Digital Ref: POWR_075
 Direction: E Date: 27/08/2022
 Description: Drain at north-western corner of Hut 62

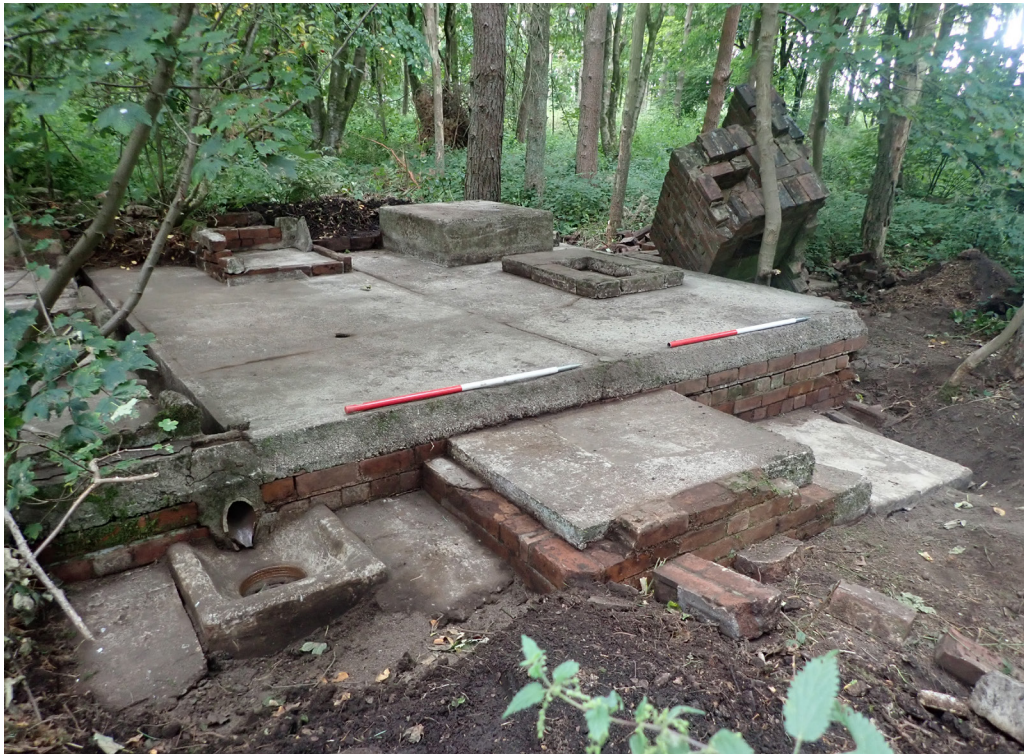
Fig. 6.38 Digital Ref: POWR_099
 Direction: NW Date: 29/08/2022
 Description: East facing elevation of Ablutions 54

The base of Hut 54 (54.002) was constructed similarly to the other huts investigated with a brick foundation capped by two concrete slabs. The hut was accessed at the eastern side of the building by Doorstep 54.007 (Fig. 6.38). The stairway was constructed with three concrete slabs on a brick foundation. The top step contained a concrete pad measuring 1.25m north to south and 0.8m east to west, 0.92m with brick wall, abutting the eastern brick wall. The middle step, to the north of the top step, was made of a concrete pad measuring 0.92m east to west and 0.4m north to south. The lower step was made of another concrete pad measuring 0.96m north to south and 0.92m east to west. The brick foundation was four courses high in a stretcher bond with the top course in header bond. On the bottom concrete step was the imprint of a cat’s paw (Fig. 6.39).

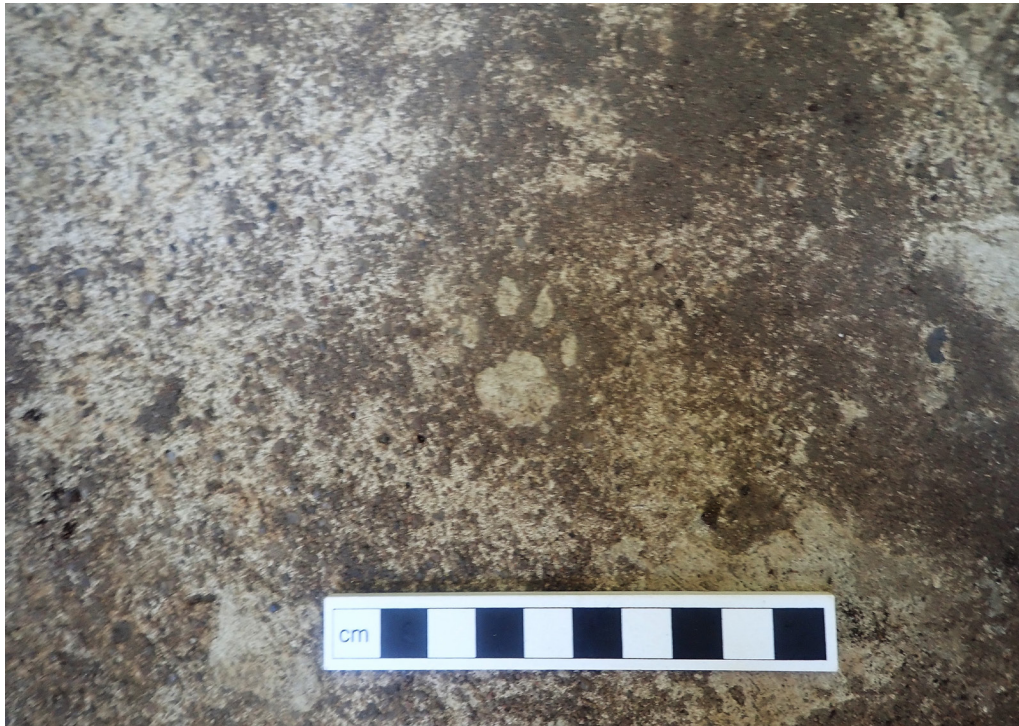
Fig: 6.39 Digital Ref: POWR_145
 Direction: NE Date: 31/08/2022
 Description: Cat pawprint on Stairway 54.007

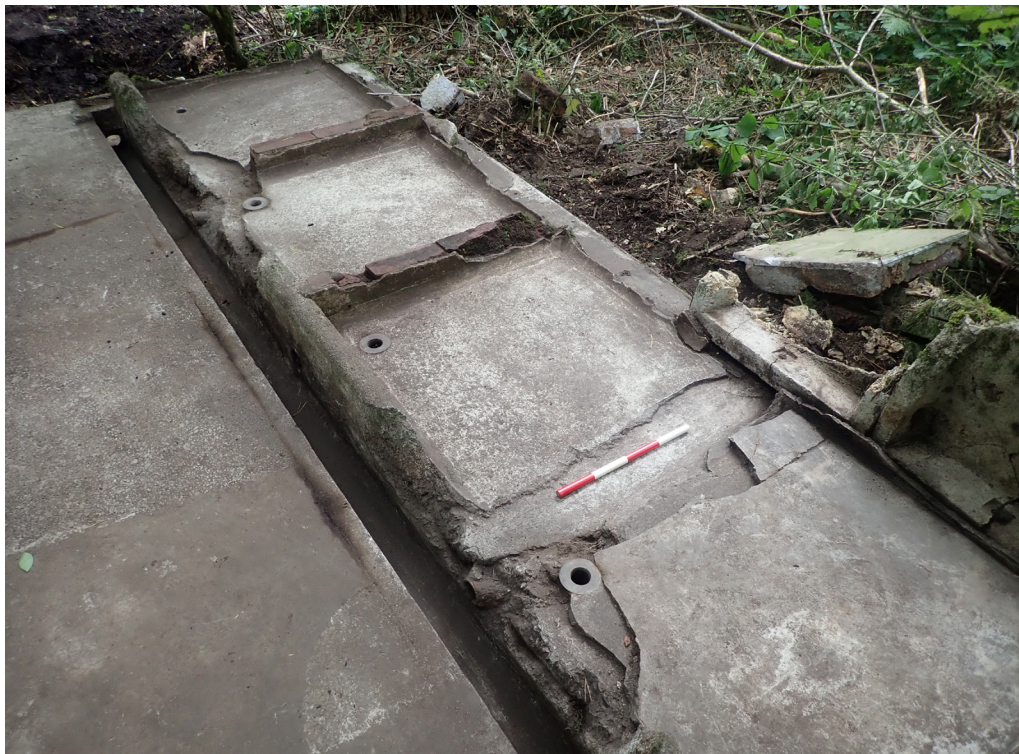
Fig: 6.40 Digital Ref: POWR_118
 Direction: SE Date: 29/08/2022
 Description: Cubicles 54.003

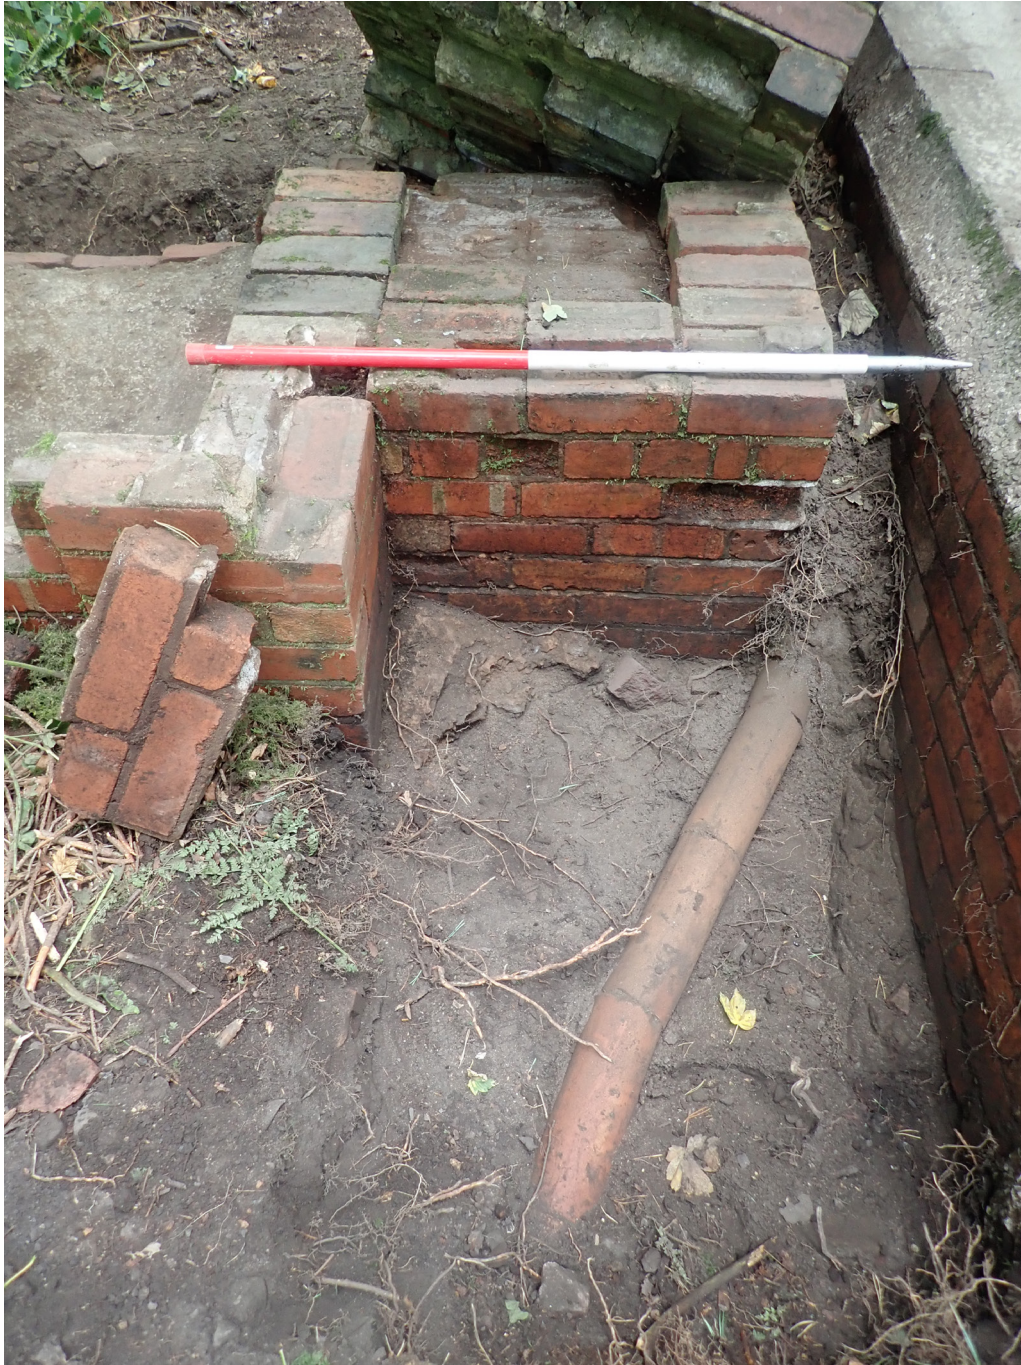
Fig: 6.41 Digital Ref: POWR_134
 Direction: E Date: 29/08/2022
 Description: Chimney 54.017 and drain pipe 54.012

Further drainage was found along the eastern wall, directly north of the stairs and comprised a brick gutter (54.013). The exposed length of the gutter measured 0.41m long, 0.30m wide and 0.12m in height and was formed with two separate rows of bricks. It was exposed to 0.41m long, 0.30m wide and 0.12m deep. A further ceramic drainpipe was recorded along the northern exterior of Hut 54 running away from the Hut continuing north-west beyond the limits of the investigation (54.012; Fig. 6.41).

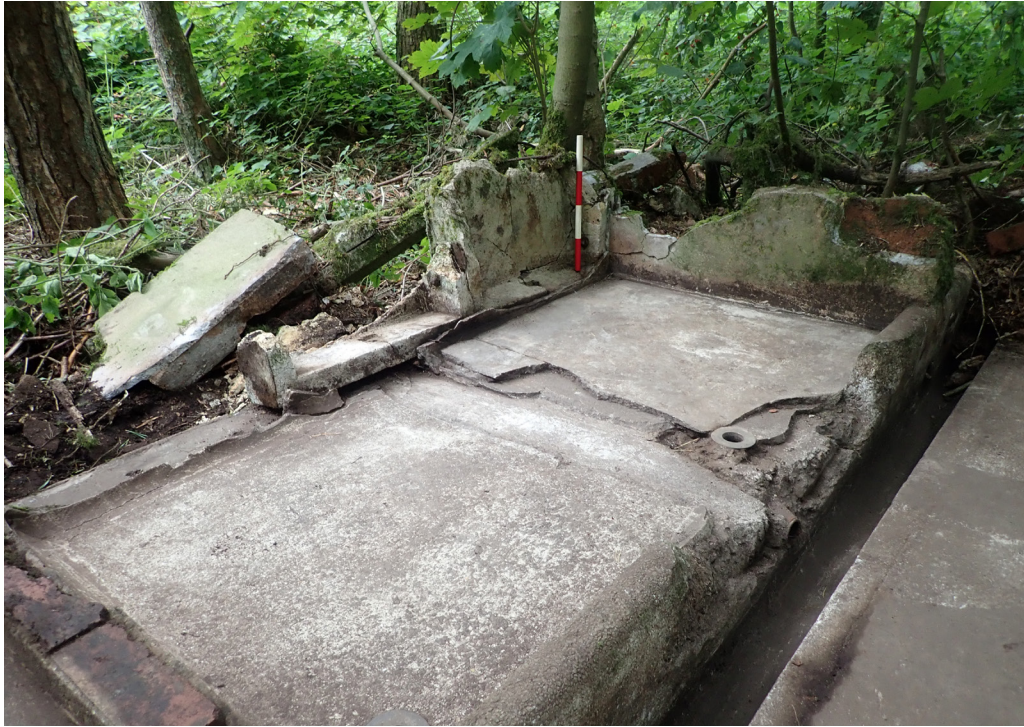
Fig: 6.42 Digital Ref: POWR_116
 Direction: SW Date: 29/08/2022
 Description: Cubicles 54.003

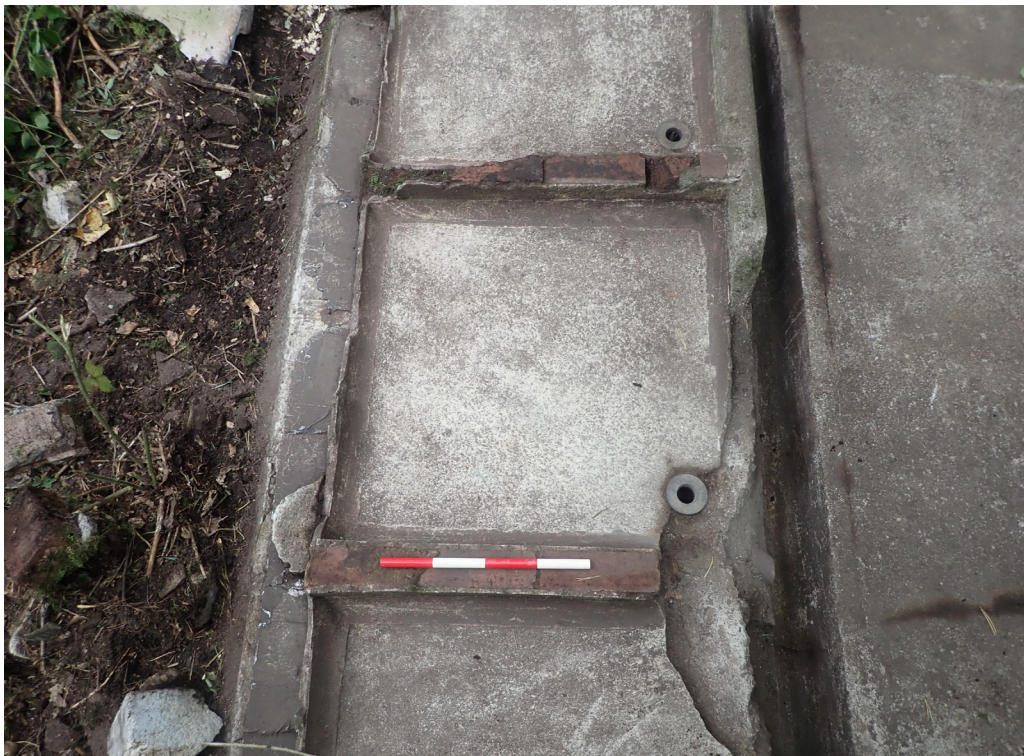
Fig: 6.43 Digital Ref: POWR_114
 Direction: SW Date: 29/08/2022
 Description: Cubicles 54.003

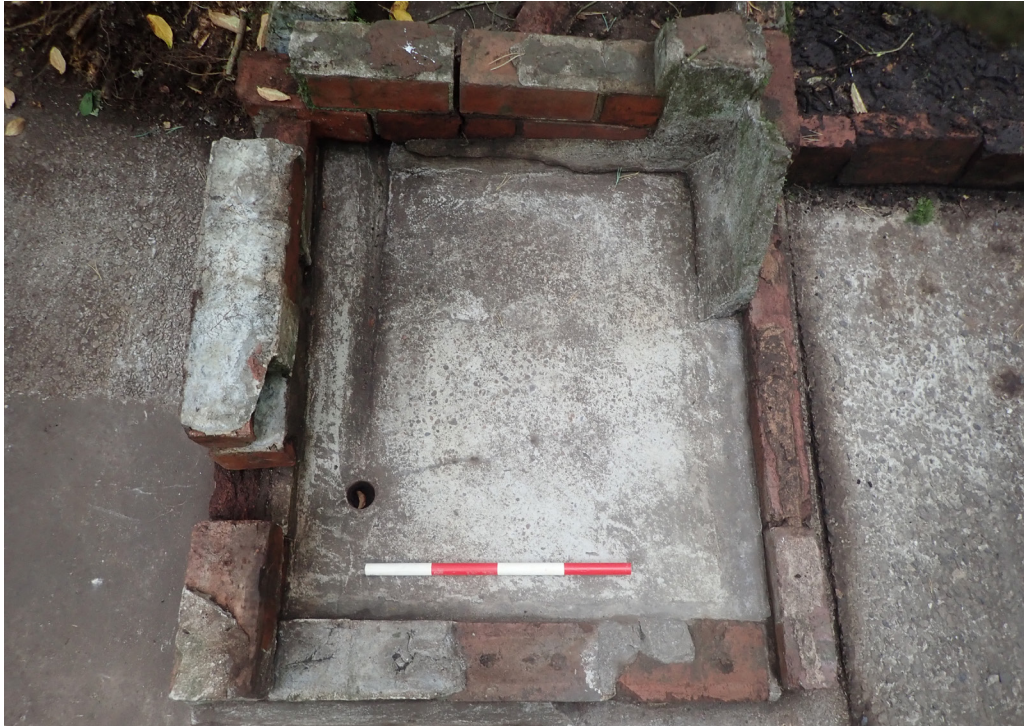
Fig: 6.44 Digital Ref: POWR_123
 Direction: W Date: 29/08/2022
 Description: Plan of cubicle 54.009

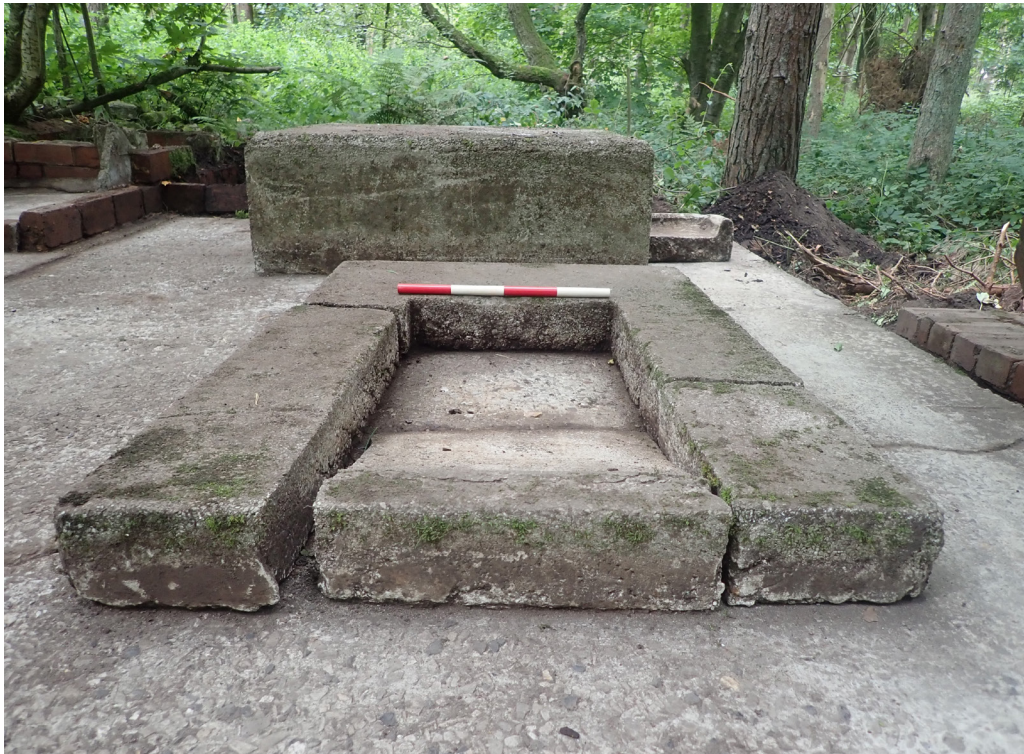
Fig: 6.45 Digital Ref: POWR_128
 Direction: SW Date: 29/08/2022
 Description: Ash pan 54.004
