Lodge Moor Prisoner of War Camp, Redmires Plantation Redmires Road, Sheffield South Yorkshire

Community-Led Archaeological Excavation
Report No. Y612/22

Community-Led Archaeological Excavation

Report No. Y612/22

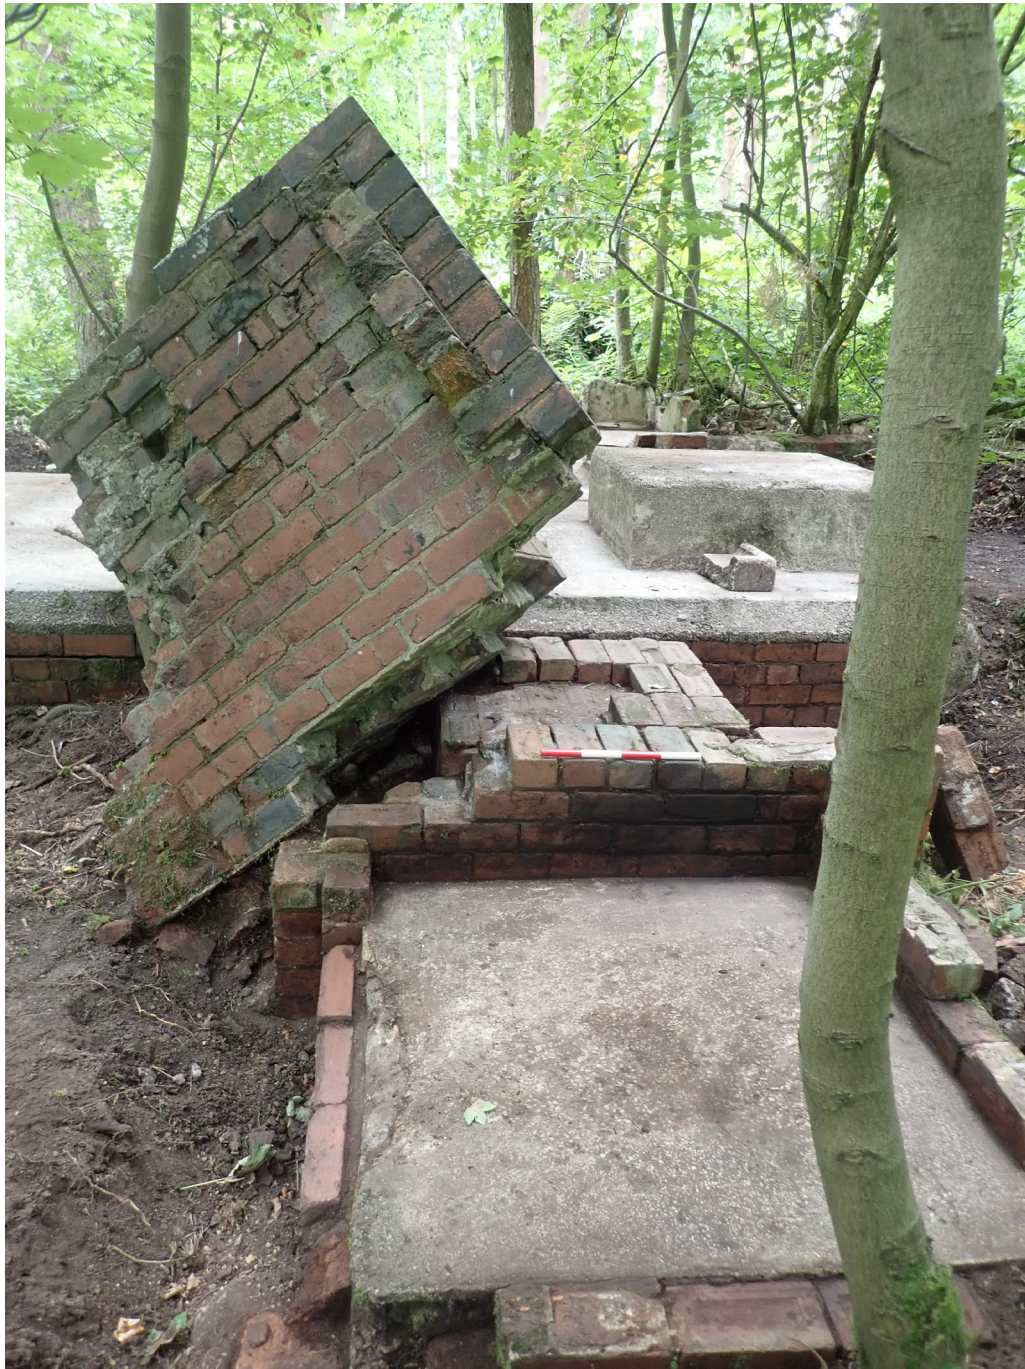
Fig: 6.46 Digital Ref: POWR_131
 Direction: S Date: 29/08/2022

Description: Detail of dislodged Chimney 54.017 and exterior building 54.015

In the centre of the exposed area of Hut 54, along its northern elevation, was a chimney structure measuring 1.2m long and 0.71m wide (54.017). It had partially collapsed and still stood in excess of 1.5m (Fig. 6.46). The chimney bricks were laid on bed in a variation of the English Garden formation with liberal use of mortar to infill gaps. A metal grate was visible on one part of the chimney. At ground level, the chimney structure was not physically attached to the main base. However, to the immediate north was appended an extension with a concrete slabbed floor which measured 1.20m long, 1.15m wide and 0.65m high (54.015). The eastern wall (54.011) of this extension measured 1.22m long, 0.08m-0.24m wide and 0.33m high and was formed with two courses of bricks in a stretcher bond with a grey-white mortar in between the bricks. This was tied into the northern wall of the extension (54.014), both of which were laid on a corner block of

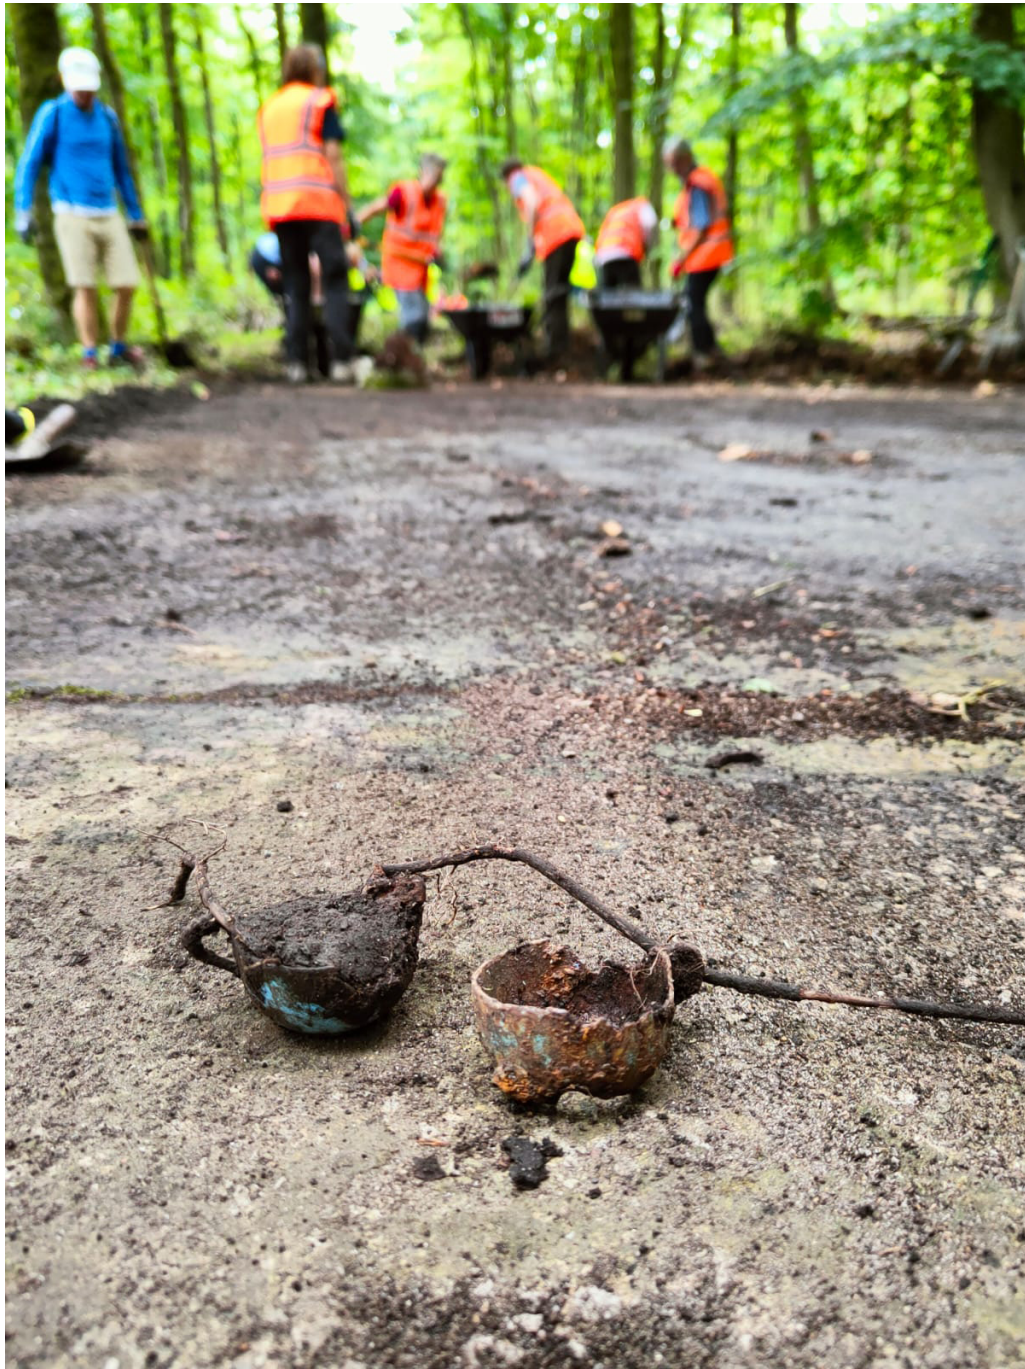
Fig: 6.47 Digital Ref: POWR_032
 Direction: N Date: 23/08/2022

Description: Small metal cups with riveted handles from 38.007 with volunteers working in background

Within topsoil deposit 39.001 was a fragile pair of miniature metal teacups. Although we know from oral history accounts that the prisoners did make toys, these small teacups in French Blue enamel are comparable to toy tea sets manufactured in the early to mid-20th century (Fig.6.47), frequently described as “vintage”.

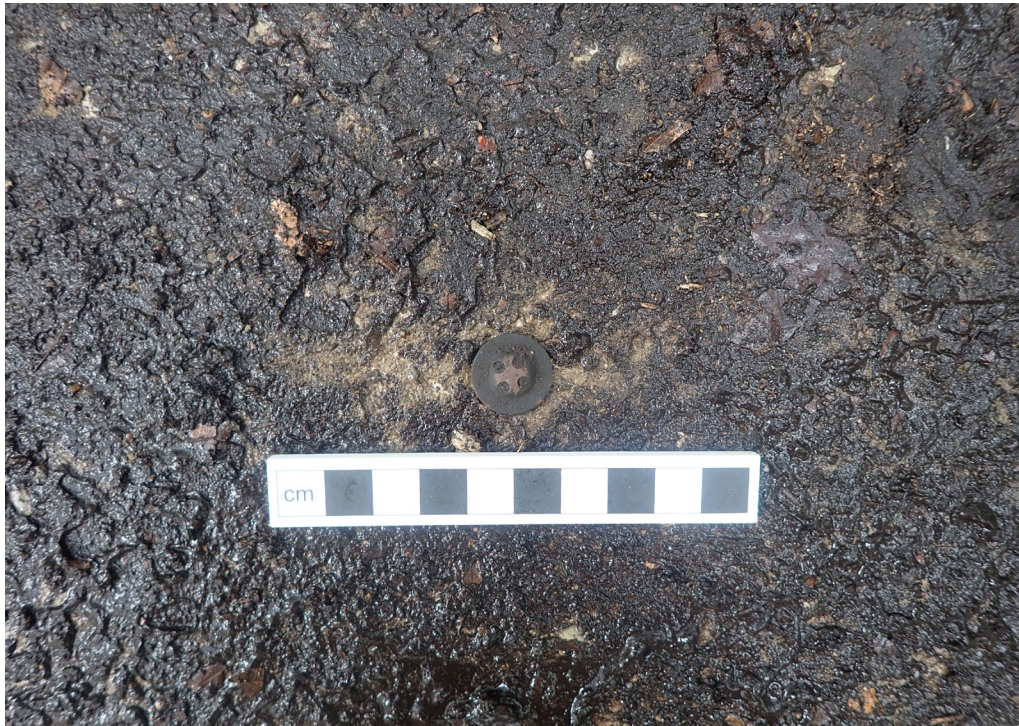
Fig: 6.48 Digital Ref: POWR_011
 Direction: W Date: 23/08/2022
 Description: Button from Hut 62

Other uniform fittings were recovered from the hut base (62.002): a steel stud for helmet chin strap or lining and non-ferrous four-hole utility button. Cleaning revealed a maker's stamp on the button: H & H Ltd B'ham, a British firm manufacturing regulation army buttons (Fig. 6.48).

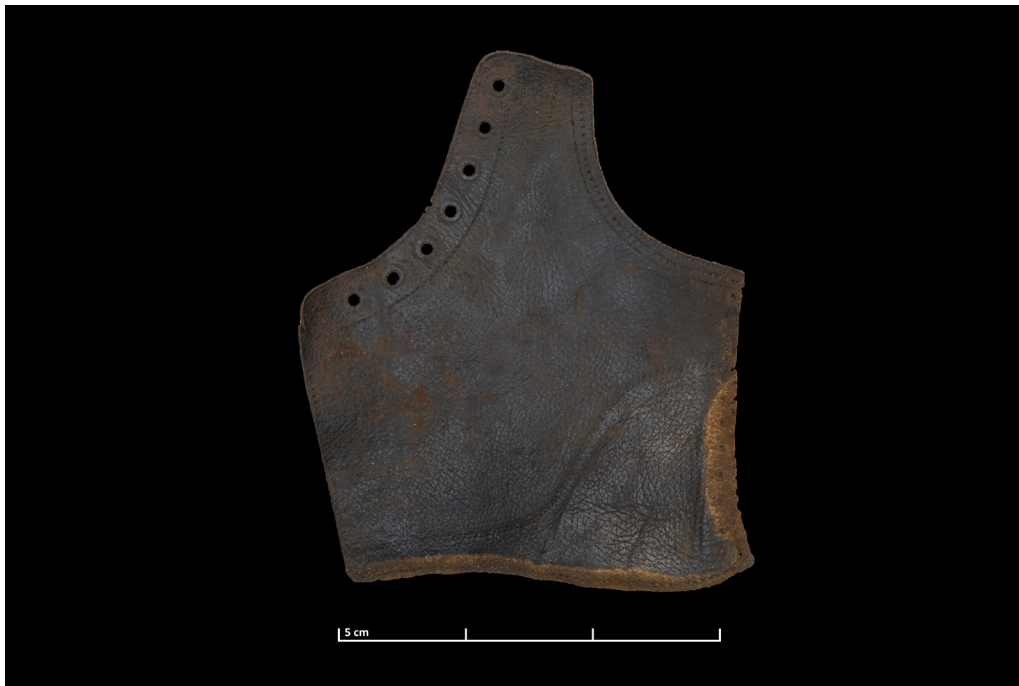
Fig: 6.49 Digital Ref: POWR_Leather_39.003_1
 Direction: N/A Date: 01/09/2022
 Description: Right back quarter from a large front-lacing derby boot (flattened)

The right quarter (Appendix 3.1) from the back of a large front-lacing derby boot, a rubber top piece (Appendix 3.2) from the heel of a boot or shoe, and a small heel lift were found in 'garden' soil south of Hut 39 (39.003; Fig. 6.49). The quarter appears to have been removed from a large working boot, presumably to salvage reusable leather for use elsewhere. This complete shoe part is not moulded, it is flat and appears to have been deliberately flattened in preparation for reuse. The machine stitching has left an impression in the leather, made by thread, indicating that it had once been part of a complete shoe. Though the leather shows only light wear it is slightly worn in places. It was found with a rubber top piece of a large D-shaped heel, it is held by a series of metal nails and is likely to be a repair. A layer from a small, stacked leather heel found with them in Deposit 39.003 matches to the seat area of the child's shoe (Appendix 3.4) from Deposit 62.006 and appears to belong to it. As Deposit 39.003 and Deposit 62.006 were found in proximity this is entirely possible.
