## **CFA ARCHAEOLOGY LTD**

**Stirling Reinforcement Pipeline,  
Cowie,  
Stirlingshire**

**Archaeological Works**

**Report No. 1547**

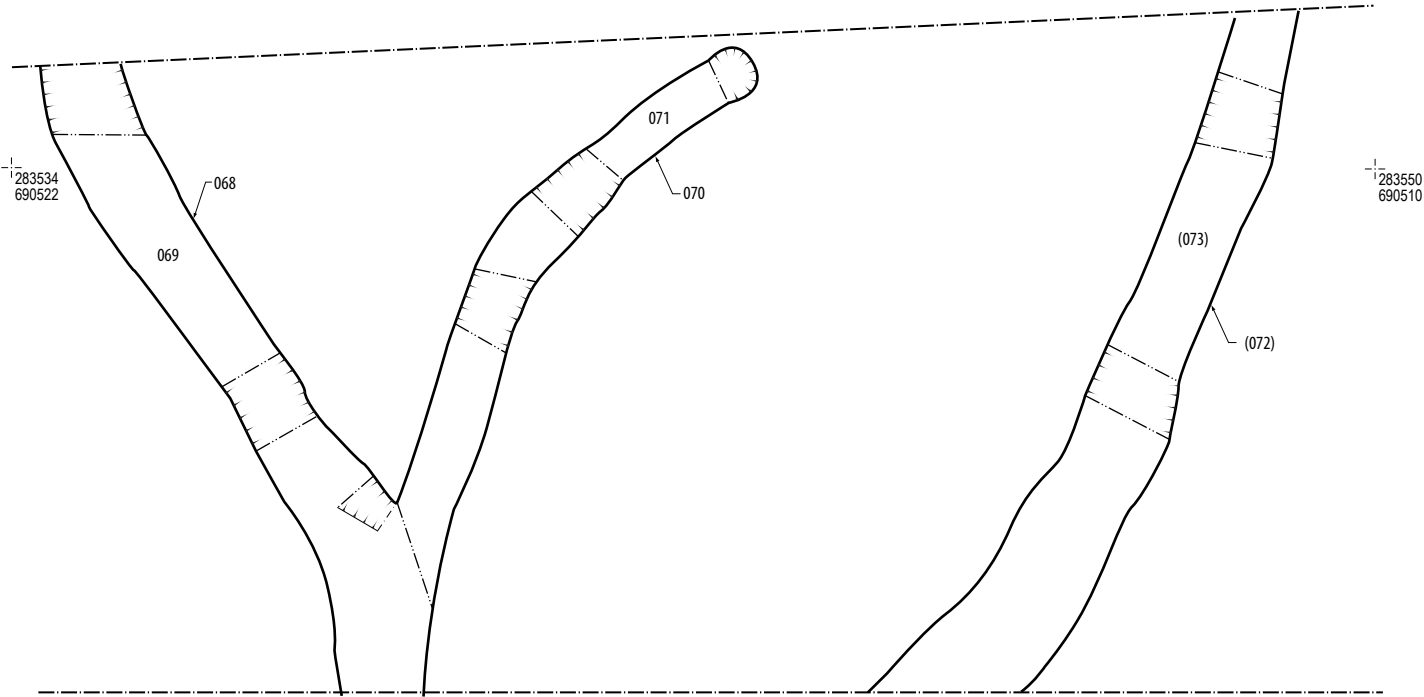
Fig 2 - Plan of Site 2

- 3.4.2 Site 2 (Fig. 2) consisted of three curving ditches (**068**, **070** and **072**). Ditches **068** and **072** extended across the full working width, but the southwestern end of ditch **070** converged with ditch **068** and a terminus was identified close to the north-eastern edge of the working width. The largest of the ditches (**068**) measured c.0.8m in width by 0.5m in depth. It had a V-shaped profile and contained a ceramic field drain. Ditches **070** and **072** were considerably shallower, measuring c.0.76m in width by 0.12m in depth and 1.1m in width by 0.1m in depth respectively. Ditch **070** appears to have been a tributary, exiting into ditch **068**. All three ditches contained 19<sup>th</sup> century pottery, suggesting that they relate to 19<sup>th</sup> century agricultural improvement.

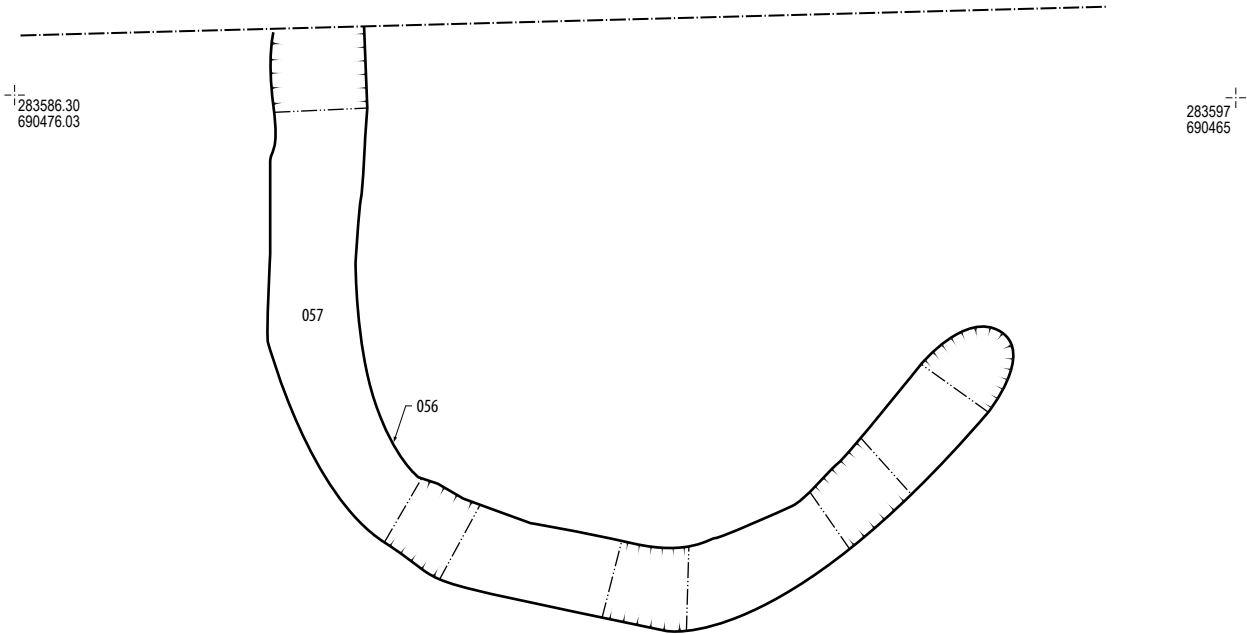
Fig 3 - Plan of Site 3

- 3.4.3 Site 3 (Fig. 3) consisted of a ditch (**056**) that extended in a south-westerly direction from the north-eastern edge of the working width before curving round towards the east where it ended at a shallow and poorly defined terminus. Five sections (**058, 060, 062, 064** and **066**) excavated across the ditch showed that it measured 0.9m – 1.1m in width by 0.08m – 0.15m in depth. The ditch had sloping sides, with the slope on the outside of the curve generally being considerably steeper than the slope on the inside of the curve. Nineteenth century pottery present within the fill (**057**) of the ditch suggests that it relates to 19<sup>th</sup> century agricultural improvement.

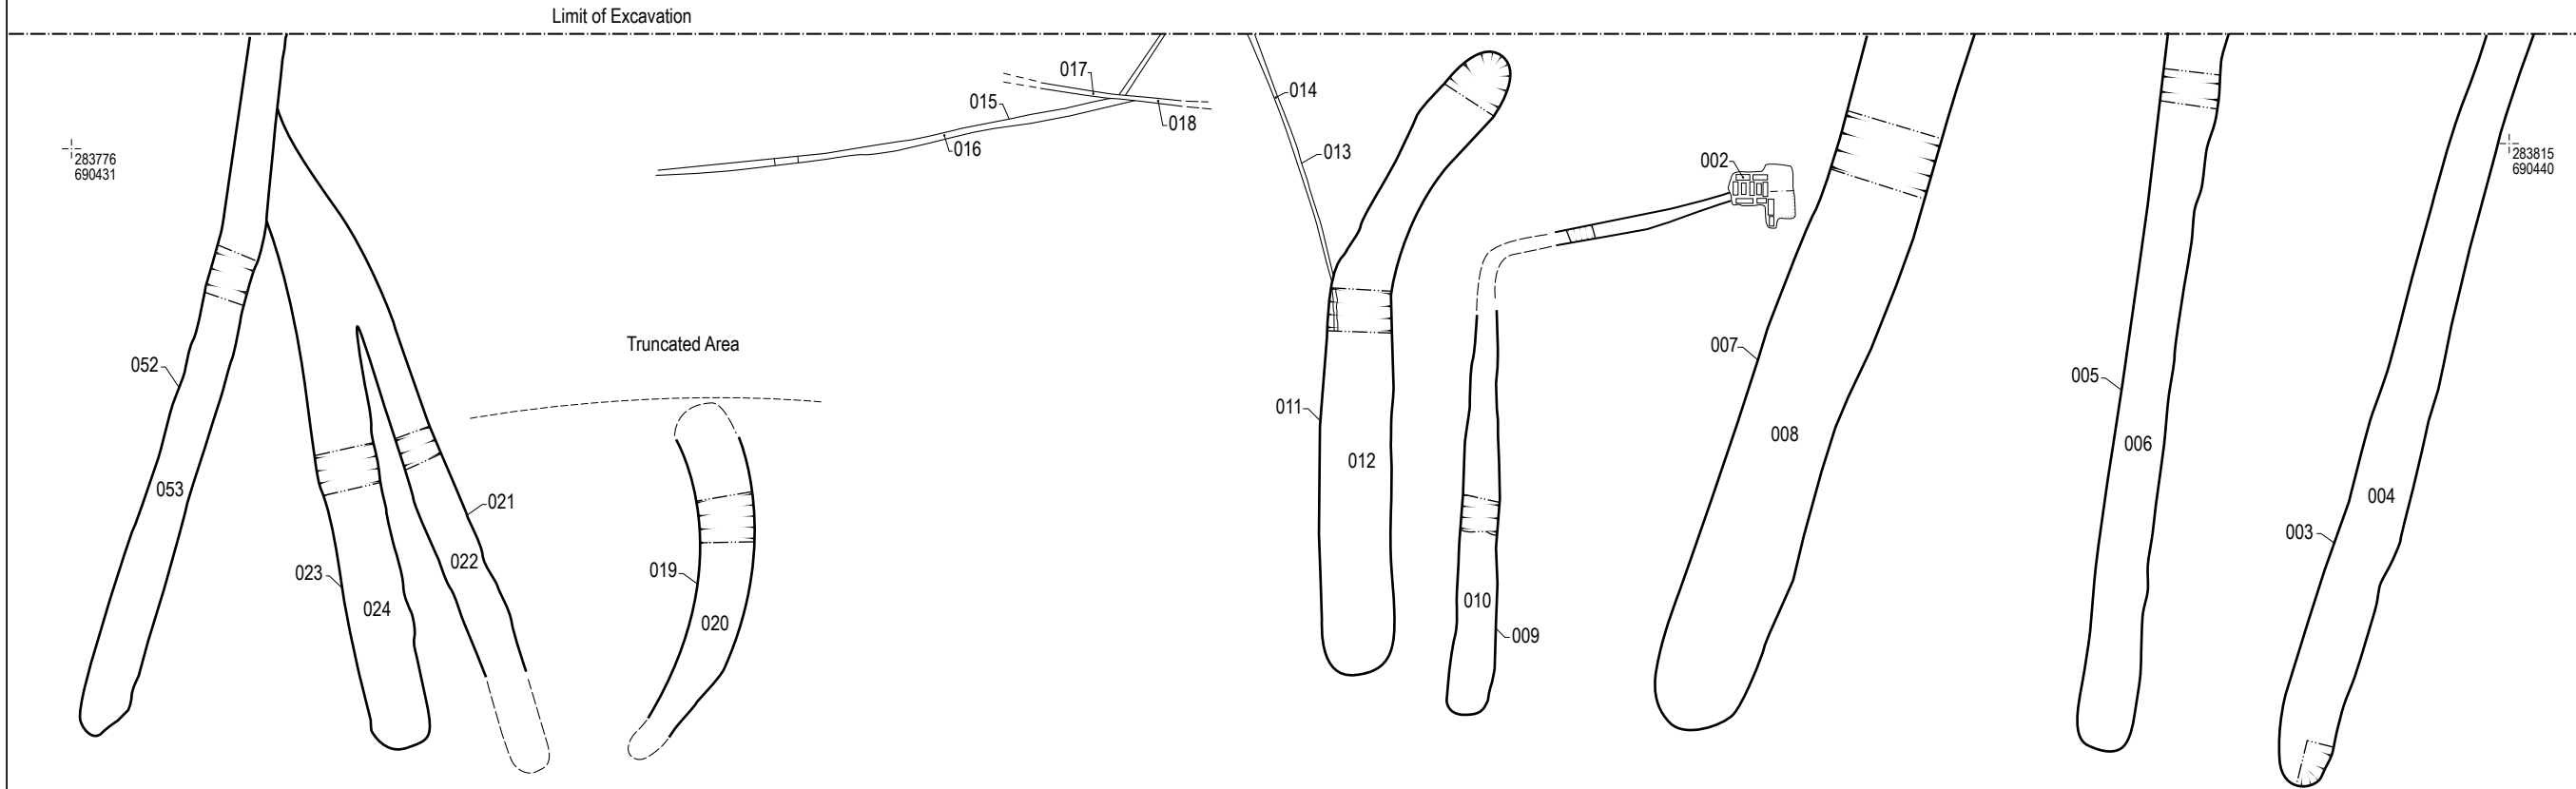
Title:  
**Plan of Site 4**

- 3.4.4 Site 4 (Fig. 4) consisted of a series of twelve linear drainage features (**003, 005, 007, 009, 011, 013, 015, 017, 019, 021, 023** and **052**) that terminated towards the centre of the working width. The majority of the ditches had a rounded profile, with the largest measuring c.1.7m in width by c.0.5m in depth. A surface of flat laid bricks (**002**) measuring 0.4m by 0.6m had been inserted into the north-eastern end of the cut for ditch **009**. The bricks (**002**) were frogged and were stamped ‘Milton of Carluke’. Nineteenth century pottery was present within all the ditches. The location of these features corresponds with the approximate location of a farmstead annotated ‘Westermoss’ (RSK Site **22**), which is depicted on the 1865 1<sup>st</sup> Edition Ordnance Survey map (Fig. 10). NGRs obtained for the features identified placed them immediately to the south of any structures depicted on the Ordnance Survey map, suggesting that they are likely to be associated drainage ditches.

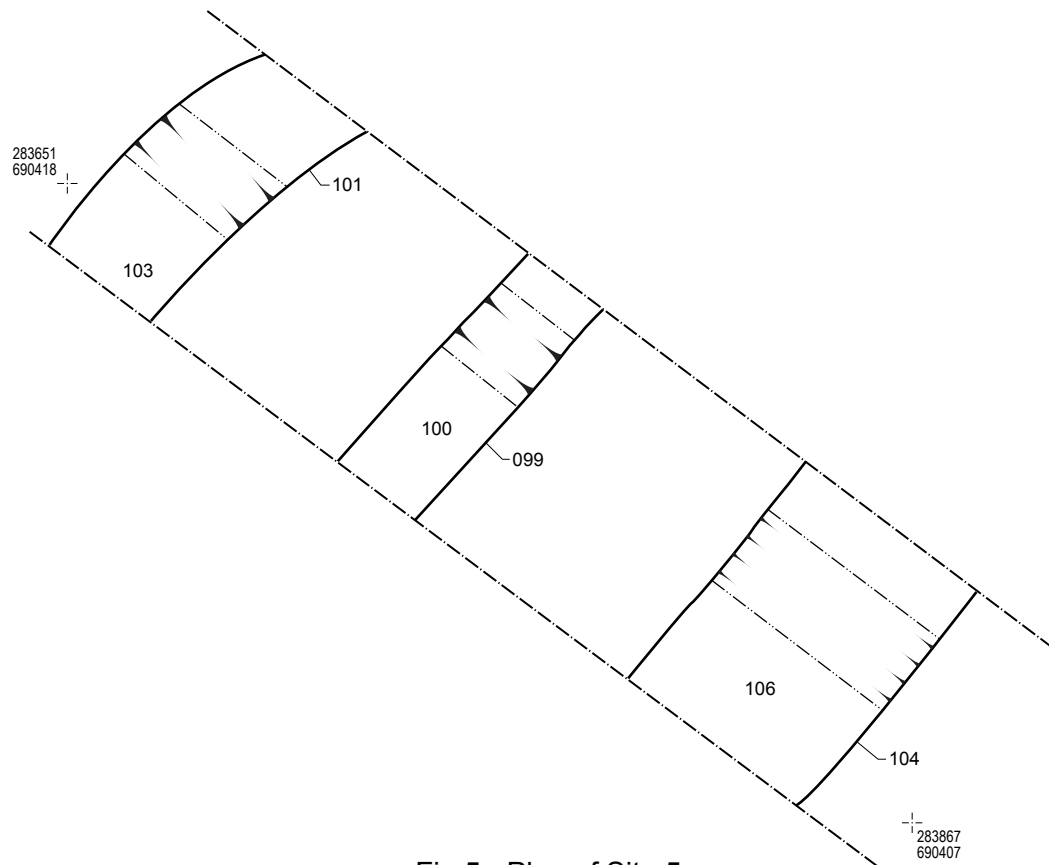
Fig 5 - Plan of Site 5

- 3.4.5 Site 5 (Fig. 5) consisted of three parallel SW/NE aligned ditch features (**099, 101** and **104**) that extended across the full working width. The largest of the ditches (**104**) measured 1.5m in width by 1m in depth and had almost vertical sides and a flat base. This feature is depicted on the 1865 Ordnance Survey 1<sup>st</sup> Edition map and was probably a field boundary (Fig. 10). Ditches **099** and **101** measured 0.7m in width by 0.08m in depth and 0.9m in width by 0.2m in depth respectively. They both contained fragments of 19<sup>th</sup> century field drain.

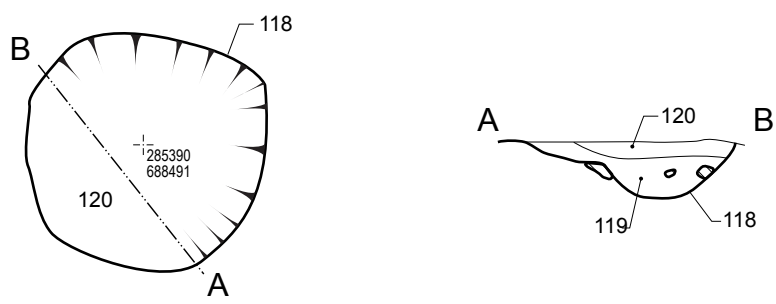
Fig 6 - Pit 118, plan and NE facing section

- 3.4.6 Site 6 (Fig. 6) consisted of a single circular pit (**118**). The pit measured 0.6m in diameter by 0.16m deep and had sloping sides and a rounded base. The primary fill (**119**) of the pit consisted of mid brown clay rich sand and the upper fill (**120**) consisted of dark brown sandy silt. There was no dating evidence recovered from the pit, but a soil sample was recovered for analysis.

- 4.4 Site 6, Site 8 and Site 9 all consisted of pit features. The gently sloping nature of the ground on which they were located together with the presence of a small watercourse nearby would potentially have made this an area suitable for prehistoric settlement. No dating evidence was recovered, but these sites are considered to have the potential to be prehistoric in date. Consequently, it is recommended that a programme of post-excavation analysis is carried out on the soil samples recovered.

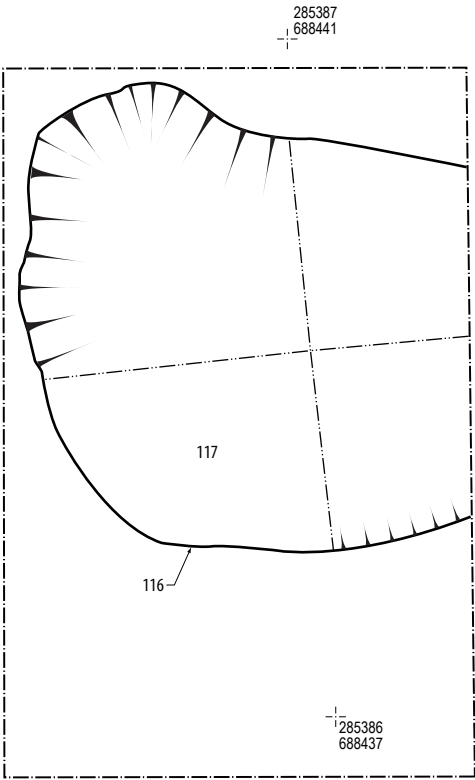
Fig. No:	7	Revision:	A	Client:	Land & Marine Project Engineering Ltd
Title:	Plan of Site 7				
Project:	Stirling Reinforcement Pipeline, Cowie

- 3.4.7 Site 7 (Fig. 7) consisted of a spread (**117**) of dark silt containing shattered limestone and charcoal that sat within a shallow cut (**116**) with a depth of c.0.15m. The spread, which was situated next to a small watercourse, measured c.3m north to south, but the east to west dimension was not established because it continued beyond the eastern extent of the working width. The appearance of the limestone suggests that it may have been fire cracked. There was no dating evidence recovered, but the presence of fire cracked stone close to a watercourse might suggest that it was the remains of a burnt mound of prehistoric date. A soil sample was retained for analysis.

- 4.3 Site 7 consisted of a dark spread containing shattered limestone and charcoal, which was situated next to a small watercourse. This feature may have been a burnt mound of prehistoric date. Post excavation analysis is recommended on the soil sample recovered from this feature.

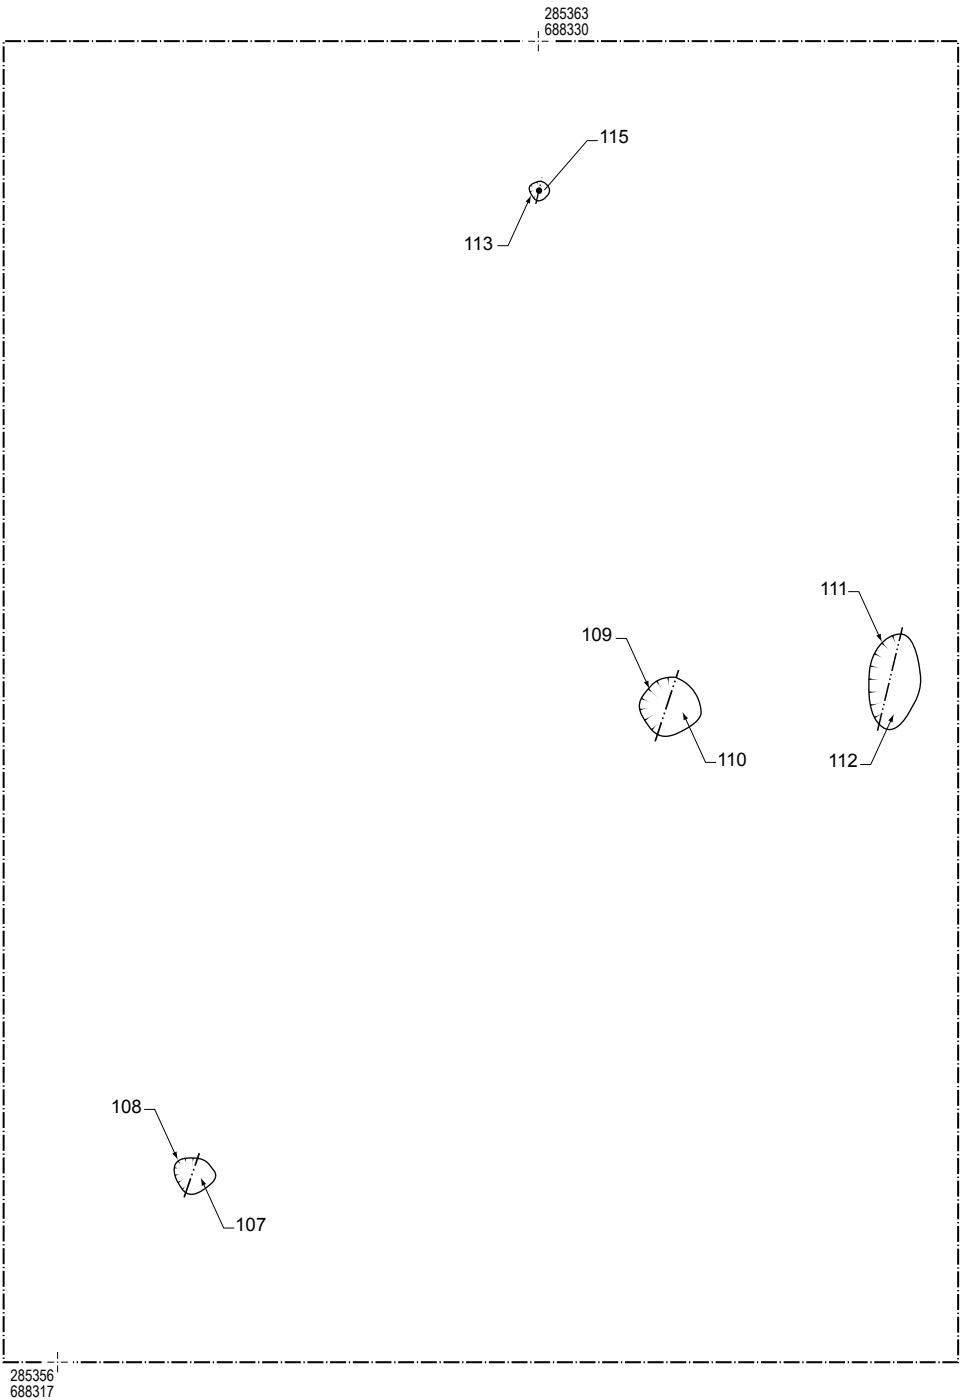
Fig. No:	8	Revision:	A	Client:	Land & Marine Project Engineering Ltd
Title:					
Plan of Site 8					
Project:					
Stirling Reinforcement Pipeline, Cowie

- 3.4.8 Site 8 (Fig. 8) consisted of a group of four pit features (**107**, **109**, **111** and **113**), which had been cut into a gentle north facing slope. There was no dating material recovered from any of the pits, but soil samples were retained for analysis. All the pits were 100% excavated. Details of the individual pits are given below.

- Pit **107** was circular in plan, measuring 0.38m in diameter by 0.18m deep. It had sloping sides and an irregular base and contained a single fill (**108**) consisting of dark brown sandy silt.

- Pit **109** was roughly circular in plan, measuring 0.6m in diameter by 0.06m deep. It had sloping sides and a flat base and contained a single fill (**110**) consisting of dark brown sandy silt.

- Pit **111** was oval in plan, measuring 0.8m north to south by 0.5m east to west and had a depth of 0.08m. It had sloping sides and a flat base and contained a single fill (**112**) consisting of dark brown sandy silt mixed with pink clay.

- Pit **113** was roughly circular in plan, measuring 0.34m in diameter by 0.06m deep. It had sloping sides and a sloping base and contained two fills. The lower fill (**114**) consisted of fine grey sand and the upper fill (**115**) consisted of a circle of dark brown sandy silt measuring 0.14m in diameter by 0.04m deep.

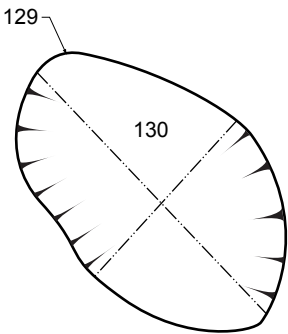
Title: Plan of Site 9

- 3.4.9 Site 9 (Fig. 9) consisted of a group of four pit features (**121**, **124**, **127** and **129**). There was no dating material recovered from any of the pits, but soil samples were retained for analysis. Details of the individual pits are given below.
- Pit **121** was roughly circular in plan measuring 0.9m in diameter by 0.24m in depth. It had sloping sides and a rounded base and contained two fills. The

lower fill (122) consisted of grey sandy silt and the upper fill (123) consisted of black clay-rich silt with stone inclusions.

- Pit 124 was roughly circular in plan measuring c.1m in diameter by 0.24m in depth. It had sloping sides and a rounded base and contained two fills. The lower fill (125) consisted of grey sandy silt and the upper fill (126) consisted of black clay-rich silt.
- Pit 127 was oval in plan, measuring 1.8m north-west to south-east by 1m north-east to south-west. It had irregular sloping sides and an irregular base and contained a single fill (128). The fill consisted of black clay-rich silt.
- Pit 129 was oval in plan, measuring 2.25m north-west to south-east by 1.4m north-east to south-west. It had sloping sides and a flat base and contained two fills. The lower fill (131) consisted of grey sandy silt and the upper fill (130) consisted of black clay-rich silt.
