**Glencorse Water Treatment Works,
Glencorse Mains, Penicuik, Midlothian**

Archaeological Watching Brief

Report No. 1578

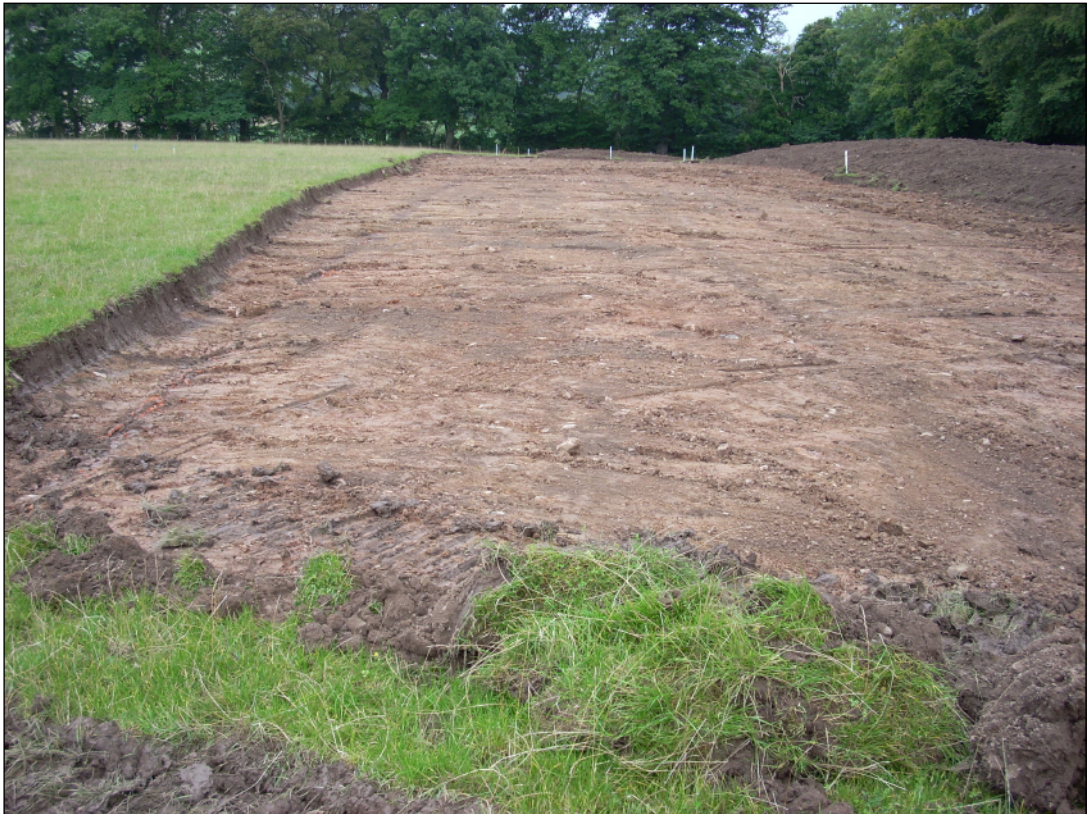
Fig. 2 - General shot of site from SSE

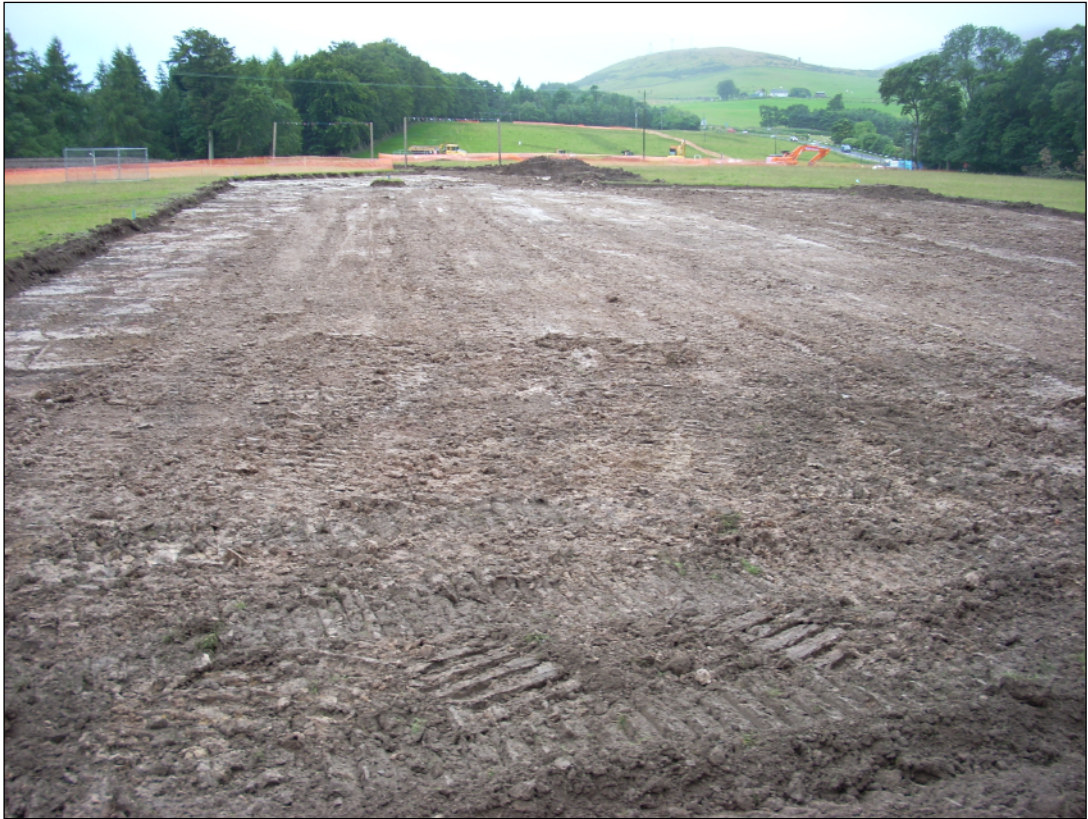
Fig. 3 - General shot of site from SW

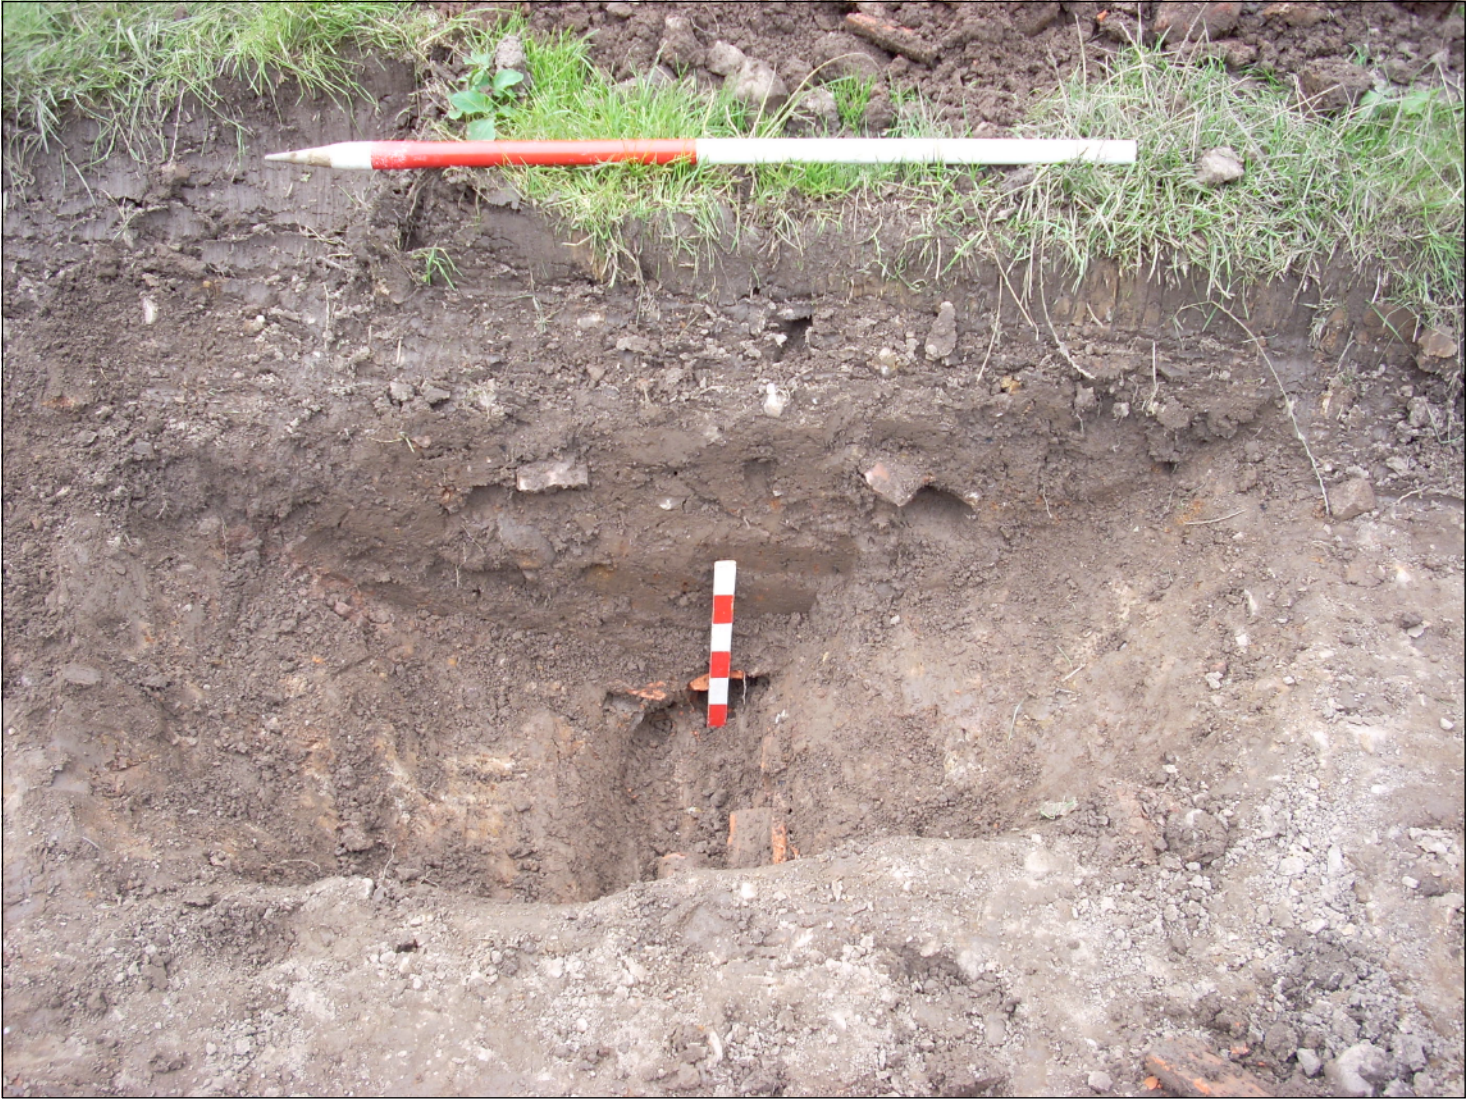
- 3.2.1 A linear ditch (**008**) (centred NT 23319 62601, Fig. 4) was revealed in the south-west part of the site, bordering the southern edge of the watching brief area. A section excavated through the ditch showed it to be 1.3m wide by 0.5m deep, with irregular sloping sides and a narrow, channel-like flat base. Deposits within **008** consisted of an upper fill (**003**), 0.18m deep, of homogeneous mid brown clayey silt; a 0.22m deep secondary fill (**004**) of dark orange-brown clayey silt, and a 0.1m deep basal fill (**005**) of wet greyish silt. **005** contained a broken piece of clay drain pipe (**006**). Both **005** and **006** were within a channel formed from broken pantiles (**007**).

- 3.2.2 Ditch **008** underlay the position of a removed modern wire-and-post field boundary. It also corresponded to the line of a linear ditch identified in Trenches 29 and 52 during the evaluation of the WTW area (Kirby 2008), running through Field 3, and as such probably represents the continuation of this feature. This was a field boundary ditch associated with the boundary of a plantation strip present on the 1854 Ordnance Survey First Edition 6" map (Kirby 2008).

Fig. 4 - SE facing section of field boundary ditch 008
