July 2008

Commissioned by Scottish Power Ltd

**High Alderstocks Steading,
West Brown Castle, Strathaven, Lanarkshire
Standing Building Survey**

Report No. 1525

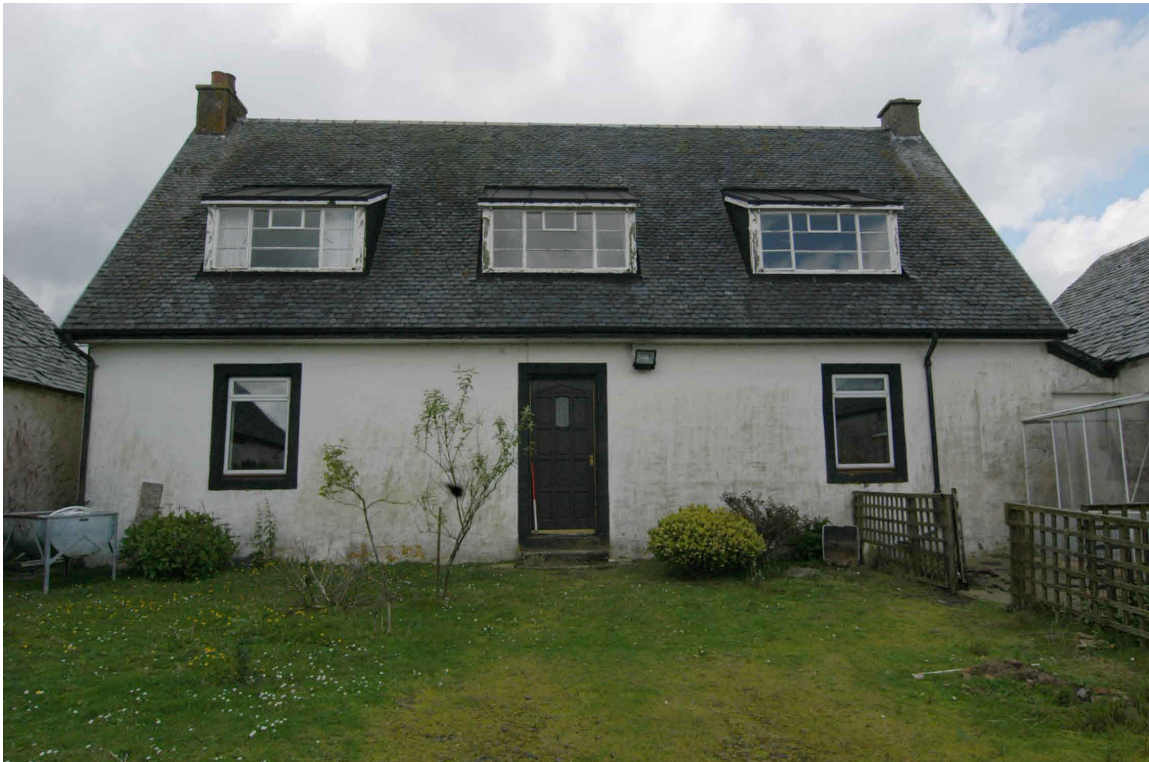
- 3.2.12 The south elevation was built of well-coursed cement rendered sandstone blocks and faced the U-shaped courtyard. The quoins were not visible. A rubble and concrete damp course skirt, 0.31m high, was visible at the base of the wall. A breeze block wall had been inserted into the gap between the Farmhouse and the East Range creating the passage that connected the kitchen to the East Range. A large stone lintel and sloping slate roof had capped this wall. The elevation contains a doorway, all of which had black painted raised margins. The door was a moulded wooden door with a single pane of frosted glass and two steps lead up to the entrance. The two windows were modern UPVC. Three dormer windows had been inserted into the roof. The dormer windows had wooden frames and felt covered the sides. The upper portion of the roof, above the dormers was made up of smaller slates than the majority of the roof. A felt and lead roof ridge is present on the top of the roof. Harled chimney, cornice stacks were present at both gables and both were capped with concrete caps.

Plate 2 -Farmhouse, south-facing elevation

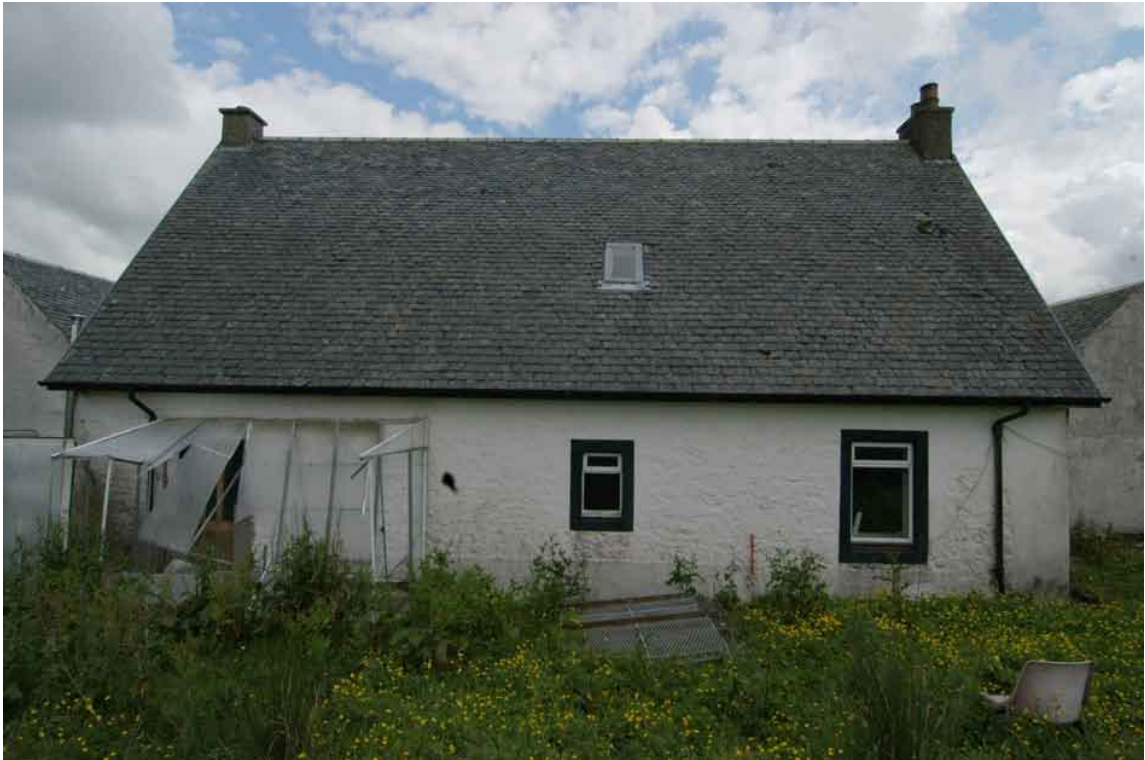
- 3.2.10 The north elevation was built of cement rendered coursed sandstone blocks, the quoins were not visible. A smoothed area of cement rendering completely masked the western quoins. A rubble and concrete damp course skirt, 0.65m high, was present at the base of the wall. The elevation was 3m high to the eaves. The elevation contained a doorway, two windows and a metal-framed skylight. The windows and door had black painted raised margins, of which the door and the western window appear to be have been later inserts. The

western window was a modern UPVC window. In front of the back door a light metal framed, plastic panelled porch lean-to was present. The porch, measured 3.6m long by 2.4m wide by 2.12m high and was built on a concrete base.

Plate 3 - Farmhouse, north-facing elevation

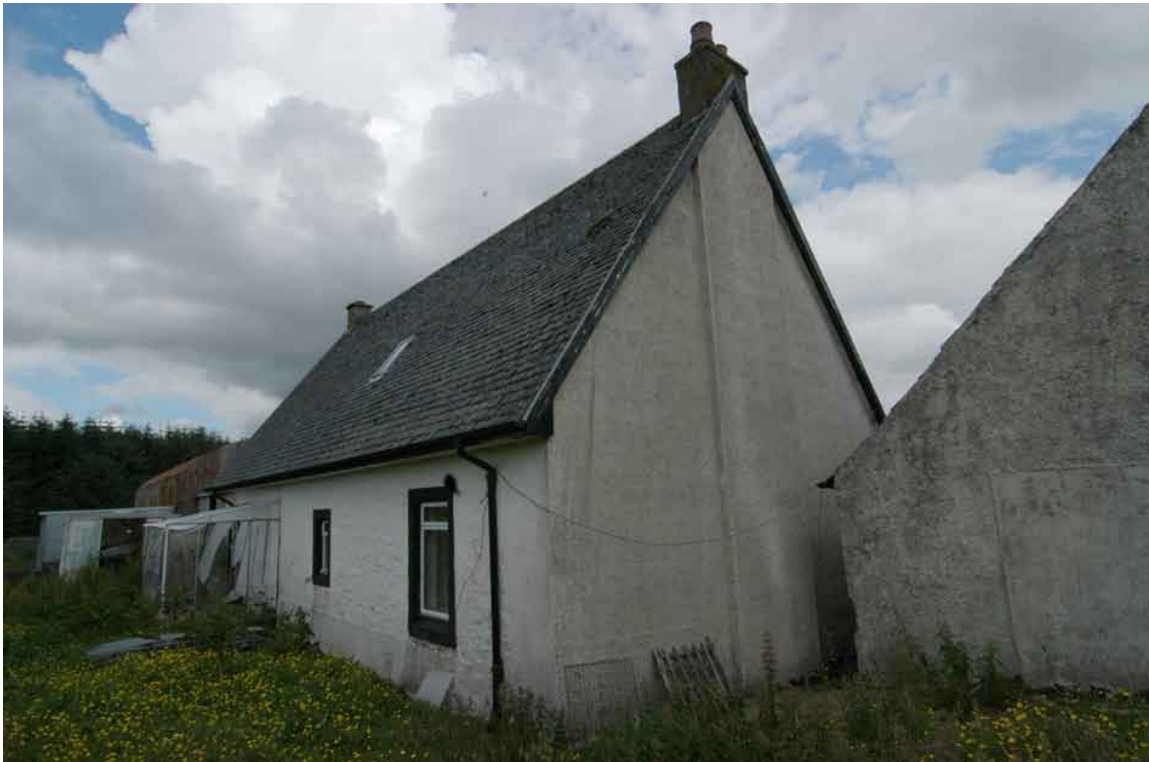
- 3.2.13 The west-facing gable had a large chimneystack, 1.6m wide, protruding from the wall by 0.13m. The fabric above the eaves was a pebble dashed harling over coursed rubble stone wall. Black painted wooden bargeboards were present on both edges of the roof. Apart from these features the wall was featureless.

Plate 4 - Farmhouse, west-facing elevation

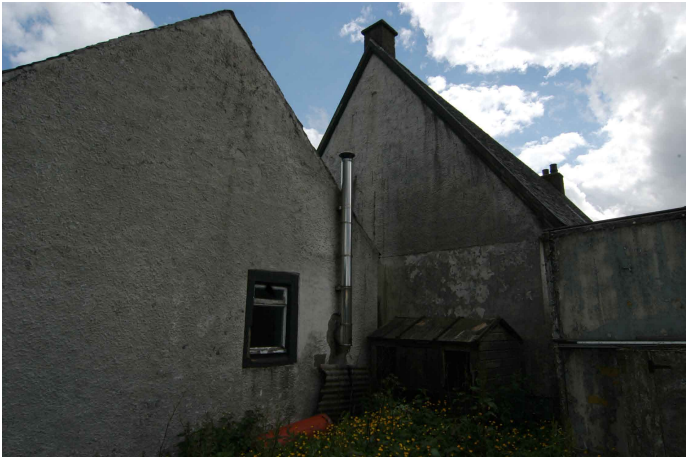
- 3.2.11 The east gable fabric below the eaves was rendered coursed stone rubble. The fabric above the eaves was a pebble dashed harling over coursed rubble stone wall. Black painted wooden bargeboards were present on both edges of the roof. The East Range was connected to the farmhouse on the south of this elevation, otherwise the elevation was featureless.

Plate 5 - Farmhouse, east facing elevation

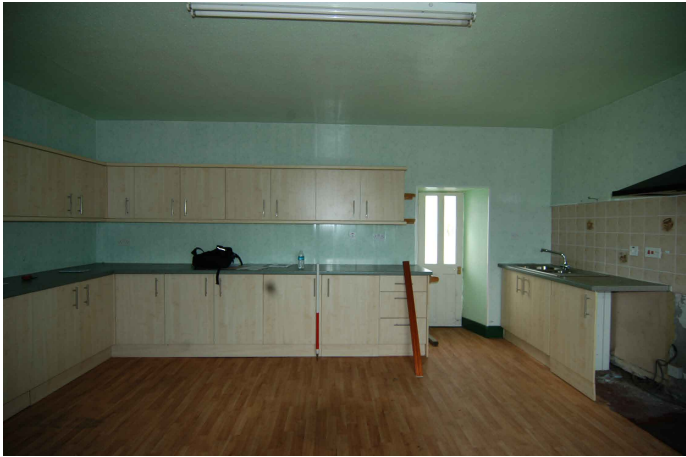
green plastic (Respatex) sheets, except above the sink and oven, on the east wall, which was tiled. The kitchen was lit by a two-pane UPVC window, which had green painted splayed wooden ingoos. The back door (1.84m high by 0.6m wide) was of a simple moulded soft with two vertical glass panes. A plank wooden door (1.89m high by 0.88m wide) with a brass handle led to the living room.

Plate 6 - Farmhouse interior, kitchen

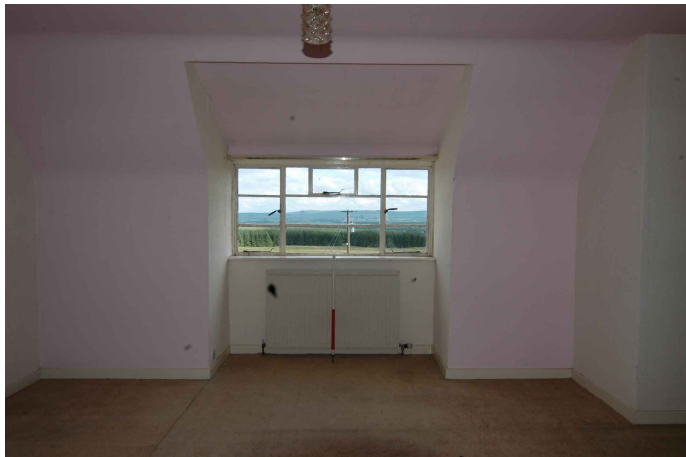
- 3.1.18 The eastern bedroom (Bedroom 1, Unit 7, Plate 9) was a Mansard roof conversion inserted into the former loft space and measured 5.72m long by 4m wide. The ceiling was a lightly stippled Artex, painted pink, which covered a plaster board ceiling. A pale brown carpet covered floorboards on the floor. White painted woodchip wallpaper covered the east and west walls, whilst coloured wallpaper covered the north and south walls. The room was lit by an eleven-pane metal-framed window in the south wall. A soft wood panel door in the west wall led to the landing. A built in cupboard with potential access to the loft was built against the west wall.

Plate 9 - Farmhouse interior, bedroom 1

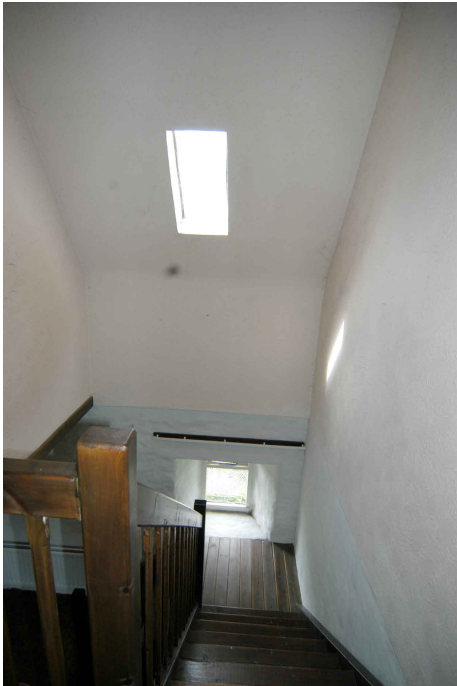
- 3.1.17 A narrow first floor landing Unit 8, Plate 8) at the top of the stairs led to two bedrooms and a boxroom. The landing itself was 2.12m long by 0.96m wide and had a brown carpet over wooden floorboard floor. The ceiling and upper part of the walls was magnolia painted Artex.

Plate 8 - Farmhouse interior, landing

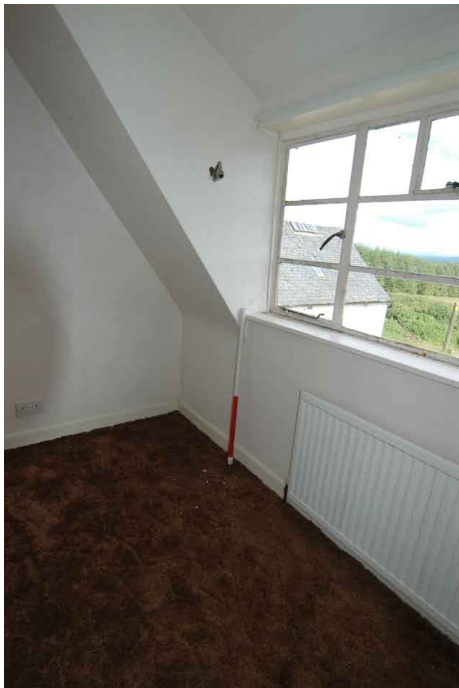
- 3.1.19 The box room (Unit 9, Plate 10) measured 2.78m long by 1.39m wide and was lit by an eleven-pane metal frame window in the south wall. The walls were pink painted woodchip wallpaper over timber framed plaster board partition walls.

Plate 10 - Farmhouse interior, box room

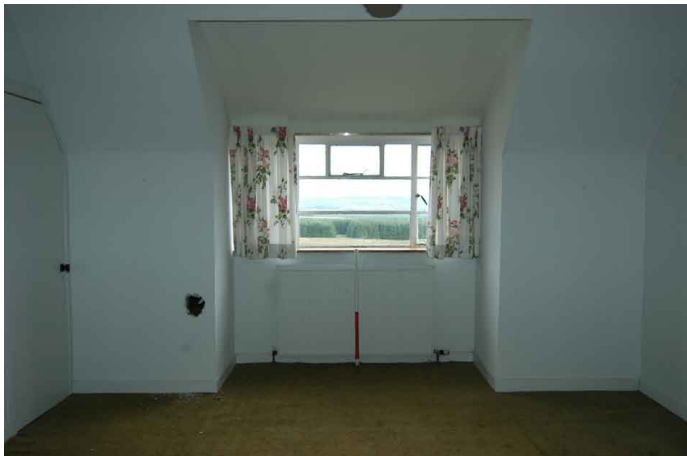
- 3.1.20 The western bedroom (Bedroom 2, Unit 10, Plate 11) was a Mansard roof conversion inserted into the former loft space in the same manner as Bedroom 1, and measured 4.18m long by 4m wide. The ceiling was a white painted plasterboard ceiling. A pale brownish green carpet covered floorboards on the floor. The walls were covered in unfinished textured wallpaper. The room was also lit by an eleven-pane metal framed window in the south wall. A soft wood panel door in the east wall led to the landing. A built in cupboard between the south wall and door contained shelves and storage hooks.

Plate 11 - Farmhouse interior, bedroom 2

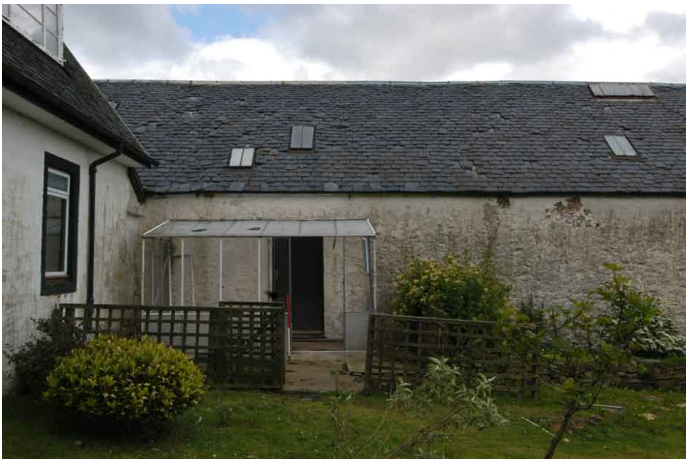
- 3.2.4 The west-facing elevation of the East Range faced into the U-shaped courtyard. It contained five metal-framed skylights in the slate tile roof. The upper portion of the roof was made up of smaller slates than the majority of the roof. A felt and lead roof ridge was present on the top of the roof. The fabric was white washed, cement rendered coursed stone rubble and the quoins were visible through the render in the south. The door was a moulded wooden

Plate 12 - East Range, west facing elevation

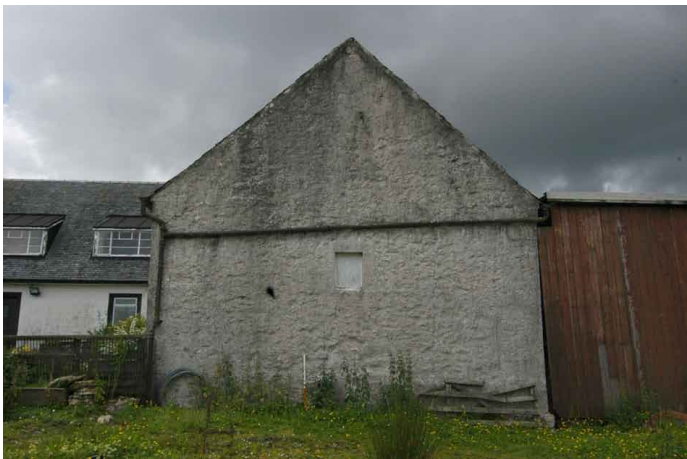
- 3.2.3 The gable at the south end of the East Range had the same fabric as the northern gable. The elevation had a wooden window, which had been white washed, and raised margin. The roughly dressed quoins were visible, through the render on both edges of the elevation. Two pipes had been inserted at the base of the wall, the scar for which had been crudely filled with rendered stone rubble.

Plate 13 - : East Range, south facing elevation

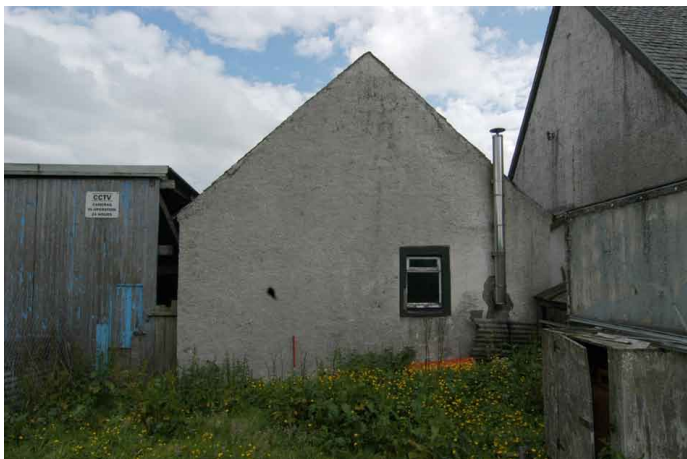
- 3.2.1 The fabric was a pebble dashed harling over coursed rubble stone wall. The gable at the north end of the East Range had been altered to accommodate the insertion of a modern steel pipe, associated with the boiler in the entrance passage. The scar from this insertion had been filled with concrete and broken brick. A two pane, white painted, wooden framed with a raised margin was present in the west of the elevation. Apart from these features the wall was plain.

Plate 14 - East Range, north facing elevation

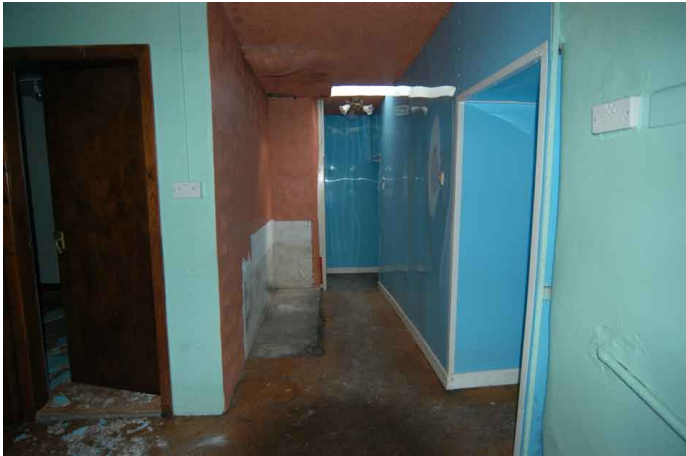
- 3.2.6 The entrance passage and inner hall (Unit 1, Plate 15) provided access to the stables, bathroom, saddle room and kitchen. The ceiling was terracotta painted Artex and the floor was cork tiles over concrete. The western walls of the passage were lined by blue plastic (Respatex) sheeting. The other walls were of painted Artex, over plastered stone, similar to the ceiling. An oil fired boiler was present against the northern wall to the left of a two pane wooden window. An extension passage built between the inner hall and kitchen contained a meter cupboard which housed a water tank and meters.

Plate 15 - East Range interior, passage

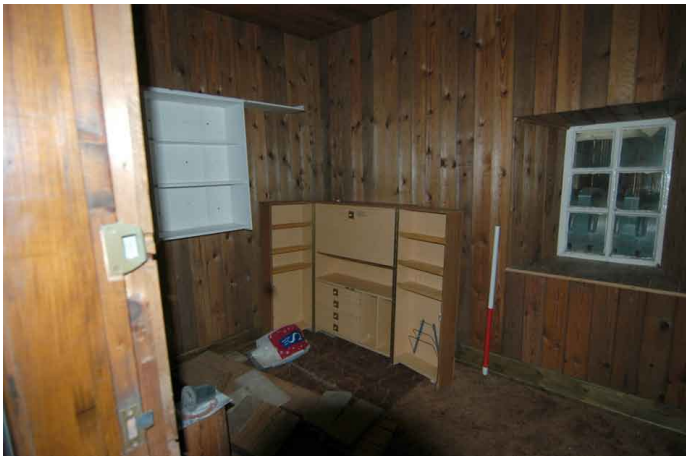
- 3.2.7 The saddle room (Unit 2, Plate 16) was lit by a six pane wooden window in the east wall of the Range. The floor was brown carpet over concrete, whilst the ceiling and walls were dark stained, tongue and groove wooden panelling with a plain skirting board (0.12m) below. The door (1.98m high by 0.76m wide) was a moulded wooden panel door with a brass handle.

Plate 16 - East Range interior, saddle room

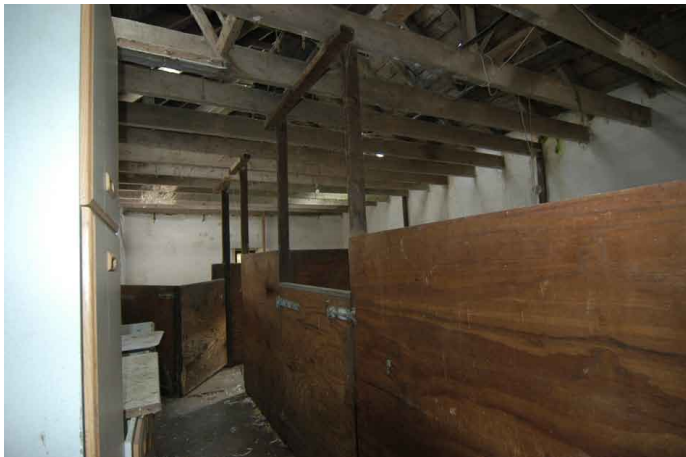
- 3.2.9 The stables (Unit 4, Plate 17) continued the original build of the range. The walls were, white washed, cement rendered coursed rubble. The floor was bare concrete of recent date. A wooden planked door (1.88m high by 1.01m wide) on iron hinges led to the Pole barn to the east. Another plank door (1.92m high by 0.92m wide) led from the stable to the passage. Two single and one double box stalls were arranged along the western and southern walls.

Plate 17 - East Range interior, stables

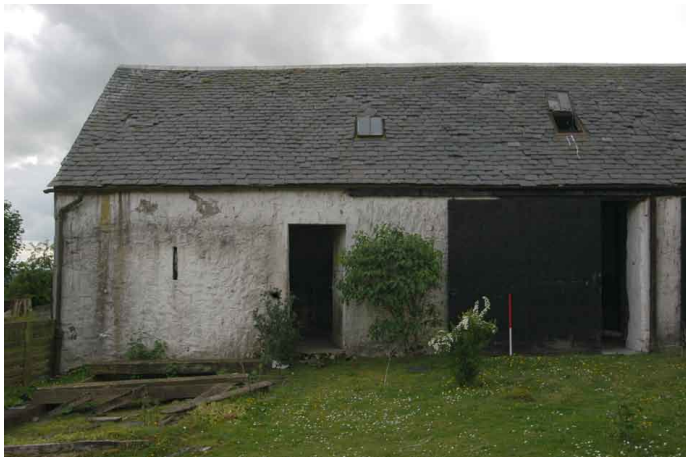
- 3.2.23 The east-facing elevation of the West Range faces into the U-shaped courtyard. The fabric is white washed, cement rendered coursed stone rubble and the quoins are visible through the render at both gables. Large rubble foundation stones are visible at the base of the wall. The elevation contains a splayed slit vent c. 1.5m above the present ground level. The vent measured 0.5m by 0.10m. The upper portion of the roof was made up smaller slates than the majority of the roof. A felt and lead roof ridge was present on the top of the roof. The roof contains three metal-framed skylights. The elevation has three doorways with lightly cement rendered whitewashed, raised margins. The southern most door was a two part wooden plank door (0.96m wide by 1.98m high) with iron hinges, and had a stone lintel. The central door (2.3m wide by 2.4m high) had a wooden frame with metal sheet exterior and was a double sliding door with a wooden lintel. The northern door (1.32m wide by 2.4m high) was a single sliding door similar to the central door.

Plate 18 - West Range, east facing elevation

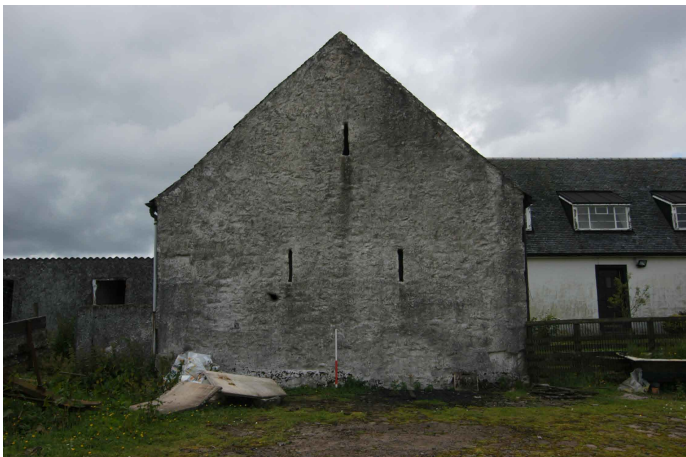
- 3.2.24 The elevation contains three splayed slit vents, two below the eaves and one above. The vents measure 0.5m by 0.10m. The fabric was rendered coursed stone rubble with large rubble foundation stones and quoins visible through the render.

Plate 19 - : West Range, south facing elevation

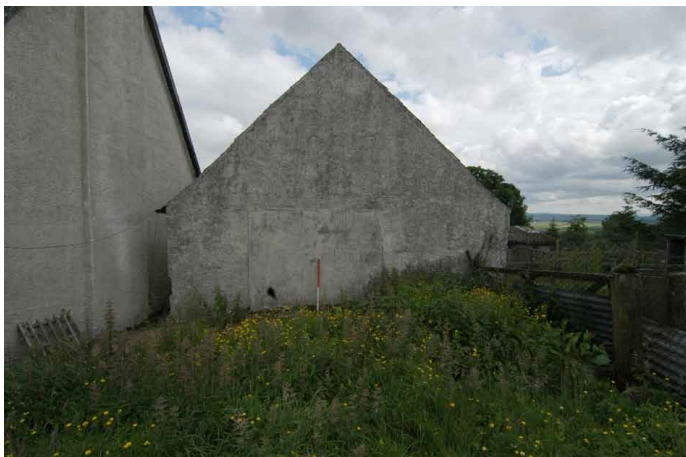
- 3.2.22 The gable fabric was rendered coursed stone rubble, but otherwise featureless. The scar of a former building abutting the West range was visible as an area of lighter plaster. The scar measured 1.76m high by 2.8m wide and the surviving stone floor protruded 2.12m to the north. No evidence of the former walls or roof was noted

Plate 20 - West Range, north facing elevation

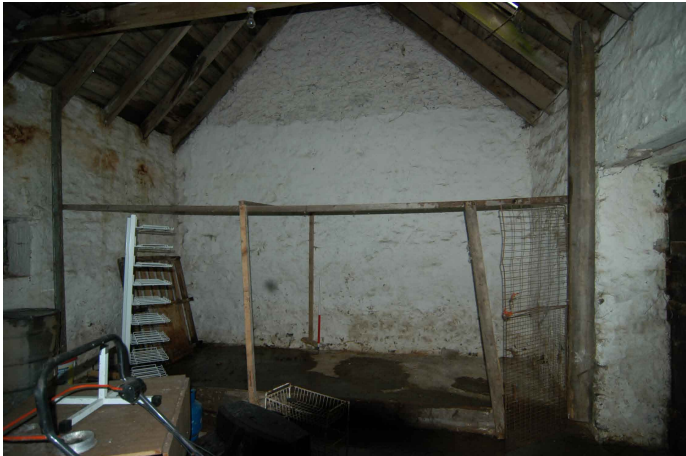
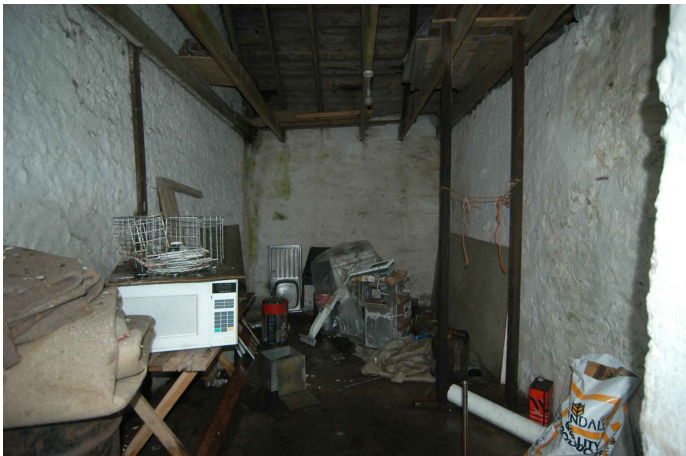
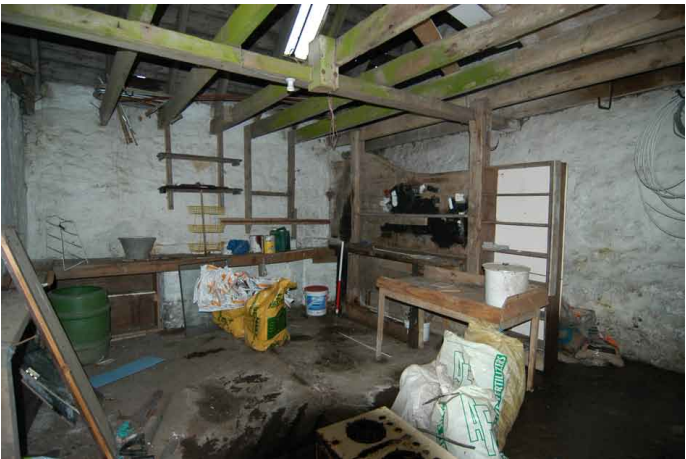
- 3.2.26 The west range was divided into three stables/loose boxes (Units 11-13) and had last been used for storage. Work benches were present in the northern compartment and this may have been a workshop. The wall between the northern and central compartments may have been reduced to accommodate

Plate 21 -
West Range interior, southern compartment

Plate 22 -
West Range interior, central compartment

Plate 23 -
West Range interior, northern compartment

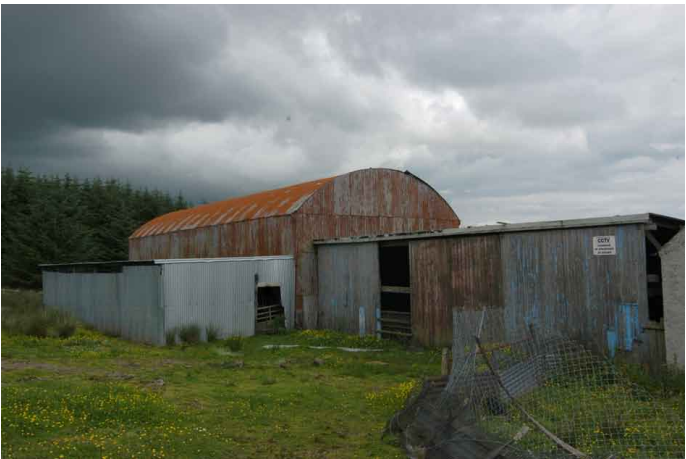
- 3.2.27 A Dutch barn, corrugated tin roof and walls, measuring 52m by 8m was present to the east of the U-shaped buildings. It was divided into 5 bays and contained a bulk feeder tank. Between the Dutch barn and the East range a Pole barn (14.5m long by 12.5m wide) with a wooden slatted roof and walls was built against the east wall of the East Range. Another timber-framed lean-to with corrugated tin walls was built against the southern wall of the Dutch barn.

Plate 24 - General shot of barns to east of steading

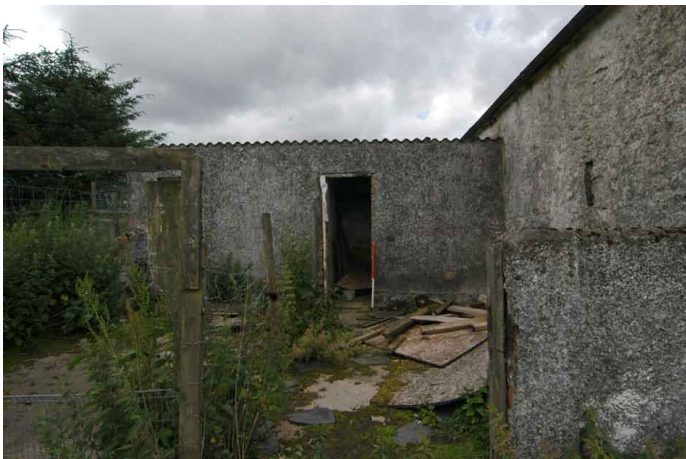
Plate 25 - General shot of buildings to west of steading

- 3.2.25 The west-facing elevation of the West Range contained two, splayed slit vents (measuring 1.5m by 0.10m) c. 1.5m above the present ground level. Only the southern vent was visible due to the construction of a harled brick outbuilding, which abutted the West Range. This outbuilding (Plate 25) had two stalls with a fenced enclosure in front. It measured 4.4m wide by 3.6m long. The roof contained two metal-framed skylights. Quoins were visible through the render at both gables. A number of fences were present against the northern part of the elevation.
