March 2008

**1-3 Musselburgh Road, Dalkeith**

**Archaeological Evaluation**

**Report No. 1460**

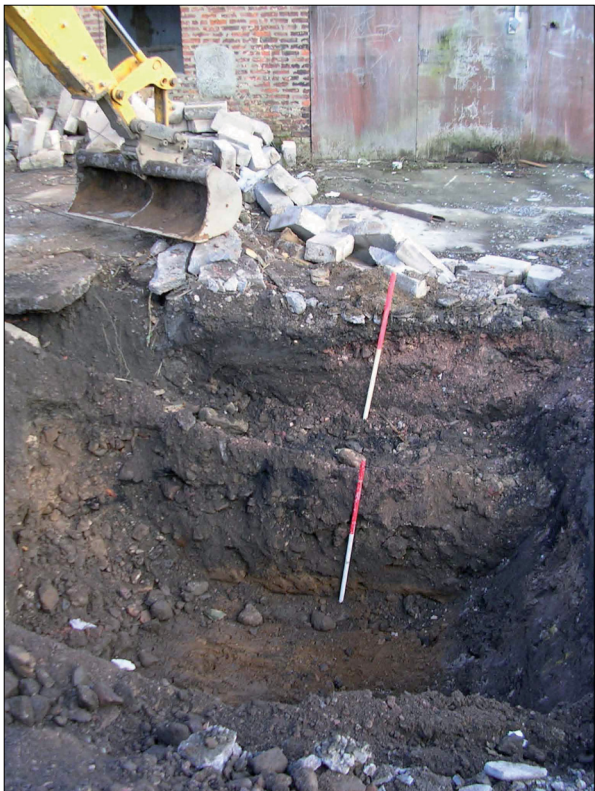
- 3.1.2 Trench 1 was located at the southern edge of the site in between a range of existing buildings and the southern boundary wall. A 5m long section (Trench 1) at excavated down to natural which was identified 2m below the modern site surface (Plate 1). A 0.2m thick surface of concrete (**100**) was removed to expose a 0.2m thick layer of red blaes (**101**). This overlay a 0.1m thick black layer of mixed charcoal, coal and silt (**102**). Beneath this lay a deep deposit (1.5m) of made up ground (**103**) including builders rubble, mortar, stone and late 19<sup>th</sup>/ early 20<sup>th</sup> century ceramic and glass. Excavation of this trench had to cease as was not possible to step it along its entire length due to a general lack of space as containers and skips constricted the amount of room available.

Plate 1 - East section of trench 1

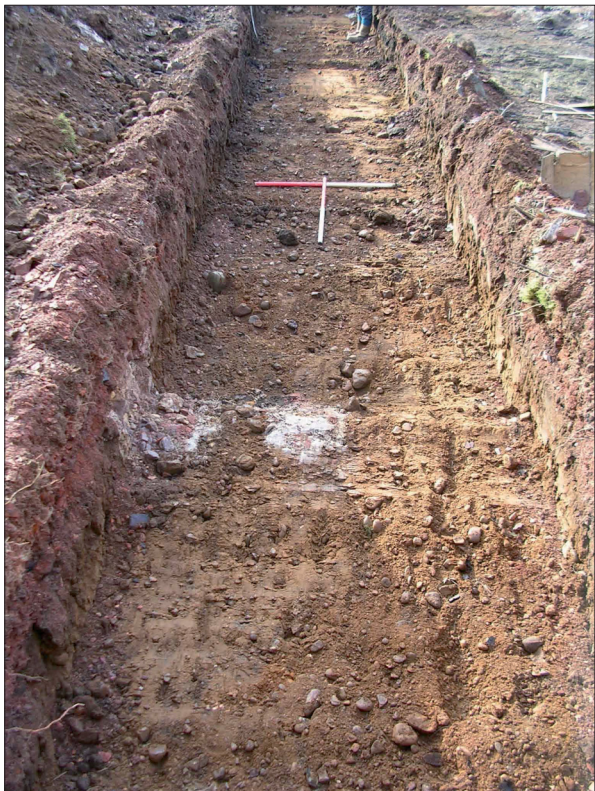
- 3.1.4 Trench 2 was positioned to cross a range of buildings and a courtyard depicted on an 1830 plan of the complex (Cressey 2008). A surface layer of red blaes (200) which was 0.2m deep overlay a thin layer of black Shale (204) 0.05-0.1m deep. Beneath this lay a 0.4m deep layer of compacted loam soil with large stone inclusions (201), below this was the natural undisturbed subsoil (202) which was a light brown sand and gravel. Towards the northern end of the trench a roughly built stone and mortar wall (203) extended about halfway across the trench and was aligned parallel to the boundary wall immediately to the north (Plate 2). The wall survived to a height of 0.4m and was 0.5m wide (plate 2).

Plate 2 - Trench 2, view south. Wall visible

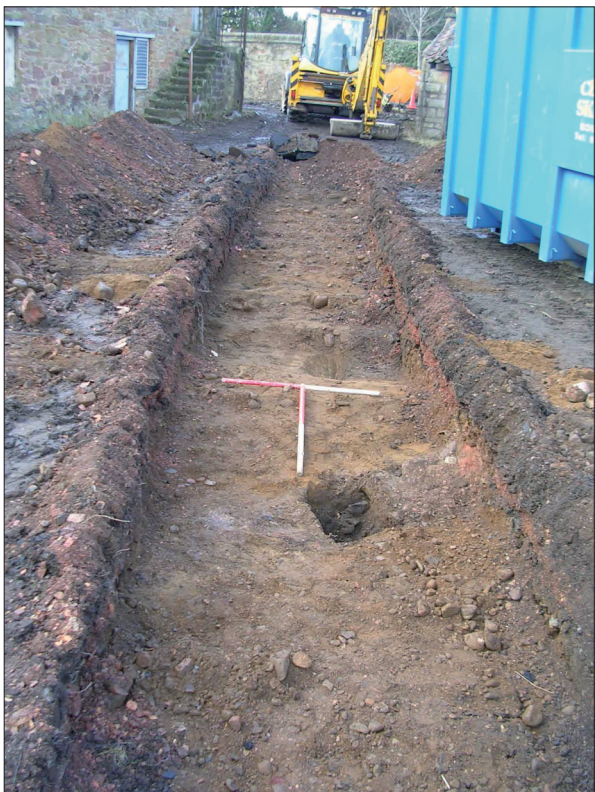
- 3.1.5 Trench 3 was positioned, as trench 2 was to evaluate the courtyard area on the 1830 plan. The upper deposit was a 0.2m layer of red blaes (300) as in trench 2. Below this was a 0.05m layer of tarmac (301). Underlying (301) was a patchy 0.06m layer of topsoil like material. Beneath this the natural undisturbed subsoil survived (303). This was a light brown sand and gravel. Three features were apparently cut in to the subsoil surface: a pit [304]; and two smaller circular features [306] and [308] respectively.

- 3.1.6 The pit [304] was circular in plan with a diameter of 0.8m and was filled with a brown silty sand (305), which contained occasional flecks of charcoal. Both the smaller features [306 & 308] were circular in plan with a diameter of 0.3m. They were both filled with black mixture of charcoal, blaes and ash (307 & 309). A fragment of modern ceramic was also found within (309), which points to a modern date for these features.

Plate 3 - Trench 3, view south-west.

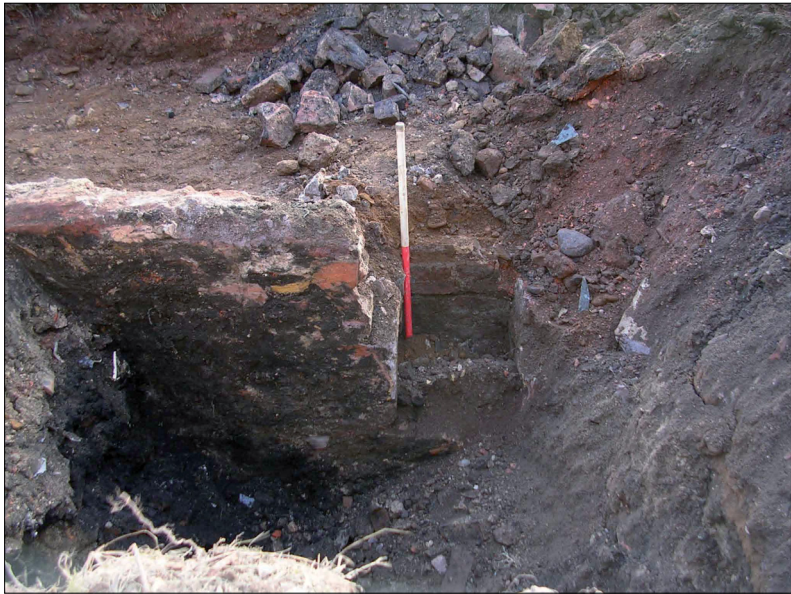
immediately to the north. The material infilling the gap between the walls (**406**) was a mixture of stone, brick, tile, ceramic and glass fragments. This material was excavated to a depth of 1.4m at which point it was stopped due to the unstable nature of the fill and a lack of manoeuvring space which prevented the safe continuation of the excavation. A brick cavity was identified in the southern wall (Plate 5). The structure was 1.7m wide and a 4m length was exposed in the trench.

- 4.2 The structural remains in Trenches 2 and 4 most likely represent what is left of a range of building shown on the 1830 estate map of the site. The structural remains in Trench 4 are likely to be what survives of a sawpit which is shown inside one of these buildings.

Plate 5 - Trench 4, saw-pit. Brick cavity visible.

- 4.5 Based on the results of the evaluation, CFA recommend that the remains of the buildings identified along the northern side of the site are stripped and mapped and the fills of the sawpit are mechanically excavated to allow the saw pit to be properly planned and the elevations recorded. However, the final decision on any further mitigation measures lies with David Connolly, Archaeological officer for Midlothian Council.

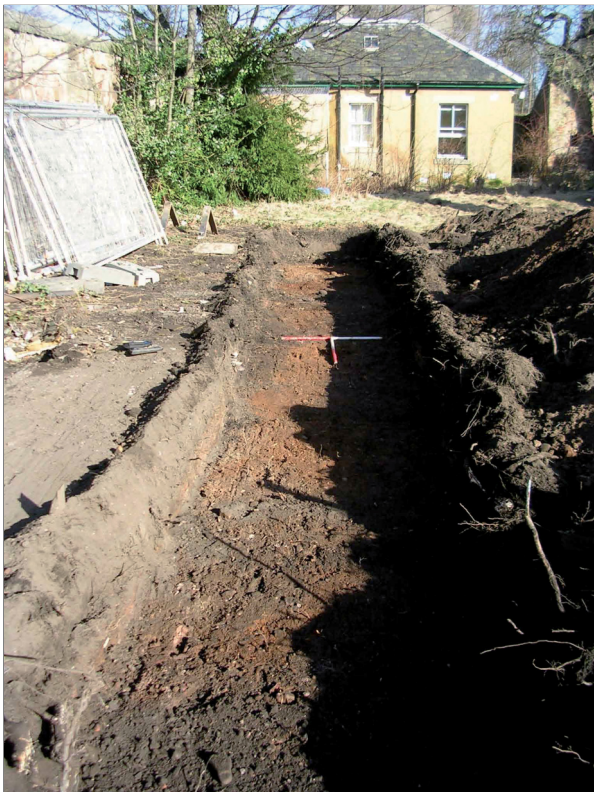
- 3.1.9 Trench 5 was positioned to evaluate an area parallel to the NW boundary wall, which contained numerous filled windows and doorways, indicating the past presence of tenement buildings. A surface deposit of dark brown topsoil (**500**) 0.3m deep was removed to reveal a demolition layer 0.1m thick (**501**). Directly under (**501**) was undisturbed natural subsoil (**502**), in order to confirm that this was natural it was excavated to a depth of 0.9m.

Plate 6 - Trench 5, general view north.

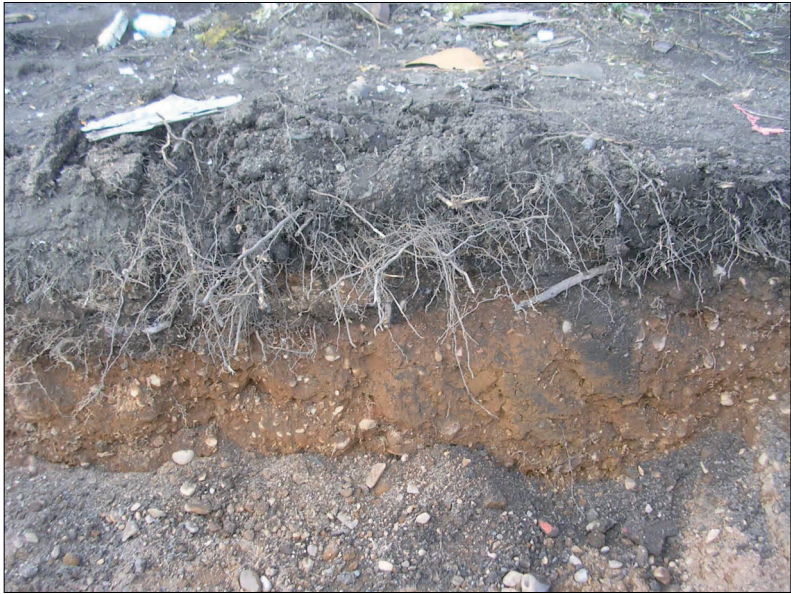
Plate 7 - Trench 5, west section

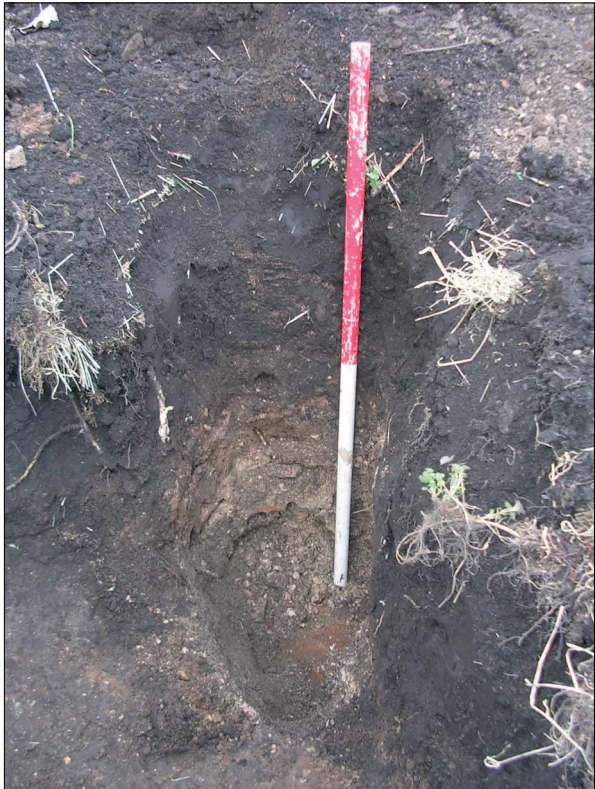
- 3.1.12 Black topsoil containing modern material (**TP300** directly overlay natural undisturbed subsoil (**TP301**). The corner of a small pit was uncovered at the northern edge of the test pit (Plate 9); this was filled with a deep deposit of ground mortar (**TP302**) and two iron bolts were found within the fill.

Plate 9 - Section of test-pit 3

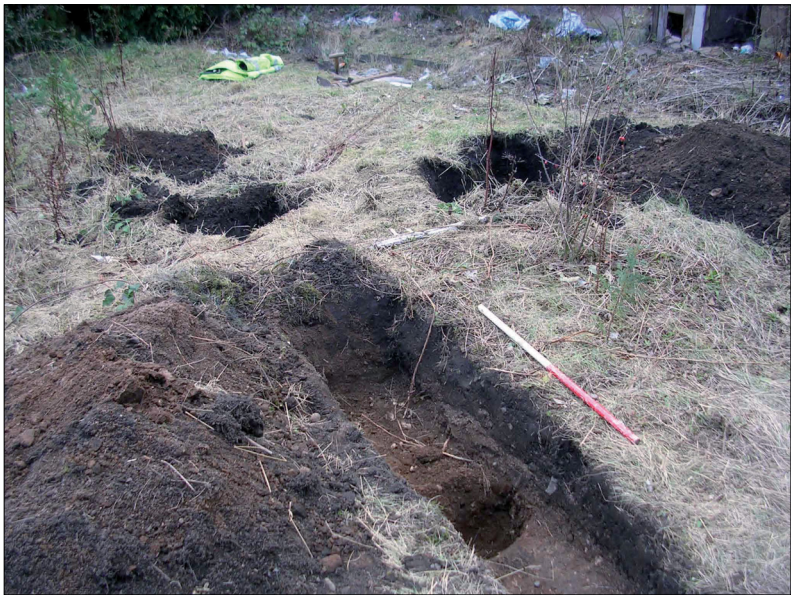
- 3.1.1 Five trial trenches totalling just over 5% of the development area were excavated (Fig. 1). Context numbers are in bold and parentheses and a full list provided in Appendix 1. Three hand dug test pits (Plate 8) were also dug to investigate an area that map evidence suggests was once occupied by a brick kiln.

- 4.3 The three hand dug test pits revealed no evidence of structural remains relating to the kiln which occupied the area to the east of building 8. However, a small pit of relatively modern date was uncovered in test pit 3.

Plate 8 - Kiln test-pits, general view, north-east
