**1-3 Musselburgh Road
Dalkeith
Midlothian**

Archaeological Works

Report No. 1476

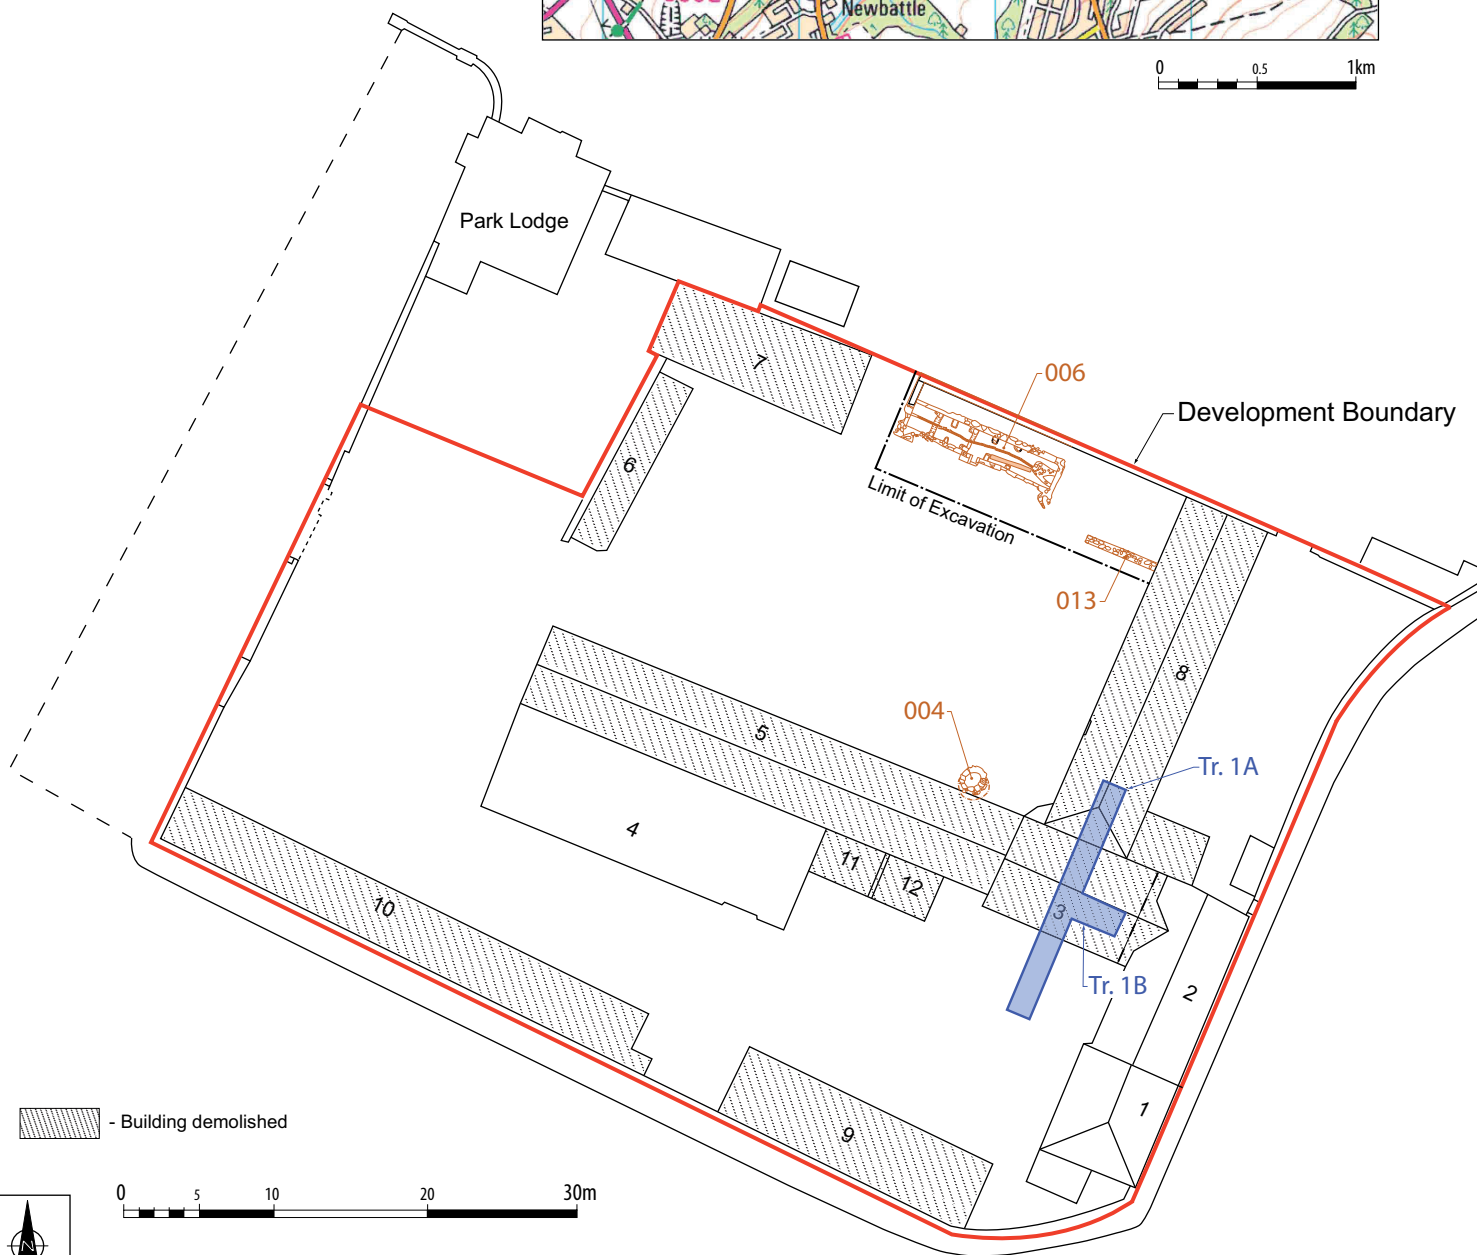
Site Location Map

- 3.4.1 Two trenches (1A and 1B) (Fig.1) were excavated in a T-shape across the footprint of Building 3, extending c.4m beyond the footprint on either side. Trench 1A measured 15m by 1.5m and Trench 1B measured 4m by 1.5m. The deposits from the trenches consisted of 0.5m – 0.9m of made ground overlying orange brown natural sand, with the deeper deposits being located towards the south western end of Trench 1A. The depths of the deposits identified tie in with those from the evaluation and indicate that a considerable amount of made ground has been deposited within the south western part of the proposed development area in order to level out the site. There were no features or deposits of archaeological significance identified in either of the trenches.
