CFA ARCHAEOLOGY LTD

March 2008

**1-3 Musselburgh Road,
Dalkeith
Standing Building Recording**

Report No. 1440

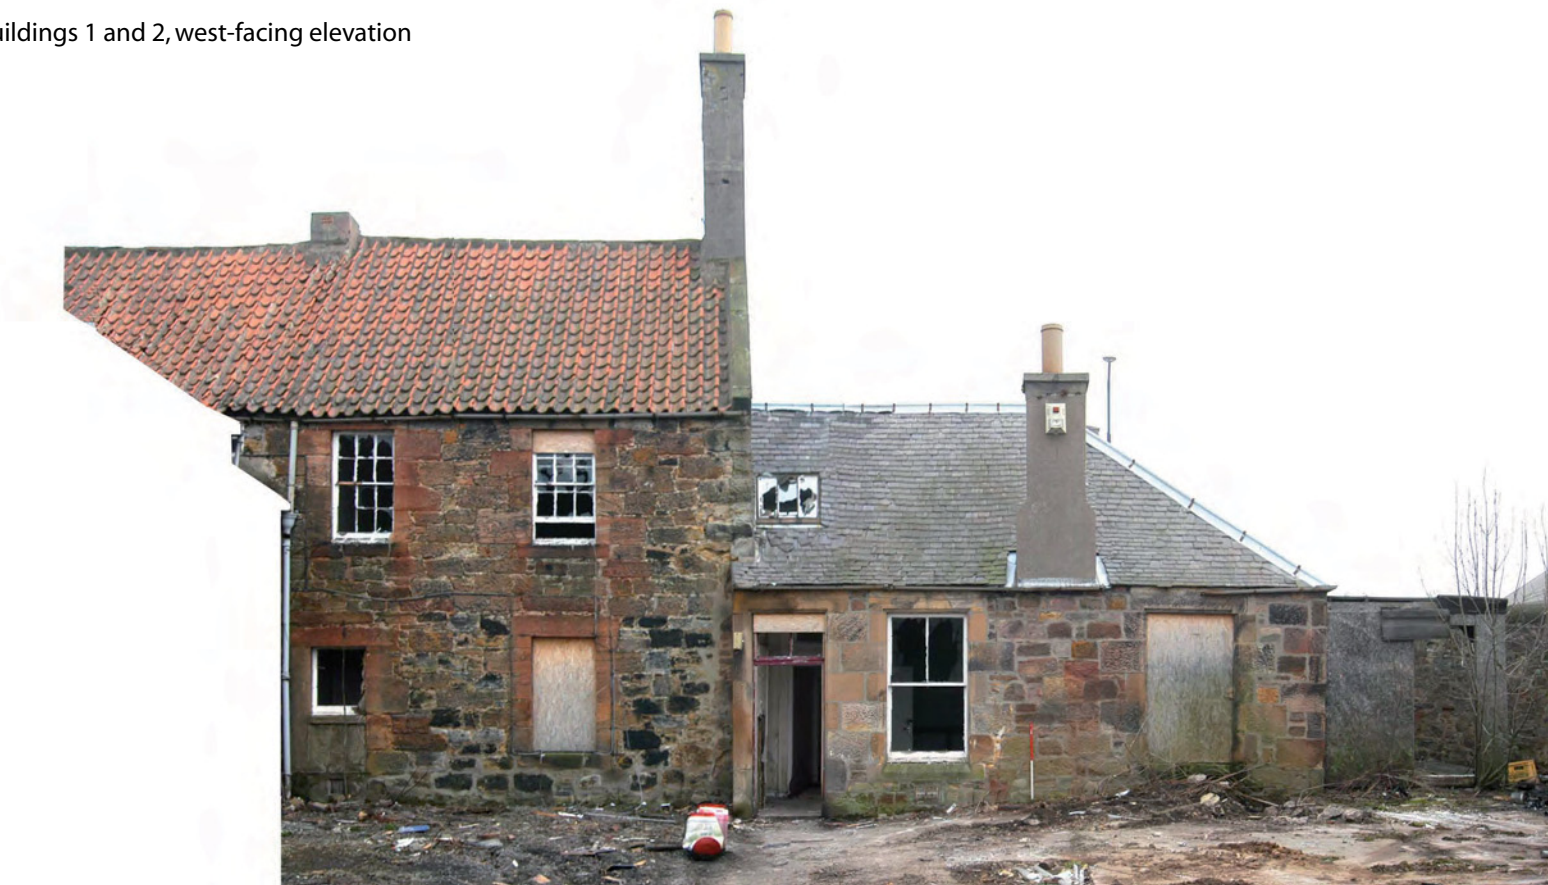
Figure 5a - Buildings 1 and 2, west-facing elevation

Figure 5b - Buildings 1 and 2, west-facing elevation

- 4.2.1 Building 1 is a single-storey rectangular annex measuring 7.8m by 6.4m, situated on the south side of Building 2. There was a building in this position in 1853, but by 1893 it had been enlarged or replaced and attached to Building 2. The structure is built of coursed sandstone (1/1) and fine dressed ashlar sandstone quoins with narrow droving (1/5). The roof (1/7) is pined at the south end and covered with blue-grey slate.

- 4.2.3 The west-facing elevation is outshot from the main elevation of Building 2 by c. 0.53m. Two windows (1/3 and 1/4) have droved surrounds (1/2) and are situated to the south of the main entrance (1/9). A shouldered chimney stack (1/6) with a single ceramic chimney pot is present. The slate roof has a single skylight (1/8). Worthy of note is the quality of the stone that has been used, together with the finish on the ashlar quoins, which contrasts with the cruder work of Building 2.

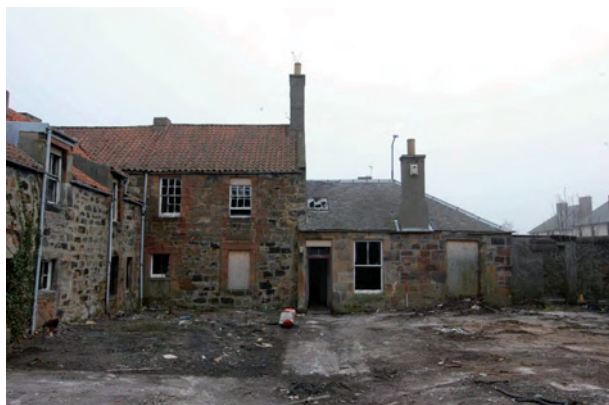
Plate 1 - Buildings 1-3 from the west

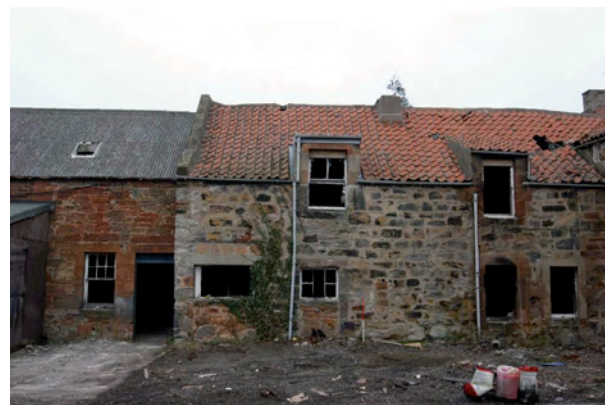
Plate 2 - South-facing elevation of Building 3

- 4.4.1 Building 3 is a one-and-a-half storey building with two dormer windows on its south-facing elevation. The building has been severely damaged by fire and there was no internal access to the floor above as the staircase has been destroyed. The south-facing elevation contains architectural elements associated with interior Units 9 and 11.

- 4.4.3 On the first floor there are two dormer windows (3/11 and 3/12). The westernmost dormer has been rebuilt, probably in the 20th century using ashlar sandstone. During its refurbishment its pantiled roof was replaced by a flat felt roof. Originally it would have been the same as the dormer to the right, which is complete with its cat-slide pantile roof. The rain-goods are cast-iron. The roof is covered with pan tiles (3/13) and the skew at the west end is raised (3/14). A central chimney stack (3/15) has been reduced to ridge level.

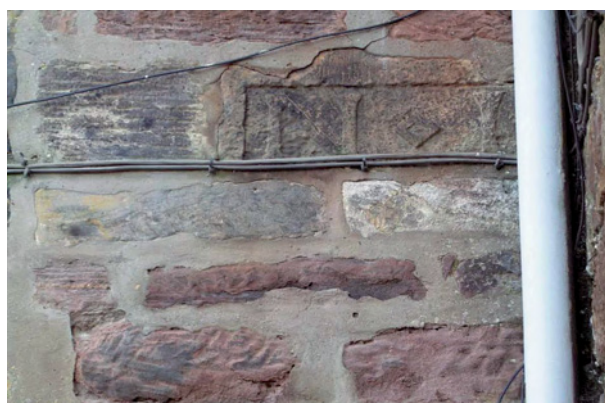
Plate 3 - 17th Century name plaque on south-facing Building 3
