CFA ARCHAEOLOGY LTD

Glenmuckloch OCCS Extension: Archeological Field Survey and Standing Building Recording

Report No. 1587

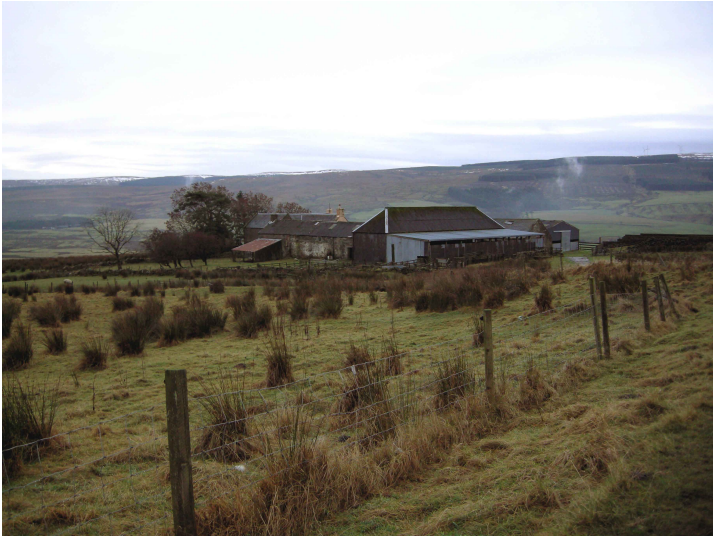
- 3.2.1 Samsiston Farm (1) consists of a recently abandoned farmhouse and steading of early 19th-century date. The farmhouse is a two-storey building constructed from dressed stone and sits at the southern end of a cobbled courtyard. Surrounding the other three sides of the courtyard are the steading buildings, which include barns, byres and stables. These are also of dressed stone construction. All the structures are still roofed and are generally in good condition. This complex of buildings is depicted on the First Edition Ordnance Survey map (1860), where it is annotated Crichtonstown.

Fig 4a - General view of Samsiston Farm, taken from the north-west

- 6.3 CFA understands that Samsiston Farm will not be demolished when the present surface coal mine is extended. The site will be cordoned-off.
- 6.4 The Chrichton's Burn structures (Site 2) lie between a new and old fence overlooking the Chrichton's Burn and are outside the Phase 7 workings. A buffer-zone will be established around the sites to protect the site from the proposed open cast works.

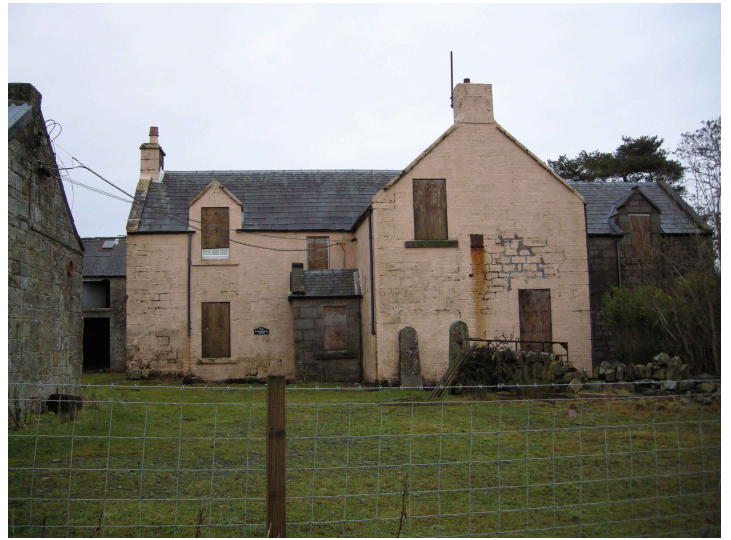
Fig 4b - Samsiston Farm House (Site 1), west-facing elevation

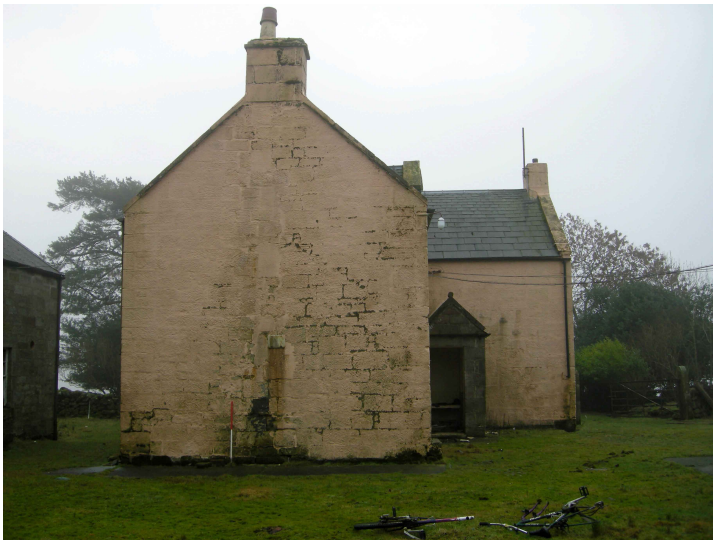
Fig 4c - Samsiston Farm House (Site 1), south-facing elevation

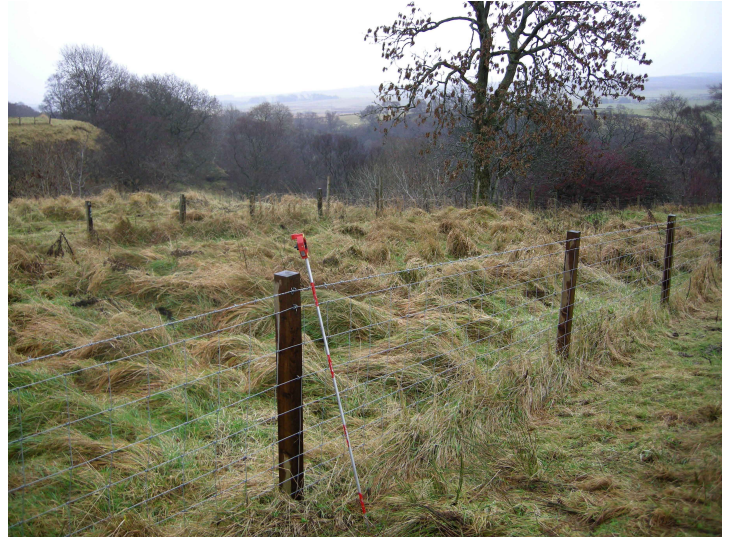
5.2.2. This building is the best preserved and is orientated north-south. Measuring 10m in length and 4m wide internally, it has walls c.1m thick that are upstanding to a height of c.0.5m. A small entrance is present on its west side.

Fig 4d - Chriton's Burn, Building A (Site 2), taken from the northwest

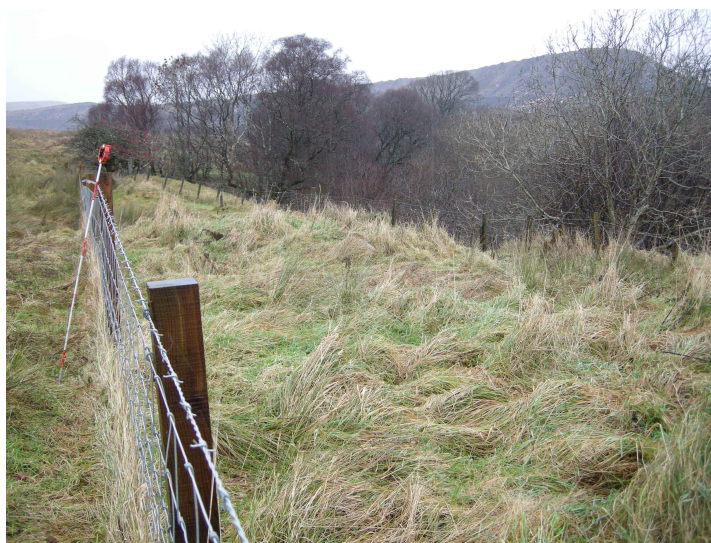
5.2.3 Building B is less well defined but it measures ca 8m north-south by 4m wide.

Fig 4e - Chriton's Burn, Building B (Site 2), taken from the southeast
