Author	Phil Moore BA
Illustrator	Leanne Whitelaw BSc MAAIS
Editor	Melanie Johnson MA PhD FSA Scot MIfA
Commissioned by	Argus Construction Ltd
Date issued	January 2009
Version	0
OASIS Reference	cfaarcha1-54263
Planning Application No	05/0394/PP & 05/0462/LB
Grid Ref	NS 447 719

**Ailsa Lodge, Erskine Ferry Road,
Bishopton**

**Archaeological Watching Brief
Report No. 1596**

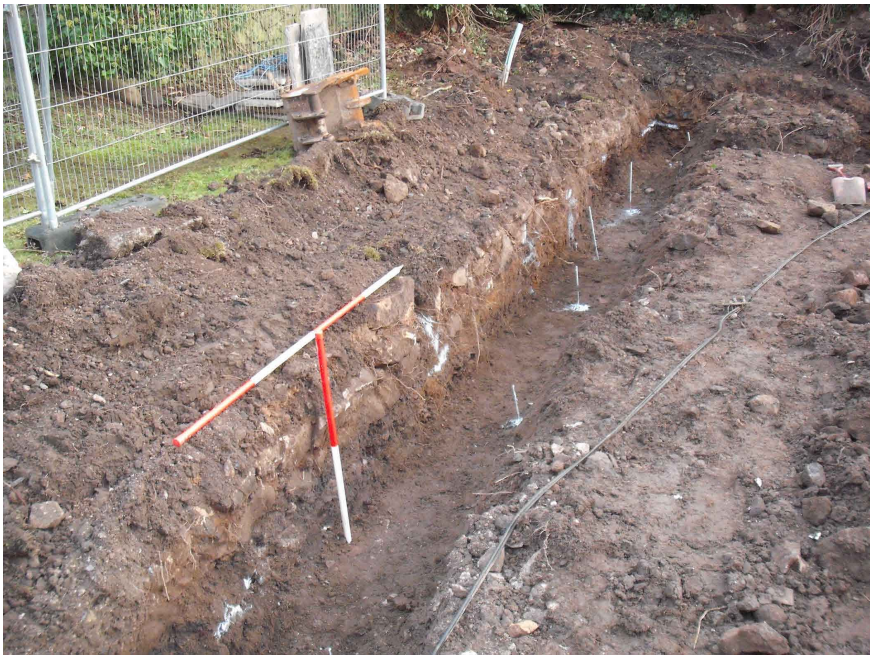
Fig 3 - Oblique shot of probable garden wall foundation (04)

- 3.7 Feature **04** (Fig 2 & 3) was observed as two uneven and irregular courses of sandstone cobbles and boulders constructed in a drystone style. The individual stone size and angularity varied considerably, with the largest example recorded measuring 0.4 by 0.25m. The excavation of **T1** had, in its position, respected the south-facing elevation of **04**, presenting a neat face/elevation of stonework within the trench. The feature measured c. 6.6m east-west and measured on average 0.3m in depth. No dating evidence was recovered.

- 3.8 The preferred interpretation is that this is the remains of a garden wall which probably dates to activity around the manse during the mid-19th century or later. It is worth noting that the surrounding, upstanding walls to the north and east were composed of comparable stonework and constructed in a similar style.

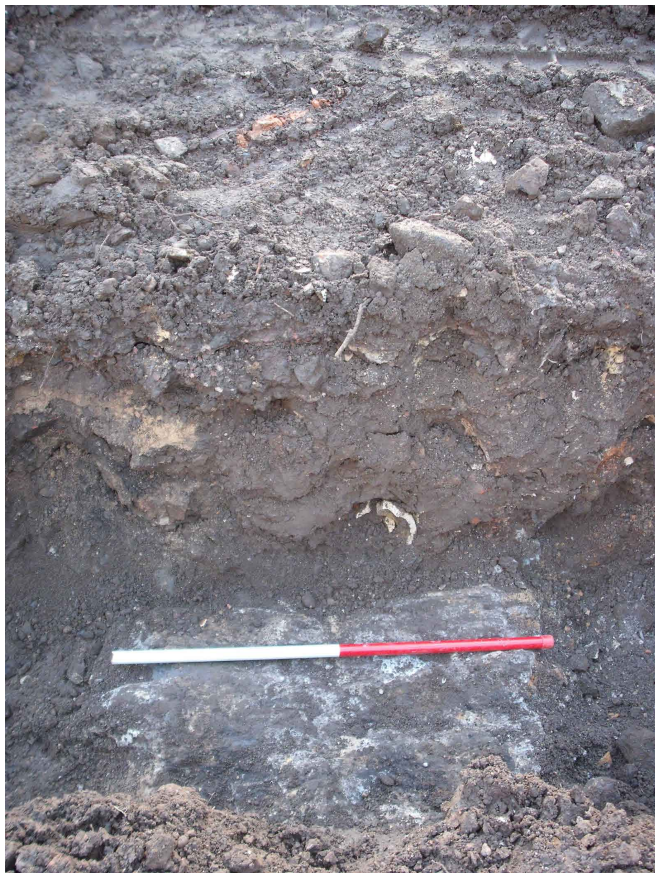
Fig 4 - Sandstone wall foundations below salt-glazed drain (06)

- 3.10 The remains of a masonry foundation structure (**06**), 0.9m wide by >1m north-south, were identified in **T2** (Fig. 4). This masonry consisted of shattered, angular sandstone fragments, bonded by a strong, pinkish grey, coarse mortar with common gravel inclusions. The structure (**06**) was located 0.7m below the present ground surface and survived to a maximum height of 0.3m. Section evidence showed **06** had probably been truncated to its recorded height by the cut for a salt-glazed drainpipe. It is unclear whether this structure was demolished to its recorded height in order to incorporate the drainpipe, or whether the structure had already been partially demolished before the pipe was inserted. A large fragment of ornate sandstone cornice had been reused within the fabric of the masonry; this stone came from the exterior of a grand

building of 17th-19th century date and would have been located immediately below the level of the eaves (Fig. 7).

- 3.11 It is unclear to which period of historical activity these foundations belong or indeed the nature of the structure represented. The position of **06** does not correspond with the present, mid-19th century building footprint. The provenance of the re-used cornice is unknown, and it remains possible that it was imported onto site as building material from another location; however, it does provide a broad terminus post quem for the structure, and it is the preferred interpretation that this structure belongs to the earliest phases of construction of the former manse, broadly dating the structure to the mid-19th century or slightly earlier.

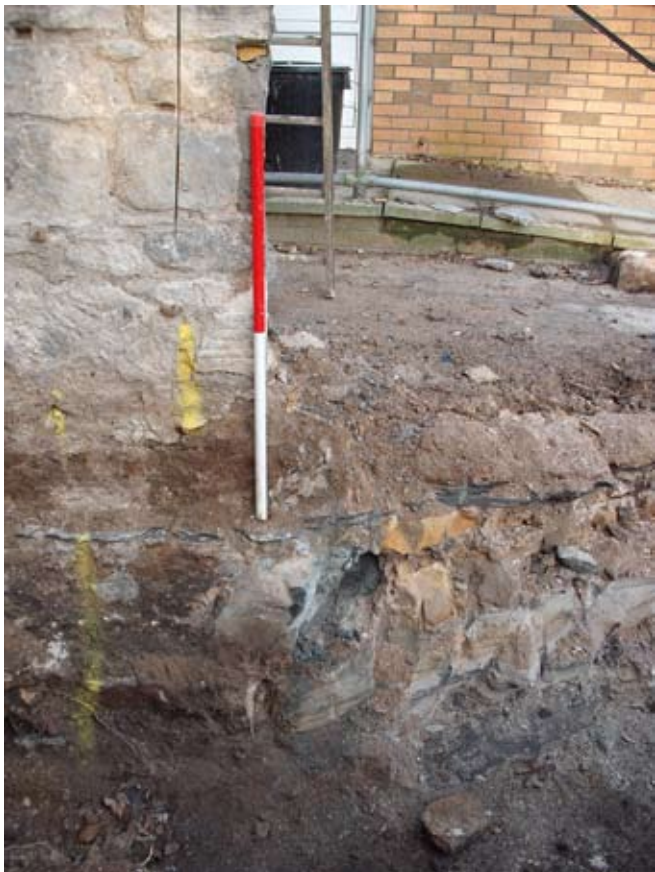
Fig 5 - Shot of fragmented sandstone foundations of demolished eastern annexe

- 3.9 Towards the western end of **T1**, the remains of the fragmented and shattered sandstone foundations (**05**) (Fig 2 & 5) which supported the recently demolished eastern annexe were observed. These remains continued east-west and beyond the excavated depth of 0.8m, which was the limit of excavation in this area. Foundation **05** was also visible in the north-facing section of **T1**, which coincided, as expected, with the former building's east-facing gable. In short, masonry foundation **05** correlates precisely with the footprint of the annexe, prior to its recent alteration and demolition, and is therefore broadly dated to the mid-19th century or later.

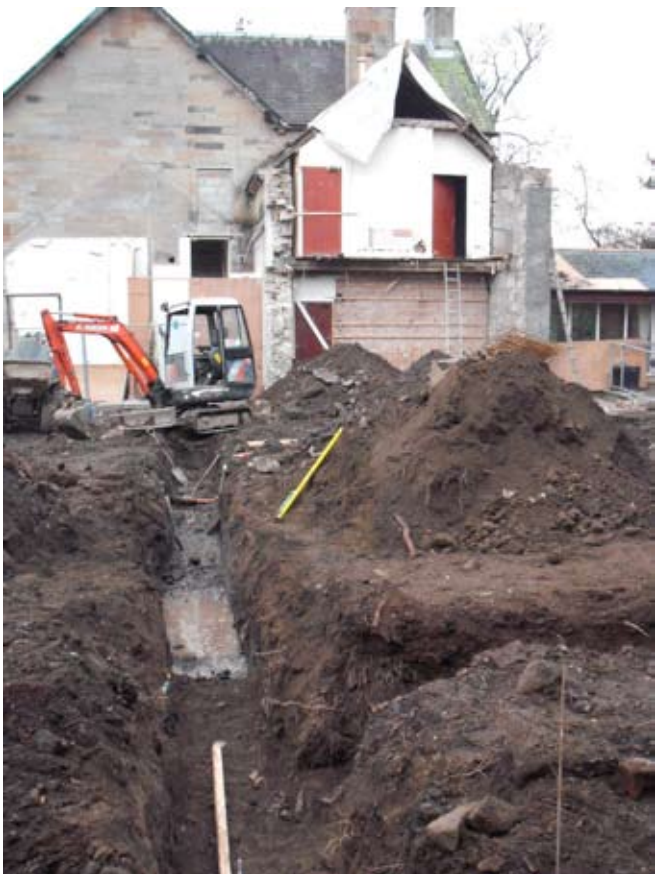
Fig 6 - General shot of site and trench 2

- 1.2.2 Prior to the commencement of work, the proposed development area comprised two annexes constructed in sandstone block-work with pitched slate roofs, which were attached to the east-facing gable end of the main building. The remainder of the proposed development area was grassed and landscaped. To the south, the site was bordered by a car park which immediately fronts onto the B815. To the east, Ailsa Lodge was enclosed by high garden walls, which bound a lawn to the north and east. Immediately to the west were the upstanding buildings that comprise Ailsa Lodge (Fig. 2). Prior to groundworks commencing the eastern annexe was demolished to ground level (Fig. 6)
