September 2008

**Hollies Barn, Cargo, Near Carlisle
Standing Building Survey**

Report No. 1543

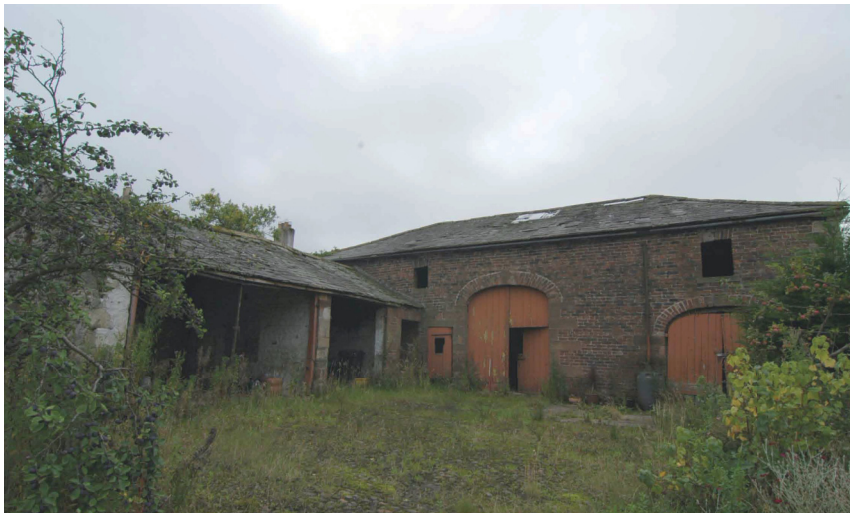
Plate 1 - General view of the east-facing elevation of the barn

The east-facing elevation is 15.3m long and 6.5m high and constructed of red-brick (033) in English garden bond with four stretchers and a single row of headers. Red and cream sandstone quoins (005) are present at the western end. The roof is slate (002) with semi-circular ridge tiles (001). Two glass and Perspex skylights are present (022 and 023). The rain goods are cast-iron (054). At ground floor level there are two arched openings. The larger of the two occupies the centre of the elevation and has a three-pointed segmented arch with brick voussoirs (030) and ashlar sandstone surrounds (031). A double-leafed, plank-built door (029) is present. The smaller arched opening is also three-pointed with brick (028) and ashlar surrounds (027). A double-leafed plank-built door is present. Between the arched openings at ground floor level there is a stone foundation course (037). On the left-hand side of the largest arched opening there is a plank-built door (032). At the first floor level there are two square-headed window openings (024 and 025). Both have brick surrounds and sandstone sills.

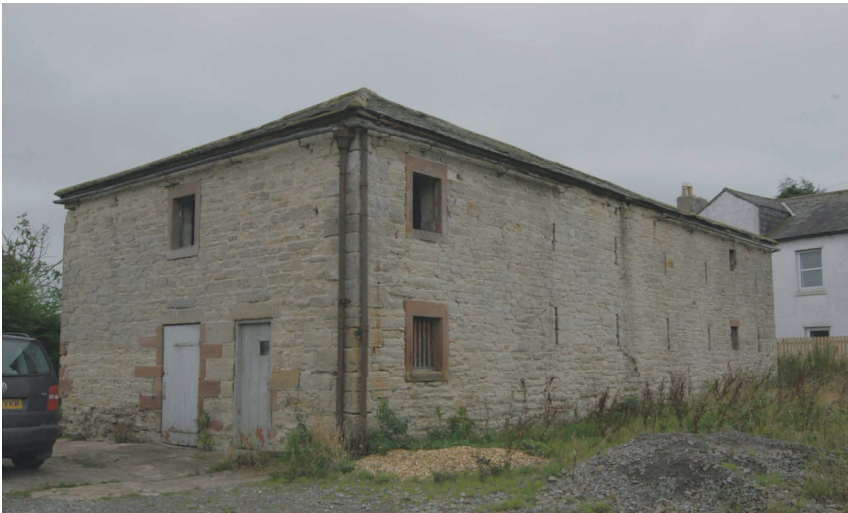
Plate 2 - General view of the west-facing elevation and barn gable

The main build of the northwest-facing gable of the barn is constructed of cream sandstone (006) with ashlar quoins (005). The pined gable roof is slate (002) with tiled ridges (001). The rain goods (003 and 004) are cast-iron. Two plank-built doors (009 and 010) are present on the ground floor divided by ashlar sandstone between them. Each door has ashlar sandstone surrounds (011 and 012).

The west-facing elevation represents the rear of the barn and is constructed of coursed sandstone (043) with ashlar quoins (005). The principal features include ten slit vents (039) and four square-headed windows (038 and 040). A metal fitting (052) is present below the topmost window (040), its function is not clear. At the base of the elevation there is a patch of brick blocking work (042) and a circular aperture (051) that extends through the wall.

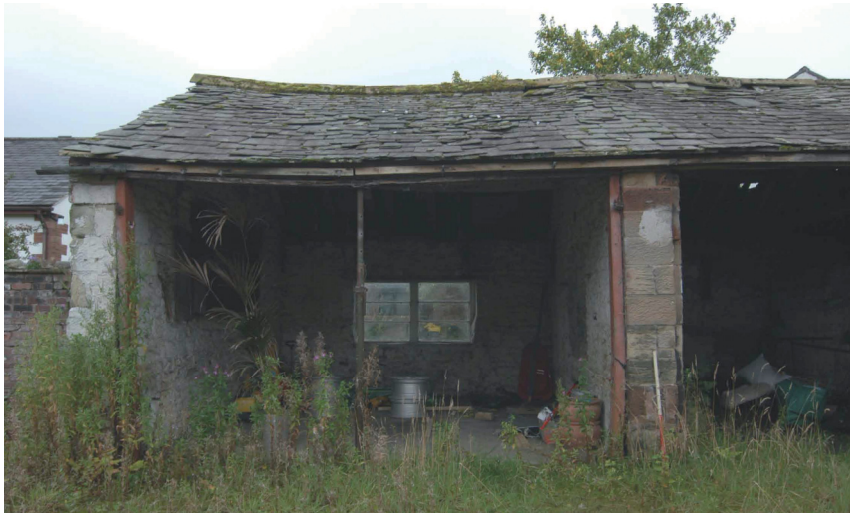
Plate 5 - East range gable and boundary wall

The elevation also includes the gable of the single storey garages on the west range. The gable is built of coursed rubble sandstone (035) with ashlar dressings (016 and 055). The roof is slate (014) with stone ridge tiles (013). A slit vent is present (034) on the right hand side of the elevation. At the centre of the gable is a property boundary wall (036).

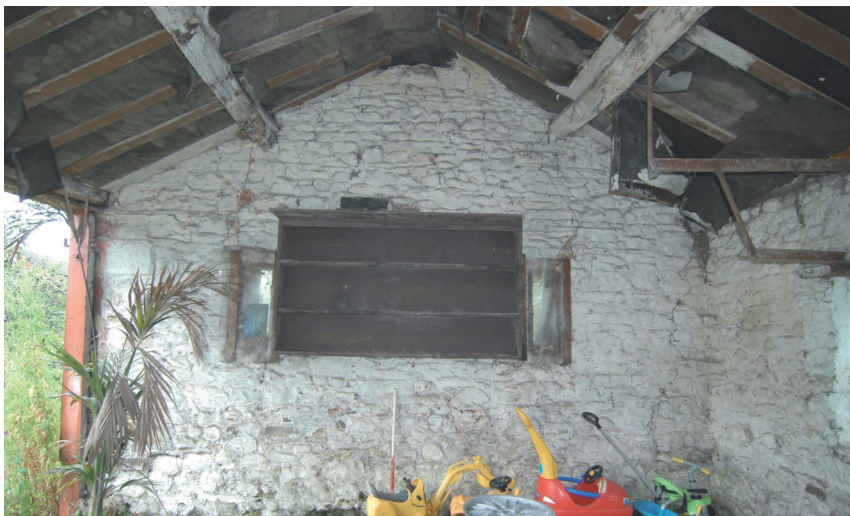
Plate 6 - Interior shot of Unit H

Unit H has a large bay opening and is opposite a large window on the rear wall (047). The presence of slit vents on the east gable wall suggest that it was originally used as an animal house and later used as an implement shed and garage. The roof timbers have been renewed but the main purlins running laterally across the unit appear to be original. These are incorporated into the fabric of the gable. Mortise joints point to the position of

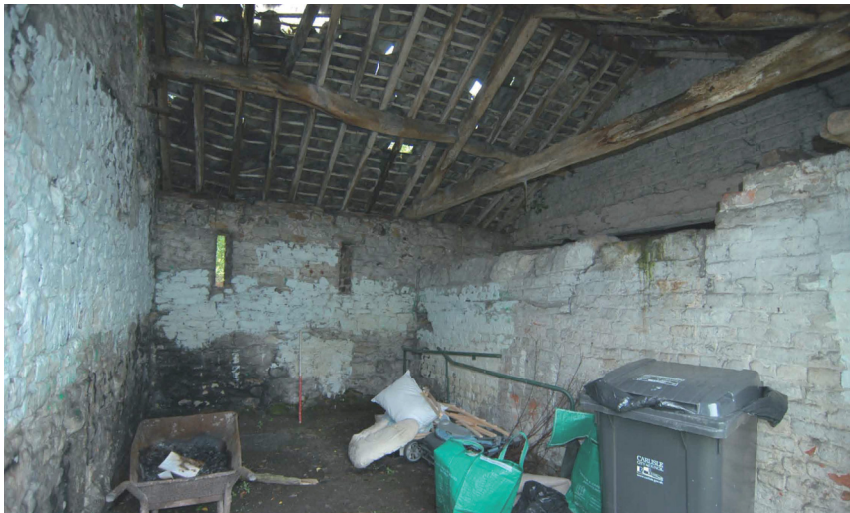
Plate 7 - Interior shot of Unit G

This unit was last used as a garage but the presence of slit vents in the south-facing elevation (Feature 050) suggest that during the 19th and early 20th centuries the unit was used as an animal house. The partition wall between units G and F is very low suggesting that it may either be secondary or reduced in height. The entrance to the garage is on the north facing elevation. The floor is cobbled and hard compacted earth.

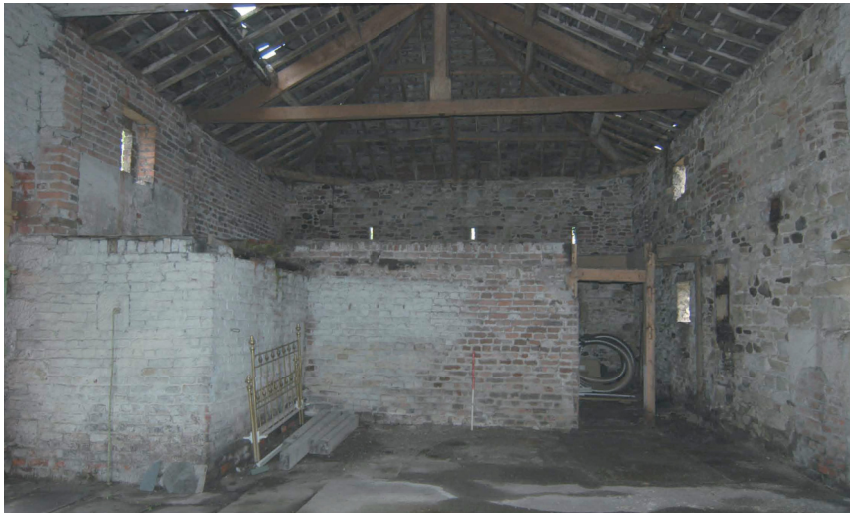
Plate 8 - Interior of the barn looking south

The barn floor is open plan. Unit D is open to the roof. At the north end of the barn a set of brick and stone steps lead up to the loft space. The east facing elevation is mainly whitewashed stone with occasional brickwork visible at the south end. The floor includes flagstones, concrete and mortar and clay. It is likely that flagstones covered the whole of the barn interior.

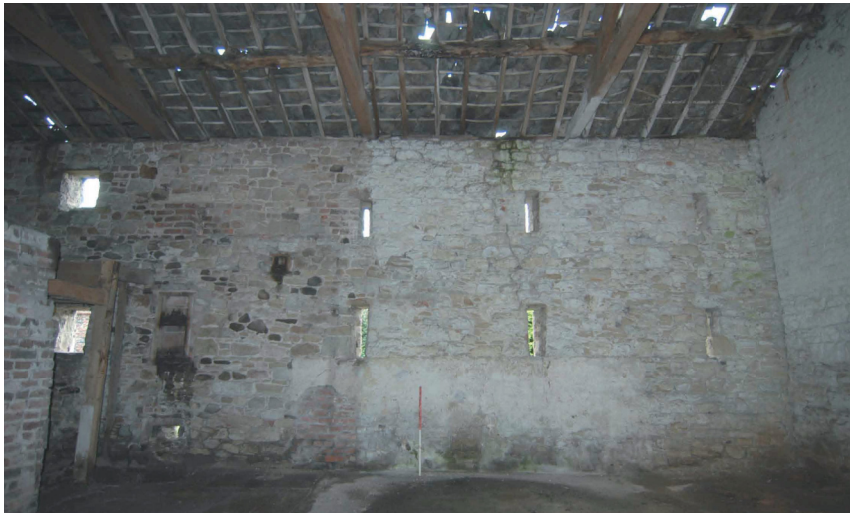
Plate 9 - Interior of the barn looking west

Inserted into the rubble-built west-facing elevation is a wooden frame supporting two bearings for supporting drive-shafts associated with either a threshing device or cattle cake crusher. Below this feature there is an aperture through the wall which may mark the position of an early horse-engine drive shaft. The 1865 First Edition map shows the position of a circular horse-engine house built against the west-facing elevation. No scars from this feature such as roof raggles or sockets are visible on the external elevation.

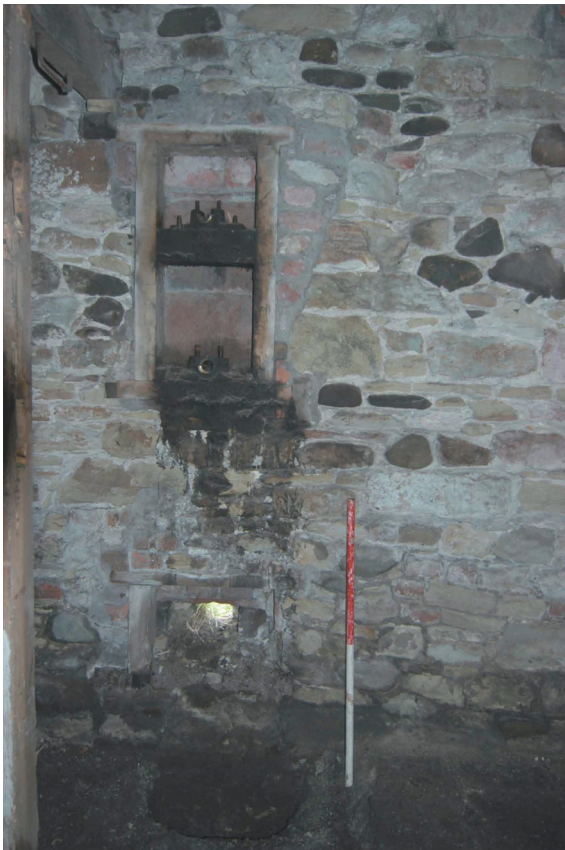
Plate 10 - Oil stained bearing plate inserted in the barn wall

There is evidence of two phases of power-generation for crushing animal feedstuffs (cattle cake which was supplied to farms as hard blocks had to be crushed before it could be used). The first is represented by a hole in the base of the west-facing elevation (Feature 051) and is related to a circular horse engine that is shown only on the 1865 Ordnance Survey map. The horse engine was removed before the survey of the 1901 Ordnance survey map. The second form of power-generation was belt driven shafts that ran through the wall supported on two bearing plates (see Plate 10) housed in a wooden frame and inserted in the barn wall. These are probably early 20th century in date; the primary power source probably being a small diesel engine housed outside the barn.

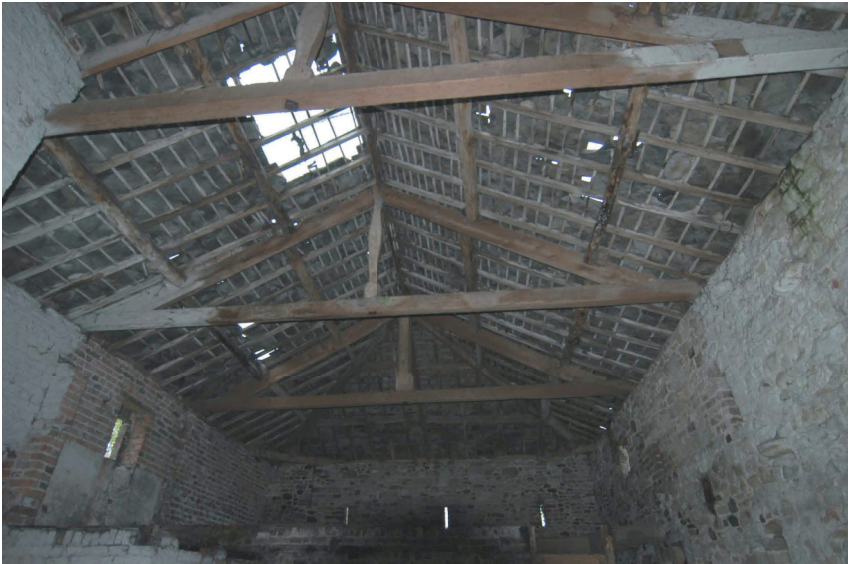
Plate 11 - General view of the A-frame roof structure

The East Range garages (Units G and H) have A-frame trusses with lap-jointed purlins that appear to have been reused from an earlier building. The shape of these timbers is highly irregular suggests that they were once part of a cruck-framed roof. The common rafters supporting the slates are probably later than the main build. The rafters rest directly on the wall head.

The barn roof is supported on A-frame trusses (Fig 3c, Plate 11) that rest directly on the wall head. These are machine-sawn timbers with carved king posts which are tied by iron bolts. The scarfe-jointed trusses support the large through purlins that are formed from large rounded branch wood. The piended roof configuration on each gable wall requires the timbers to be braced at the corners. Here cross-braces straddle the corners and carry the main trusses.

The bolted king-post A-frame trusses are probably late 19th century in date and have replaced an earlier A-frame truss arrangement, elements of which, namely the purlins, were in a suitable condition to be re-used. When the new roof was introduced the brick partition walls were built on existing rubble walls that may not have been carried through to the roof space.
