Longpark Windfarm, Stow, Scottish Borders Archaeological Watching Brief

Report no. 1617

Author	Phil Moore BA
Illustrator	Neil Kinnaird
Editor	Melanie Johnson MA PhD FSA Scot MIFA
Commissioned by	Wind Prospect Ltd
Date issued	March 2009
Version	0
OASIS Reference	cfaarcha1-57814
Planning Application No	
Grid Ref	NT 476 423

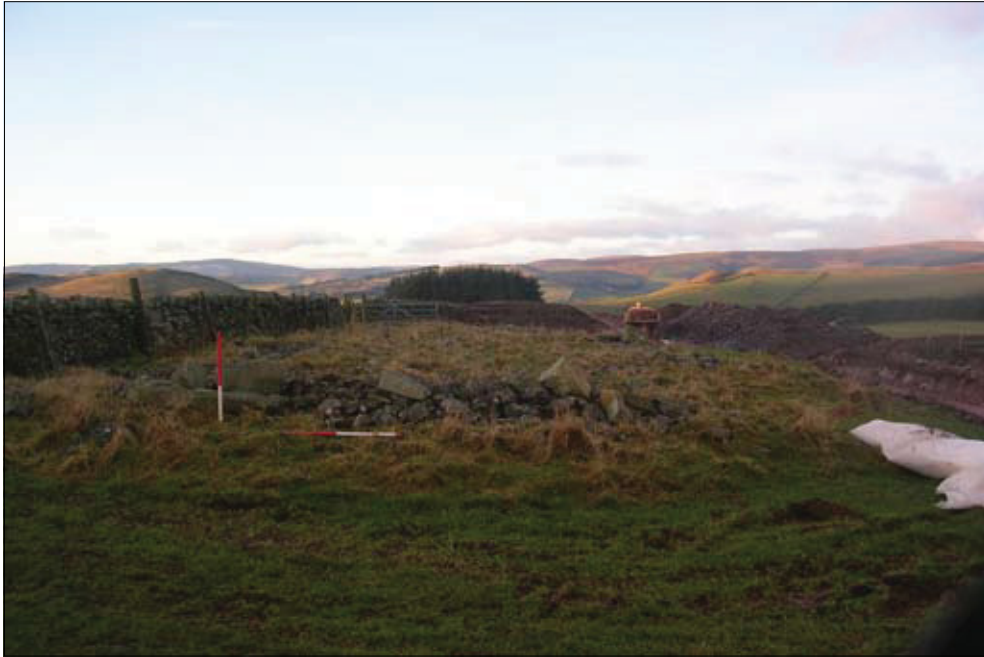
Fig. 2 - Site 29 from the east

- 3.2.1 The environmental impact assessment (ES) identified the remains of a possible building (Site **29**; NGR NT 4761 4203) which was likely to be disturbed by the construction of the access road between **T13** and **T9**.
- 3.2.2 Field reconnaissance had identified Site **29** as the remains of a possible two-compartment rectangular building approximately 17m by 6m ENE-WSW. The possible walls survived to a height of 0.2m and were defined as low turf and stone banks, amidst a concentration of stone clearance (Fig. 2).
- 3.2.3 To mitigate against the possible effects of the construction process within the vicinity of Site **29**, a buffer zone demarcated by temporary fencing was erected around the site. The potential for accidental damage to this site was further lessened by the re-routing of the access track between **T13** and **T9**.

2.3.1 The remains of a building (**29**) were fenced off to prevent any accidental damage. The features, and a suitable buffer around them, were marked out on the ground by CFA archaeologists. The fencing was erected around the marked area by the construction contractor. The fence was erected prior to construction in the vicinity of the site.

- 4.1 A watching brief was carried out during construction works at Longpark Windfarm. No features or deposits of archaeological significance were recorded at any of the watching brief locations.
- 4.2 Site **29** was fenced off and the access track between **T13** and **T9** was re-routed to negate potential impact from windfarm construction.
- 4.3 The locations of Sites **13**, **14**, **15** and **22** were photographed (Appendix 1).
- 4.4 The archive from this element of the project, comprising all CFA record sheets, maps and reports, will be deposited with the NMRS.
- 4.5 An entry in *Discovery and Excavation in Scotland* (Appendix 2) and an online *OASIS Scotland* record will be sufficient to disseminate the results of this work.

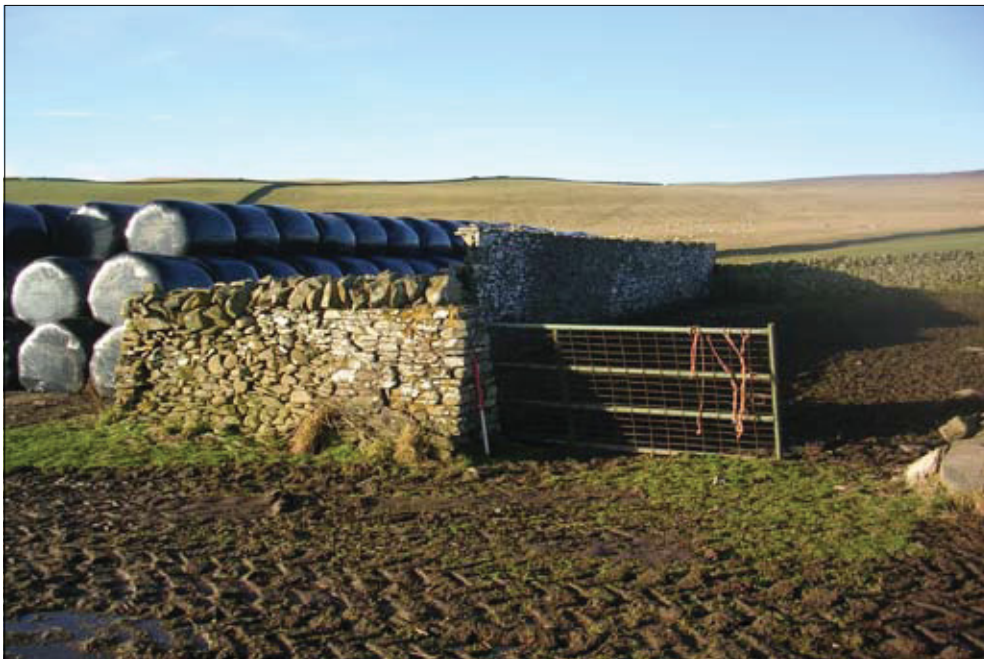
Fig. 3 - Site 15 from the south

- 3.3.2 Site **14**, the remains of a sheepwash, was located at NT 4668 4209. The site was photographed and appeared generally as described in the ES.
- 3.3.3 Site **15**, at NT 4676 4226 (centred), appeared as described and still in use and was photographed (Fig. 3).
