## **Broxburn to Humbie Farm Reinforcement Pipeline (Phase 2), Broxburn, West Lothian**

### **Archaeological Works**

**Report no. 1626**

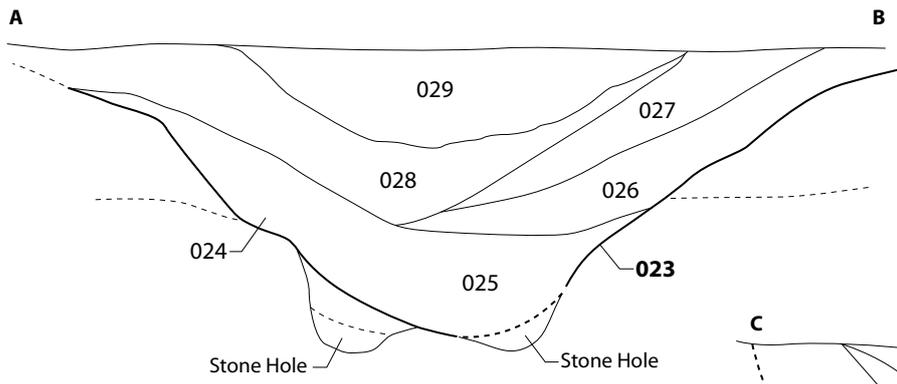
Fig. 2 - Southeast-facing section of ditch 023

- 3.3.7 Ditch **023** (Fig. 2 & 7) was c. 2.1m wide with moderately steep sides tapering to a slightly concave base at a maximum depth of 0.75m. A series of sequential fills were recorded. The primary fill (**024**) comprised sticky/soft, orangey-brown, sterile silty clay. This was in turn covered by mixed bluish-grey and waterlogged re-deposited boulder clay. Large fragments of un-worked, naturally deposited wood were preserved within this deposit and retained, along with a bulk soil sample for further analysis if required.

- 3.3.8 Further sequential deposits indicating a continued silting action of the ditch were also recorded; these were **026**, **027**, & **028**. The deposits were very similar in composition comprising greenish, dark grey clayey silt. Overall, the clarity of horizon of these fills was assessed as moderate, although slight variations in mineral content, such as fragments of coal, shale and crushed sandstone could be distinguished. The natural backfilling process was completed by the deposition of **029**. No material dating evidence was recovered from ditch **023**.

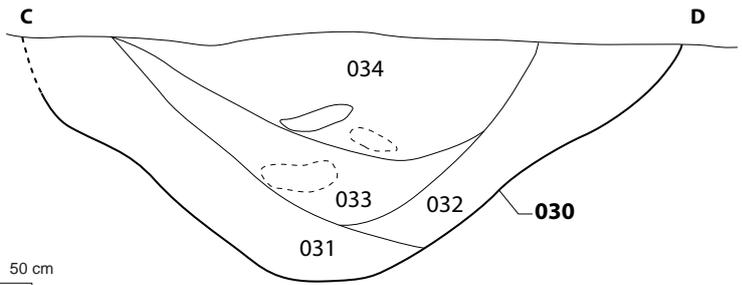
Fig. 3 - Southeast-facing section of ditch 030

- 3.3.9 Ditch **030** (Fig. 3 & 8) measured 1.74m in width and 0.64m in depth with moderately steep sides tapering to a concave base. The horizon clarity was poor-moderate with a mix of mid-brown, greenish-grey soft silty sand forming the primary deposit (**031**). This was overlain by **032**, which was distinguishable from **031** by the presence of iron panning. Deposit **033** was similar in composition to **025** in ditch **023**. This waterlogged deposit also contained fragments of preserved wood. A slump of material which was presumably contemporary with **029** capped the ditch. No material dating evidence was recovered from ditch **030**.

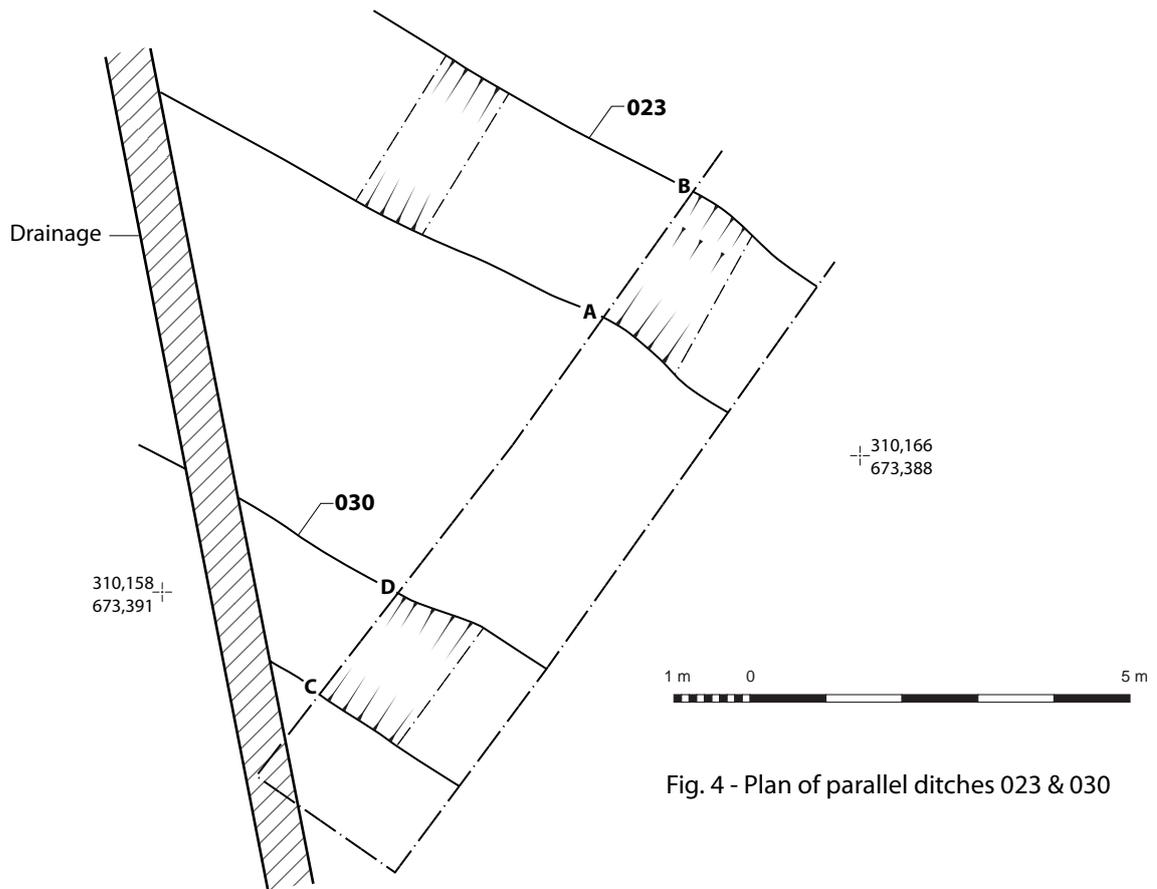
Fig. 4 - Plan of parallel ditches 023 & 030

3.3.6 The remains of two parallel ditches (**023** & **030**) were uncovered and excavated immediately north of RDX9 (Fig. 1b), which is an east-west orientated tree lined avenue that runs from a public highway at West Lodge towards Newliston House. Both ditches were orientated northwest-southeast and were initially seen as a slump of compacted sterile dark grey silt (**029** &

- 3.3.10 The preferred interpretation for ditches **023** and **030**, given the absence of dating evidence, would be an earlier phase of land division such as a field boundary. Both features appear contemporary with each other and display similar characteristics in size, shape and the nature of the infilling deposits. Map regression shows the features pre-date the 1<sup>st</sup> Edition OS map (1856), century, although a linear field boundary is depicted on a plan of Newliston dated c. 1760 (NAS: RHP2150, interrogated as part of the DBA, RSK 2008). The map shows a plan of the parks to the south and east of Newliston with acreages, boundaries and plantations. Subsequent changes to the original layout of the estate are shown in later editions. The parallel ditches enclose a central 4m wide strip of land, which was absent of features, although it is reasonable to suggest the up-cast may have possibly formed a central bank of which no trace could be seen (Fig. 4). The last phase of large scale alteration to the landscaping occurred in 1835 by W.S. Gilpin (Inventory of Historic Gardens and Designed Landscapes) and included work on the east and west avenues. Since this time it is believed no major alterations have been made; however, formal construction of the gardens began in the 1720s (Inventory, *ibid*), and these features are probably mid-eighteenth century in date.

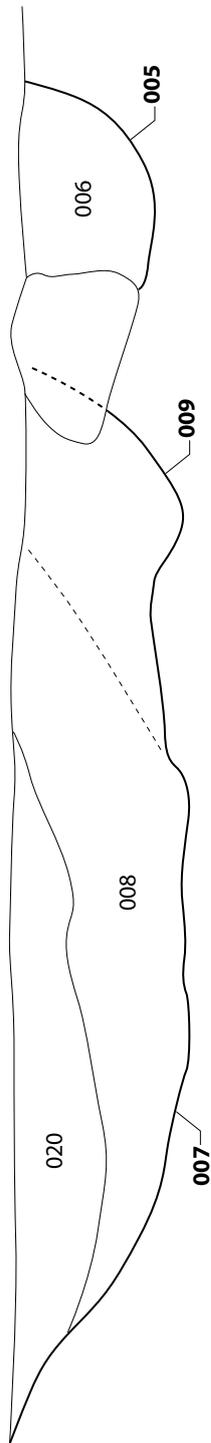
Fig. 5 - East-facing section of cutting pits 007, 009 & 005

3.3.14 A series of intercutting pits (**005**, **007** & **009**) were excavated on level ground near to RDX 10 (NGR: NT 10376 74095). Pits **005** and **007** were cut into a mix of natural sand and gravel to depths of 0.34m and 0.46m respectively. Pit **005** was rapidly backfilled by deposits **008**, **019** & **020**. These deposits were characteristically similar in composition comprising a slightly greenish/dark grey mix of compacted sand and silt with varying degrees of coal and stone inclusions. Pit **005** had a single fill (**006**) which was generally as described above; although it was more friable when disaggregated. The evidence for pit **009** and fill **010** is more circumstantial and is based on slight nuances seen in section and plan (Fig. 5), particularly faint tip lines of re-deposited bands of sand in deposits **008** and **010**. All pits contained 19<sup>th</sup> century pottery and window and bottle glass in their basal deposits, which were retained.

3.3.15 It is the preferred interpretation that pits **005**, **007** & **009** are the product of late post-medieval mineral extraction on a small scale, with similar 18<sup>th</sup> century marl pits having been recorded in cartographic sources from the local area (NAS: RHP2150, interrogated as part of the DBA, RSK 2008)

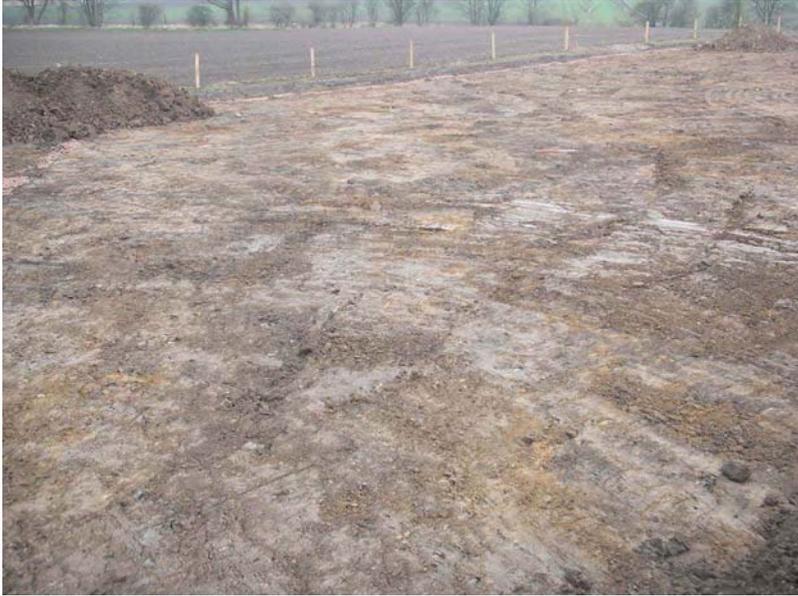
Fig. 6 - General shot of ditches 023 & 030, after topsoil removal section 9

**034**) which continued obliquely across the working width (Fig. 6). An area was cleaned by machine to remove residual deposits of subsoil (**002**), at which point both features became clearly visible.

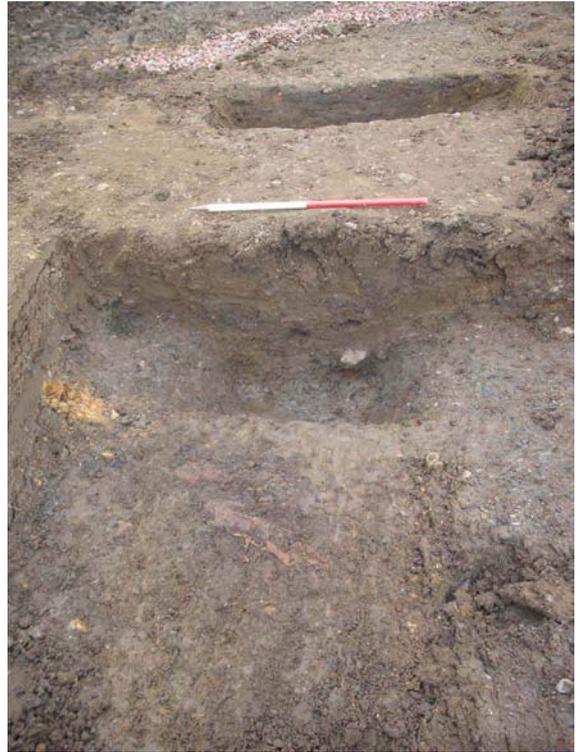
Fig. 7 - Southeast-facing section of ditch 023, section 9

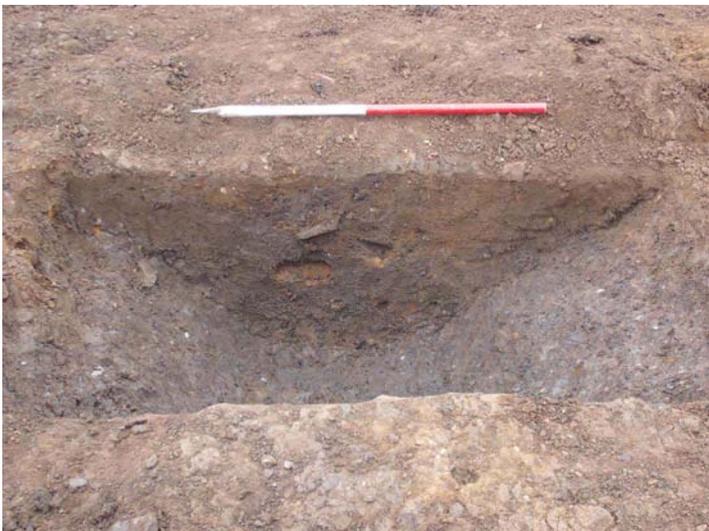
Fig. 8 - Southeast-facing section of ditch 030, section 10

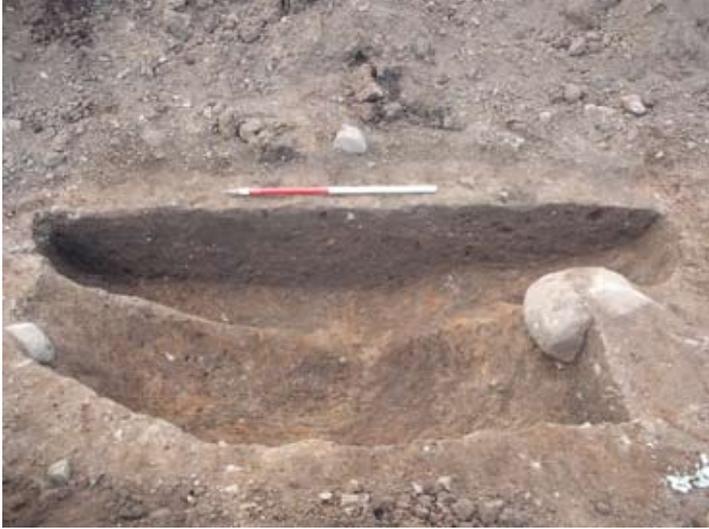
Fig. 10 - General shot of intercutting pits 005, 007 & 009, section 10

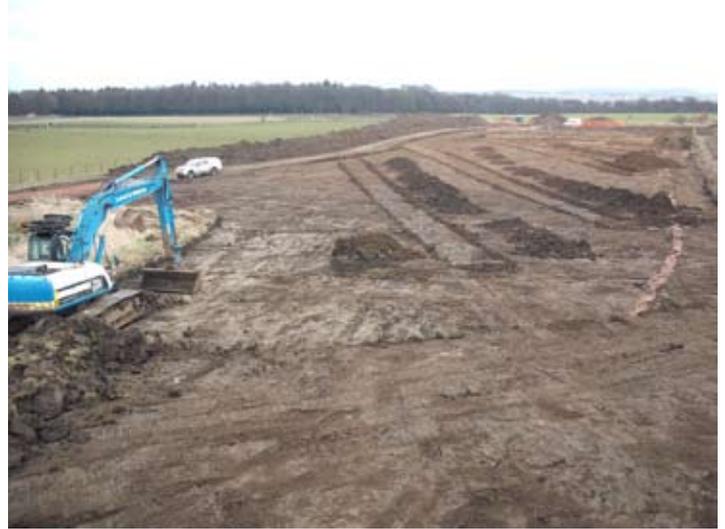
Fig. 11 - General shot of section 10 after monitored subsoil removal

3.3.12 Topsoil and subsoil removal in Section 10 was done under direct archaeological supervision in order to determine if there were any remains associated with RSK DBA Sites 32 and 68. The area of monitored topsoil removal extended from RDX10 northwards, and included all land up to the Niddry Burn (RVX2) (Fig. 1b, 1c). The topography crested and sloped downward towards the Niddry Burn, which resulted in topsoil deposits ranging from 0.20m deep at higher datum to 0.40m deep. As the working width continued toward the Niddry Burn, the depth of subsoil (**002**) increased up to depths of 0.40m below the subsoil. In the close vicinity of the Niddry Burn itself a thin, dark grey layer of sterile colluvium (**003**) was noted with visible plough scars on the surface. A test pit in this area recorded overlying deposits up to 0.95m in depth before natural gravel deposits were reached. Due to the depth of underlying subsoil, a series of strips were cleaned across the working width to the required archaeological horizon (Fig. 11).

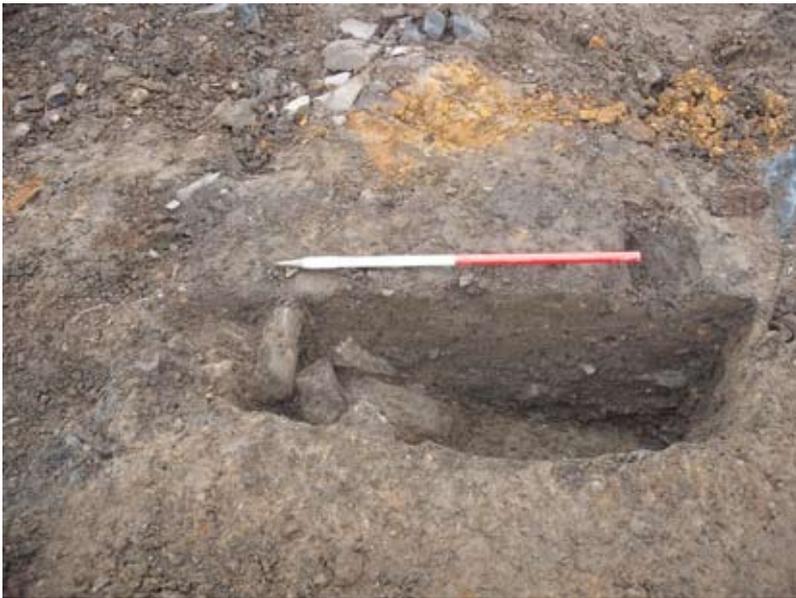
Fig. 12 - Southwest-facing section of pit 021, section 10

- 3.3.16 North of the Niddry Burn, the remains of a steep-sided sub-rectangular pit (**021**) orientated northwest-southeast, >1.8m by 0.98m in width was excavated at NGR: NT 10407 74203. The pit contained a single fill of firm, greenish/dark grey re-deposited boulder clay, with occasional small to large cobble inclusions. Excavation of the fill produced fragments of 19<sup>th</sup> century white porcelain and the feature is interpreted as late post-medieval agricultural activity of unknown purpose.

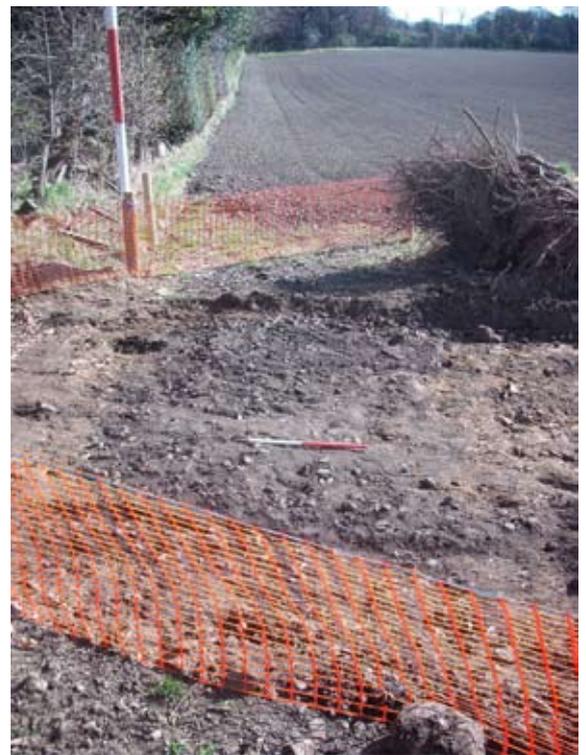
Fig. 13 - General shot of trackway 037, section 8

3.3.3 Trackway **037** was uncovered immediately south of RDX9 (NGR: NT 10149 73296 centred). The feature was seen in plan as an east-west orientated spread of compacted small to medium sized cobbles of mixed angularity within a very shallow depression. Interspersed within these cobbles were very rare inclusions of abraded brick or tile and 19<sup>th</sup> century white porcelain. The surface, which cambered slightly, showed some slight evidence of rutting. The remains measured c. 3m in width, and could be observed running parallel to RDX9 in both directions. This continuation was evidenced by a concentration of cobbles disturbed by ploughing in the adjacent fields (Fig. 13).

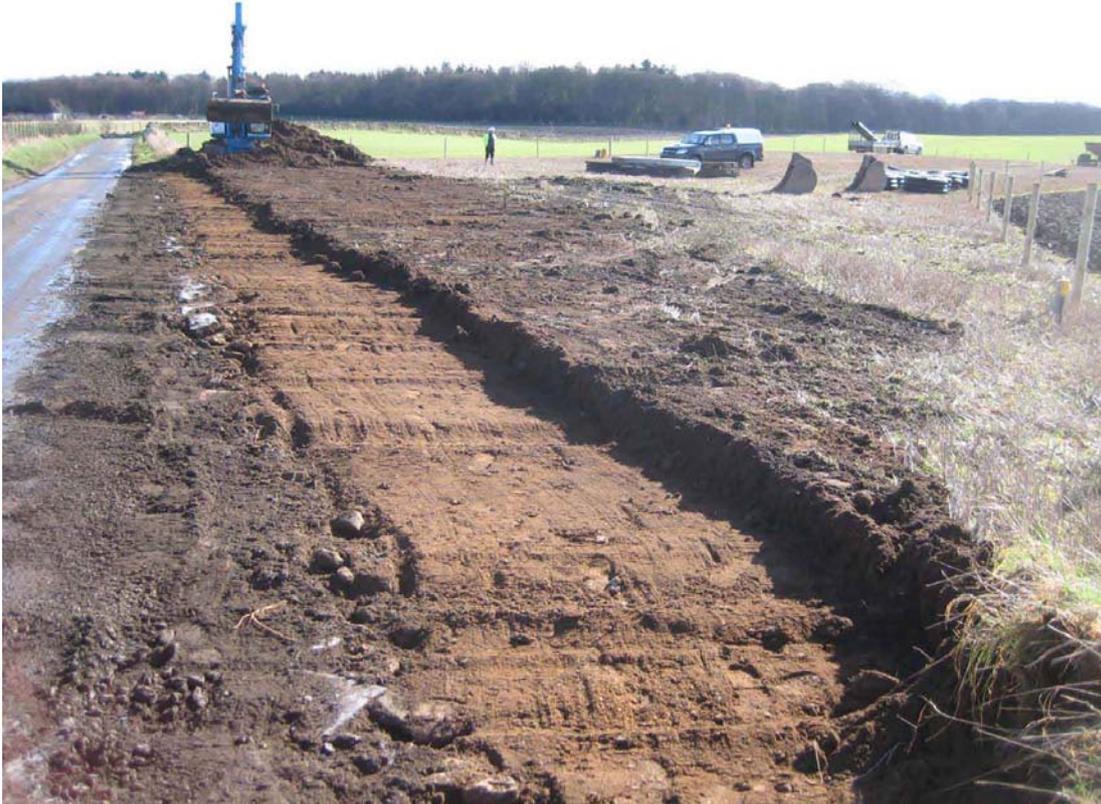
Fig. 14 - General shot of Wall foundation 004, section 9

3.3.11 The foundations of a drystone wall (**004**) measuring 0.7m in width were uncovered for a total of 53m (Fig. 14) during breakthrough at RDX 10. The remains ran parallel to the existing highway, which runs generally in an east-west direction at this point. The foundation comprised large angular to sub-rounded cobbles, the largest example of which measured 0.45m by 0.25m by 0.26m.

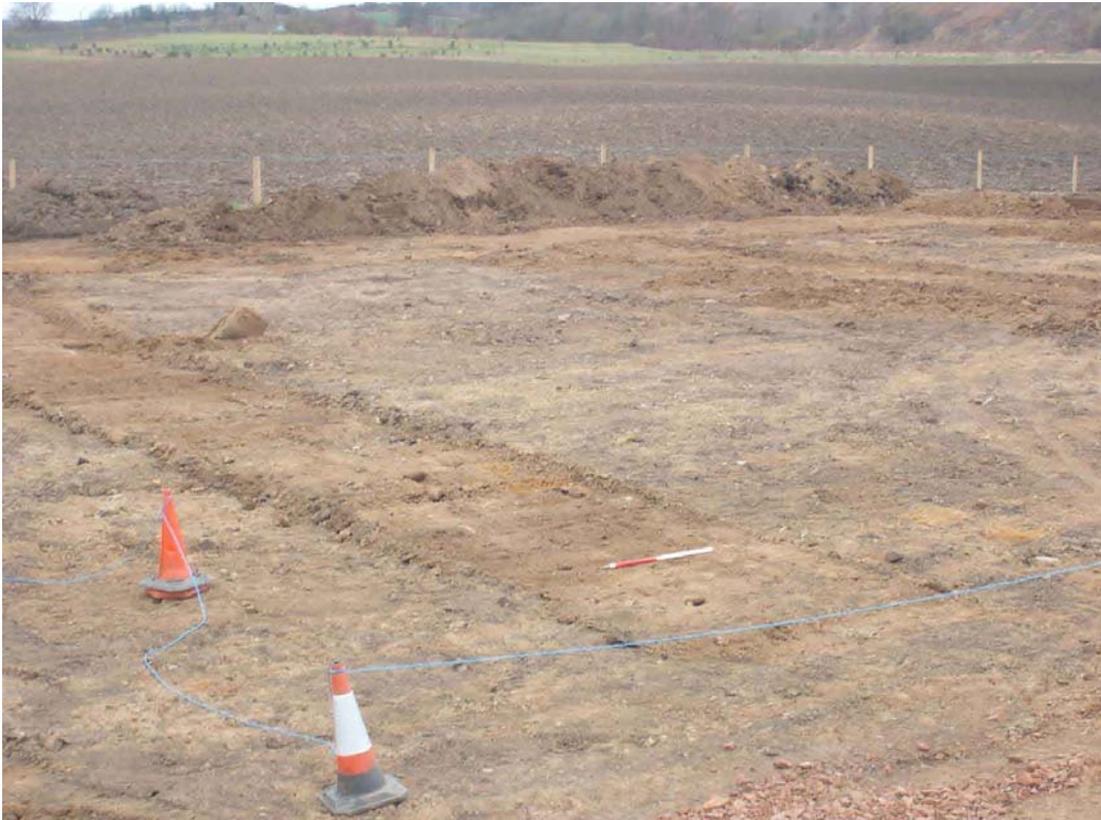
Fig. 15 - Evidence of rig-and-furrow cultivation, section 10

3.3.13 No evidence of 'Hill Law' farmstead (RSK DBA Site 32) was identified. Two lengths of north-south orientated broad rig cultivation (**011** & **013**) were exposed on level ground close to RDX 10. Both furrows measured c. 2 – 2.3m in width and were spaced 9m apart centre to centre. Subsequent agricultural cultivation had truncated both furrows to depths of <0.05m and both features were seen as fragmentary strips of subsoil (**002**) in very shallow linear depressions (Fig. 15).

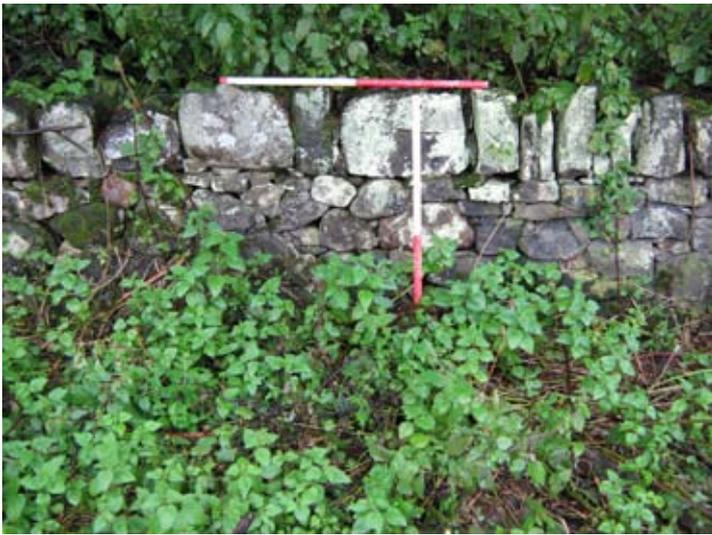
Fig. 16 - Pre-demolition shot of wall FB01

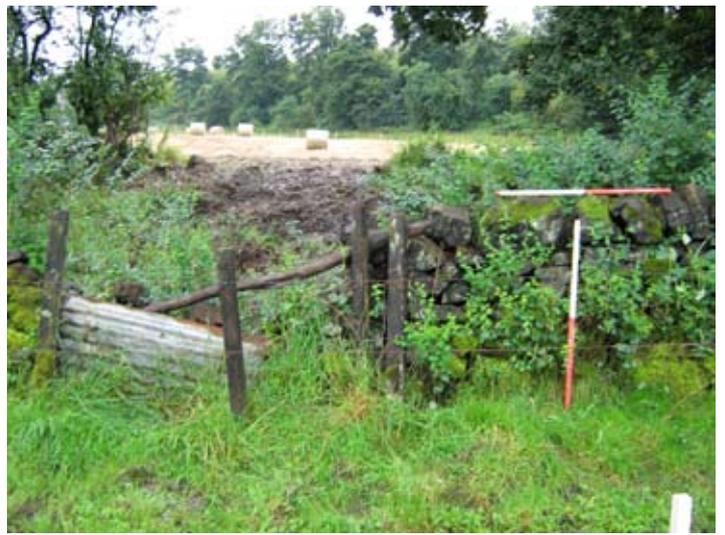
Fig. 17 - Pre-demolition shot of wall FB02

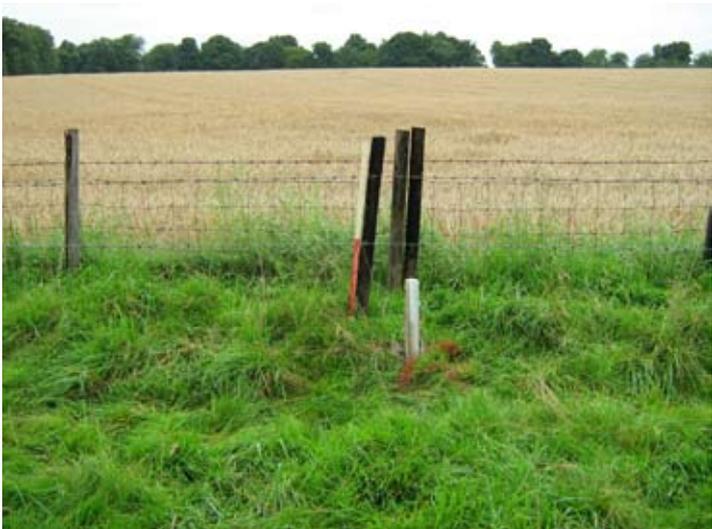
Fig. 18 - Pre-demolition shot of bank/fence FB03

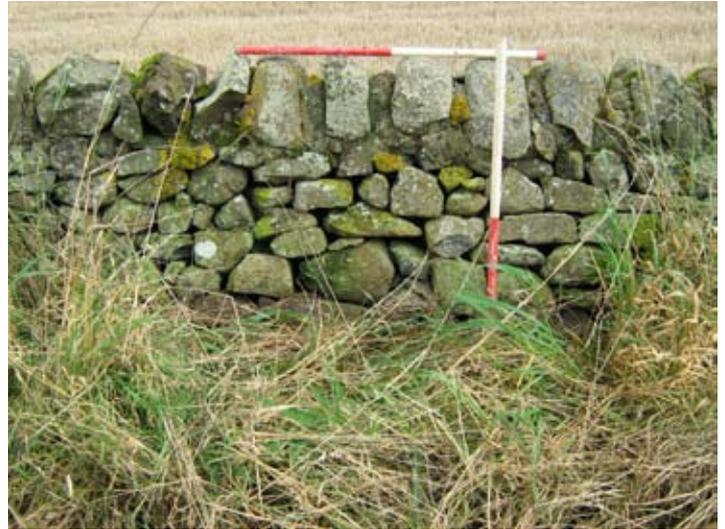
Fig. 19 - Pre-demolition shot of wall FB04

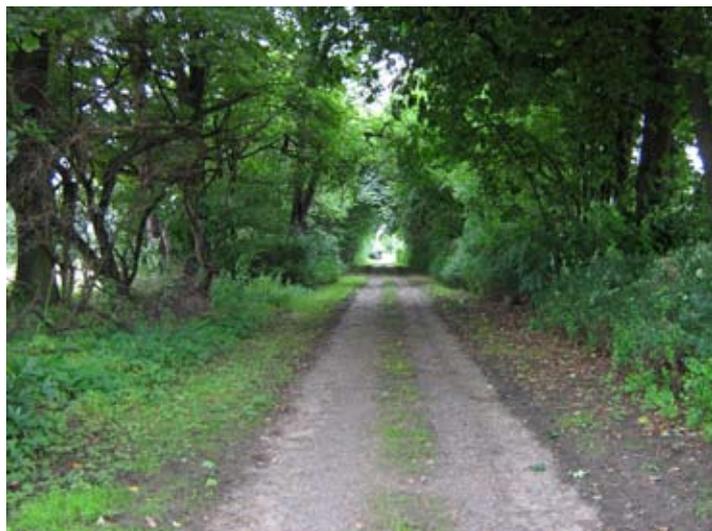
Fig. 20 - General view of avenue FB06/FB07

- 3.2.2 The dismantling of these field boundaries was undertaken during Phase II and observed under watching brief conditions. As an addendum to the Phase I scheme of works, **FB07**, which was interpreted as the possible remains of a fragmentary drystone wall within Section 8, was found to consist of a surface scatter of medium to large sandstone boulders which probably accumulated in this location as a process of field clearance from ploughing activity during the late 19<sup>th</sup> century onward.

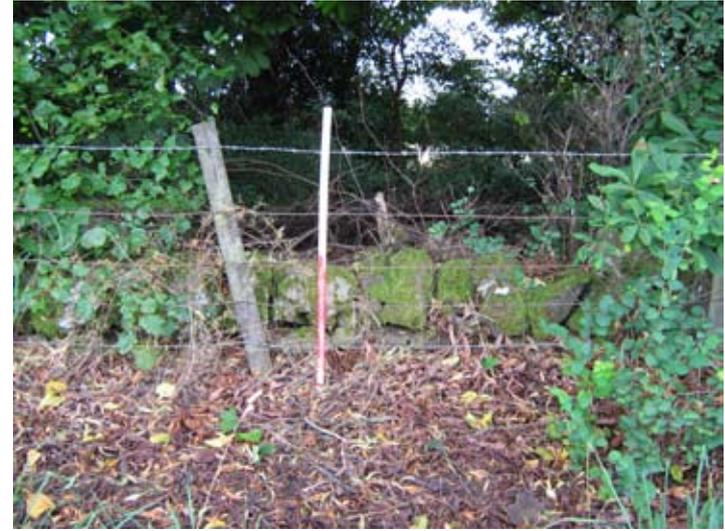
Fig. 21 - Pre-demolition shot of wall FB06

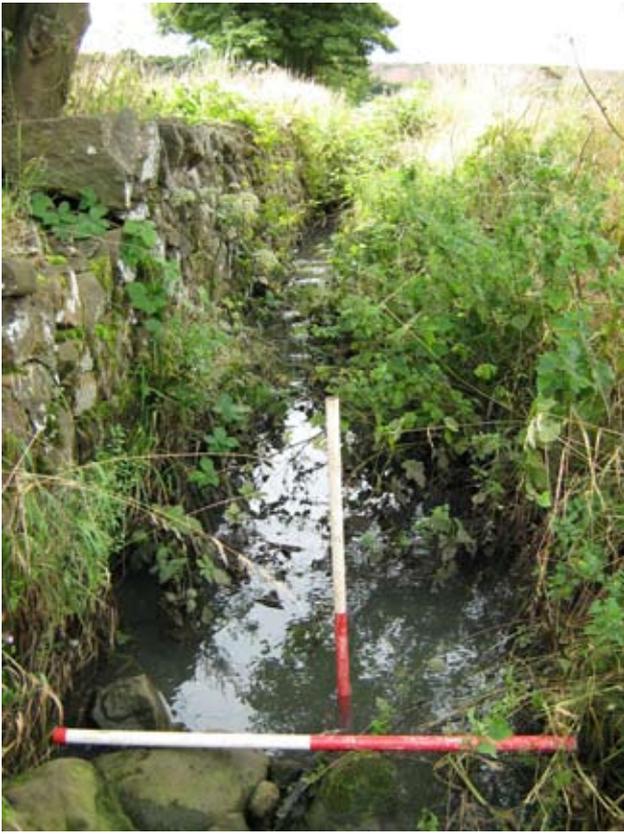
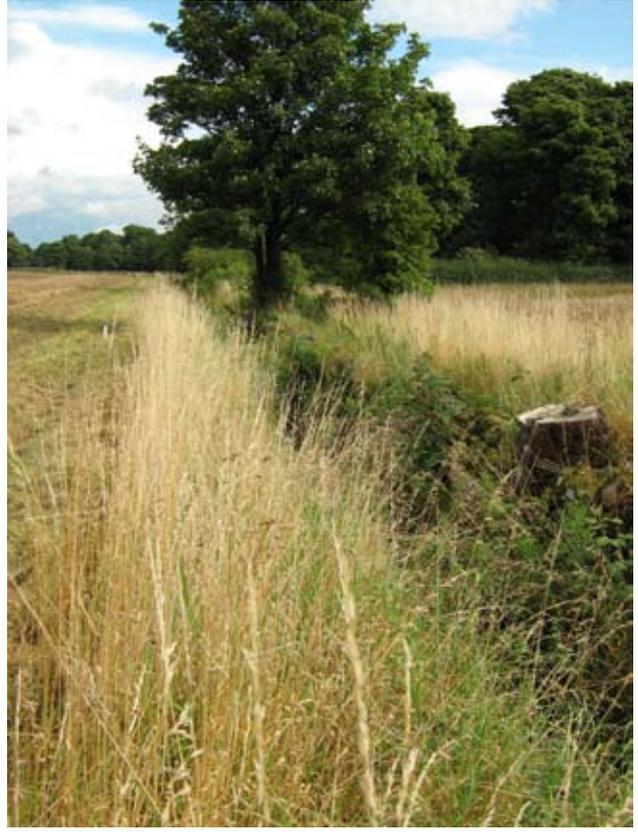
Fig. 22 - Pre-demolition shot of boundary FB05

Fig. 23 - Pre-demolition shot of boundary FB05

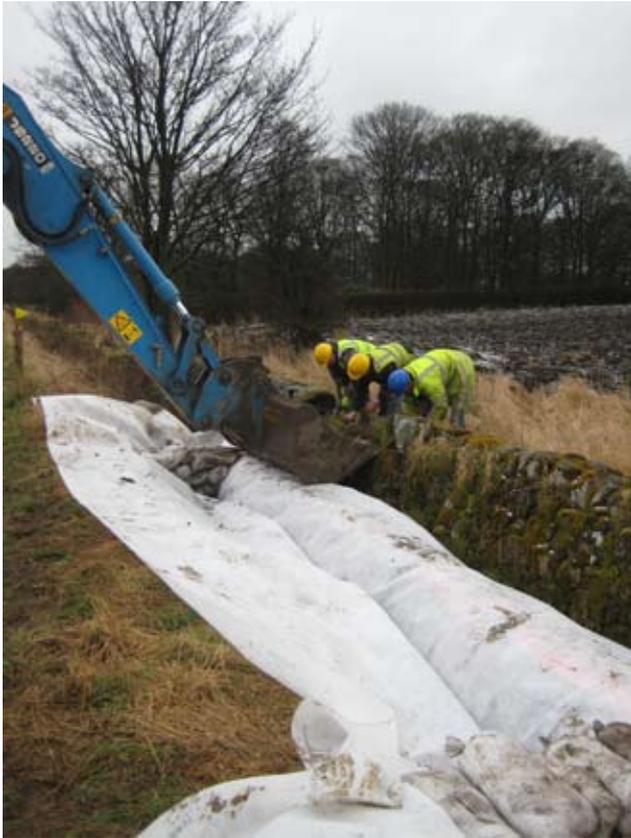
Fig. 24 - Flume pipe in place within ditch and demolition of upper courses of boundary wall FB05 in progress

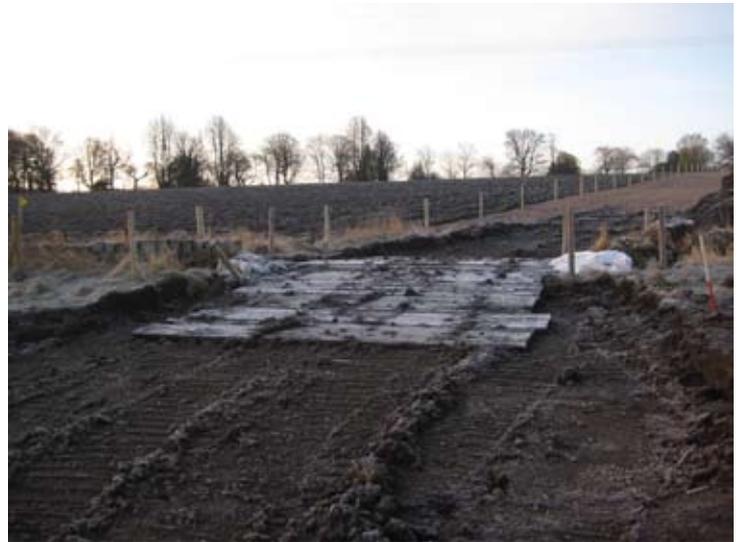
Fig. 25 - Completed access point across the top of the flume pipe and boundary wall FB05
